# **In situ Temperature Evolution and Failure Mechanisms of LiNi<sub>0.33</sub>Mn<sub>0.33</sub>Co<sub>0.33</sub>O<sub>2</sub> Cell under Over-Discharge Conditions**

Linmin Wu, Yadong Liu, Yi Cui, Yi Zhang, Jing Zhang\*

Department of Mechanical Engineering, Indiana University-Purdue University Indianapolis,  
Indianapolis, IN 46202, USA

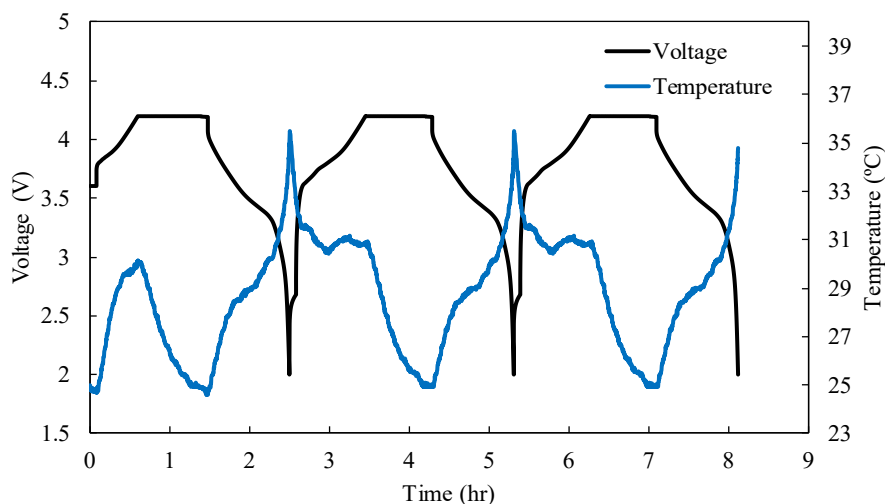
The electrochemical performance of a LG 18650 NMC cell under normal charge-discharge cycles is shown in Fig. 1. The voltage and temperature curves are plotted for the first three cycles. For the constant current charging, the temperature increases  $5.2^\circ \text{C}$  for the first cycle and decreases  $4^\circ \text{C}$  to  $4.5^\circ \text{C}$  for the rest of two cycles. The temperature decreases  $5.1^\circ \text{C}$  for the first cycle and  $6^\circ \text{C}$  for the rest of two cycles during the constant potential process. There are large increases in temperature of about  $10.2^\circ \text{C}$  for the discharge process.

Fig. 1 Voltage and temperature curves of the 18650 NMC cell under normal charge-discharge cycles.

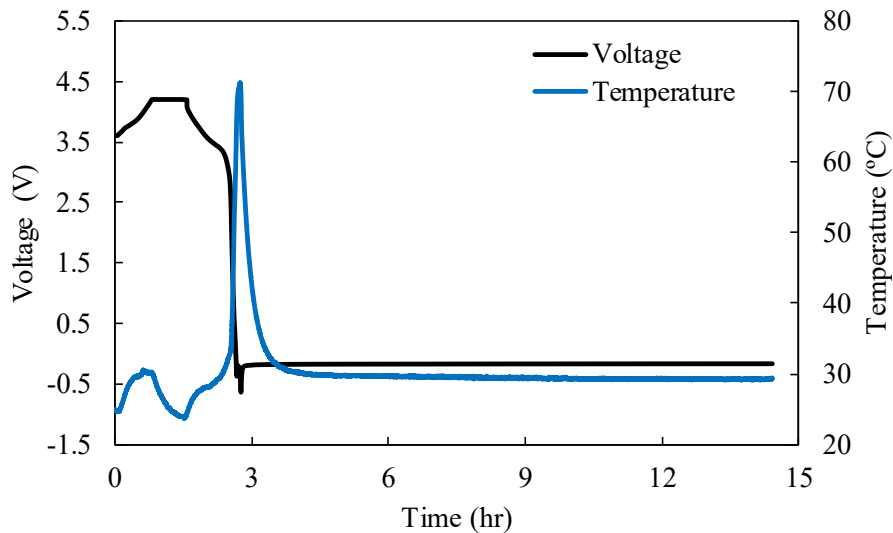
The cell was also cycled in over-discharge conditions. The voltage and temperature curves for the 120% over-discharge are shown in Fig. 2. There is a clear correlation between the voltage and temperature. The cell failed after only 1 cycle. During the over-discharge process, the voltage drops sharply from 2.0 V to -0.8 V, and then goes back to -0.16 V and maintains at -0.16 V. Meanwhile, the skin temperature increases dramatically to 73 °C for over-discharging. After the 120% over-discharge process, the cell was not able to charge, which means the failure of the cell. The large increase of temperature indicating strong exothermal reactions happened inside the cell. This phenomenon implies there might exist micro short circuit inside the cell. It can also be concluded that 120% over-discharge for 18650 NMC cells is extremely detrimental to the cycle performance.

Fig. 2 Voltage and temperature curves of the 18650 NMC cell under 120% over-discharge condition.

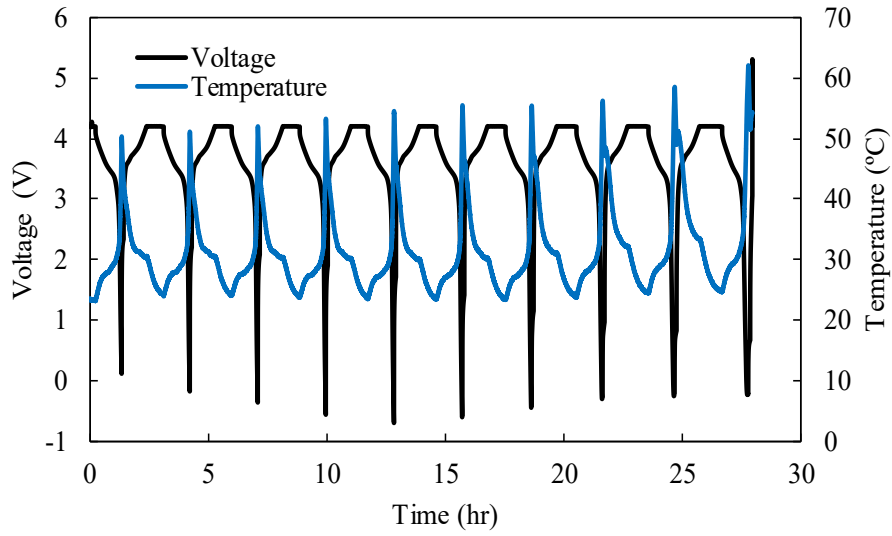
Since the 18650 NMC cell under 120% over-discharge condition failed only after 1 cycle, it is hard to observe the performance change during the cycling. In order to monitor the electrochemical behavior change during the over-discharge process, the NMC cell under 110% over-discharge condition was also studied. The voltage response and monitored temperature for over-discharging is shown in Fig. 3a. Similar to the 120% case, there is a clear correlation between the voltage and temperature. The cell failed after 10 cycles. The voltage at the end of the discharge process becomes negative after 1<sup>st</sup> cycle. It decreases for the first 5 cycles, and reaches the minimum -0.81 V at the 5<sup>th</sup> cycle. And then, the voltage increases until the 10<sup>th</sup> cycle. At the end of the 10<sup>th</sup> cycle, the voltage is still negative, which is -0.21 V. After 10<sup>th</sup> cycle, the voltage increases dramatically to 5.62 V and the cell was unable to discharge, which implying the failure. The temperature evolution during the over-discharge condition is also shown in Fig. 3a. The temperature increases from 23.2 °C to 61.7 °C. The temperature at the end of discharge process, which is the peak temperature at each cycle, shows a trend of increase with a rate of 1.13 °C/cycle (see Fig. 3b), while the temperature at the end of the charging process has a much smaller increase speed, which is 0.16 °C/cycle. The peak temperature values and discharge capacity retention of the NMC cell are given in Fig. 3b. With the increase of the cycle number, the capacity retention decreases from 100% to 99.7% for the first 7 cycles, and then decreases sharply to 96.7% at the end of 10<sup>th</sup> cycle. Meanwhile, the peak temperature of the NMC cell increases sharply from 55.1 °C to 61.74 °C for 7<sup>th</sup> cycle to 10<sup>th</sup> cycle. The above observations suggest the micro short circuits formed under 110% over-discharge conditions, and strong exothermal reactions occurred inside the cell. With the increase of the cycling number, the micro short circuits were developing, which can cause further damage to the electrochemical performance.

Fig. 3 (a) Voltage and temperature curves of the 18650 NMC cell under 110% over-discharge condition. (b) Peak temperature and discharge capacity retention of the 18650 NMC cell under 110% over-discharge condition.

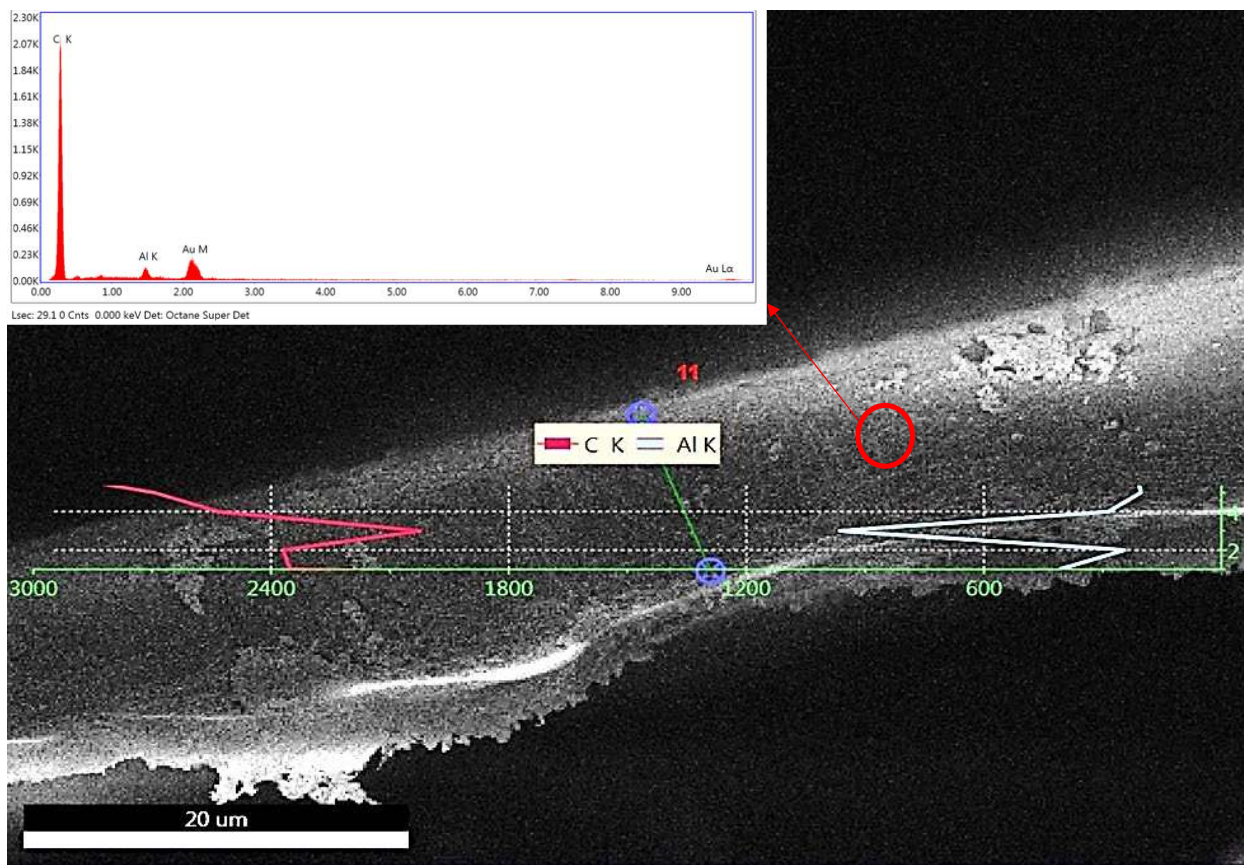
Fig. 4 SEM image of the separator under normal charge-discharge condition. EDX line and area scan results are shown in the image.

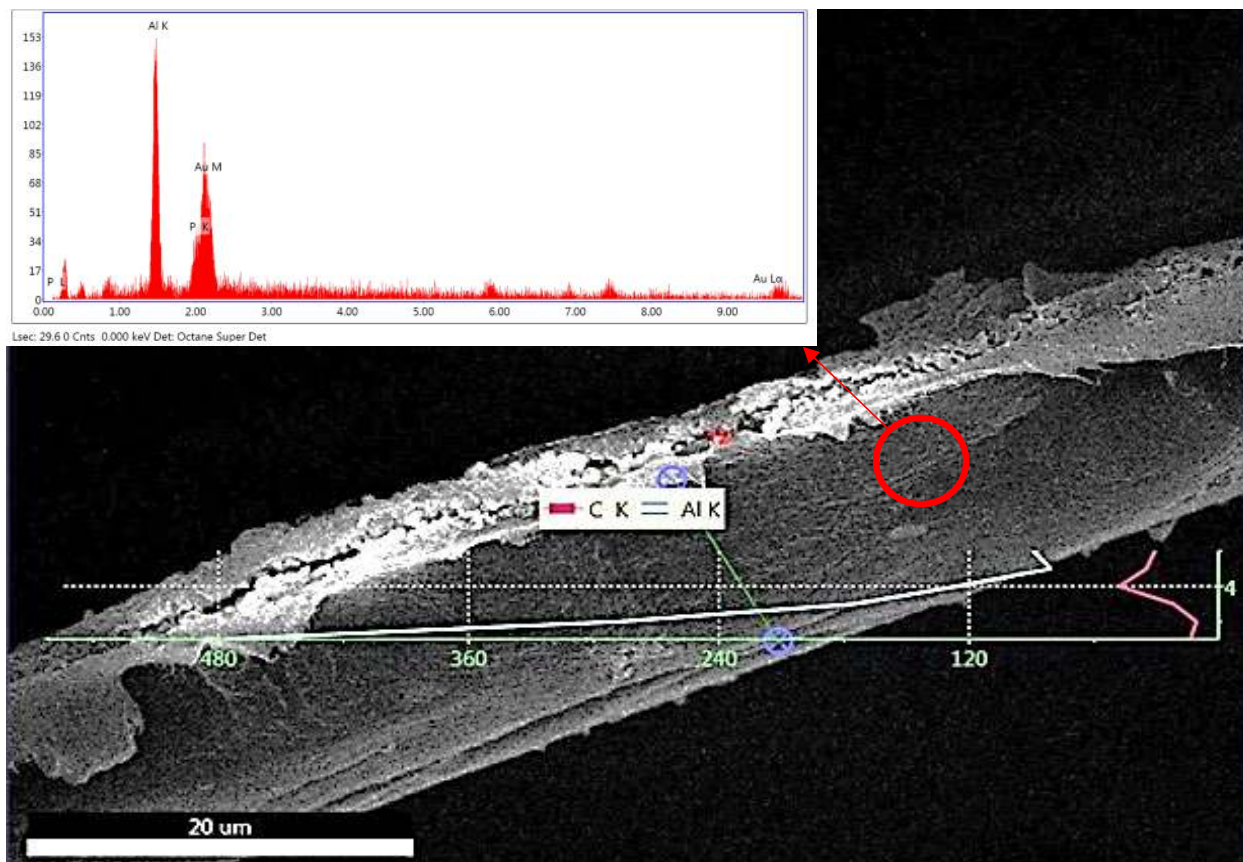
the increase of the cycle number, leading to a uniform distribution of the melted spots. Similar to the 110% over-discharged sample, large amounts of aluminum were found inside the 120% over-discharged separator (see Fig. 6), and the content of aluminum is higher than carbon. Although EDX results can not show absolute contents of the elements, it can show the changes of relative contents. The relative amount of aluminum increases dramatically after over-discharging. It seems like something formed in the separator during over-discharging.

Fig. 6 SEM image of the separator under 120% over-discharge condition. EDX line and area scan results are shown in the image.

short circuit during over-discharging, other ceramic material needs to be used as additives to the separator instead of aluminum. Such ceramic additives should have high temperature tolerance and good chemical stability inside the battery.

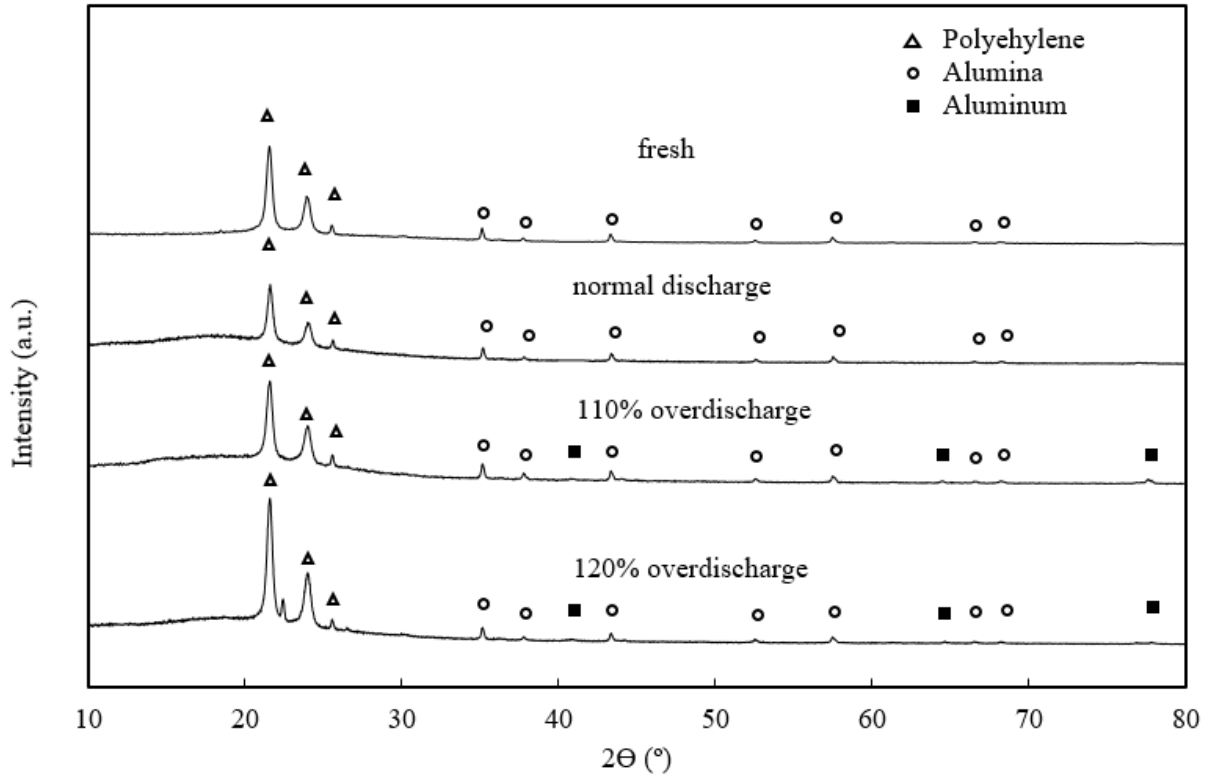
X-ray diffraction was conducted to reveal the compositional change inside the separator after over-discharging. The XRD patterns for the fresh separator, and the separators under normal discharge, 110% over-discharge and 120% over-discharge conditions are shown in Fig. 7 (a) and (b). Before  $30^\circ$ , the peaks of polyethylene, which is the major composition of the separator, were shown. Meanwhile, some alumina peaks were found in both cycled and uncycled separators. This implies that the alumina was not formed inside the separator during the charge and discharge process, and it was coated inside the separator during the manufacturing process. It is noted that

around  $41^\circ$ ,  $65^\circ$  and  $78^\circ$ , the aluminum peaks exist for the separators under 110% and 120% over-discharge conditions, while no aluminum was found for the fresh separator and the separator under normal discharge condition. This suggests the aluminum was formed inside the separator under over-discharge conditions.

Fig. 7 XRD patterns for fresh separator, and separators under normal, 110% and 120% over-discharge conditions. (a)  $2\theta$  ranges from  $10^\circ$  to  $80^\circ$ ; (b)  $2\theta$  ranges from  $30^\circ$  to  $80^\circ$ . The XRD patterns were zoomed in to make alumina and aluminum peaks more visible.
