In situ testing and modeling of cultural heritage buildings in Peru

P.B. Lourenço, G. Karanikoloudis & F. Greco

ABSTRACT: This paper provides the results of *in situ* testing and modelling of four case studies in Peru and is part of the ongoing Seismic Retrofitting Project, under the auspices of the Getty Conservation Institute (GCI): Casa Arones (Cusco), Hotel Comércio (Lima), Ica Cathedral (Ica) and Kuño Tambo (Acomayo). These are mostly earthen buildings made with adobe, with the presence of large amounts of timber and, in some cases, brick masonry and rubble stone masonry (mostly for the base course in contact with the ground). *In situ* testing consist of an extensive sonic testing campaign and dynamic identification. Advanced modeling of two case studies allowed demonstrating that these structures have a high vulnerability and require strengthening measures.

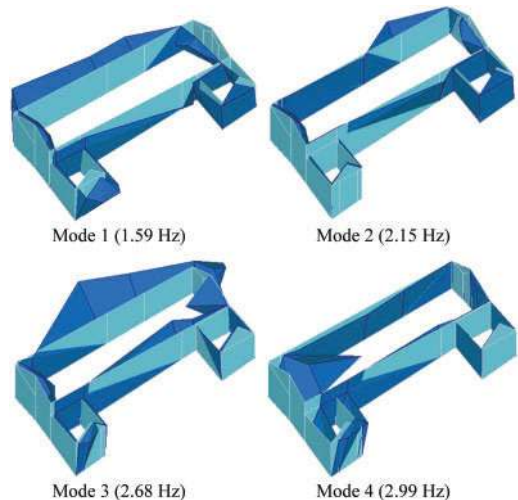
Figure 3. Mode shapes obtained from the SSI Method, of the first four modes, with interpolation.

The first four modes were defined and the frequencies and damping ratios for each method were obtained, see Figure 3. As can be seen from the configuration of the mode shapes, the structure seems not to have global modes involving continuity of the different parts. The dynamic response is characterized by the absence of box behavior, with lack of connection between the lateral and gable walls, and between the walls and roof. This lack of connection can be associated with the visible cracks close to the corners. Thus, each wall seems to be excited mostly independently, with mode shapes similar to those of a cantilever beam. Note that the measuring points' resolution is low, given the time constraints.

Mode 1 corresponds to the first mode in the transversal direction of the nave. Both the lateral and gable walls of the nave experience a symmetric 1st order out-of-phase excitation with high amplitudes. In mode 2, the configuration is similar, except by the fact that the west wall of the nave has a 2nd order curvature, with a deflection point near the middle span. Mode 3 corresponds to a complex mode, which involves the in-phase and out-of-plane excitation of the west wall, with the north façade in a 2nd order curvature. Lastly, the

mode 4 is mainly characterized by the high amplitude of the out-of-plane deflection of the south façade.

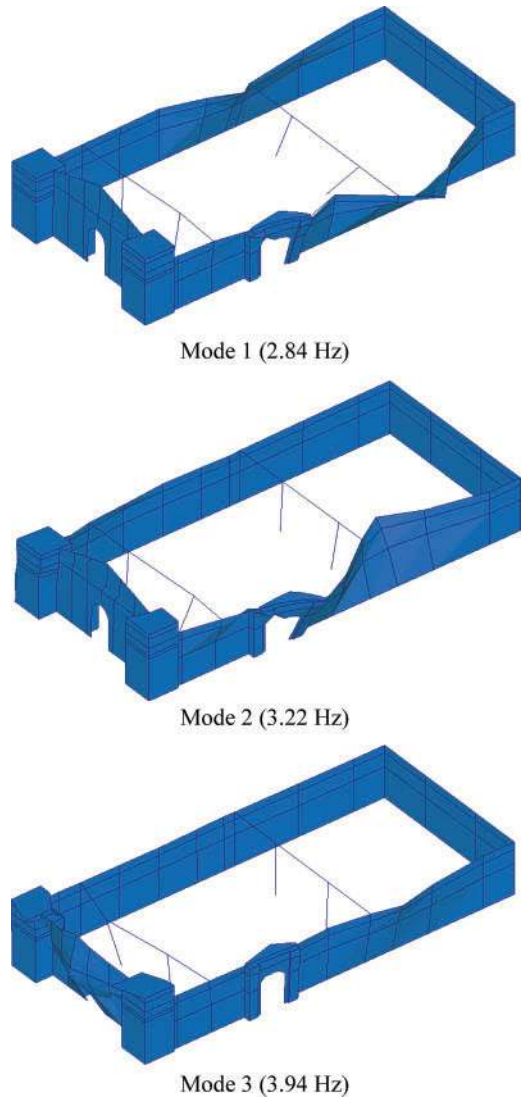
Figure 6. Mode shapes obtained from the SSI Method, of the first three modes, with interpolation.

The selection of poles and the link of modes from the four setups using the SSI methods are presented in Figure 5. The first three modes were analyzed as the higher modes do not have a significant influence on the dynamic behavior of civil engineering structures and the calibration of a numerical model based on several modes is difficult, see Figure 6. Mode 1 corresponds to the 1st mode in the transversal direction of the longitudinal side walls of the Cathedral. Both the longitudinal walls of the nave experience a 1st order out-of-phase excitation with higher intensity in the north wall in the transept area, meaning again that the timber structure seems weakly connected to the masonry structure. Mode 2 identifies the 2nd order curvature of the north wall, with a deflection point near the middle span, between the two measured points. Mode 3 corresponds to a complex mode, which is mainly characterized by the out-of-plane movement of the main façade.

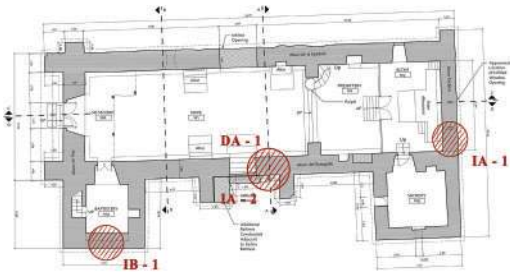
Figure 8. Locations of the sonic tests in Kuño Tambo Church.

As an example, the locations of the tests performed in Kuño Tambo Church are shown in Figure 8. Indirect sonic tests corresponding to the codes IA – 1 and IA – 2 have been performed on adobe masonry walls of the east wall and of the north façade. Due to the presence of paintings in the interior of the Church as well as the different level between the interior and exterior, just one direct test was possible (DA – 1) corresponding to the same grid of the one defined for the test IA – 2. Finally, the base course has been tested (IB – 1) with

indirect sonic tests on the exterior side of the baptistry wall, on the east side of the Church.

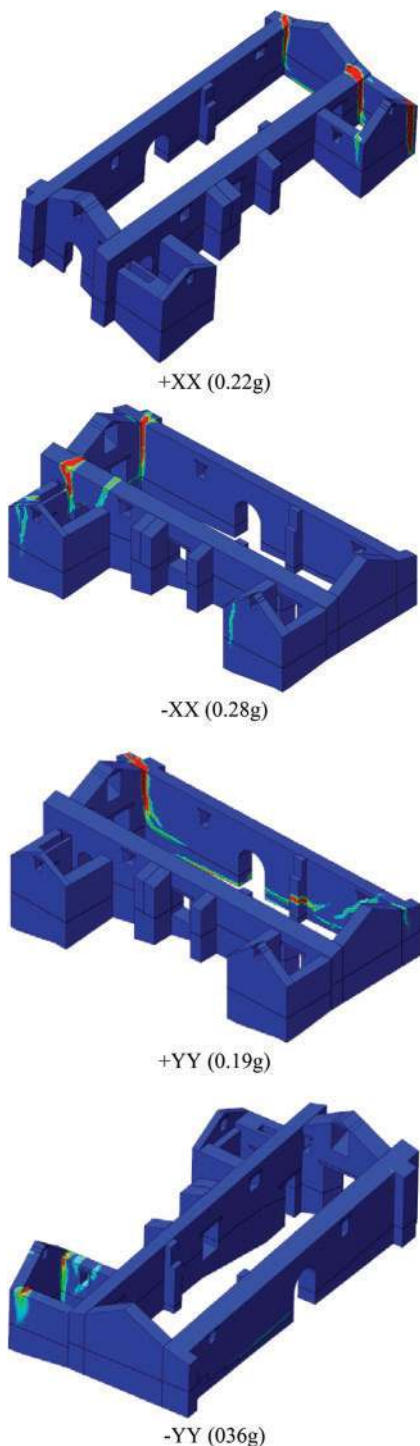
Figure 9. Distribution of maximum principal tensile strains at ultimate stages for different loading directions (red indicates maximum crack opening). The capacity of structure (measured by a percentage of the mass horizontally applied) is also shown).

The results in terms of maximum principal strain at failure are shown in Figure 9 at collapse. One of the structural deficiencies of the church is large asymmetric distribution of stiffness in the transverse direction of the nave. The aligned walls and buttresses of the east part, when activated through diagonal compression, have a stiffer response and a larger lateral capacity.

The failure mode with the lowest capacity, the out-of-plane overturning of the west lateral wall, controls the response, and the obtained minimum value is 0.19 g. According to the pushover analyses, strengthening is needed in multiple directions, since the overall capacity does not reach the peak ground acceleration for the region (0.30 g).

The weakest directions, with very low lateral capacity for the structure without ties are the east-west direction (+YY) and the south-north direction (+XX). Karanikoloudis and Lourenço (2015) showed that with the usage of an adequate tying system, the capacity of the structure in east-west direction (+YY) is significantly increased but the same does not happen in the south-north direction (+XX), where the adequacy of remaining partly destroyed buttressing walls (not

considered in the model), and their connection to the church, must be addressed.

The possible reintroduction of the buttresses in the west lateral wall will increase the stiffness in the west part and will much positively contribute to the behavior of the nave and will increase the global capacity of the structure. The connection of the ties to the walls should be reestablished, ensuring adequate behavior in tension and compression by using a larger cross section and anchor keys/embedded timber trusses, and two new ties should be possibly added to reduce the large spacing between existing ties. New ties should also be inserted at the top of the baptistery and sacristy sidewalls, in order to limit out-of-plane local collapse modes. The connectivity in the intersections between walls can also be enhanced with the use of corner keys, which can stiffen the gable walls and prevent out-of-plane collapse modes. Such corner keys can be placed in the corners of the north gable wall, the baptistery and sacristy.

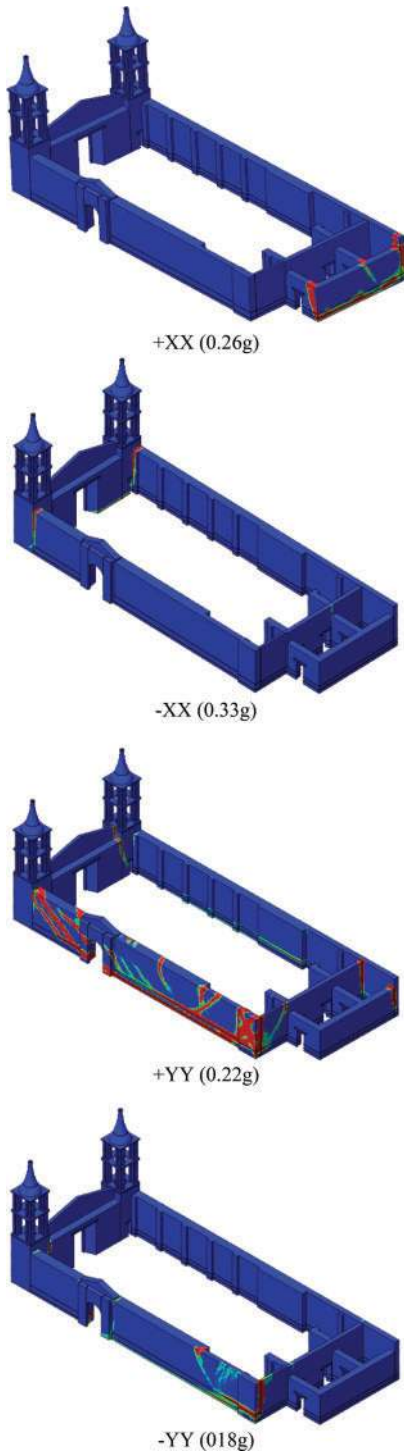
Figure 12. Distribution of maximum principal tensile strains at ultimate stages for different loading directions (red indicates maximum crack opening). The capacity of structure (measured by a percentage of the mass horizontally applied is also shown).

The results in terms of maximum principal strain at failure are shown in Figure 12 at collapse. From the pushover analyses performed, it can be concluded that the masonry envelope has a better seismic performance in the XX direction of the numerical model than YY direction, as expected. Transversal directions are usually the weakest in this type of buildings. The minimum capacity of the masonry structure is in the -YY direction of the numerical model, which is a value of 0.18 g, which is the controlling failure load

and mechanism. This value is much lower than the PGA considered in the code for the region (0.40 g).

A good correlation of damage observed in-situ due to the Pisco earthquake of 2007 and in the numerical model is noticed. It can be concluded reasonably that the FEM model is representing well the global response of the structure. The failure modes in all the directions of the numerical model involves the development of flexural cracks at the base course of the masonry envelope. The integration of the two substructures (timber and masonry) in a combined model provided an increase in seismic capacity of about 25% in both orthogonal directions, when comparing the complete timber and masonry structure with respect to only the masonry envelope. As the timber structure is rather complex and the connections between the two structures play a relevant role in the response, this strength increase must be considered with much precaution.

Global strengthening is therefore required and needs to address the most vulnerable region of the structure identified by the pushover analysis, i.e. the wall near the north-western corner of the Cathedral, as well as other out-of-plane mechanisms. The reduction of the out-of-plane vulnerabilities found might be addressed by tying, additional buttressing, ring beams, proper connections and / or other measures. Ensuring adequate connection between the timber and masonry substructures also provides better global response of the structure.
