# In-situ thermography of automated fiber placement parts

# In-Situ Thermography of Automated Fiber Placement Parts

Elizabeth D. Gregory<sup>1a)</sup> and Peter D. Juarez<sup>1b)</sup>

<sup>1</sup>*NASA, Langley Research Center, Hampton, Virginia*

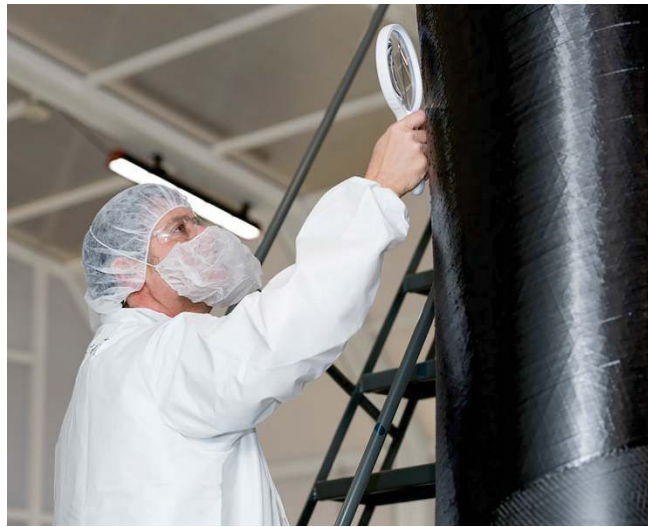
**FIGURE 2.** Example of actual visual inspection of a composite AFP part.

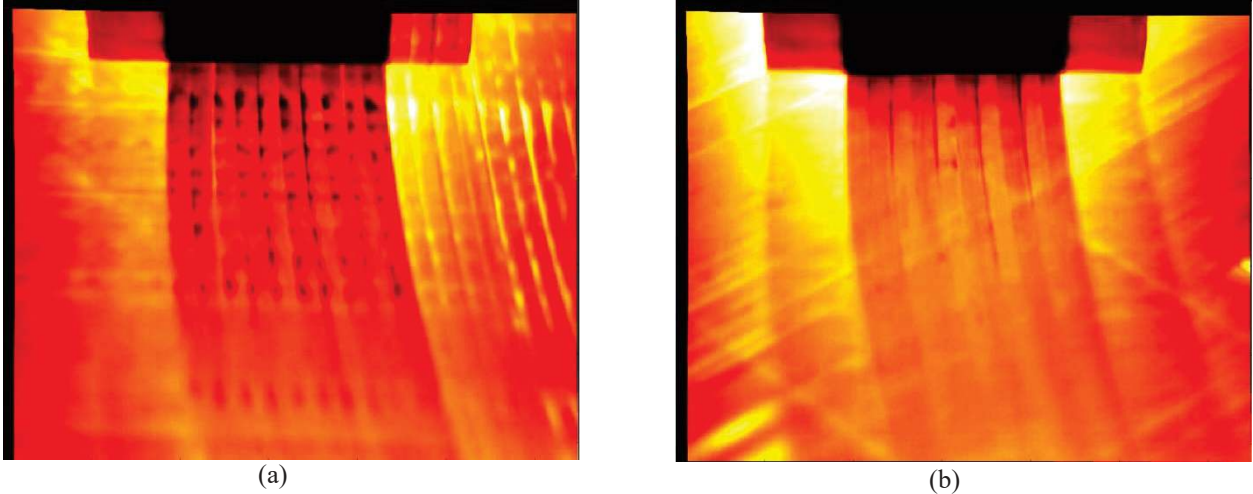
Figure 5 shows some the individual frames captured by the in-situ thermal camera. Subfigure a) shows examples of tows that are peeling-up due to the steering compared to subfigure b) that shows tows without the peel-up. The black corresponds to cooler areas so the tow peel-up appear as dark, cool spots.

**FIGURE 5.** Example of a single frame of data collected by the integrated thermal camera on ISAAC AFP system at NASA Langley.

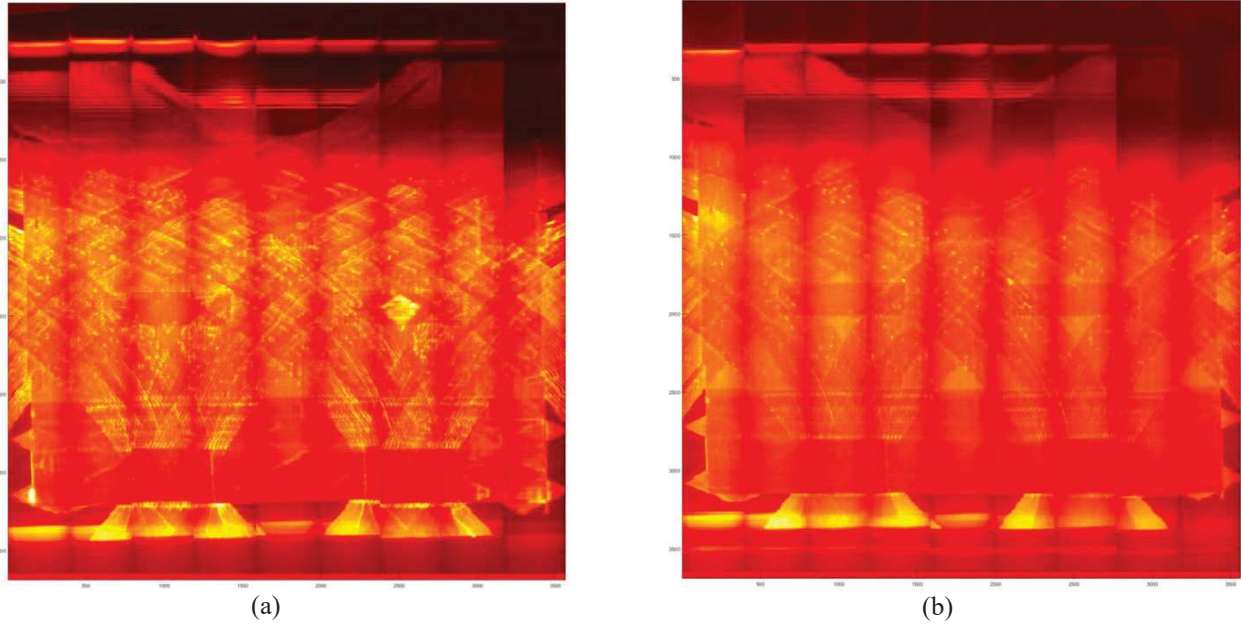
**FIGURE 7.** Temporally aligned *in-situ* Thermography data for the Go-1 risk mitigation panel before (a) and after a debulking cycle (b).

Secondly, the major concern of the GO-1 risk mitigation panel build was tow peel-up that occurs over time after the course is placed, allowing time between when fiber placement and scanning optimizes the opportunity to observe tow peel-up. Figure 7(a and b) shows the thermographic scan data that has been spatially registered and temporally aligned.

Figures 8a and 8b show the spatially registered and temporally aligned data for the GO-1 cylinder. The areas of concern observed in the data collected prior to the debulk cycle are the edges of the tows in the tow steered courses. The change observed after debulking is dramatic as shown in subfigures b) of Figs. 7 and 8.

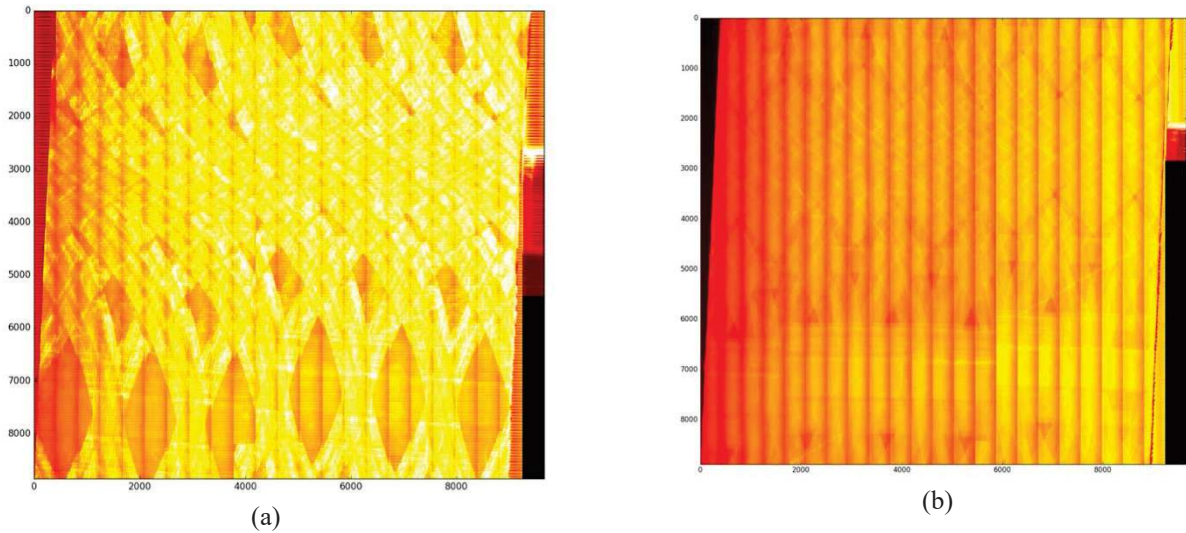
**FIGURE 8.** Temporally aligned *in-situ* Thermography data for the Go-1 Cylinder before (a) and after a debulking cycle (b).
