Incidence and Causes of Physical Failure of Artificial Habitat Structures in Streams of Western Oregon and Washington

CHRISTOPHER A. FRISSELL AND RICHARD K. NAWA

*Oak Creek Laboratory of Biology
 Department of Fisheries and Wildlife, Nash Hall 104
 Oregon State University, Corvallis, Oregon 97331, USA*

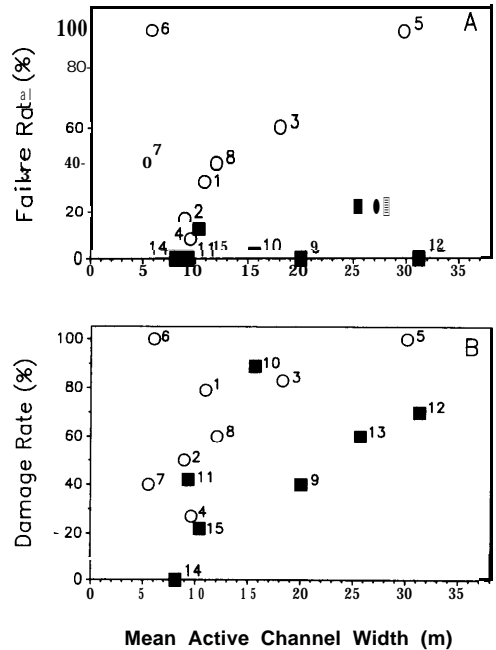
Rates of damage were higher in larger and wider streams (Figure 2B). Projects in streams with active channel widths wider than 15 m had a median damage rate of 79% (range, 50-100; N = 6) whereas those with active channels narrower than 15 m were highly variable and had a median damage rate of 50% (range = 0-100; N = 9). Southwest Oregon data suggested a roughly linear increase in failure rate with stream width (Figure 2A). In southwest Washington, failure rate apparently was not correlated with stream width, although impairment and therefore damage rate were correlated with stream size. There was no clear relationship between drainage basin area and failure or damage rates. Because climatic and hydrologic characteristics of individual streams vary within a region, active channel width is a better site-specific, integrated measure of streamflow and asso-

FIGURE 2.- (A) Failure and (B) damage rates of projects in southwest Oregon (open circles) and southwest Washington (solid squares) in relation to active channel width. Stream numeric codes are given in Figure 1. Damage rate includes both failed and impaired structures.

ciated hydraulic stresses than is basin area. Channel width is influenced by bank material erodibility (Schumm 1960; Richards 1982), which also affects structure performance (see Mode of Failure).

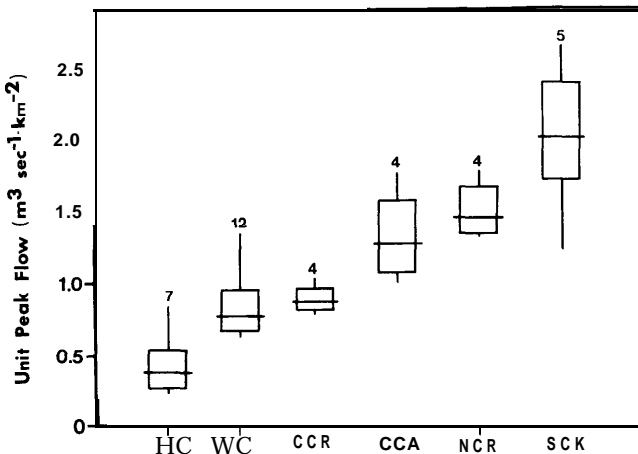
The regions with highest peak flows include the north Coast Range and south Coast Range-Klamath Mountains in Oregon, which are very steep areas with intense rainfall and frequent rain-on-snow events, and the Columbia Cascades, part of the Cascade Range immediately north and south of the Columbia River subject to severe and frequent winter storms that funnel through the Columbia Gorge either from coastal or interior areas. The south Coast Range-Klamath Mountains region, which had the highest incidence of damage

FIGURE 4. - Box plots of 10-year peak flows standardized by drainage area for streams in six regions of western Oregon. Horizontal bar is the median, box is the interquartile range, and vertical line is the data range. Number is the sample size. HC = High Cascades; WC = western Cascades; CCR = central Coast Range; CCA = Columbia Cascades; NCR = north Coast Range; and SCK = south Coast Range-Klamath Mountains.
