Inglesinhos convent: Compatible renders and other measures to mitigate water capillary rising problems

Journal of Building Appraisal (2009) 5, 171–185. doi:10.1057/jba.2009.28

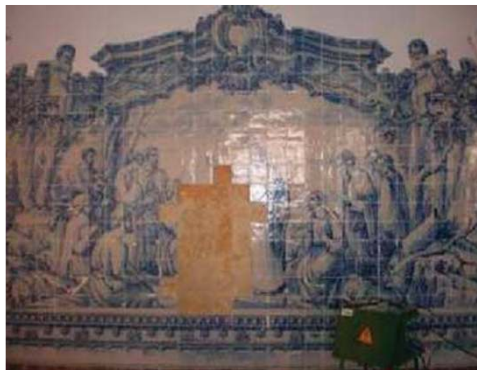
Figure 3: Lacuna in the interior glazed tiles ('azulejos') showing the old lime plaster.

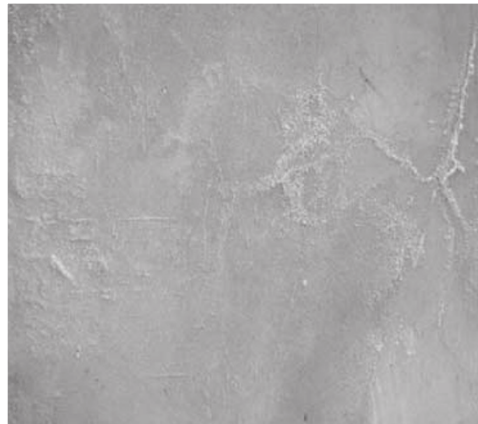
Several anomalies appeared after application of the new renders and plasters: dark moisture stains, salt efflorescences, loss of cohesion of the paint, blisterings and detachment of the paint (Figures 4–6).

Figure 4: Efflorescences in the rendering cracks.

The impermeable external coverings were removed – synthetic finishing, polymeric paints and other polymeric products – and were replaced by a lime-based finishing coat for the regularization of the walls and a silicate-based paint. The lime-based finishing

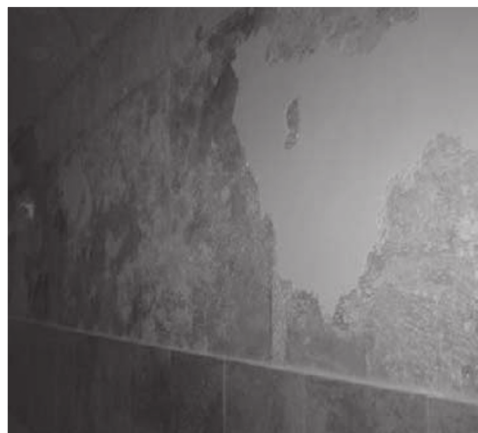
Figure 5: Detachments (large lacuna) of internal finishing.

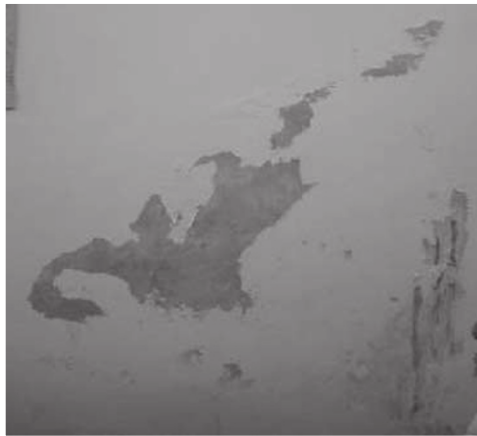
Figure 6: Detachment of the render painting.

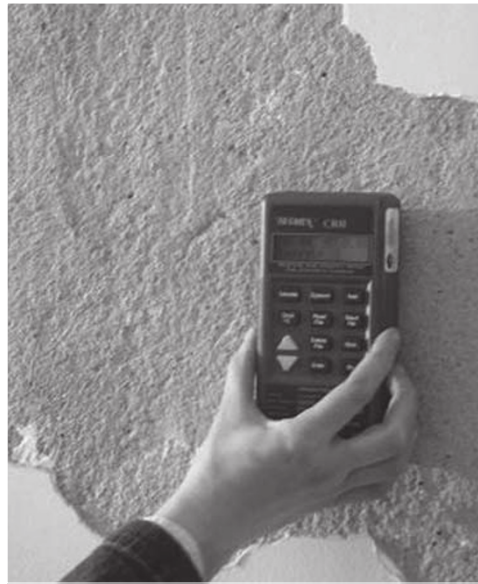
The portable humidimeter (Figure 9) – Tramex CRH – is a device used to evaluate water content in walls (Henriques, 2001; Massari and Massari, 1993; and Veiga *et al*, 2009). This test was performed in several internal and external walls, at different heights – 0.30 m and 1.80 m from the pavement – and in two different conditions – dry weather and after a rainy week – in order to determine the possible origin of the water. The results of these measurements are summarized in Tables 1 and 2.

The comparative analyses of the results reported that the walls of the ground floor experienced higher humidity than those of the higher floors. The interior walls were found to have high moisture contents, almost as high as those of the external walls. This moisture increased after rainy periods. In the interior walls and some exterior walls, the humidity content was higher at the base, decreasing towards the top of the walls. High moisture contents were concentrated at the base of the vaults and in other places, especially near the windows and under the cornice. These results showed that the main water source is not infiltration by exterior walls, and that there is capillary rising water

Figure 9: Evaluation of the moisture content with portable humidimeter.

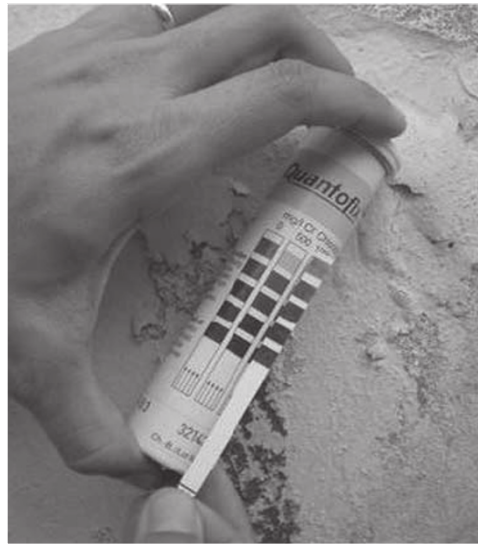
With the strip tests (Figure 10), information on the type of salts present was obtained, as well as information on the degree of contamination, based on semi-quantitative determination of the ions associated with the type of salt (Borrelli, 1999 and Veiga *et al*, 2009). The results of these measurements are summarized in Table 3.

The salts present were found to be mainly sulphates (large content in one of the interior walls) and chlorides, but some nitrates were also detected. Their presence was probably due to the interaction of contaminated water from the ground, to the presence of cement in the mortars and to the existence of salts in other wall materials or in the ground. Salts can be transported in a porous material only if dissolved in water (Lubelli *et al*, 2006), and thus their presence indicates water transport through the walls. Despite the lower dissolution rate of sulphates, when compared with the other salts present, the circulation of water in the walls can promote their dissolution and dissemination (Ottosen *et al*, 2008).

Figure 10: Strip tests – semi-quantitative determination of salts.

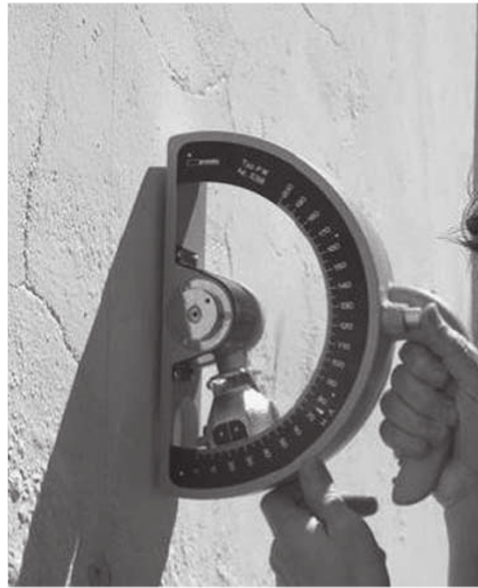
The tests with the pendular Schmidt impact hammer (Figure 11) – Schmidt PM – and those with the Durometer Shore A (Tavares and Veiga, 2007) (Figure 12) based on ASTM D22240, were performed to assess the strength of the superficial layers of renders, in order to verify how the moisture content affected the mortars' cohesion. The results are summarized in Tables 4 and 5.

The tests showed the reduction in mechanical strength and cohesion of the degraded renders, by comparison with measurements performed on experimental panels made *in situ* and with determinations carried out in previous case studies on sound mortars (Tavares *et al*, 2008). The tests with the pendular Schmidt hammer were more expressive than those with the Durometer, which affects more superficial layers.

Figure 11: Pendular Schmidt impact hammer test.

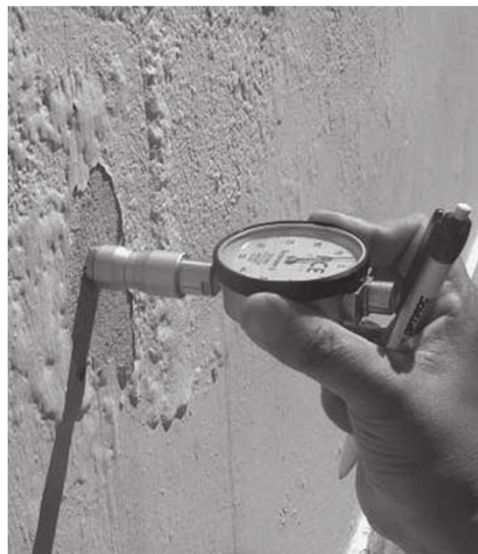
Figure 12: Durometer test.
