An Investigation of Diesel-Generator Shaft and Bearing Failures.

Abstract: A shaft failure in a 634 kW diesel generator after 4000 hours of operation required investigation, especially when similar sets began to show signs of excessive bearing housing wear. The failure was found to be due to torsional fatigue caused by operation at an unforeseen resonant condition. The damage to the bearing housing of this type of set was also attributed to this behaviour.

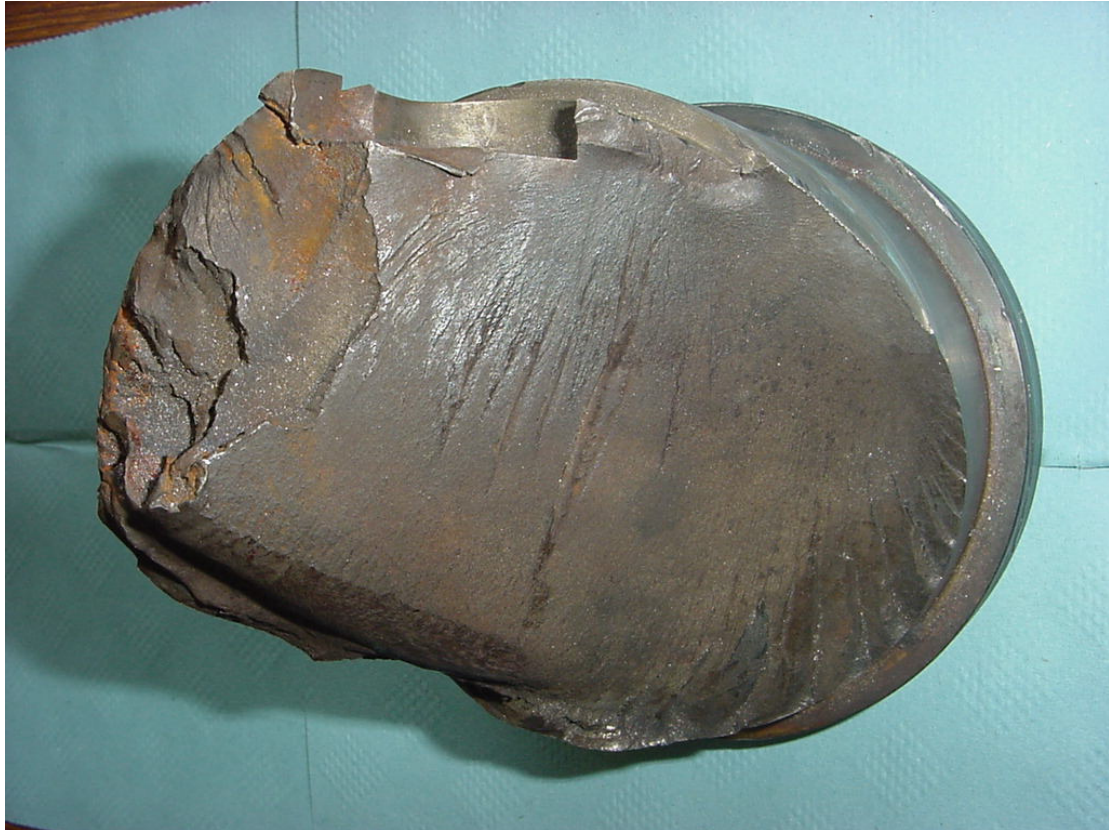
The generator shaft that failed was 110 mm diameter at the section where the break occurred. The fracture occurred near to the coupling end of the machine and the fracture surface included the keyway that was used to locate the coupling half on the generator shaft. Figure 1 shows the “generator side” of the failed shaft. The fractured surface was predominantly at 45° to the shaft axis and showed the classic signs of being a torsional fatigue failure.

The fracture surfaces had suffered significant consequential damage during the failure process so the site of initiation of the fatigue could not be determined with certainty using fractographic methods. Two potential sites were identified; 1) the keyway root 2) a possible indication of a 6 mm material defect, near to the surface of the plain shaft and approximately 20 mm from the keyway.

ESDU 86028 (2) provides information on stress concentration factors in standard keyways suggesting that the critical area is at the root where the parallel section meets the semicircular end and stress concentration levels of 3.4 – 4.0 are applicable based on the maximum shear stress in a plain shaft. The keyway root radii were checked to ensure that there was no possibility that they were sharper than the standard forms for which the data was applicable. The keyway dimensions were found to conform to the standard dimensions. This suggested that a fluctuating torsional shear stress of the order of 50 MN/m² would be necessary to initiate a fatigue failure from this site. It can be seen from Figure 1 that the fracture surface did include this most highly stressed region of the keyway.

Figure 1 View of fractured shaft looking from coupling end towards generator.

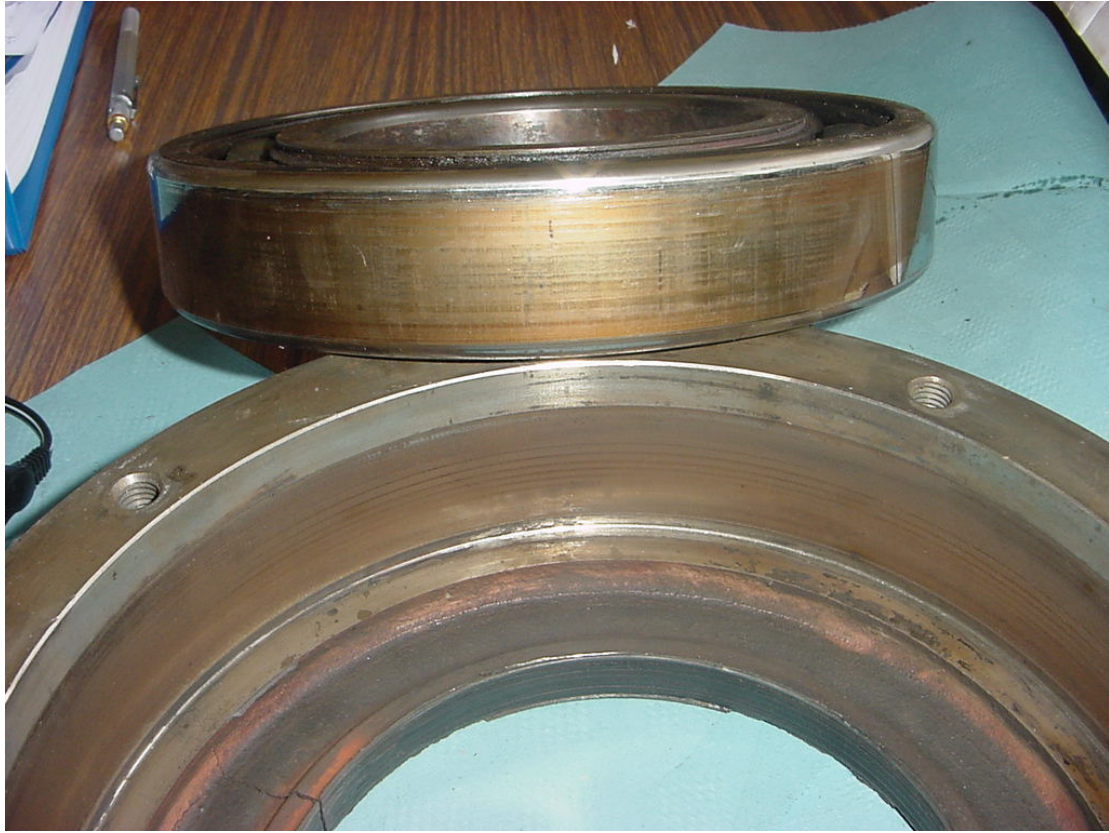
The bearing was a deep groove radial ball bearing of 120 mm inside diameter. The bearing itself had not failed but the cast iron housing showed excessive wear in the region where the outer race of the bearing sat. Micrometer measurements of the wear indicated reasonably uniform radial wear of 0.21 mm (0.008 inches) suggesting that

the outer race had been rotating within the bearing housing. This hypothesis was supported by circumferential marks and gouges on the outer race and discoloration of the bearing due to heat. Figure 2 shows the outer race of the bearing and the housing showing the wear and the marks. The discoloration showed a bluish tint over a 45° segment suggesting that a temperature of 290°C had been reached. The centre of this area was blackened so this temperature was considered to be an underestimate of the peak temperature actually attained within the bearing.

The bearing housing also showed signs of melting, plastic deformation and cracks on the inner bore (Figure 2) but this was attributed to the shaft failure rather than action within the bearing prior to the shaft failing.

Figure 2 View of bearing and housing showing circumferential wear and marking.

The bearings and housings of similar sets were inspected and replaced where necessary. Existing and future designs of diesel driven generator sets are to be scrutinised for the possibility of torsional resonance under part load conditions.

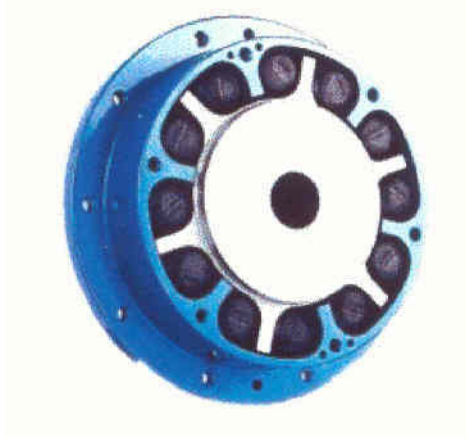
The coupling consisted of 12 rubber cylinders interspersed between driving and driven steel plates as shown in Figure 3. A visual inspection of the coupling found evidence of mechanical damage to the hub in the form of deformation and burring of some of the drive blades and blade cutting damage in the 6 rubber drive elements. The 6 drive elements had suffered excessive permanent set and all of the elements showed signs of hardening. The increase in hardness suggested that the elements had been subjected to high temperatures. This could have been due to high ambient operating conditions (operating temperatures of 70°C were common within sets operating in this region) or heat generated within the rubber if it was subjected to excessive, fluctuating compressive loading produced by torsional oscillation of the shafting system.

Figure 3 Flexible coupling of the type used on the diesel-generator set.

To cure the problem it was necessary to separate the 1st natural frequency of the system from the main torsional excitation frequency to avoid resonance under any load condition. To ensure this, it was necessary to reduce the natural frequency of the system at full load so that it lay below the excitation frequency of 37.5 Hz. This would result in the 1st natural frequency moving further away from 37.5 Hz as the load was reduced. By changing to softer, silicon rubber flexible elements within the coupling it was possible to start with a 1st torsional natural frequency of 34 Hz at full load. This was shown to be far enough away from the excitation frequency to significantly reduce torsional vibration problems. An added advantage of moving to silicon rubber was its ability to operate at higher ambient temperatures.

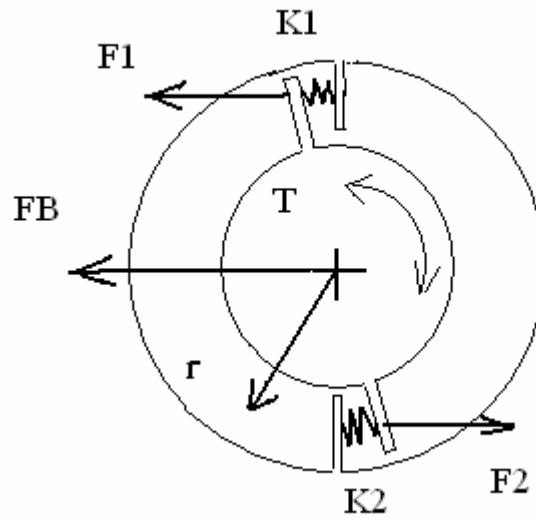
Even though the probability of torsional resonant operation had been established there was no obvious connection between this and the damage to the bearings and housings which required a rotational, radial force of high magnitude. A forcing mechanism could be envisaged by considering a simplified dynamic equivalent form of coupling (Figure 5). k_1 is an equivalent spring representing half of the rubber elements on one side of a given diameter and k_2 represents the remaining half on the other side of the diameter. Due to manufacturing tolerances, variations in material properties etc. it is unlikely that k_1 will be exactly the same as k_2 . Assuming that for the “worst” diameter $k_1 = 0.9.k_2$. The torsional stiffness of the coupling at full load was specified as:-

Although the exact magnitude of the radial bearing force could not be accurately established it was considered that this proposed mechanism showed the possibility of generating a large, rotating, radial force from a torsional resonant operating condition and could explain the damage that was evident on a number of sets.

Figure 5 Equivalent dynamic model of flexible coupling.

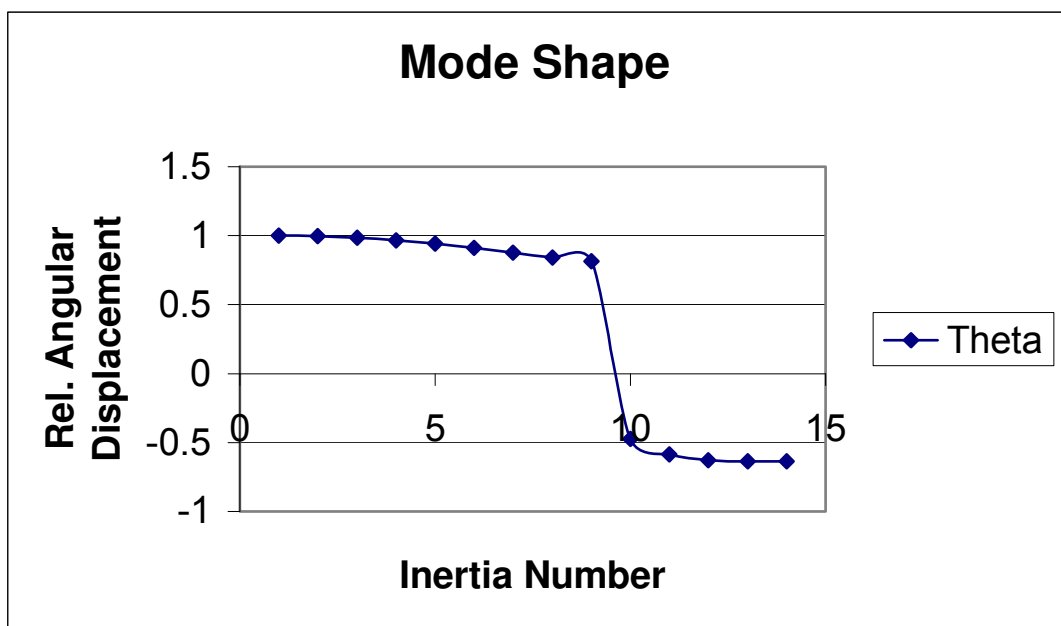
However, it was considered that at some part load condition there was likely to be a point when the 1st torsional natural frequency would coincide with the 1 ½ times excitation frequency (37.5 Hz) and resonance would occur. Assuming a linear reduction in coupling torsional stiffness with load indicates that this would be achieved when operating at approximately 89% of full load. Table 2 shows the Holzer analysis for this case.

Upon consultation with the operators of the machines it was confirmed that the generators were being routinely operated at part load, especially 80-90% part load.

Figure 7 Torsional mode shape for diesel-generator at 89% load.
