Lessons Learned from the St. Francis Dam Failure

J. D. Rogers, "Lessons Learned from the St. Francis Dam Failure," *Geo-Strata*, vol. 6, no. 2, pp. 14-17, American Society of Civil Engineers (ASCE), Mar 2006.

By J. David Rogers, Ph.D., P.E., P.G., M.A.S.C.E.

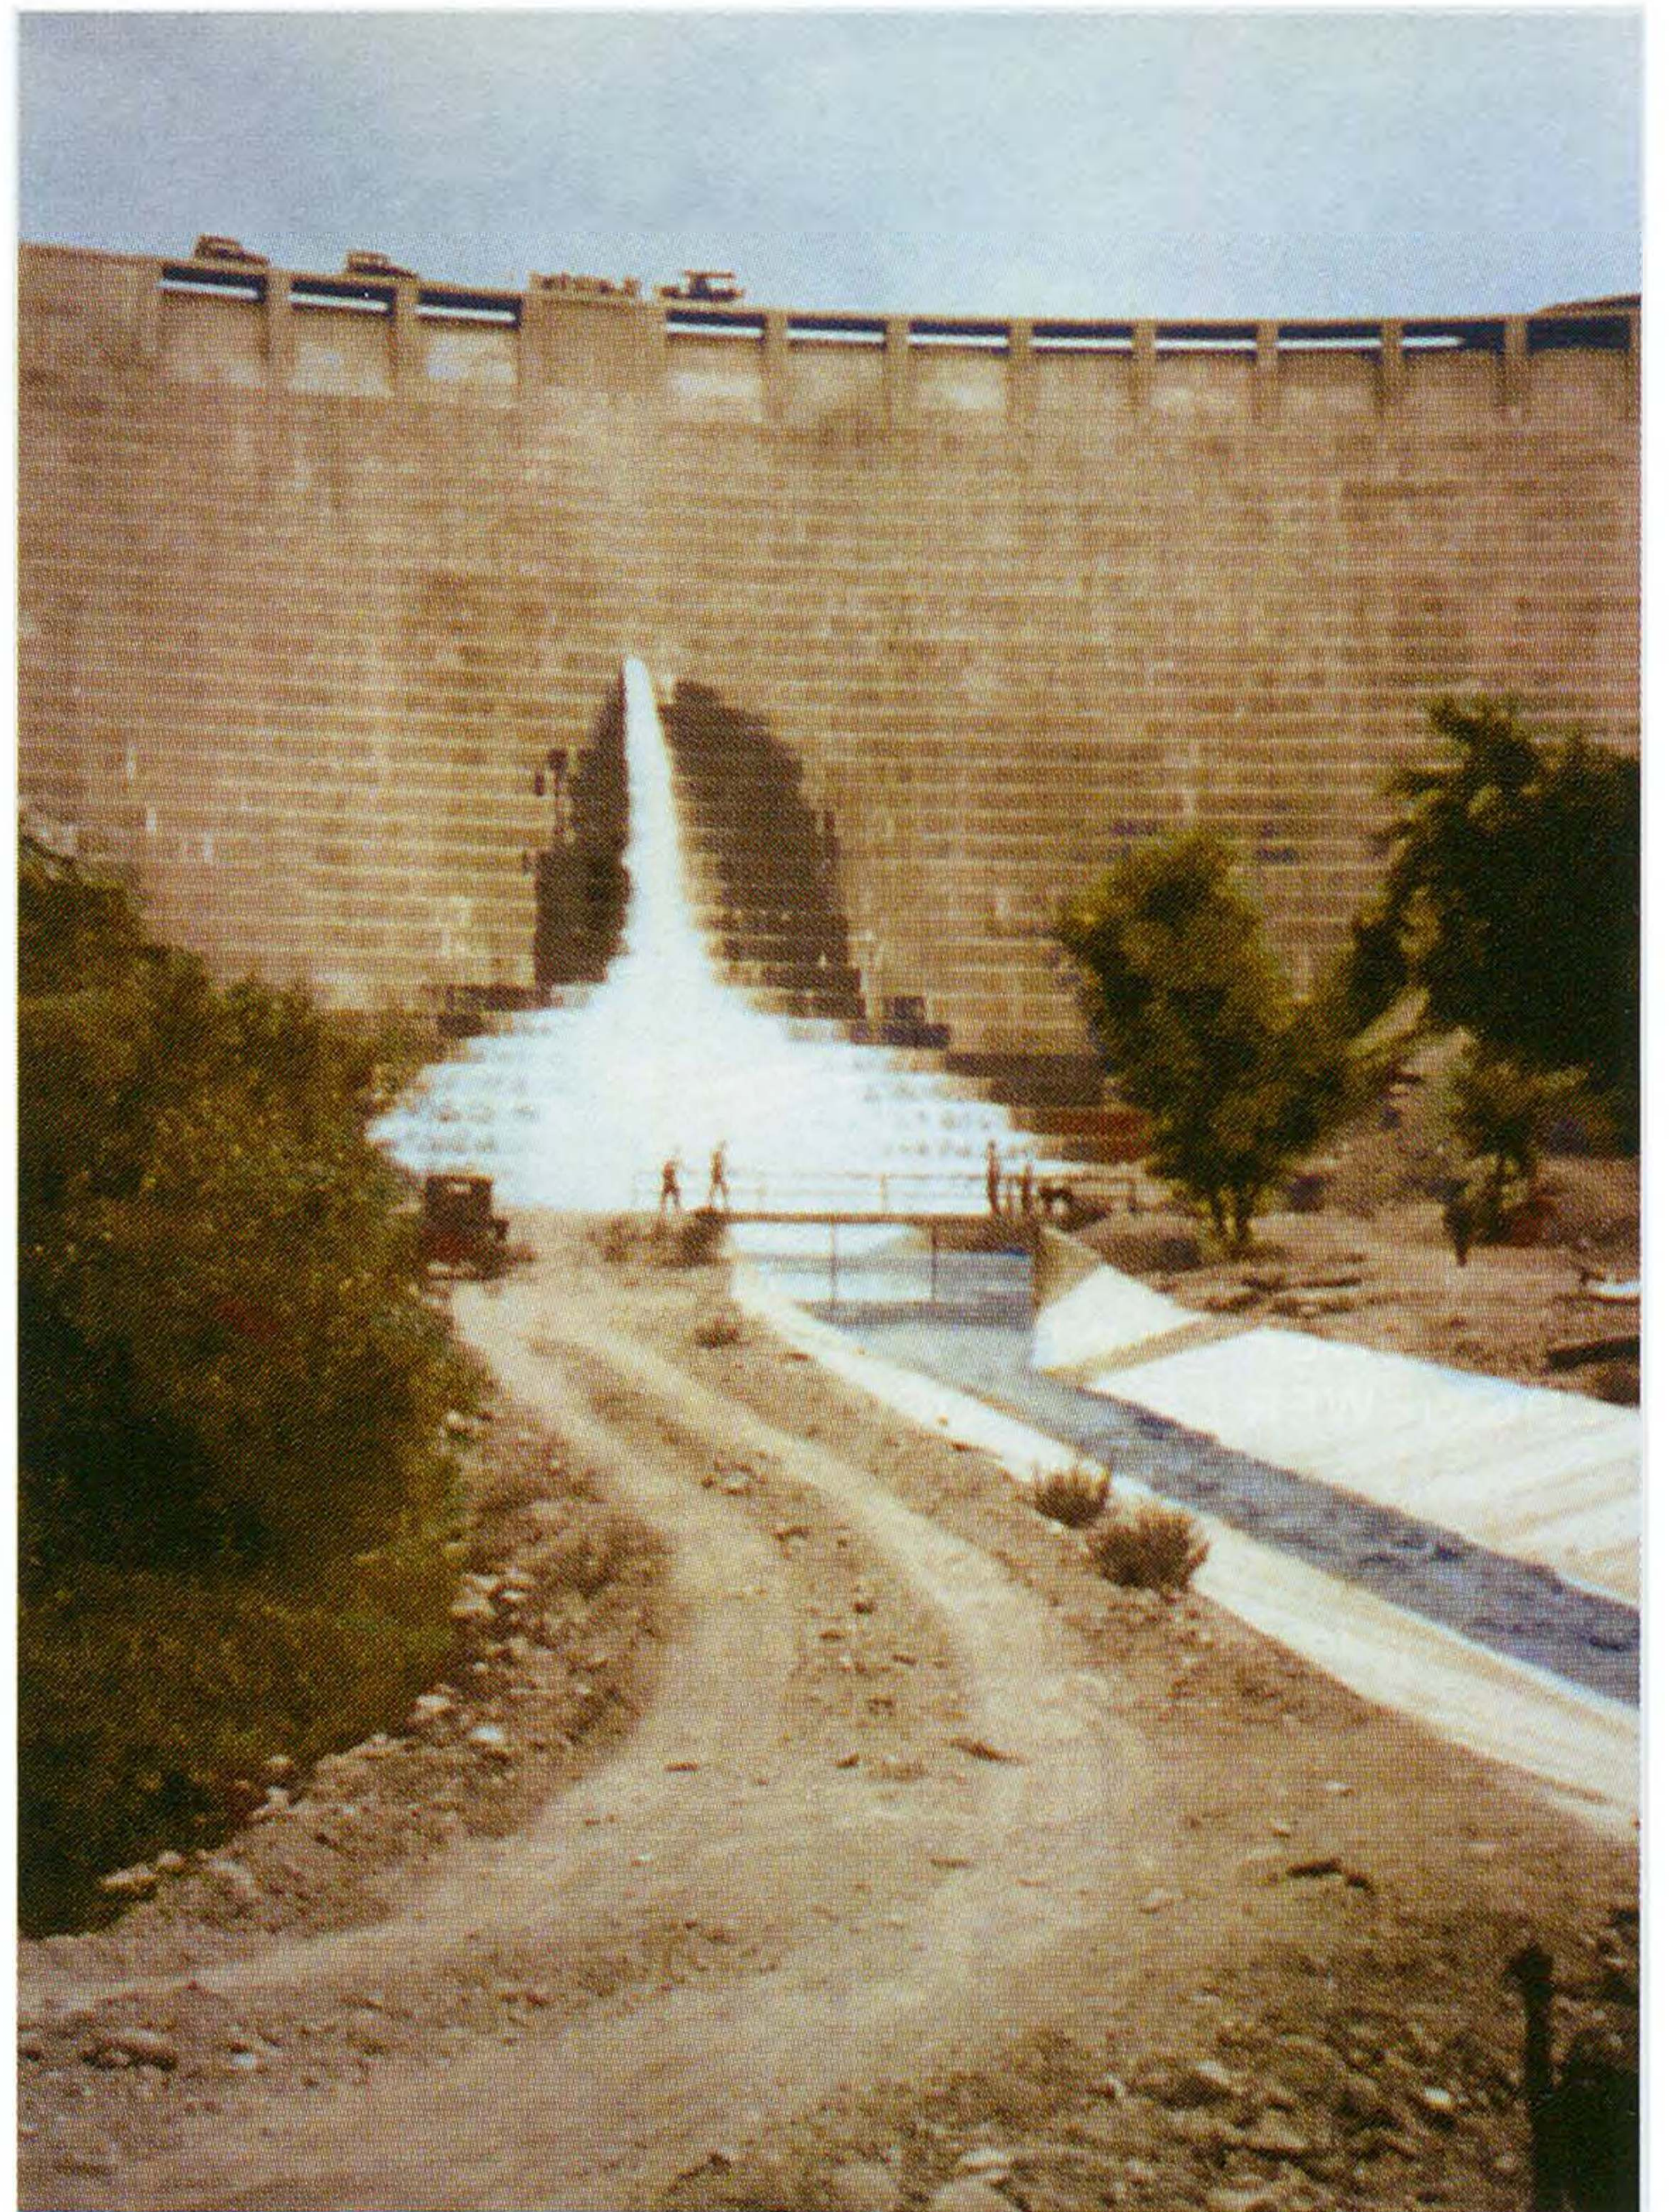
The St. Francis Dam (Figure 1), a curved concrete gravity structure 209-feet high, located in the mountains about 35 miles north of downtown Los Angeles, failed catastrophically near midnight just before March 12, 1928. The failure released 36,180 acre-feet of water down San Francisquito Canyon on a turbulent 55-mile journey to the Pacific Ocean near Ventura, killing 450 people. As the deadliest American civil engineering failure of the 20th century, the city of Los Angeles paid more than \$7 million in restitution to the victims' families and affected landowners. The sudden failure of a new concrete dam constructed by a reputable public agency had enormous repercussions within the civil engineering profession, especially in California.

Figure 1. St. Francis Dam was a curved concrete gravity arch structure 209 feet high, constructed between April 1924 and May 1926 (W.L. Huber Collection, U.C. Water Resources Center Archives, Berkeley, colorized by P. Horton).

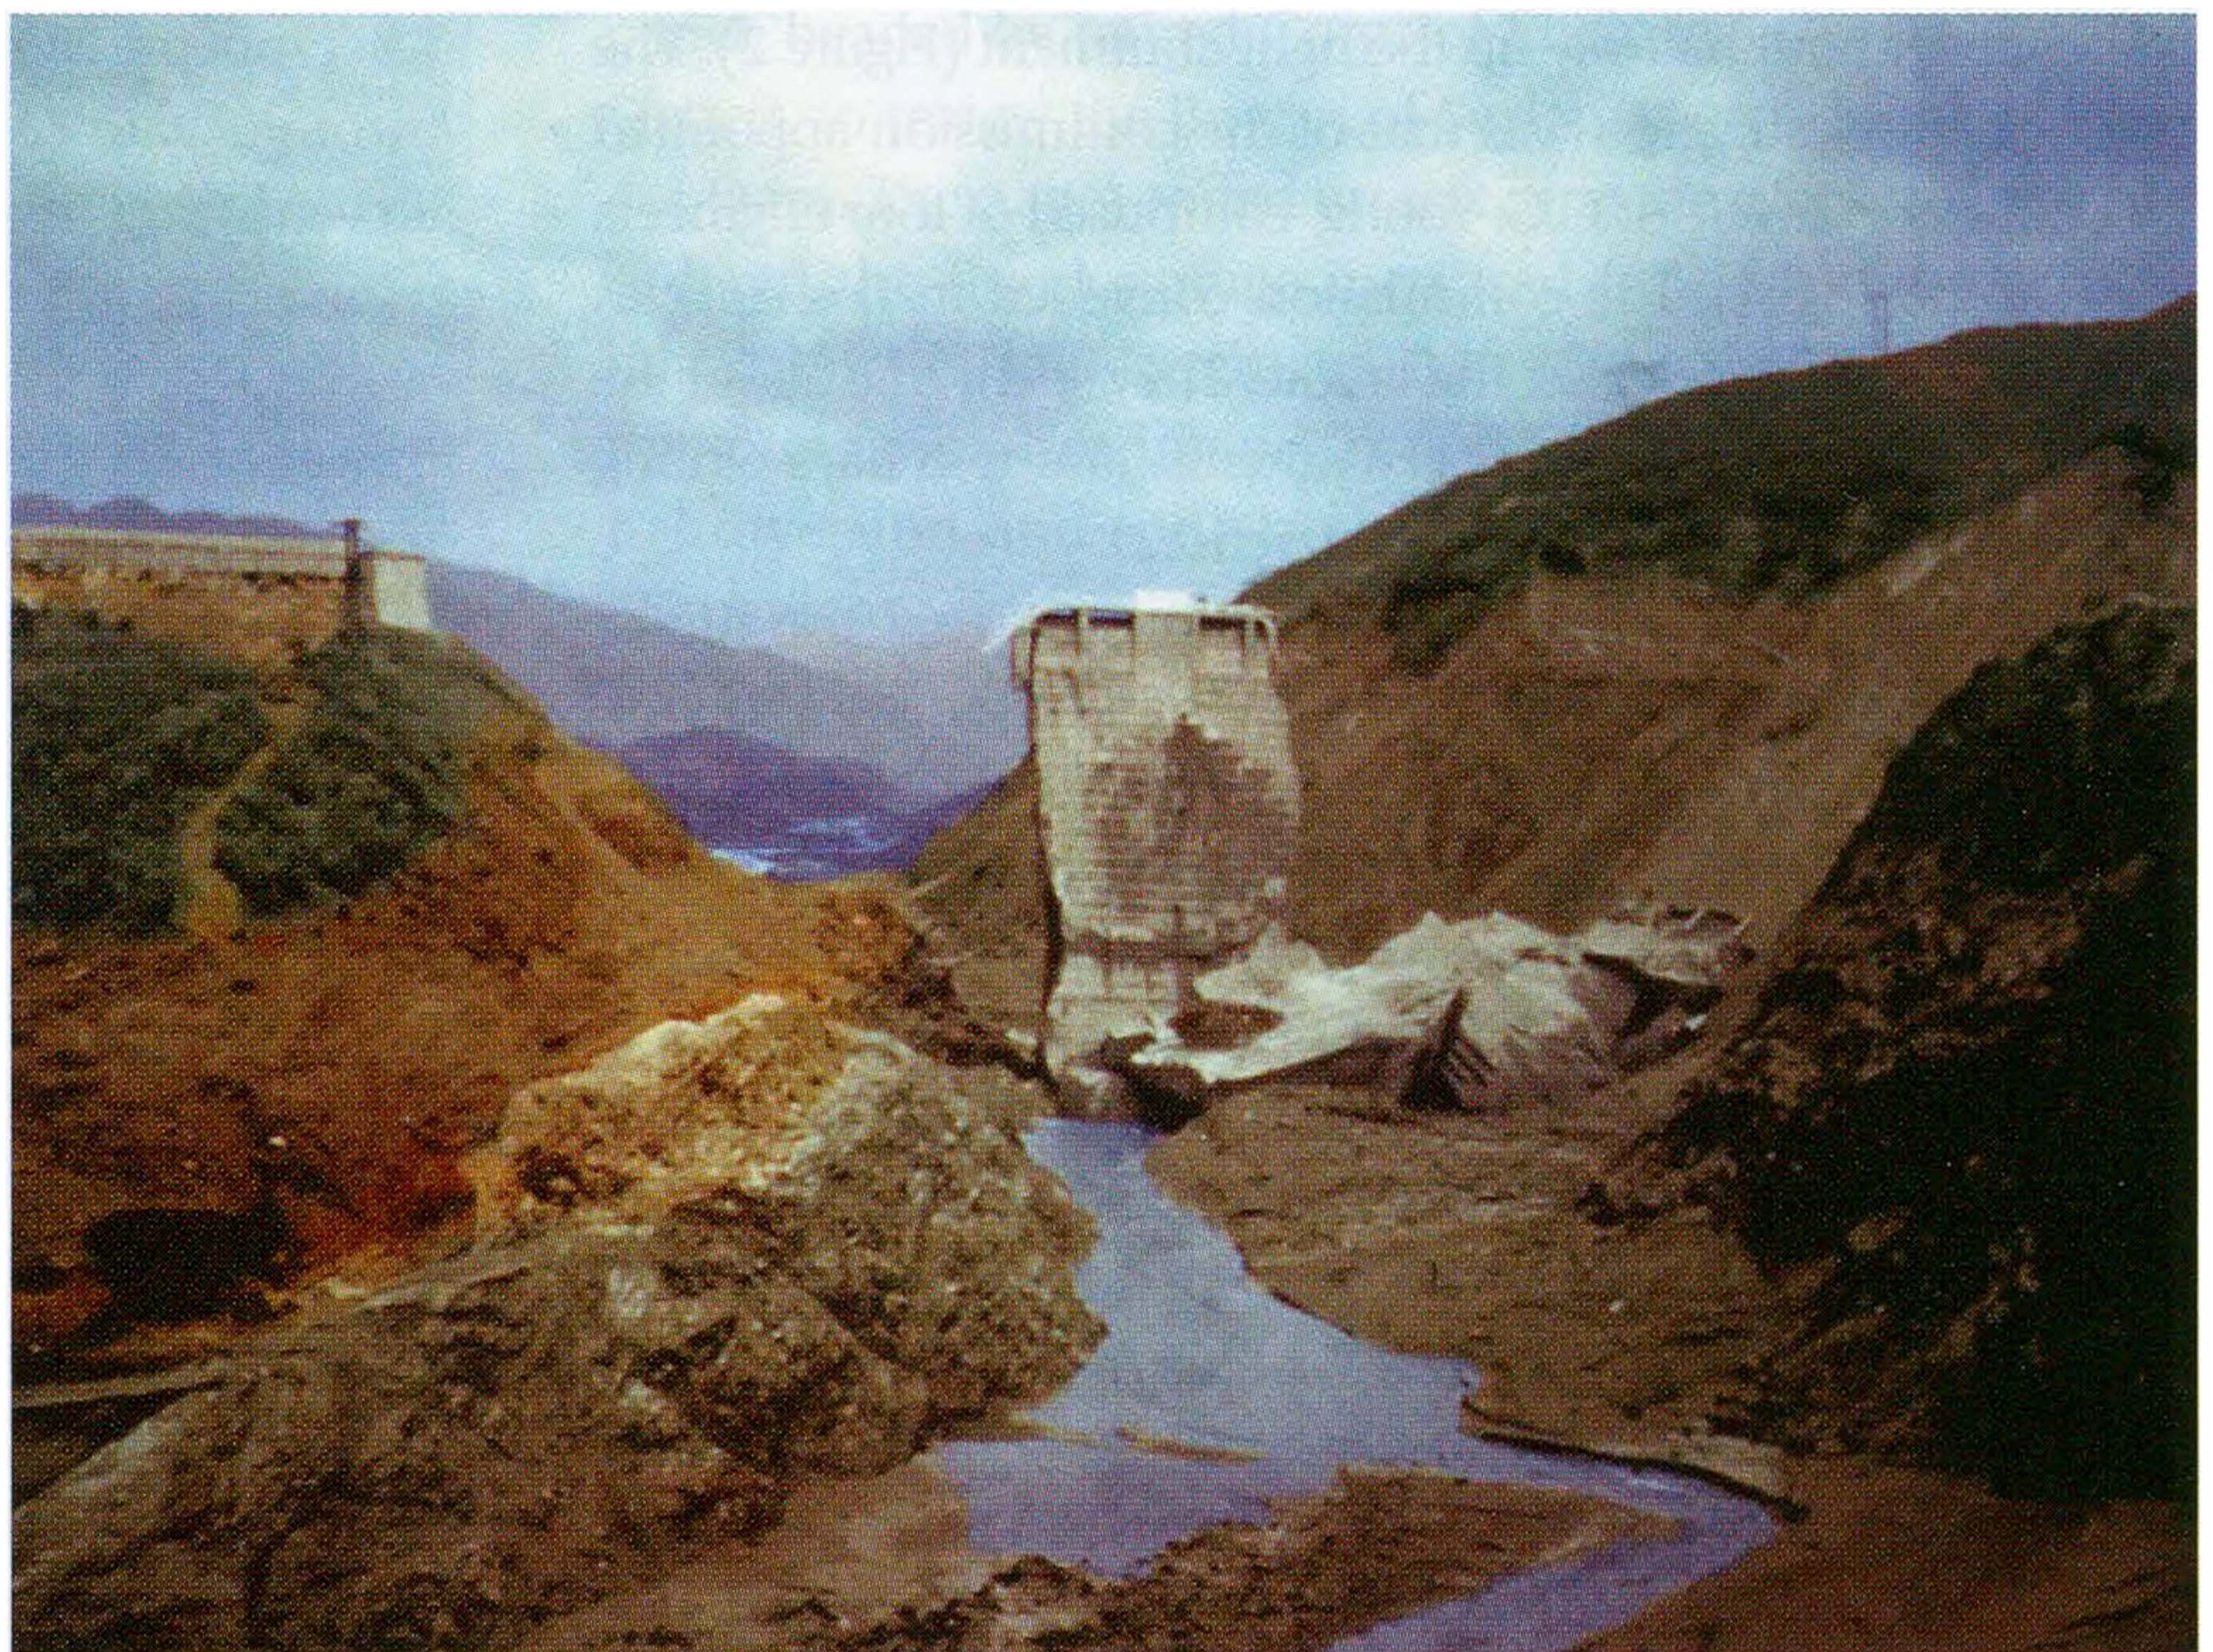
The dam failed catastrophically just before midnight on March 12, 1928, killing nearly 450 people. A dozen panels were appointed to investigate the failure by various agencies and interested parties. They pointed to the dam's inadequate foundation as the culprit—specifically, the tendency of the Vaqueros formation to slake profusely upon saturation, and alleged hydraulic piping of this material along the San Francis-

Figure 2. Ground view looking upstream at remains of the St. Francis Dam after its untimely failure in March 1928. Note the dramatic fault contrast between the Vasquez conglomerate at extreme left with the silvery Pelona Schist. The San Francisquito fault pierced the dam's right abutment and was blamed for the dam's collapse (C.H. Lee Collection, U.C. Water Resources Center Archives, Berkeley, colorized by P. Horton).

quito fault, about halfway up the right abutment (Figure 2). The most cited investigation was that of the commission appointed by California Governor C.C. Young, comprised of four engineers and two geologists. The commission convened in Los Angeles on March 19—a week after the failure. They spent one day at the dam site, two days reviewing documents, and two days writing its report, which was released on March 27.

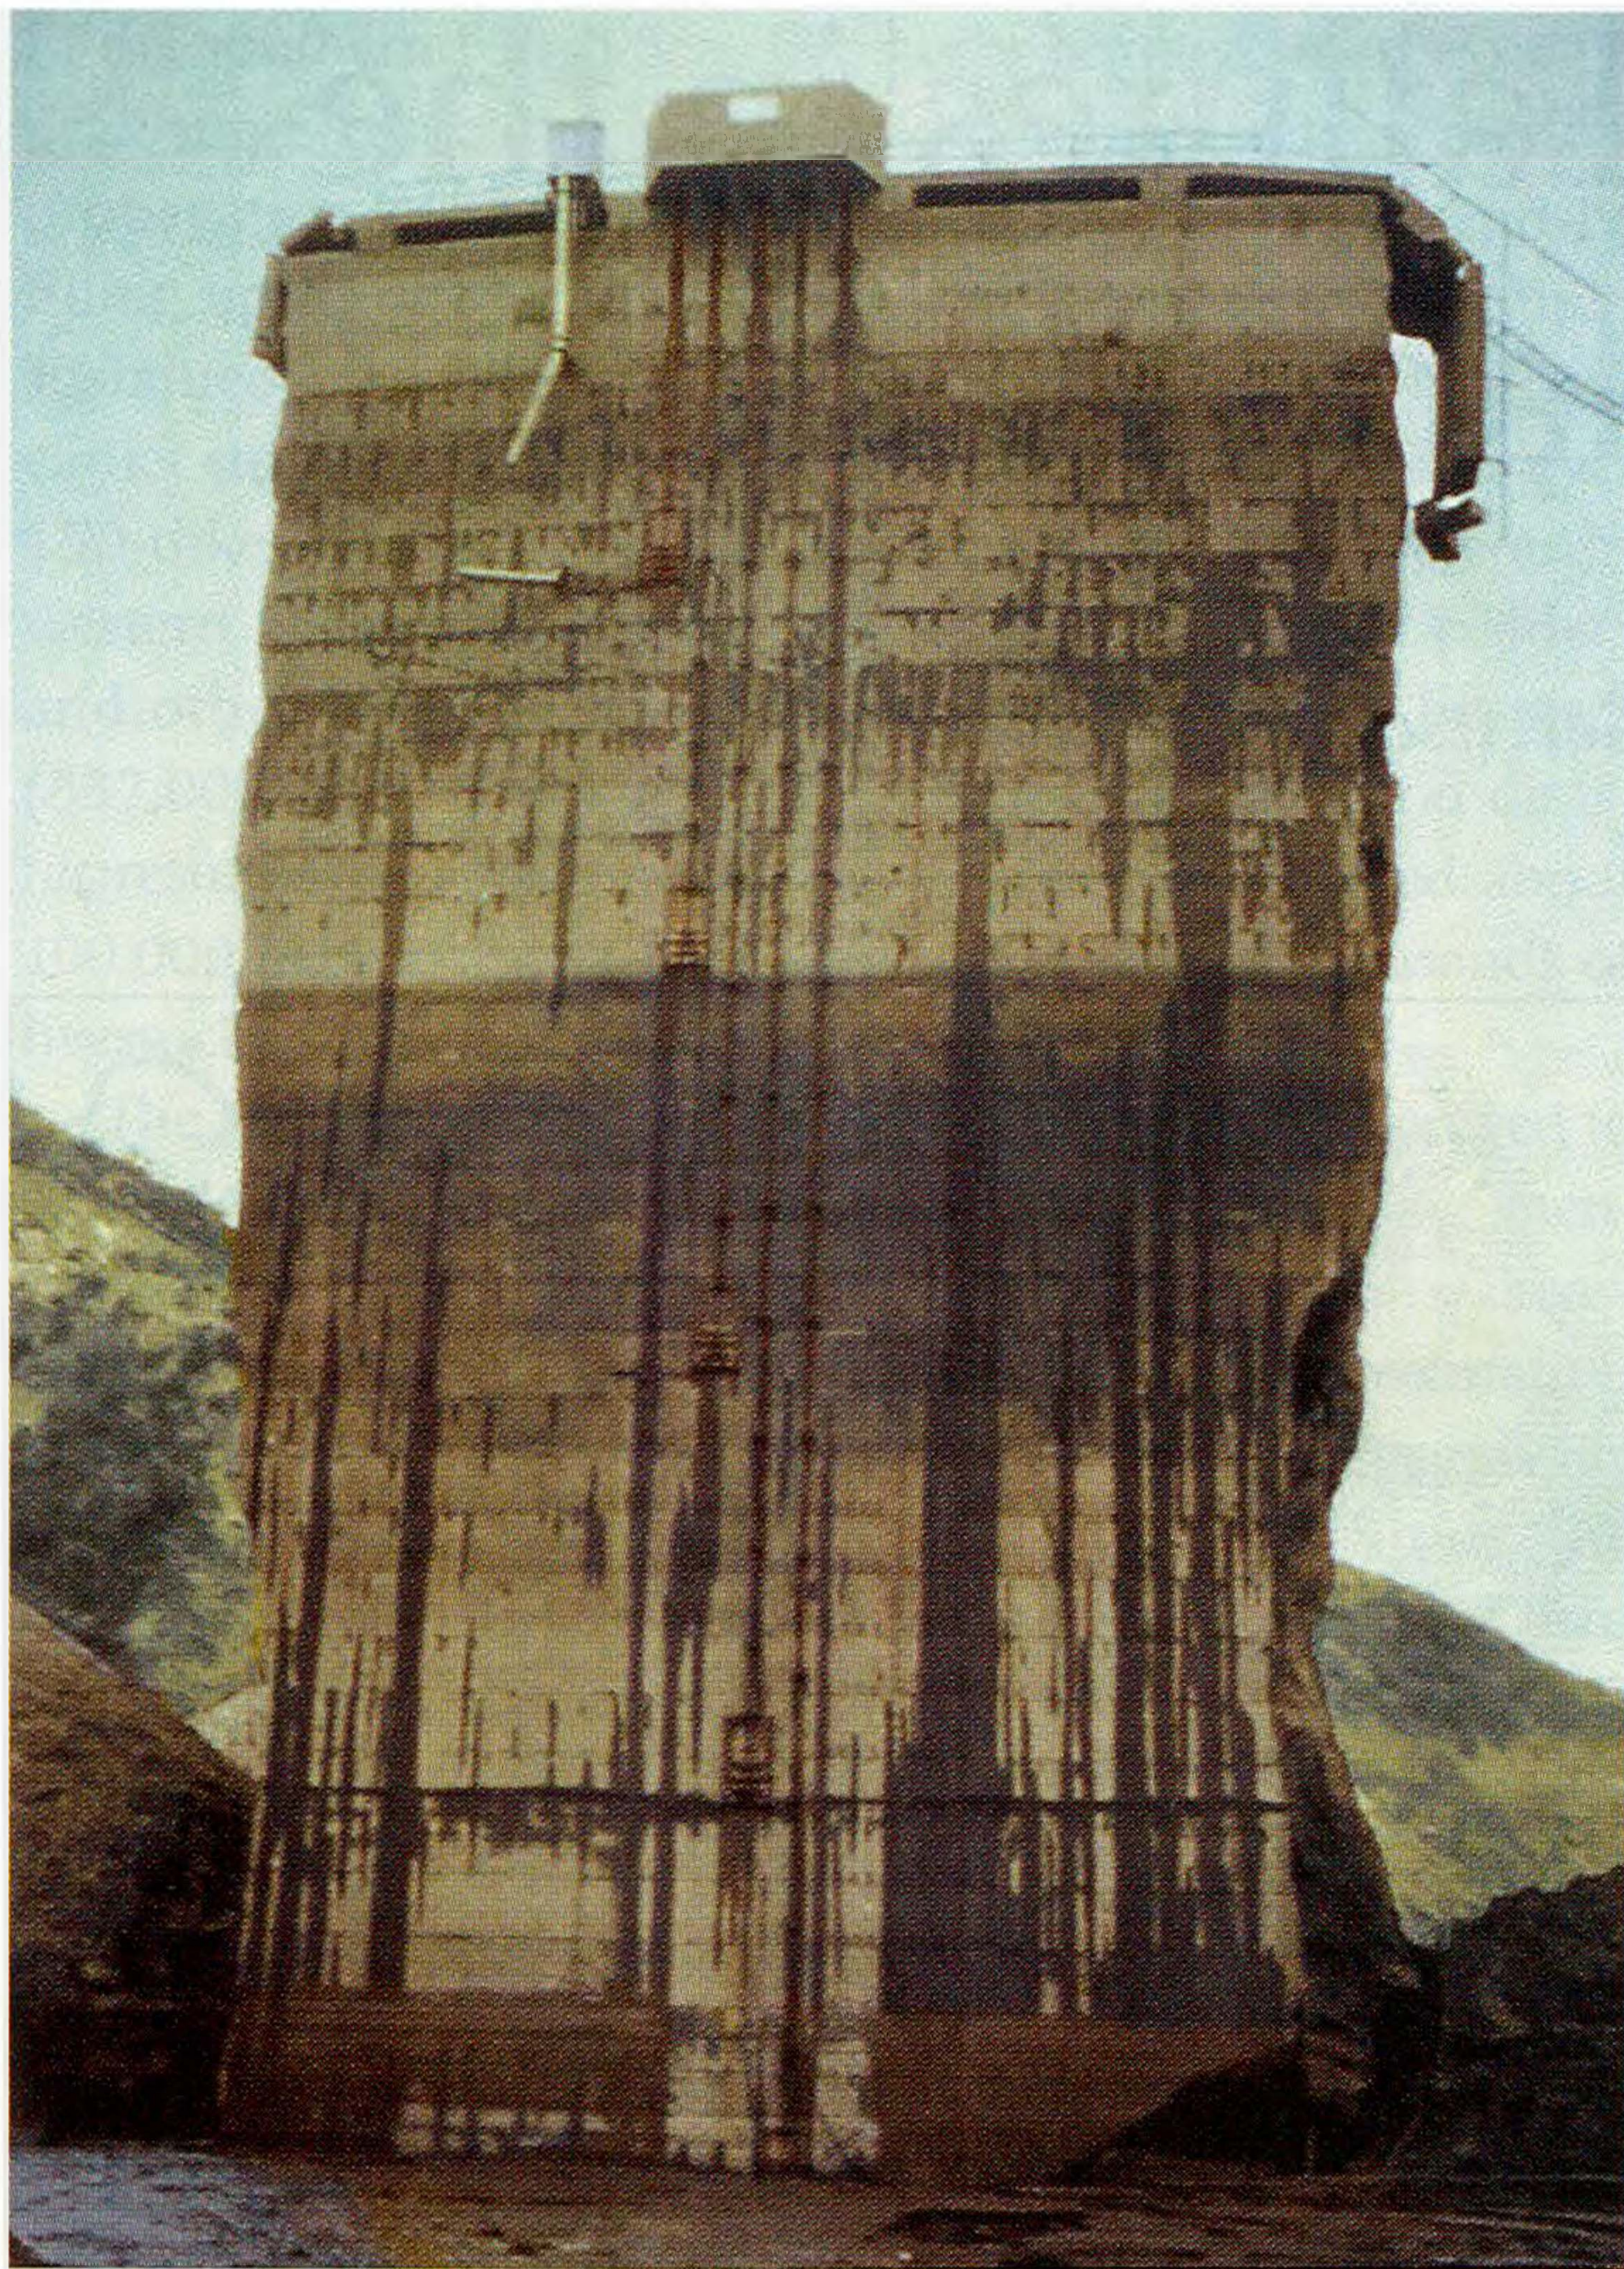
Subsequent studies I have made suggest that the dam's untimely demise was more complex than originally thought, involving the partial reactivation of an ancient bedrock landslide which comprised the dam's entire left abutment. A Stevens Water Stage Recorder on the dam's surviving central block (Figure 3) recorded a slight drawdown of the reservoir pool from 8:00 pm onward, which dropped with increasing severity during the last 40 minutes of the record. The 1928 investigations assumed the gage recorded simple outflow, but post-failure images show a massive tension crack at the dam's upstream heel, containing the gage attendant's wooden access ladder (Figure 3). This suggests that the dam's heel was in tension and tilting downstream when the dam failed. After the failure, Mulholland testified that the factor of safety against overturning "was in excess of 4," but the repeated heightening of the dam without commensurate increases in the base width created a dangerous situation. A simple check of full

reservoir pressure inside the heel crack shows that the overturning factor of safety would have been reduced to 0.77! The Stevens Gage actually recorded a half degree of cantilever tilt, which I confirmed using a 2D finite element model.

Figure 3. Upstream face of the remaining portion of St. Francis Dam, after the failure. The broken Stevens Gage can be seen near the crest, bent towards the left abutment, indicating out-rushing water flow in that direction. A prominent crack up the upstream heel is seen at lower right hand side (C.H. Lee Collection, U.C. Water Resources Center Archives, Berkeley, colorized by P. Horton).

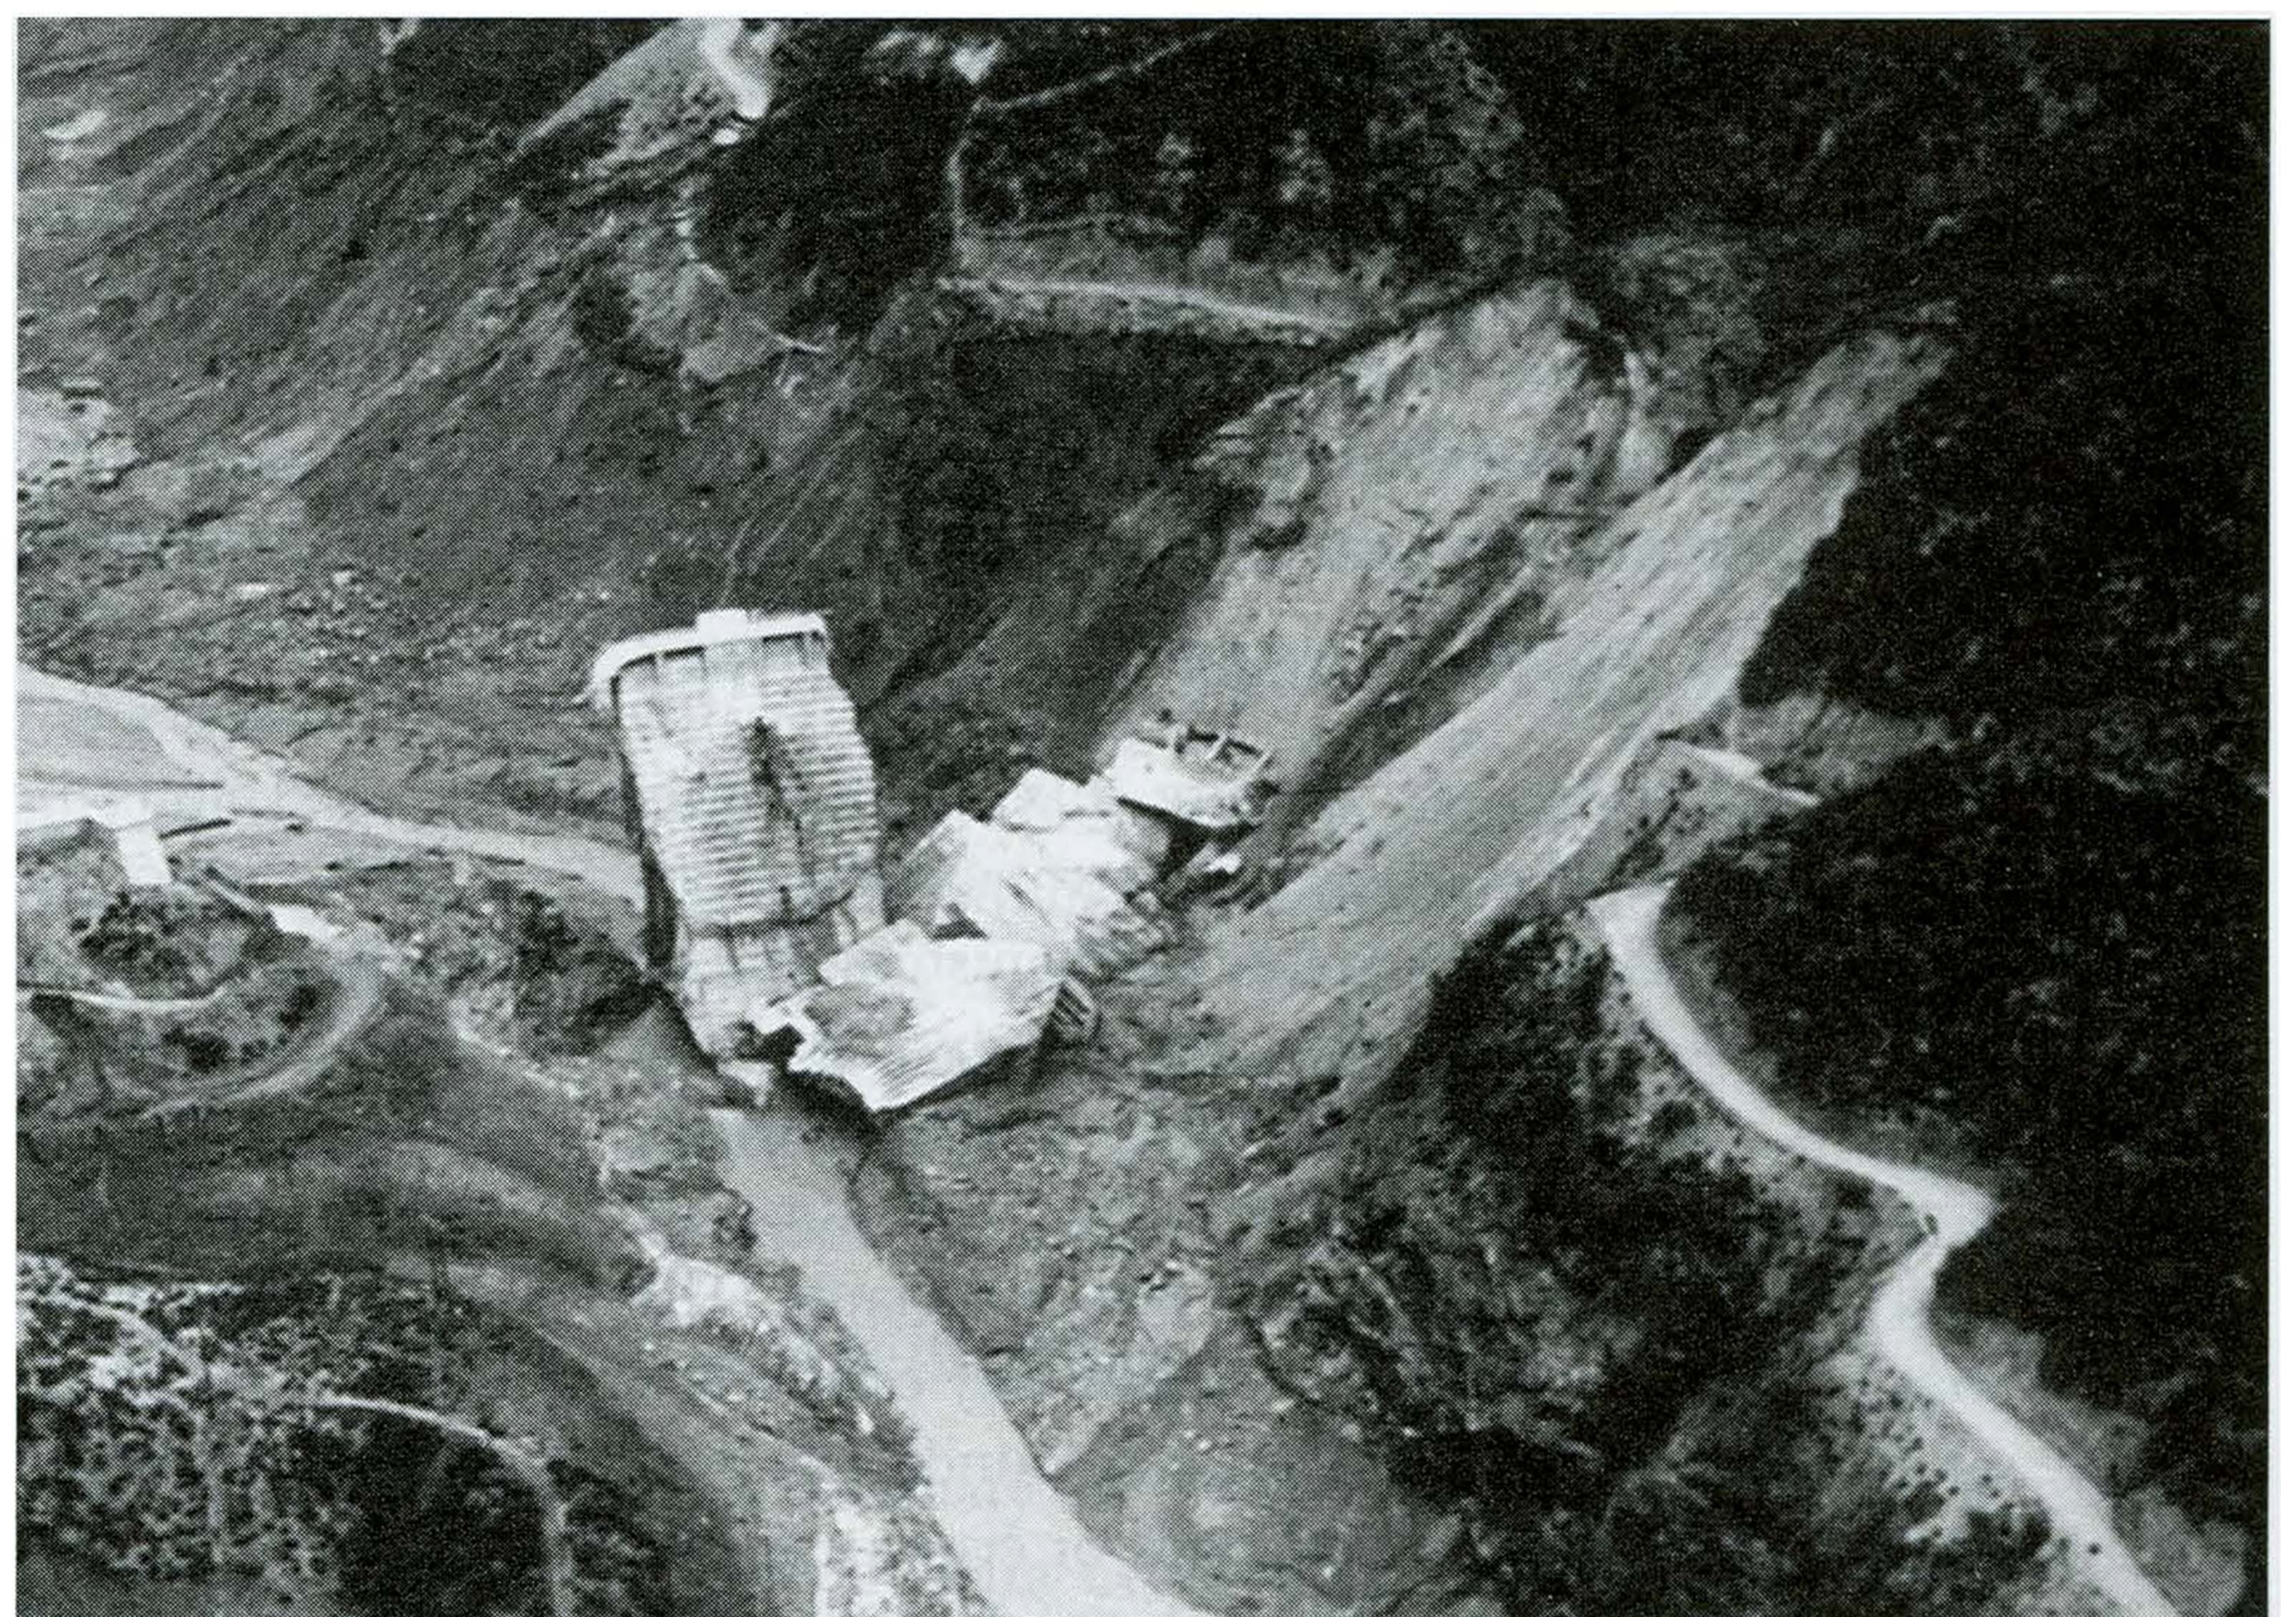
Southern California Edison County's 70 KV Lancaster power line ran along San Francisquito Canyon, past the dam. It was destroyed at 11:57-1/2 pm where it crossed the dam's left abutment 40 ft above the dam crest. Physical evidence suggests that the entire left abutment detached itself as a massive landslide carrying a portion of the dam on 700,000 yd³ of schist (Figure 4). This formed a temporary landslide dam which the outpouring reservoir quickly enlarged, reaching a peak outflow of about 1.7 million cfs.

Figure 4. Aerial oblique view of the St. Francis Dam failure taken the following morning, looking upstream. The left abutment landslide is clearly visible, extending almost 200 feet above the reservoir pool elevation (Spense Aerial Photo Collection, UCLA Geography Department).
