# LIFELINES PERFORMANCE AND MANAGEMENT FOLLOWING THE 22 FEBRUARY 2011 CHRISTCHURCH EARTHQUAKE, NEW ZEALAND: HIGHLIGHTS OF RESILIENCE

## SUMMARY

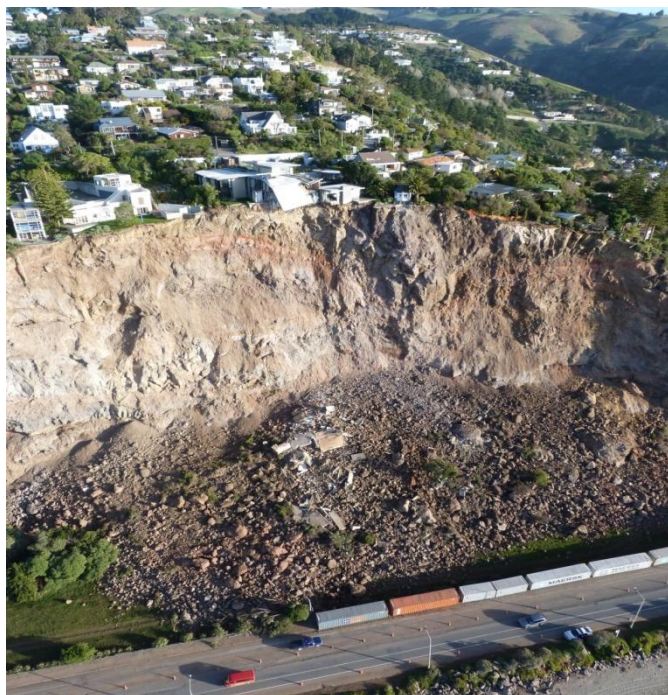
scale cliff collapses occurred in Redcliffs and Sumner (south-east Christchurch suburbs). Up to 15 m of cliff failed along sub-vertical cooling fractures and through intact rock during each shaking event due to very high vertical and horizontal accelerations ( $>1.0g$ ). This led to hundreds of houses being severely damaged, requiring evacuation, and ~100 houses unlikely to be reoccupied both at the cliff top and base (Bell, 2011). Power, water and sewage services were also severely damaged in the hill suburbs. Clifton Hill collapses threatened the seaward road linking Red Cliffs and Sumner to Christchurch city, requiring the use of ballasted shipping containers to be used as a temporary catch fence (Figure 3).

**Figure 3:** Cliff collapse at Clifton Hill following the 22 February and 13 June 2011 earthquakes - flown 14 June 2011. Note the partially collapsed house and use of ballasted shipping containers as temporary catch fences (Photo credit: Marlène Villeneuve/David Bell).

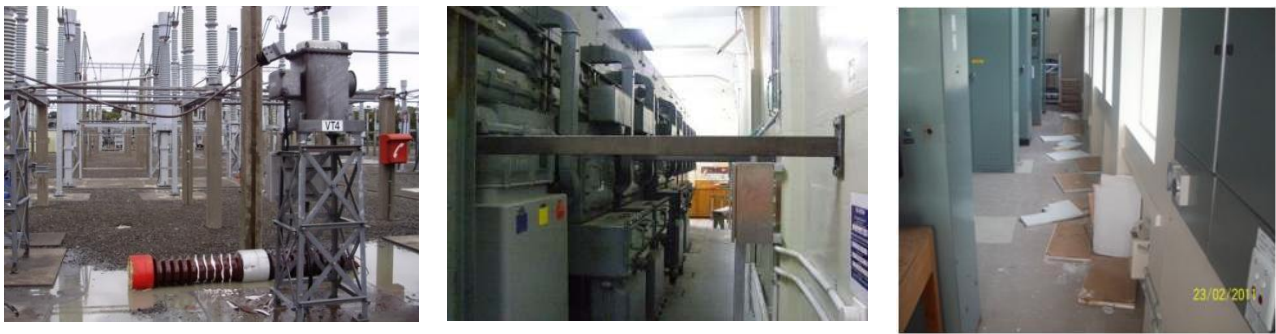
Damage at the Bromley substation occurred in the 66 kV switchyards and 220 kV switchyards, where severe liquefaction occurred (Figure 5a), and within the adjacent control building from where the switchyard equipment is controlled and operated via switchboards (Figure 5c). Damage to the 220 kV switchyard included a broken 220 kV capacitor voltage transformer (CVT; Figure 5a). Damage to the 66 kV switchyards included two broken 66 kV transformer bushings (replaced by using bushings from a spare transformer available on site) and failure of a 66 kV cable circuit.

Figure 5: Bromley Substation: a) 220 kV failed current voltage transformer; b) Bromley bracing installed at the front and rear of the switchgear panels; c) dislodged ceiling tiles in the control and relay building, (Photo credit: Transpower).

Within the Bromley substation control building, short-term remedial work was undertaken soon after the earthquake to temporarily repair and enable the 11 kV switchboard equipment to return to service (Figure 5b). Action has been already taken to rebuild the Bromley substation and to install new 11 kV switchgear and switchboard. The new switchboard will be immediately available from an on-going substation construction project in Timaru.

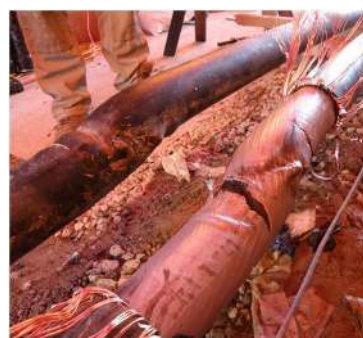
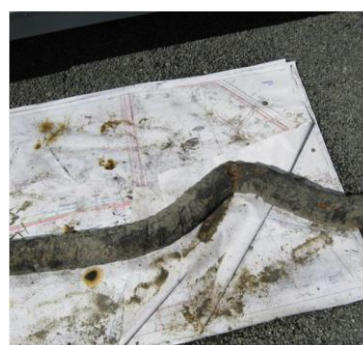
Regarding the 11 kV underground cable network, 14% cables were damaged, 330 km out of a total of 2,300 km (Figure 8b). A total of more than 1000 faults were identified and repaired at 31<sup>st</sup> August (Orion Media release 31<sup>st</sup> August 2011). The affected 11 kV cables were either aluminium, or copper core cables of different length, diameters and types, including: paper lead; paper-insulated lead-covered, armoured, PILCA; PILCA HDPE cables, PILCA with a high density polyethylene HDPE outer jacket; cross-linked polyethylene, XLPE cables with PVC and HDPE protective outer jackets.

Figure 8: a) 66 kV XLPE cable fault; b) Typical 11 kV internal cable damage (Photo credit: Orion).

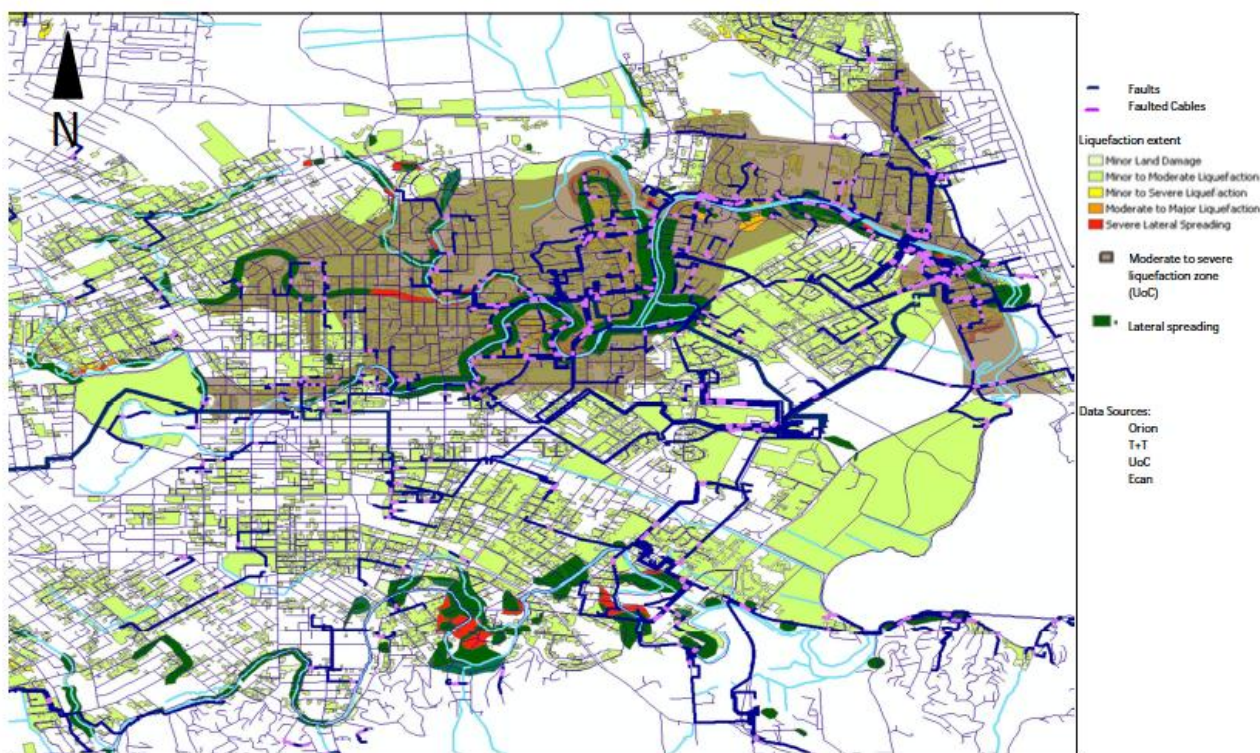
Figure 10 presents Orion 11 kV faulted cables following 22nd February earthquake overlaid with Tonkin and Taylor liquefaction map (Tonkin and Taylor 2011) and the "Drive-Through" Reconnaissance map (Cubrinovski and Taylor, 2011). It is worth noting that the two land damage maps show a general agreement with each other. Table 2 summaries the

**Figure 10:** Orion 11 kV faulted cables following 22nd February Earthquake liquefaction maps from Tonkin and Taylor (2011) and Cubrinovski and Taylor (2011).

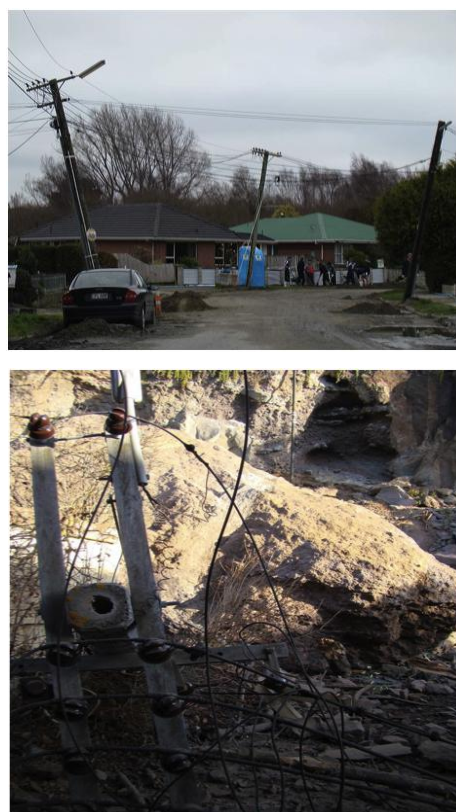
The 33 kV, 11 kV and 400 V overhead lines experienced some relatively minor damage including cracked insulators and poles affected by liquefaction (Figure 11).

**Figure 11:** Damage to the distribution over-head lines: a). (Top) Leaning poles due to a combination of shaking and liquefaction in Kingsley street; b). Poles and insulators along the Sumner road affected by rockfall and landslides. (Photo credit: Andrew Massie CPIT).

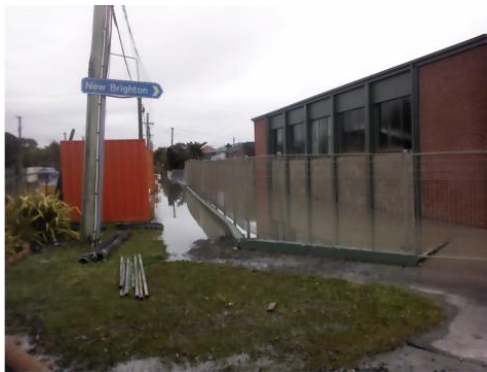
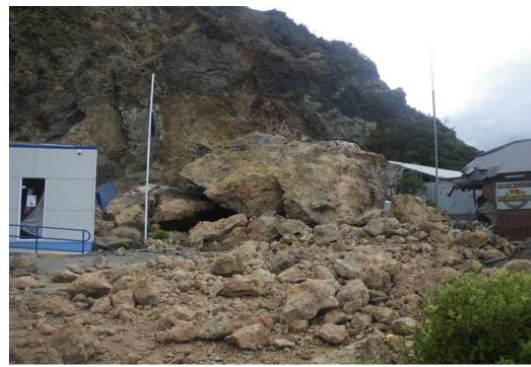
Of approximately 300 distribution building substations located in Christchurch urban area only 4 experienced significant damage. The Sumner substation was hit by a rockfall (Figure 12b).

**Figure 12: Damage to Orion substation: a) (Left) New Brighton substation . (Photo credit: Orion.; b) Sumner substation hit by a boulder falling from the Sumner Cliffs (Photo credit: Andrew Massie CPIT).**

The construction of a new substation in the Rawhiti Domain was commissioned, as well, as part of the immediate recovery plan to replace the severely damaged New Brighton substation.

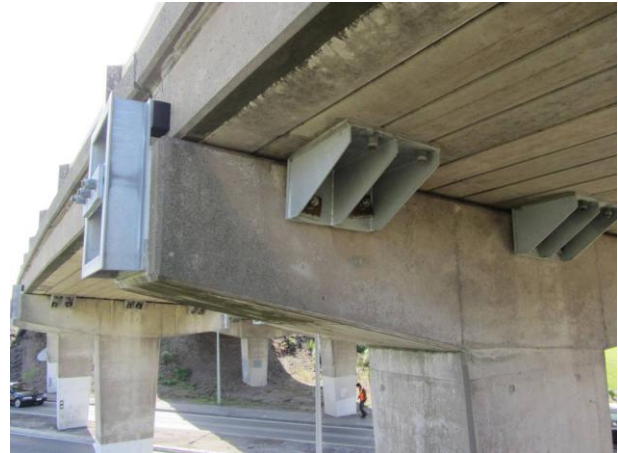
Pre-earthquake seismic improvements to bridges on Highways 73 and 74 proved successful in resisting substantial loads and keep the highways in operation post-earthquake (Figure 16).

**Figure 16:** Pre-earthquake seismic improvements to bridges on Highways 73. (Photo credit: Craig Davis).

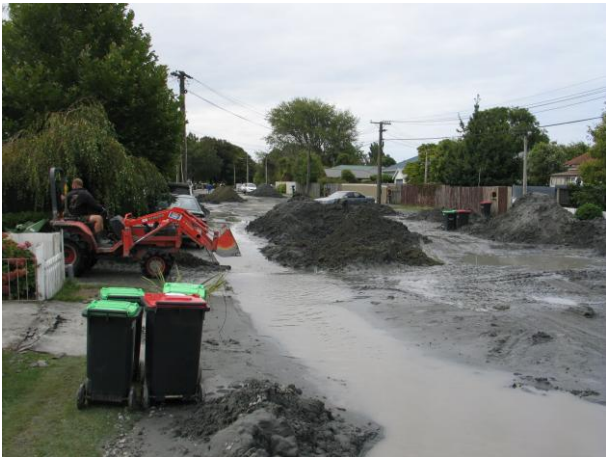
The 22<sup>nd</sup> February 2011 earthquake induced widespread liquefaction phenomena across the Christchurch urban area that resulted in widespread ejection of silt and fine sand (Figure 18). This created unique impacts to many lifelines. Road networks with significant liquefaction ejecta deposits were difficult to transit or impassable for two-wheel drive traffic and contributed to traffic congestion. Liquefaction ejecta, continually eroding over time, had the potential to infiltrate and contaminate the damaged storm water system and the urban waterways. Due to the extensive damage to the sewage disposal networks, there was the risk that much of the liquefaction ejecta had been contaminated with raw sewage creating a long-term health risk to the population (P. McDonald & J. Rutherford pers. comm., 2011; Weeraseskara, 2011). During hot and windy conditions the dry, finer portions of silt was mobilised by the wind creating a respiratory health hazard.

**Figure 18:** Piles of liquefaction ejecta cleaned from residential properties and roads, ready for removal by heavy earth moving machinery at Bracken Street in the suburb of Avonside. (Photo credit: Jarg Pettinga).
