**Loading, Degradation and Repair of
F-111 Bonded Honeycomb Sandwich
Panels - Preliminary Study**

DSTO-TR-1041

**Airframes and Engines Division
Aeronautical and Maritime Research Laboratory**

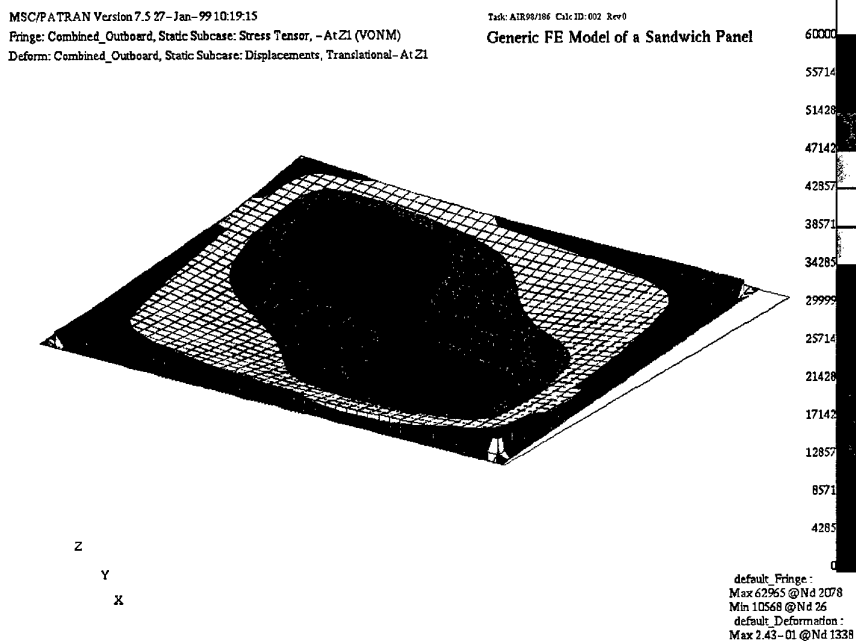
Figure 11: Contour plot of inner face stresses

A comparison of centre panel stresses from each individual load case indicated that the face stresses were dominated by the shear, which contributed about 70% to the total stress field, followed by the aerodynamic pressure, about 20%, and the axial load, about 10%. Note that the stress or load distribution here is typical of a fuselage panel and may be different for aerodynamic surfaces such as rudders, ailerons or flaps where aerodynamic pressure may play a larger role. Work has not been undertaken in this study to examine the load and stress distribution of such components.

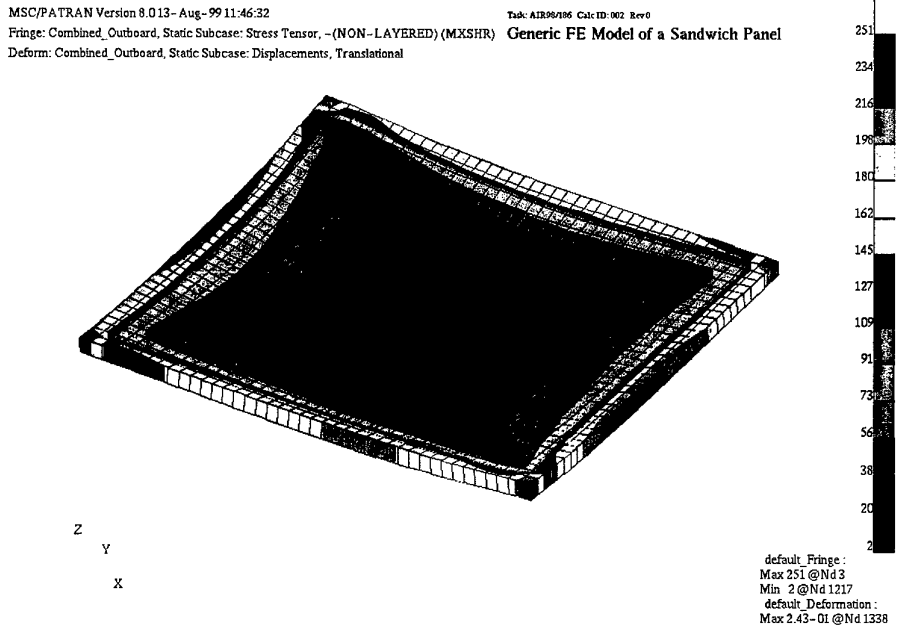
Figure 12 shows a contour plot of the shear stresses in the core. The core shear stresses are representative of the shear loads experienced by the face to core bond. The stresses compare very well with the OEM calculations, despite the coarseness of the simplified FE model. (It is important to note that both the OEM calculation, and the FE analysis reported here, were both similarly simplistic and the true shear stress distribution in panel 3208 may be different.) The results also indicate higher core shear stresses near the panel edges (~250 psi).

Figure 12: Contour plot of shear stresses in the core

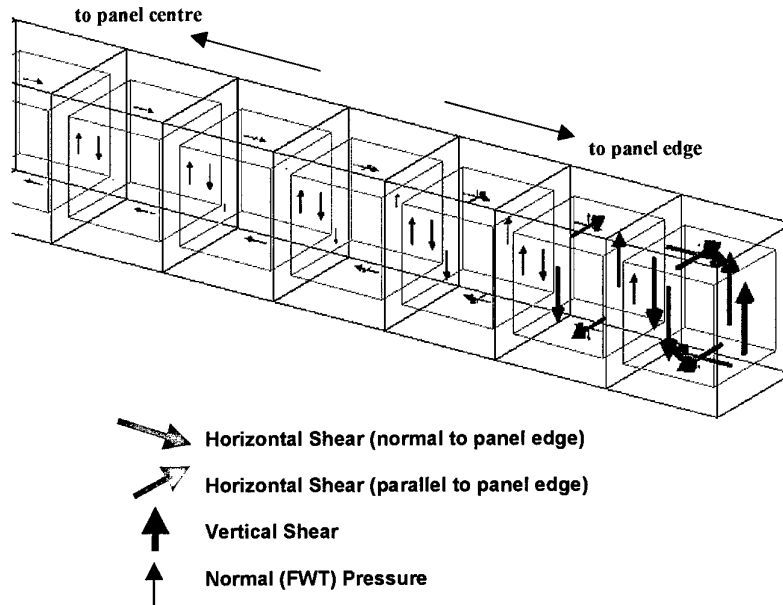
Closer examination of the internal load distribution in the core can be seen in Figure 13. This figure also shows how the shear stresses dominate the total core stress field.

Figure 13: Internal loads in honeycomb core near the panel edge

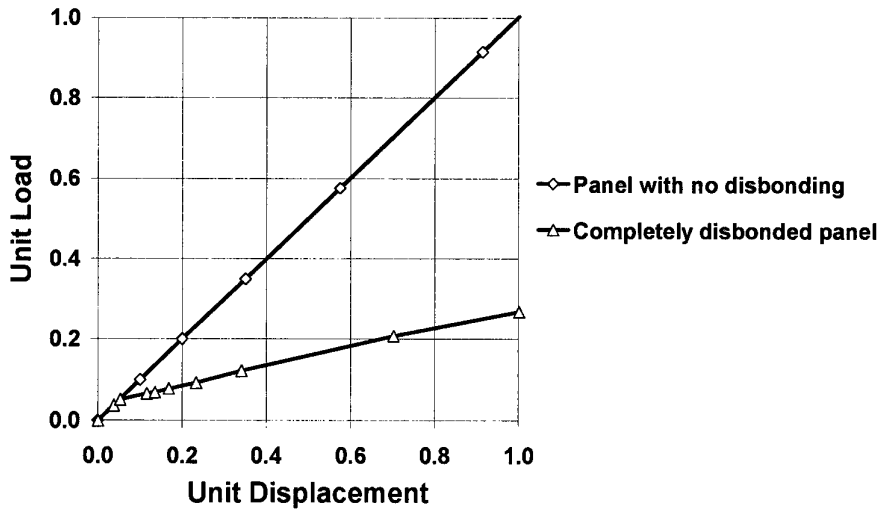
The load-displacement response is shown in Figure 14 and this shows that the onset of general buckling instability begins at about 5% of ultimate load. Further, more realistic, work is planned which will consider the effect of smaller disbonded regions.

Figure 14: Load-displacement response of an intact panel and a completely disbanded panel.

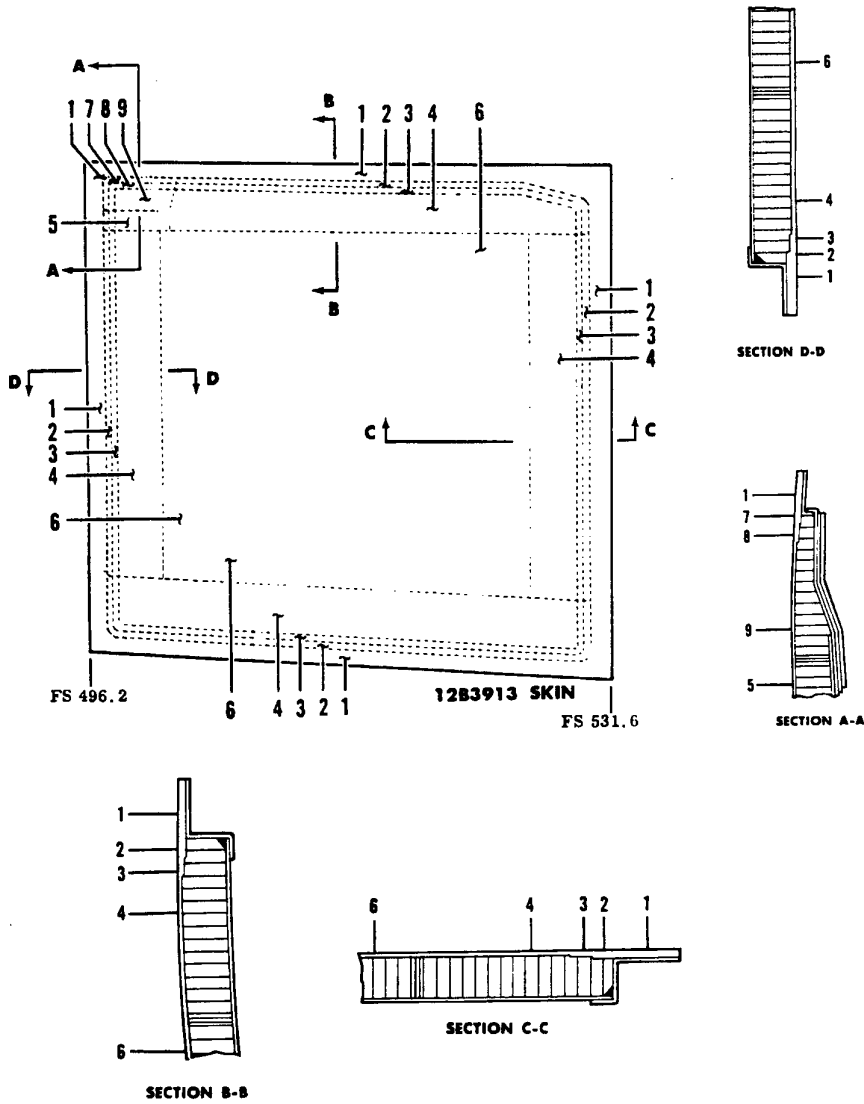
Figure 16: Structural detail of panel 3208. [2]

Table 2 is a description of the defects that have occurred in panel 3208 along with pictorial representations of the defects. (Note that these diagrams are not intended to be an exact replication of the defect, rather an approximate representation of their size and shape.)
