# Local site effects and incremental damage of buildings during the 2016 Central Italy earthquake sequence

## ABSTRACT

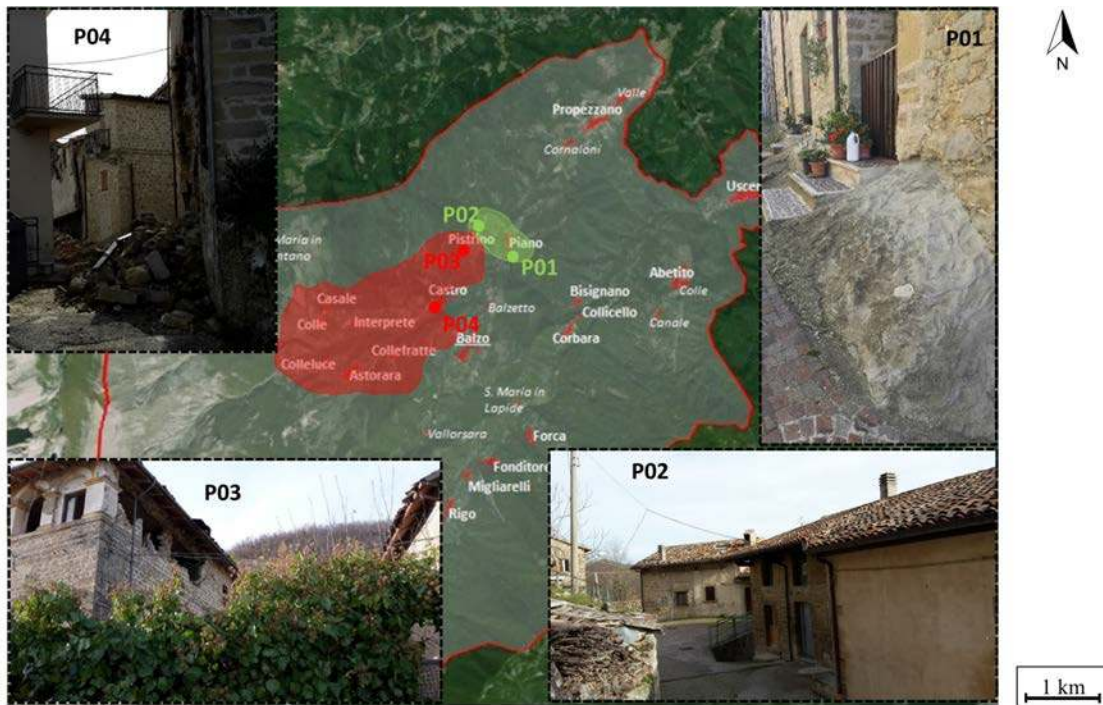
222 Other Montegallos hamlets, such as Astorara, Castro, and Colleluce in the southwestern  
223 part of the area at a distance of 1.5 to 2.5km from Piano, located on quaternary deposits  
224 resting on rock, experienced high levels of damage and several cases of total collapse (D5).  
225 For example, Figure 3-P04 shows a street in Castro that was blocked by the debris of a  
226 damaged building. Given the proximity between Castro (highly damaged) and Piano  
227 (practically undamaged), and the very similar structural systems and construction standards,  
228 it is probable that Castro experienced stronger ground motions than Piano, due to significant  
229 topographic amplification. A view of the 3D model obtained with a drone survey over the  
230 entire area can also be found in BYU-PRISM (2016). It shows the typical crest configuration  
231 of the zone, leading to possible 2D topographical effects.

233 **Figure 3.** Spatial distribution of building damage across the municipality of Montegallo.

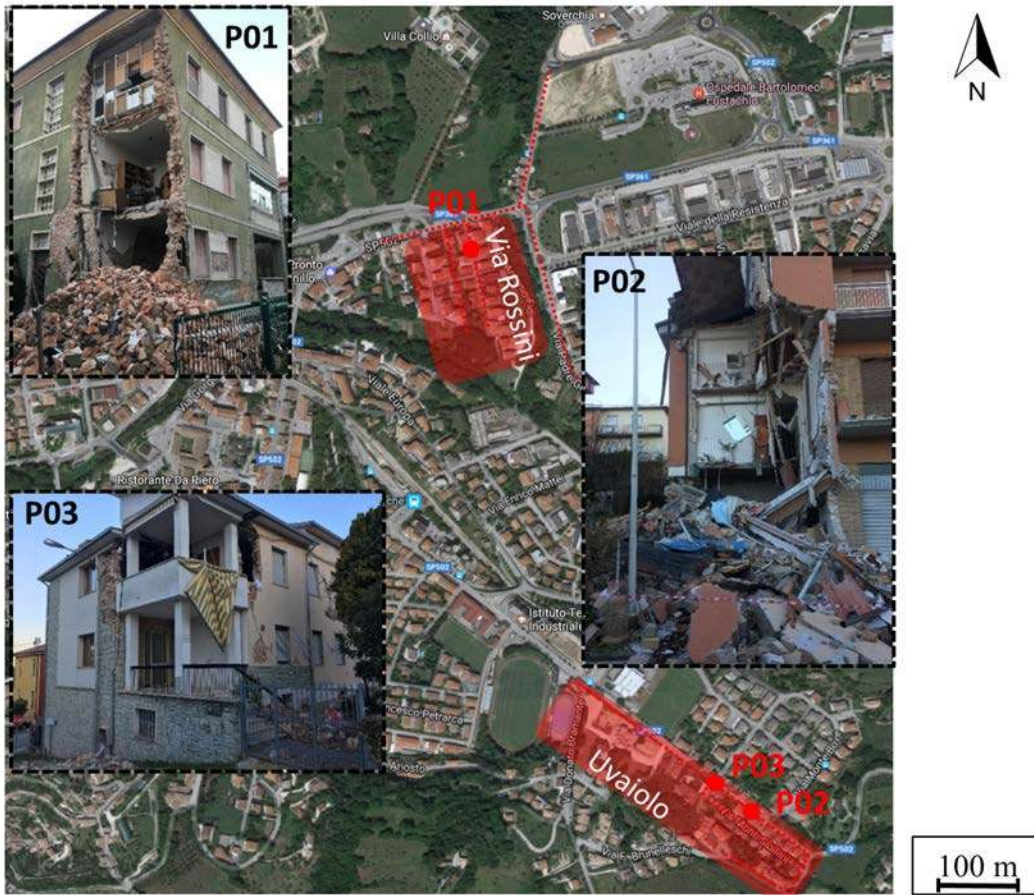
235 Other examples of local site effects were identified in some areas of San Severino Marche  
 236 (number 11 in Figure 2). San Severino Marche is a town in the Province of Macerata, in the  
 237 Marche region, located about 50 kilometers south-west of Ancona and about 25 kilometers  
 238 south-west of Macerata. It has about 12,000 inhabitants, and it comprises more than 40  
 239 hamlets. Unlike Montegallo, San Severino has districts where most of the buildings are of  
 240 reinforced concrete, built in the 1960s and the 1970s. Within San Severino Marche, two  
 241 neighborhoods along Via Mazzini and Via Rossini attracted most of the GEER  
 242 reconnaissance team attention due to the evident and quite localized damage observed  
 243 (Figure 4). Via Mazzini is located uphill while buildings along Via Rossini are constructed  
 244 on the ancient riverbed of the Potenza River. It is deemed that stratigraphic amplification is

245 likely to have taken place due to the presence of soft shallow sediments resulted from the  
 246 river artificial channeling operations. Similar damage patterns and site effects have been  
 247 observed in Tolentino (number 10 in Figure 2), as described in GEER (2017).

**Figure 4.** Characteristic building damage within the town of San Severino Marche.

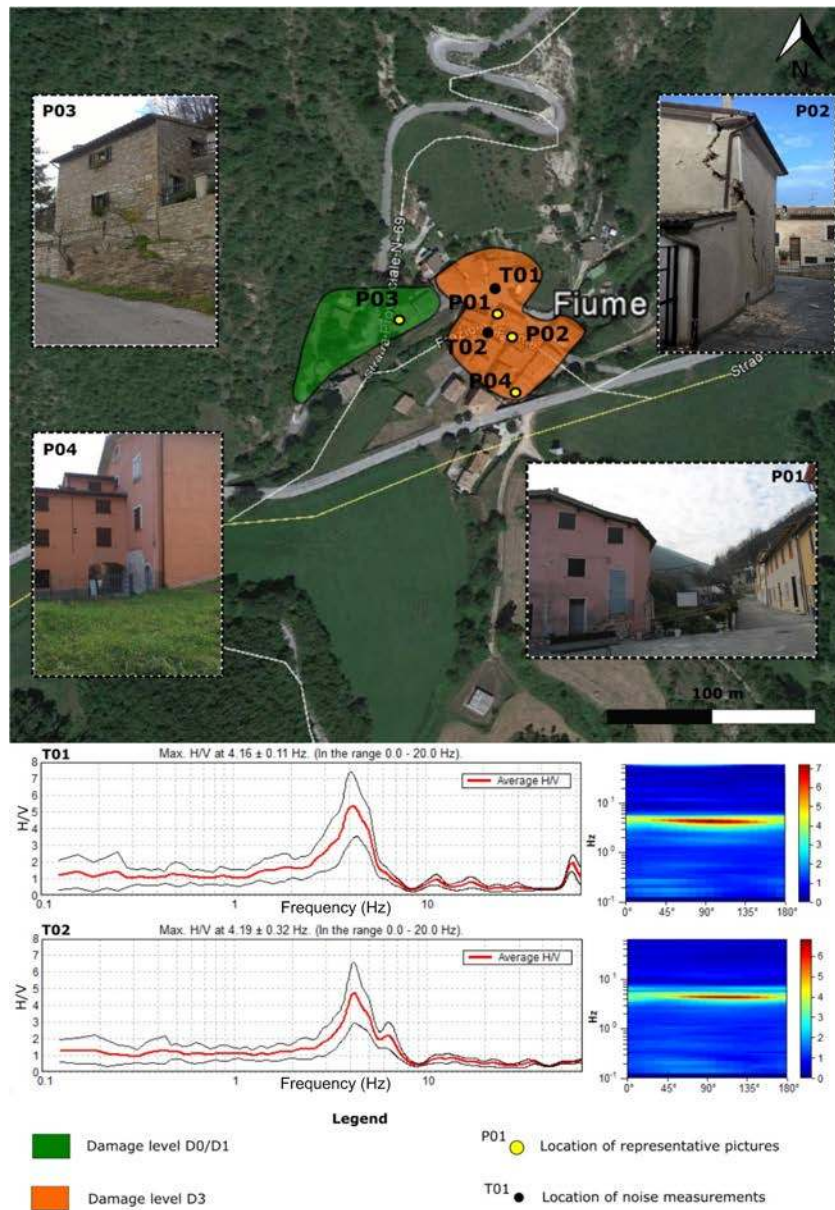
265 eastern part of the hamlet, founded on colluvial and alluvial deposits resting on bedrock,  
266 suffered high levels of damage (D3) as shown in reference pictures P01-P02-P04, whereas  
267 the western part, built on travertine rock, had only negligible damage (D0/D1, P03).

268 Two noise measurements (T01-T02 in Figure 5) were performed in the damaged zone  
269 (east side of the hamlet) during the GEER mission. A portable Tromino tomograph was  
270 employed and the total duration of each measurement was approximately 15 minutes.  
271 Horizontal-to-Vertical (H/V) spectral ratios were computed by using the geometrical mean of  
272 horizontal components. In addition, H/V ratios were computed by rotating the horizontal  
273 component between  $0^\circ$  and  $180^\circ$  (directional or polar HVSR), in order to investigate  
274 preferential directions of site amplification (i.e., the polarization of ground motion). Both  
275 H/V and polar H/V are reported in Figure 5 showing a large H/V peak around 4 Hz, which  
276 shows significant stiffness contrast between the upper soil layers and the underlying bedrock,  
277 i.e. a typical proxy of local site amplification.

293 **Figure 5.** Damage zonation within the village of Fiume (up). Location and results of noise  
 294 measurements in terms of H/V spectral ratio (bottom left) and polar plot (bottom right).

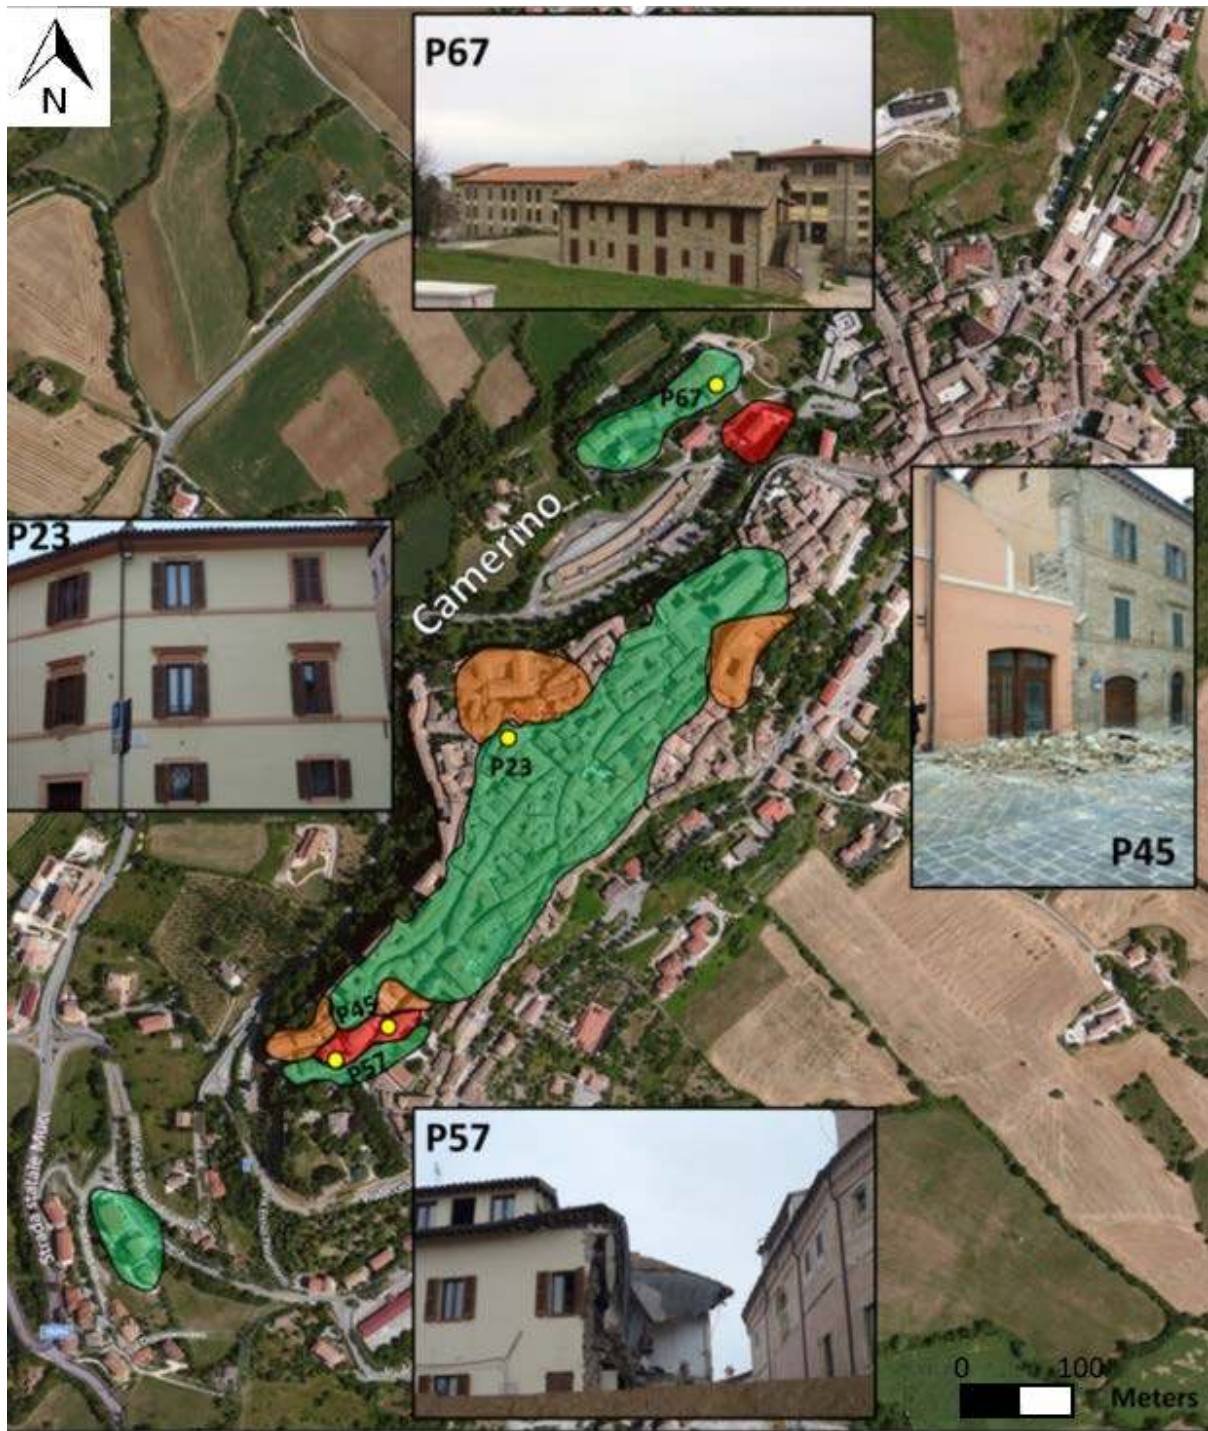
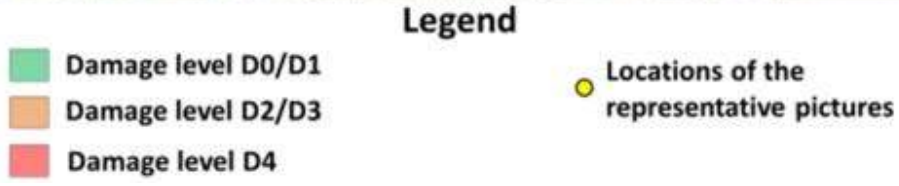
320 Figure 6 depicts the damage distribution across the main village, as inspected after the 30  
321 October event. Relatively low damage (D0 or D1) were observed within the inner part of the  
322 ridge characterized by local bedrock (GRS) outcrops. Higher damage levels (D2-D3) were  
323 observed for many of the low rise (2-3 stories) unreinforced masonry buildings, even if some  
324 of them were partially retrofitted. The damage is mainly localized on the hillside, where  
325 potential topographic amplifications and permanent deformation (due to slope instability)  
326 may be occurred. The highest damage level (D4) was observed at the SW side of the historic  
327 center and at the bottom of the Camerino hill, where several masonry structures collapsed.  
328 The observed damage distribution pattern in Camerino is consistent with site effects that  
329 could be inferred from the geological map shown in Figure S5. Strong amplification of

330 earthquake ground motions is highly probable given the thin soft layers of eluvio-colluvial  
331 soils (ML) overlying the bedrock.

**Figure 6.** Damage zonation within the historic center of Camerino with pictures of the representative structures inspected.

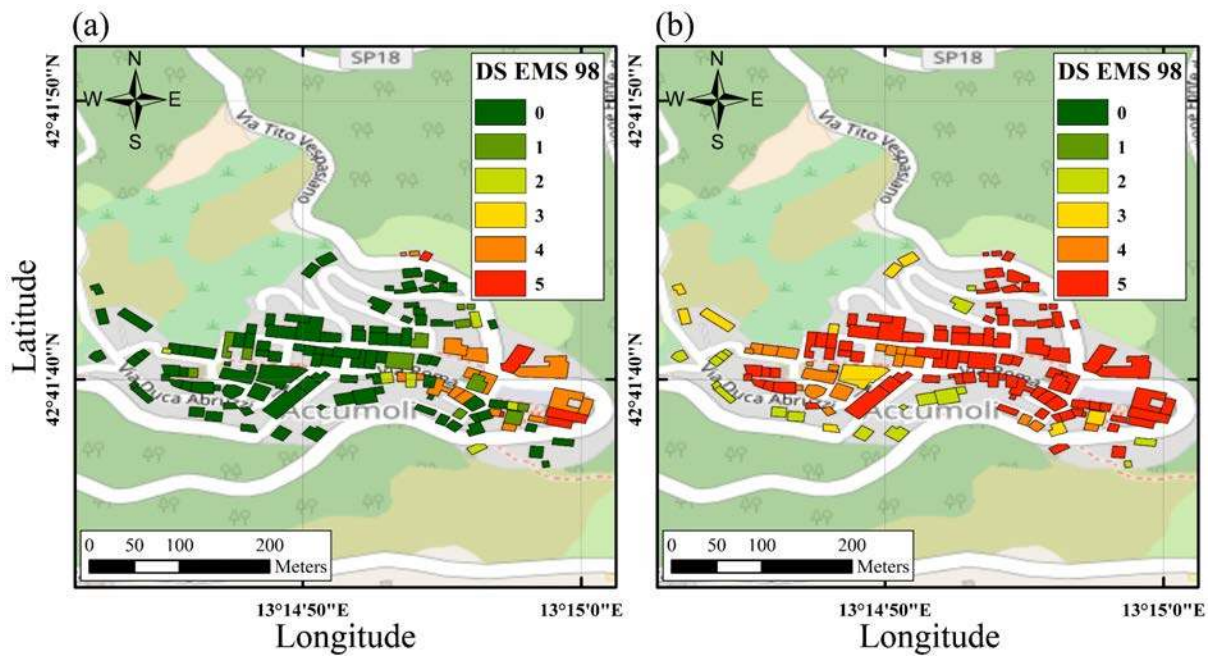
357 Figure 7 illustrates the structural damage levels observed during the two surveys, after the  
358 24 August (left) and the October events (right). After the August 24th event, the most severe  
359 damage was observed at the eastern side of the village, while the vast majority of the building  
360 stock retained its structural integrity null or with minor damage (D0-D1). However, at the  
361 end of the seismic sequence, Accumoli was almost completely destroyed. Few buildings, in  
362 the south end of the village survived the sequence of events with limited damage (D2).

364 **Figure 7.** Damage levels in the main village of Accumoli (a) after the first earthquake and (b) at the  
 365 end of the entire sequence.

366 The evolution of structural damage **during the earthquake sequence** is clearly reflected in  
 367 the observed damage: 72% of the buildings experienced zero (DS0) and 8% minor damage  
 368 (DS1) after the first earthquake, while not a single building was found intact or with minor  
 369 damage after the seismic sequence. Large damage states were in contrast more populated (4%  
 370 to 13% for DS2, 0% to 7% for DS3, 12% to 14% for DS4, and a major shift from 4% to 65%  
 371 for DS5).

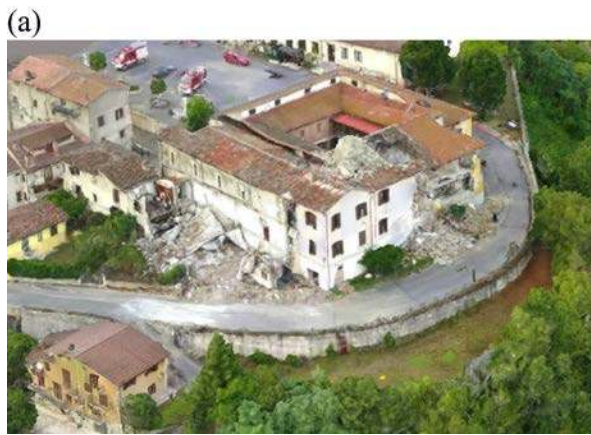
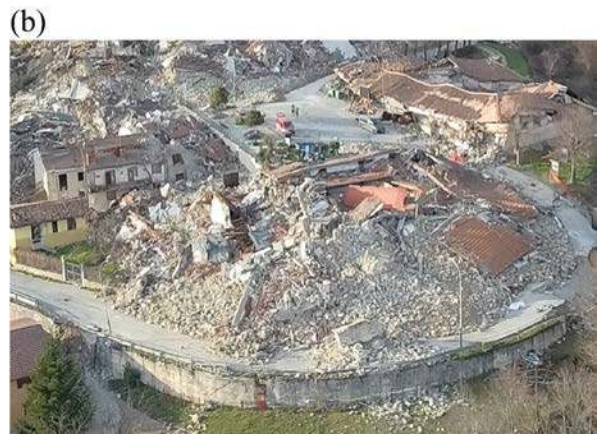
372 Figures 8a and 8b show an aerial view of the east part of the village during the first and  
 373 the second surveys, respectively, including the local church and the police station, which  
 374 eventually collapsed because of multiple earthquake excitations. **Figures 9, 10 and 11**  
 375 illustrate characteristic cases of minor-to-moderate shear and out-of-plane damage after the  
 376 August event that **led** to abrupt collapse because of the earthquake sequence. Age of  
 377 construction, high spectral accelerations for periods lower than 0.3s (which match the natural  
 378 periods of low-rise buildings) and the variation of spectral polarization across several events  
 379 were likely the main contributors to the observed catastrophic damage patterns. Given the  
 380 location of Accumoli, topographic effects may also have contributed to the observed damage.

382 **Figure 8.** Aerial photos of the east side of Accumoli after (a) the first earthquake and (b) the entire  
383 earthquake sequence.

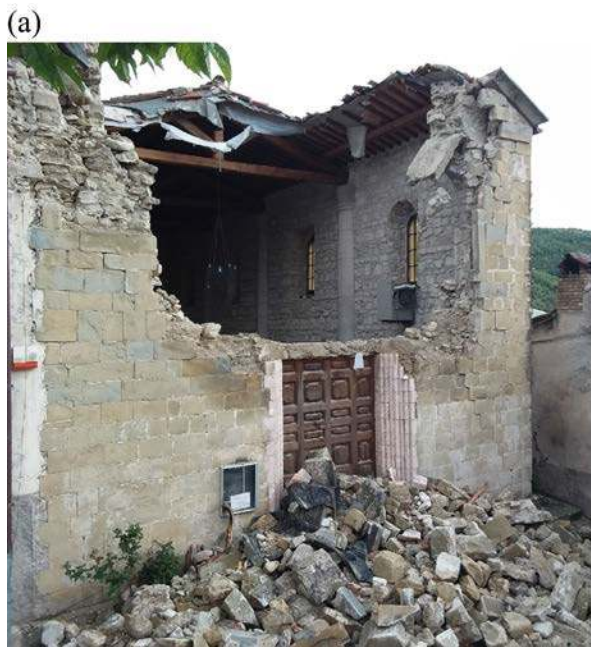
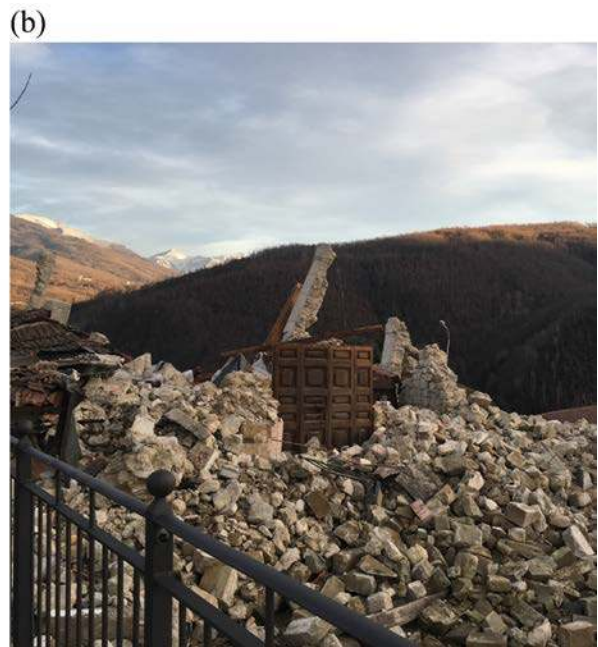
**Figure 9.** The local church: (a) after the first earthquake; and (b) after the entire sequence.

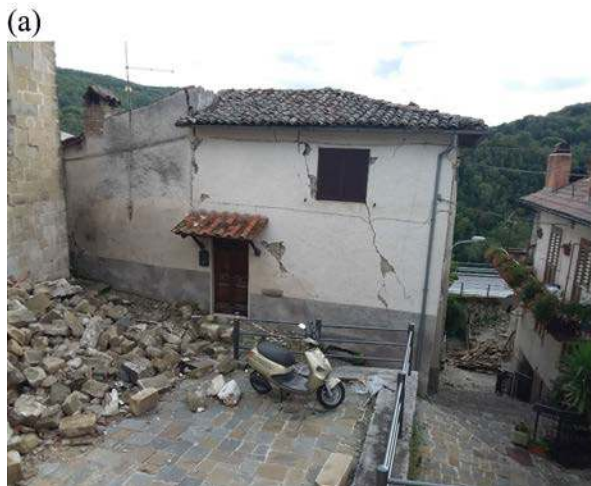
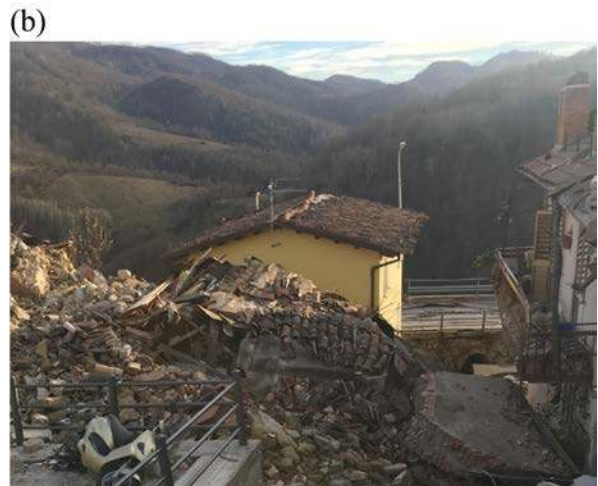
**Figure 10.** Masonry residential building: (a) after the first earthquake; and (b) after the sequence.

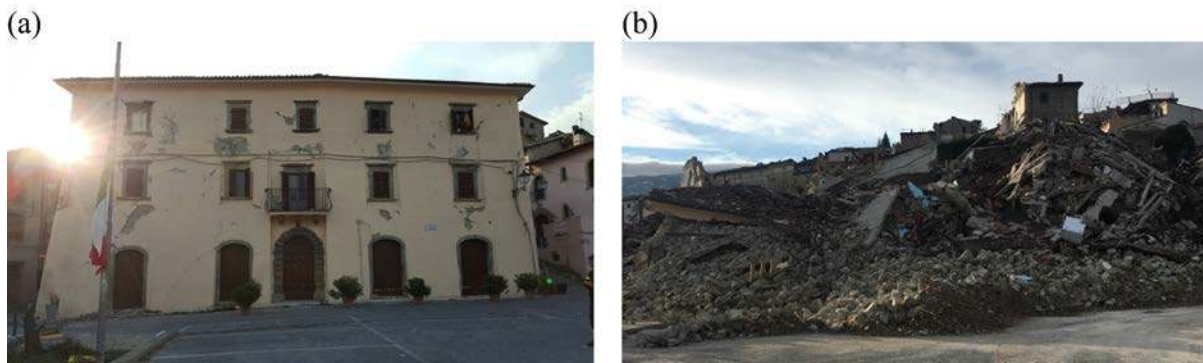
389 **Figure 11.** The town hall: (a) after the first earthquake; and (b) after the entire sequence.

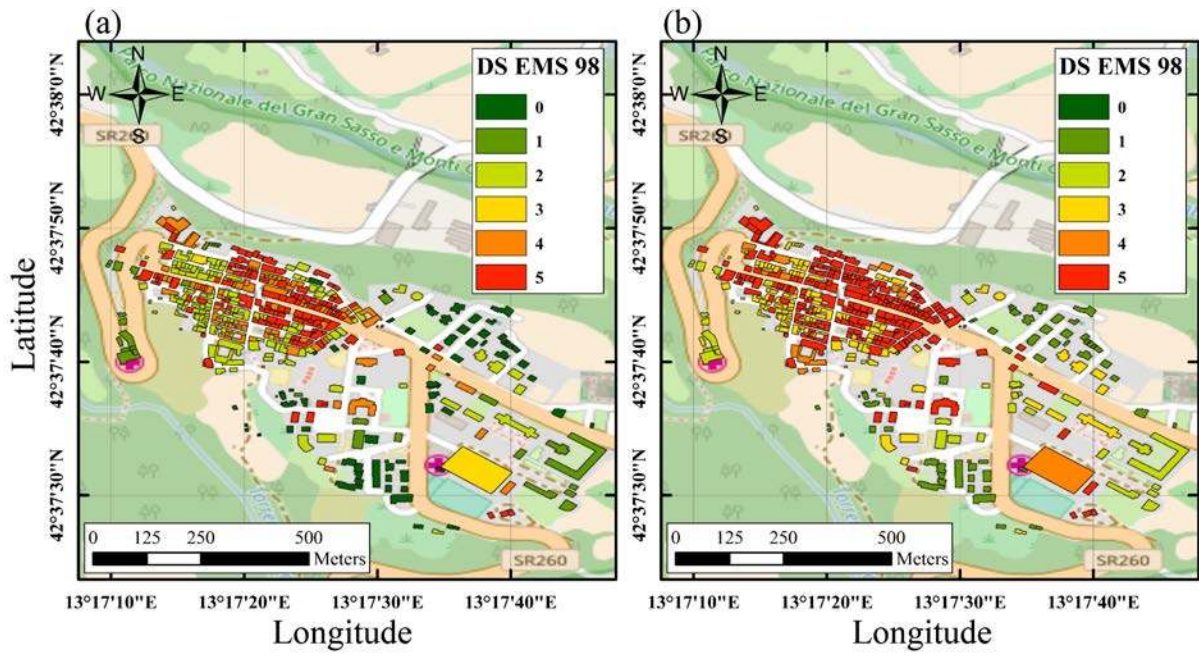
408 Figure 12 shows the structural damage levels observed during the two surveys. The 24  
409 August event caused severe damage to the south-east part of the historical city center along  
410 the main avenue (Corso Umberto I). As observed in the case of Accumoli, many buildings  
411 that were still standing after the first event with only a small residual capacity to additional  
412 horizontal actions, fully collapsed because of the subsequent September and October events.  
413 The **shifting** of damage states between the aftermath of the first event and the end of the

414 entire sequence is reflected in the following inspection results clearly indicating a major shift  
 415 to most critical damage states: intact buildings (D0) were reduced from 30% to 18%,  
 416 buildings with minor damage (D1) were increased from 5% to 10%, moderate damage (D2)  
 417 was reduced from 24% to 6%, D3 increased from 1% to 21%, D4 decreased from 17% to 3%,  
 418 and collapsed buildings (D5) had a significant increase from 23% to 42%.

419  
 420 **Figure 12.** Damage levels observed in the center of Amatrice (a) after the 24 August earthquake  
 421 (during the first survey), and (b) after the entire sequence (during the second survey).

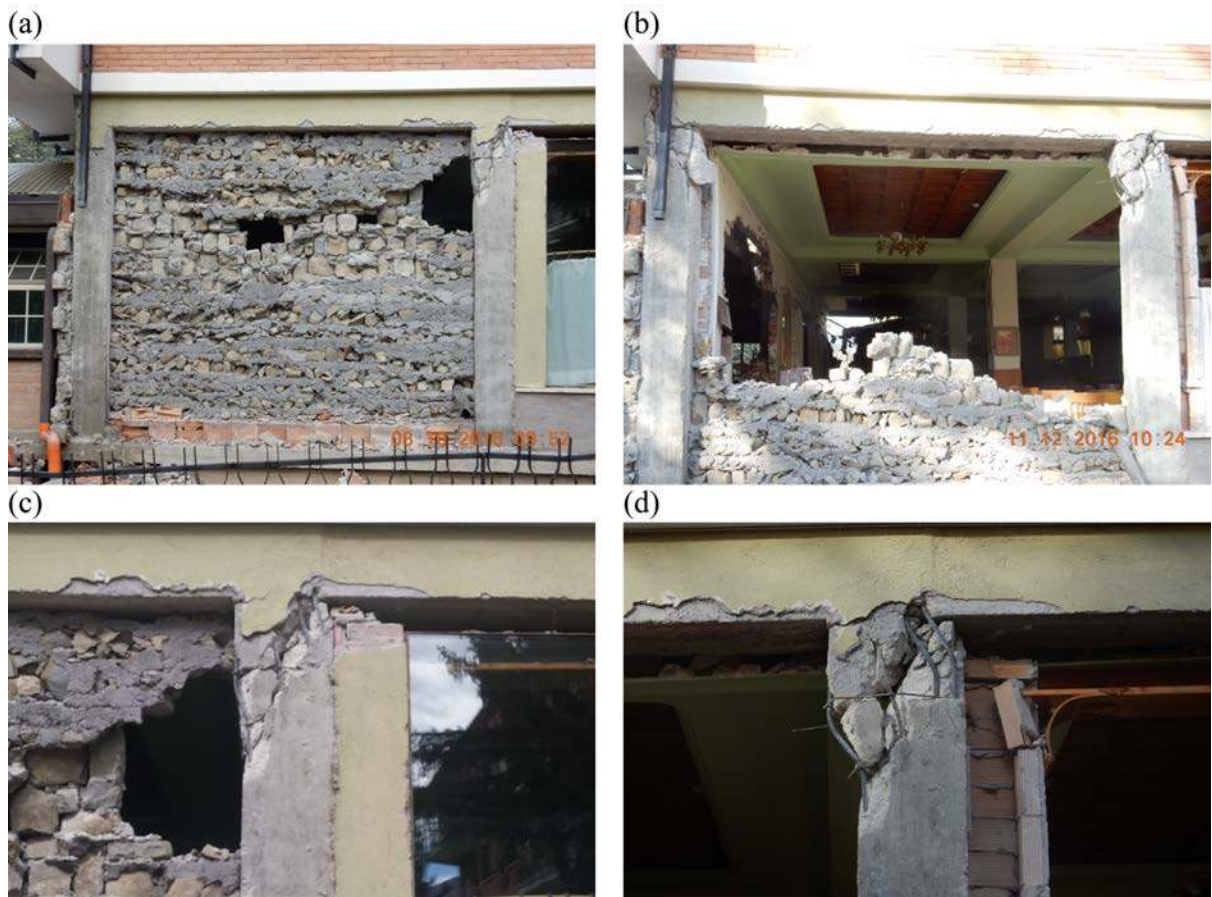
422 Even though the statistical sample of the reinforced concrete buildings was not adequate  
 423 to quantify how damage accumulates for different structural systems under multiple  
 424 earthquakes, an effort was made to compare characteristic cases at least qualitatively. An  
 425 example of a reinforced concrete building is illustrated in Figure 13. The partial out-of-plane  
 426 collapse of an external infill panel after the first event was followed by complete failure at the  
 427 end of the entire seismic sequence. A closer inspection of the top right beam-column joint  
 428 further reveals shear damage that was magnified, though not considerably, under multiple  
 429 excitations, i.e. the reinforced concrete structure retained some of its capacity thus avoiding  
 430 collapse. A similar example is shown in Figure 14. Cyclic degradation, concrete spalling and  
 431 minor longitudinal rebar buckling were indeed observed in the absence of adequate

432 transverse reinforcement, however, **global** damage state remained constantly moderate  
 433 despite the multiple earthquake events. In some cases, damage accumulation was more  
 434 significant, as for instance, in the building depicted in Figure 15, where minor damage after

446 **Figure 13.** Reinforced concrete residential building (a,c) after the 24 August earthquake and (b,d)  
447 after the entire sequence. (a,b) External infill failure and (c,d) shear failure at the column top.

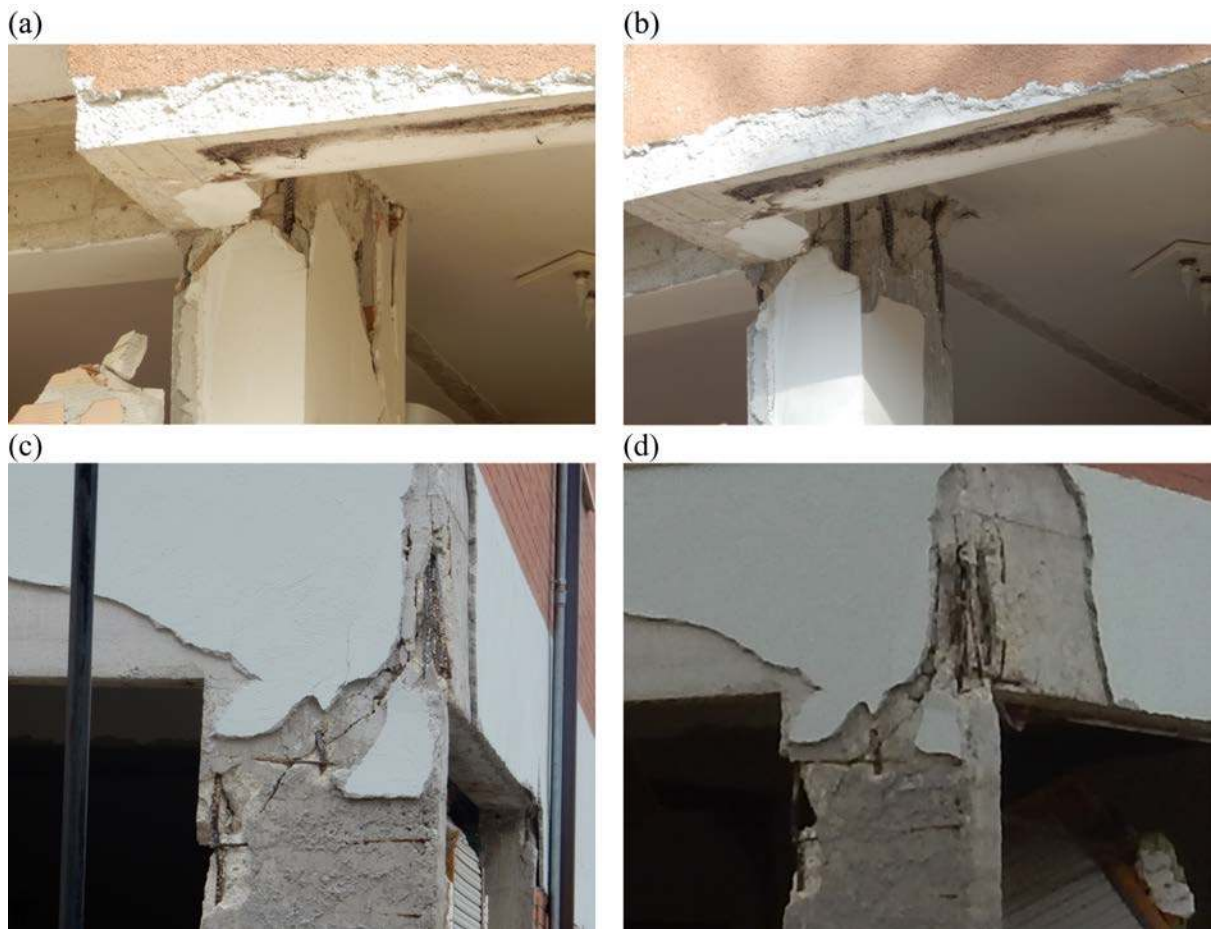
449 **Figure 14.** Beam-column joints. Concrete spalling and local bar buckling due to lack of transversal  
 450 reinforcement after the 24 August event (a,c) and after the earthquake sequence (b,d).

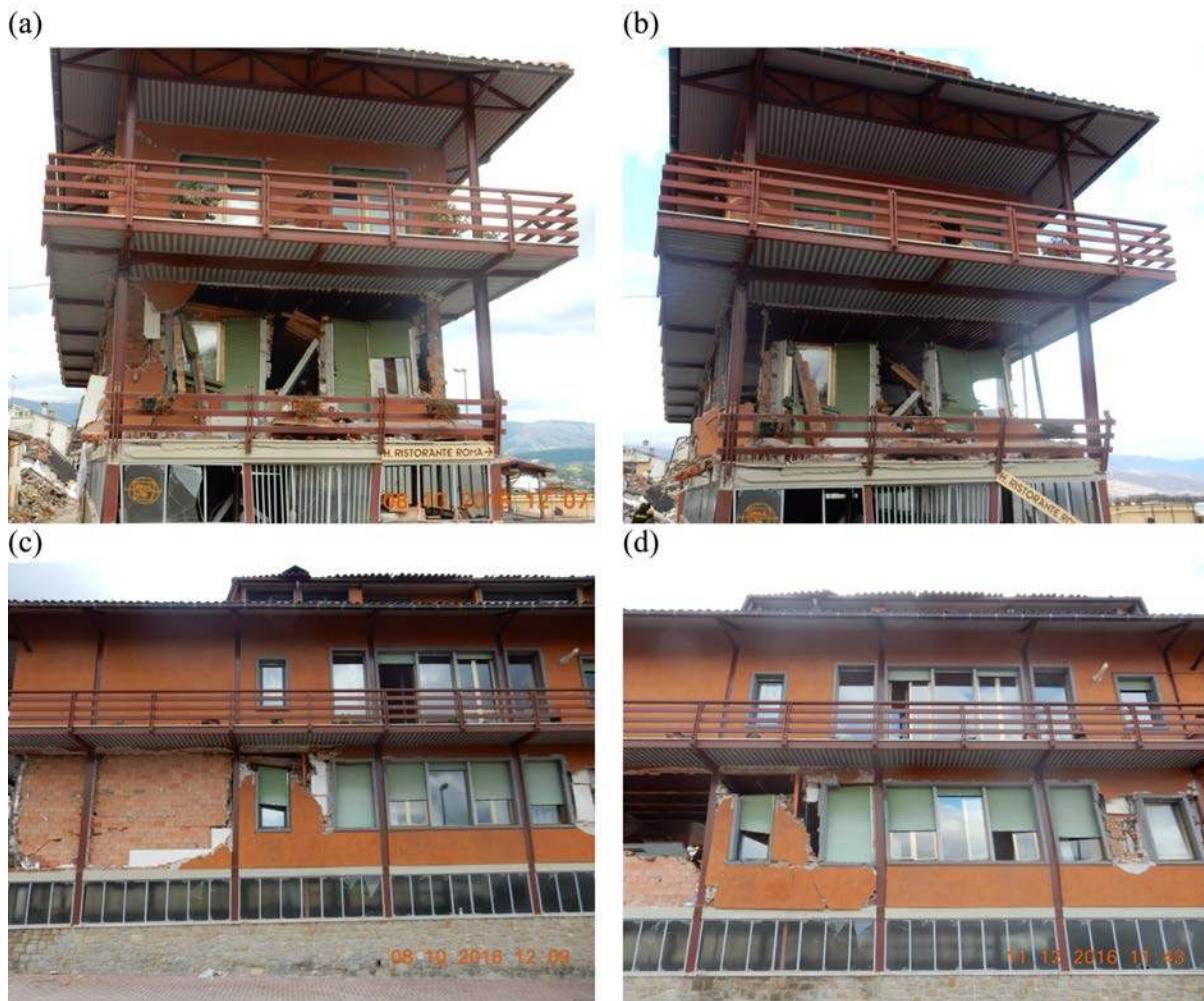
456 **Figure 16.** Steel residential building. (a,c) Limited damage after the 24 August earthquake and (b,d)  
 457 extensive damage of the infill panels at ground level with evident residual drift after the entire  
 458 sequence.

459 **Such a steel structure** consists of a basement, a ground floor, and two upper stories  
 460 alongside a shorter top story that serves as a penthouse. After the 24 August event, the  
 461 damage was mainly confined to the infill panels, with only small local flange instabilities  
 462 observed at the top of two front columns of the ground floor. At the end of the entire seismic  
 463 sequence, the building experienced permanent deformation along its longer direction, as  
 464 shown in Figure 16. Such permanent deformation was localized at the second level of the  
 465 building with a visible residual inter-story drift due to the relative positions of infills and  
 466 openings. Preliminary finite element analyses of the building confirmed that the fundamental  
 467 period of the structure is approximately equal to 0.75 sec. This was an uncoupled  
 468 translational mode along the long side, which was mainly attributed to the orientation of the

469 steel columns with their strong axes aligned with the short side of the building. Naturally,  
 470 residual drift developed along the longitudinal (weak) axis. Evolution of structural damage is

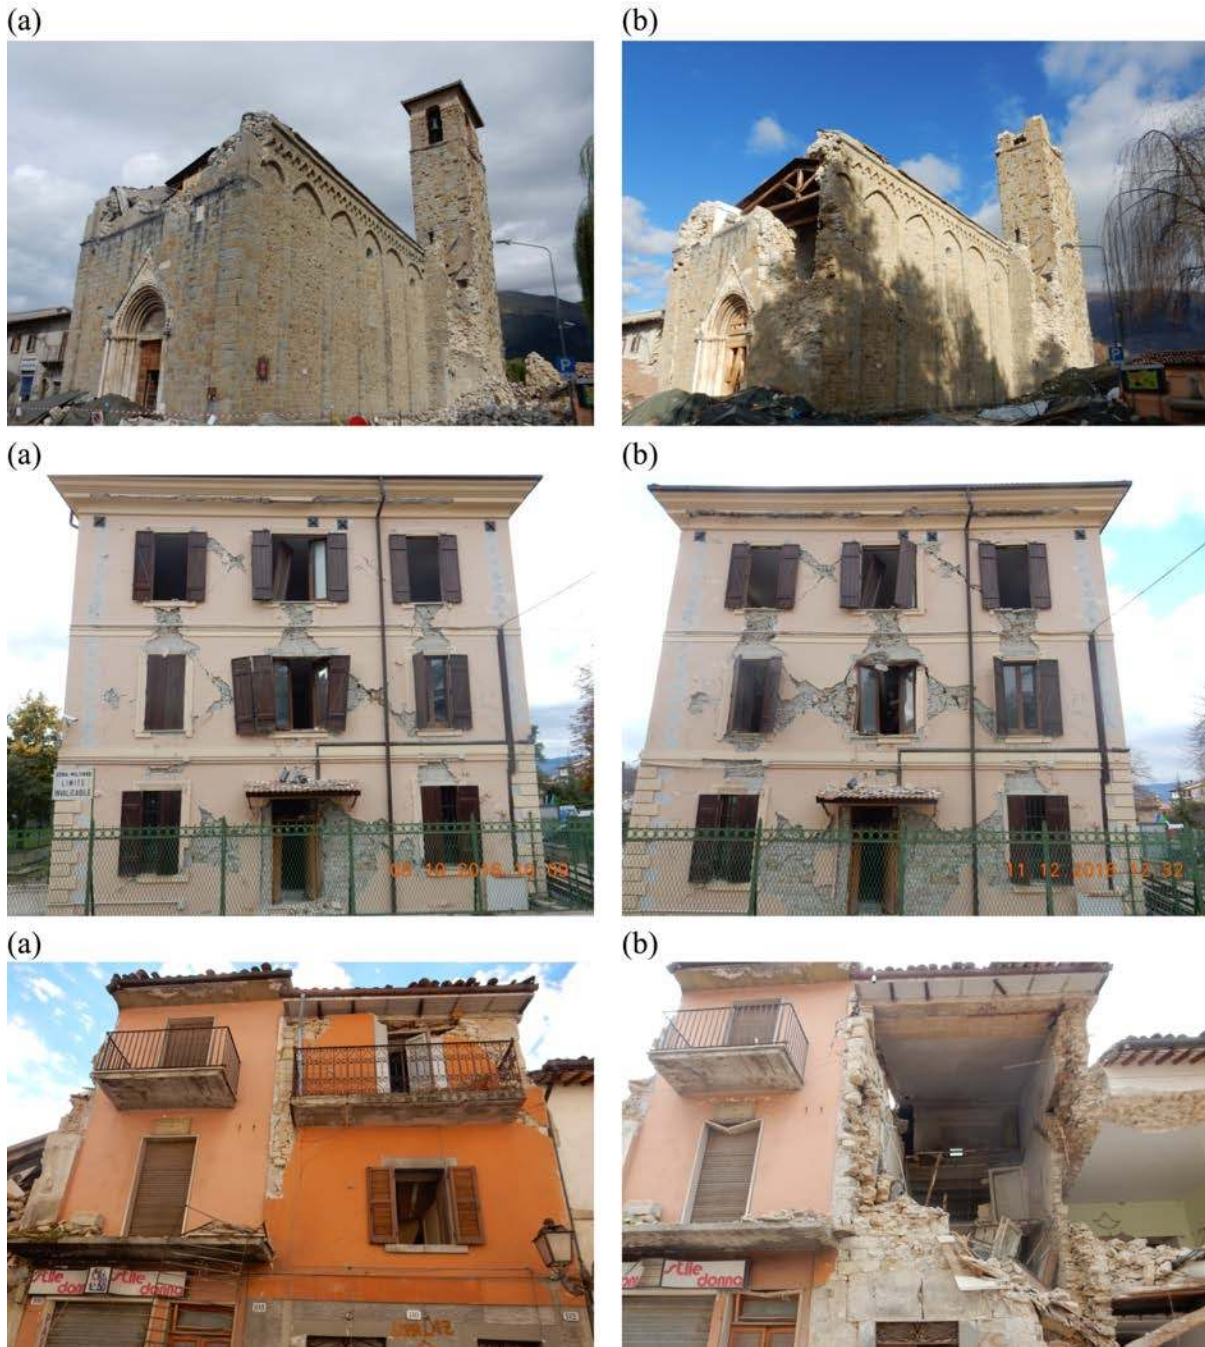
471 also clearly seen in several characteristic masonry structures, such as the church of  
472 Sant’Agostino (Figure 17, top), the local police (“Carabinieri”) station (Fig. 17, middle) and  
473 typical residential buildings (Fig. 17 bottom and Fig. 18).

475 **Figure 17.** Incremental structural damage of the church of Sant’Agostino (top), the local police  
476 station (middle) and one of the several masonry buildings collapsed after (a) the event of 24 August  
477 earthquake and (b) the entire sequence.

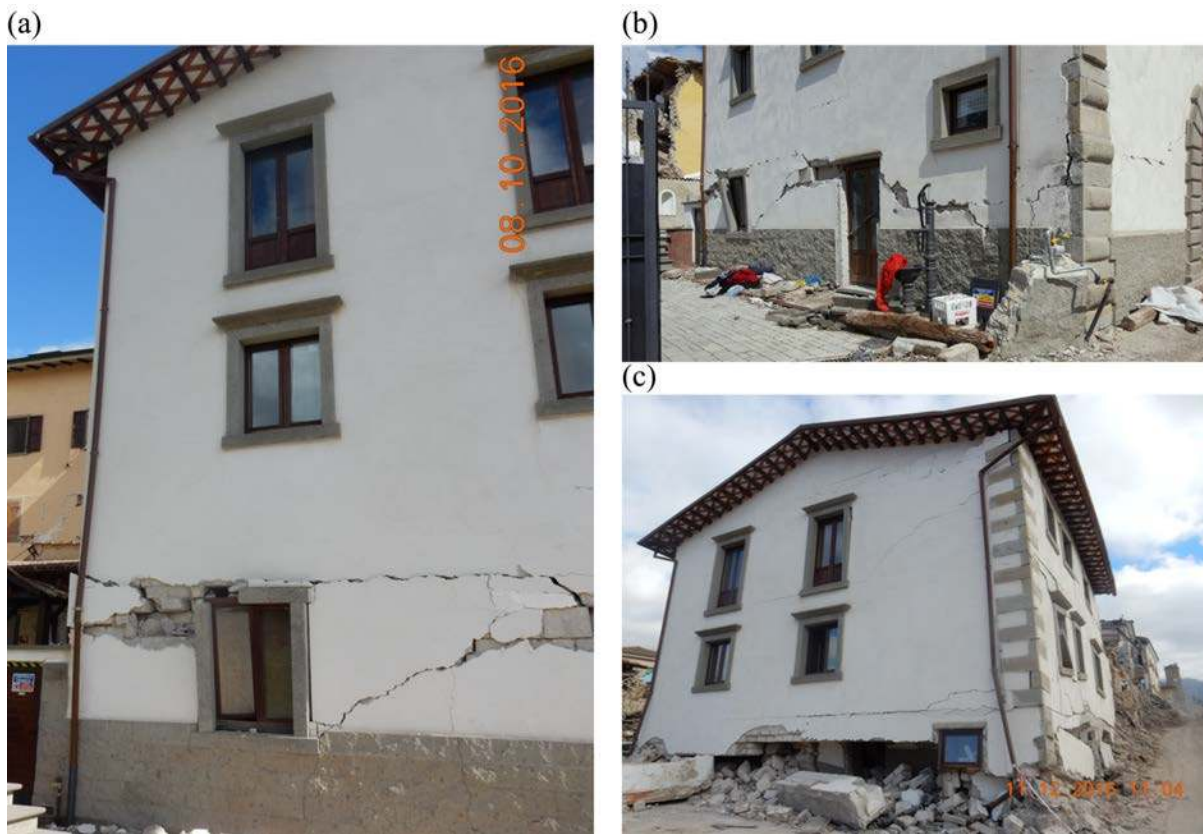
479 **Figure 18.** Residential masonry residential building after the 24 August earthquake (a, b) and (c) after  
480 the entire sequence. Shear failure of the ground floor bearing wall leads to soft story collapse at the  
481 end of the third event.

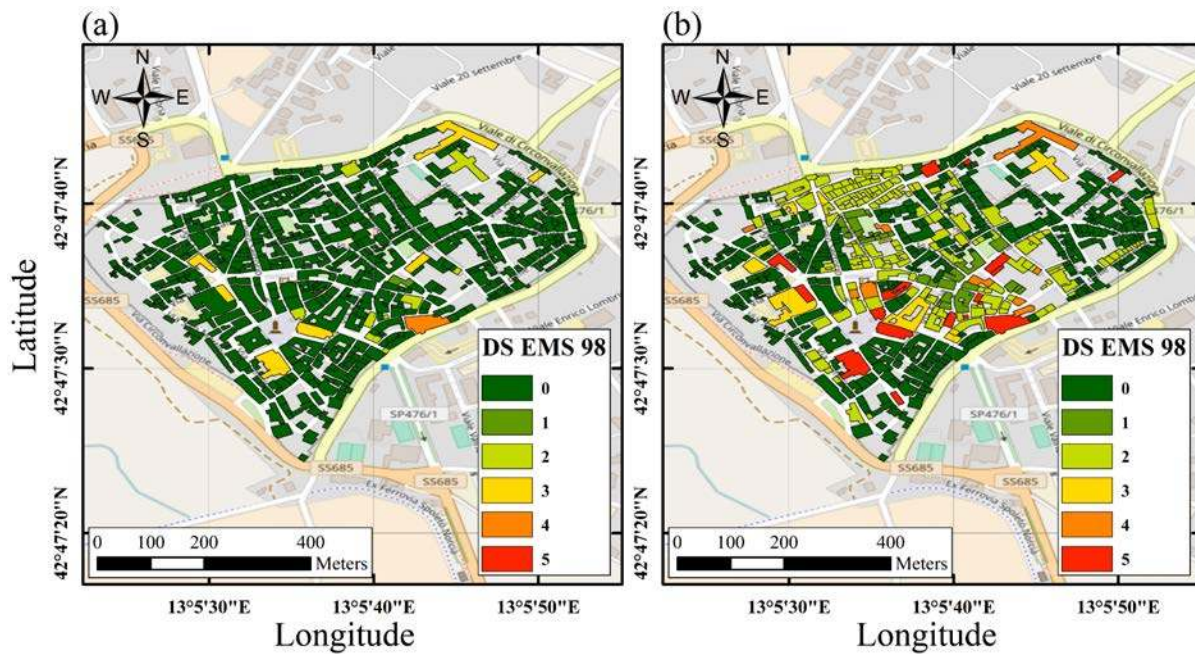
514 Figure 19 shows the structural damage levels observed during the two inspection  
515 campaigns. Following the 24 August earthquake, only a small number of buildings  
516 experienced medium or severe damage, located mainly in the historical center of the town.  
517 This good performance can be primarily attributed to two reasons. First, after the 1859  
518 earthquake, the reconstruction of Norcia was based on a set of new practical rules of thumb  
519 prescribing a minimum wall thickness, the use of buttresses, the reduction of building height,  
520 the use of vaults only at ground floor and the mandatory presence of good wall-to-wall  
521 connections. The increased wall thickness is still visible in many structures, and in several  
522 buildings, the wall thickness varies linearly along the height of the first story. Secondly, a  
523 series of repair and strengthening works followed the 1997 Umbria-Marche event, **which**

528 observed at the end of the seismic sequence, mainly in heritage construction such as churches  
 529 and monasteries. The following variation of cumulative damage was reflected in the  
 530 statistical distribution of the different damage states: intact buildings (DS0) were reduced  
 531 from 97% after the first earthquake to 67%, which was a substantial change in structural  
 532 behavior. Minor damage (DS1) also increased at the end of the entire sequence to 4% from  
 533 almost 0% after the first event. The same applies to moderate damage (DS2), it increased  
 534 from 1% to 24%, previously, and to DS5 increased from 0% to 3% in the first event, DS3 and  
 535 DS4 remaining practically constant.

536  
 537 **Figure 19.** Damage distribution in the historical center of Norcia (a) after the 24 August event and (b)  
 538 at the end of the entire seismic sequence.

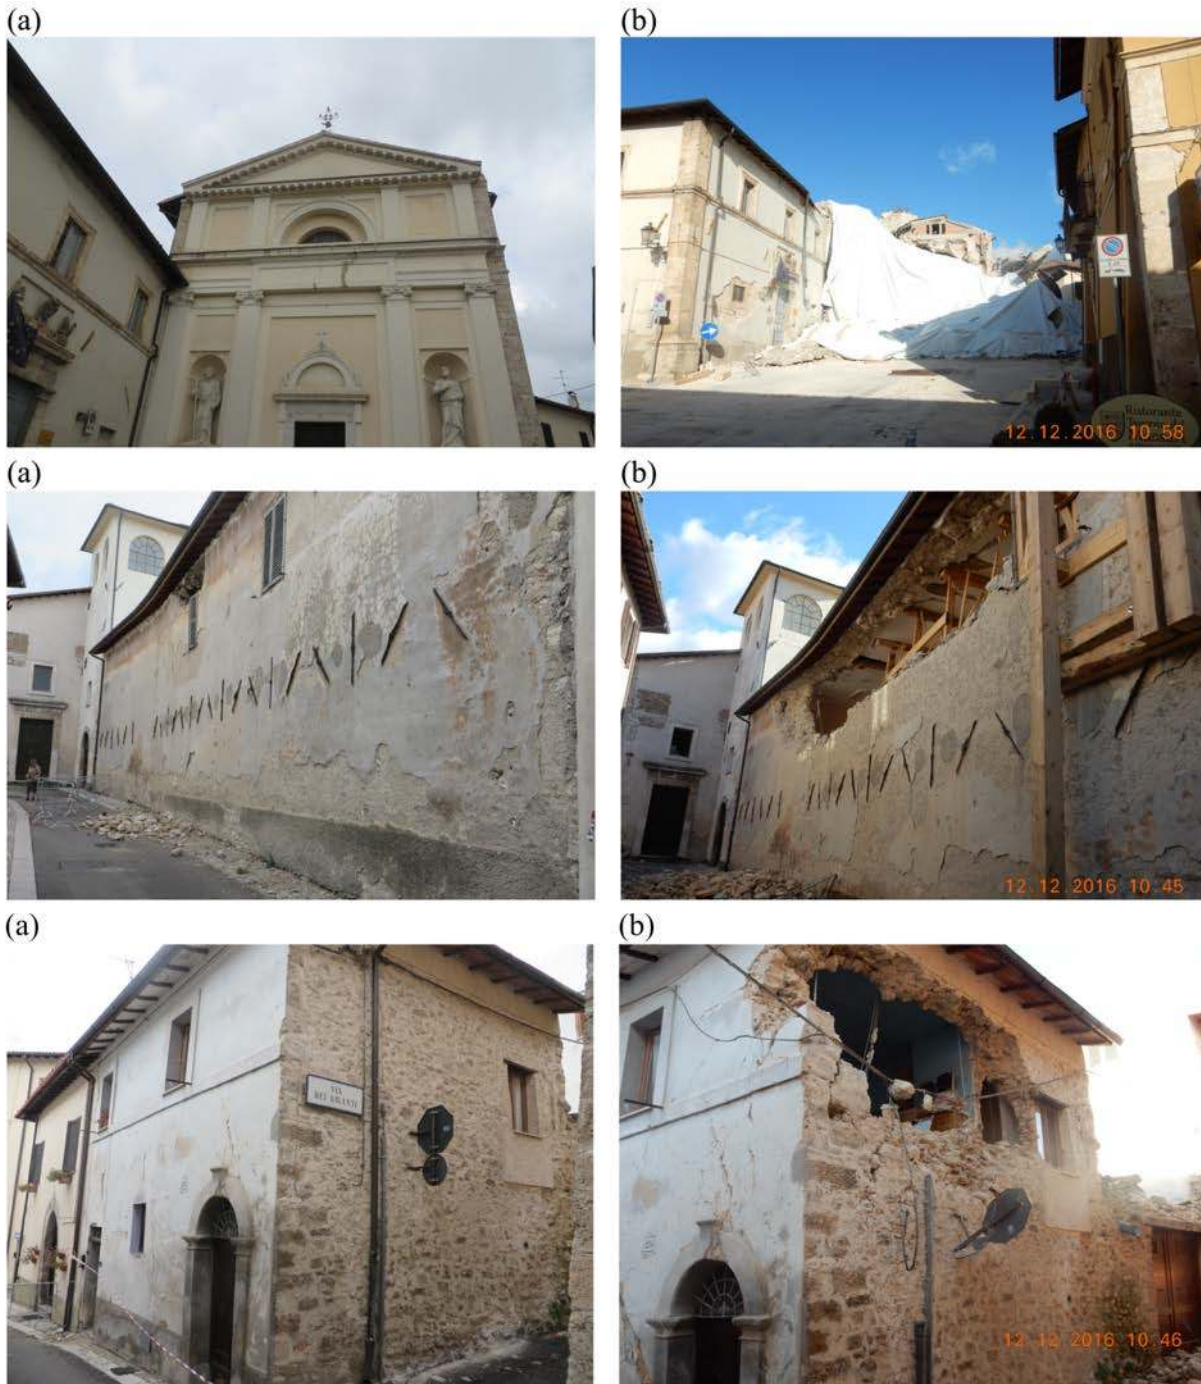
539 Figure 20 (top) shows one of the churches that was slightly damaged by the M6.1 24  
 540 August seismic event but collapsed following the M6.5 30 October event. Many historical  
 541 churches in Norcia experienced similar damage evolution, as shown for instance in Figure 20  
 542 (middle), where the out-of-plane failure of a historic monastery and the partial loss of support  
 543 of the roof is depicted. Notably, the wall failure was concentrated at a level higher to that of  
 544 the seismic retrofit, thus highlighting that the retrofit shall not be only localized on the  
 545 ground level but also take into consideration the reduced axial load and weak diaphragm  
 546 action of the masonry walls at the higher level. Figure 20 (bottom) shows two masonry  
 547 residential buildings with irregular masonry construction that experienced only minor  
 548 cracking during the first earthquake, but significant out-of-plane and in-plane wall failure

549 under subsequent events.

551 **Figure 20.** Seismic damage observed in characteristic masonry buildings (a) after the 24 August  
 552 earthquake and (b) at the end of the entire seismic sequence.
