# Local site effects and incremental damage of buildings during the 2016 Central Italy earthquake sequence

## ABSTRACT

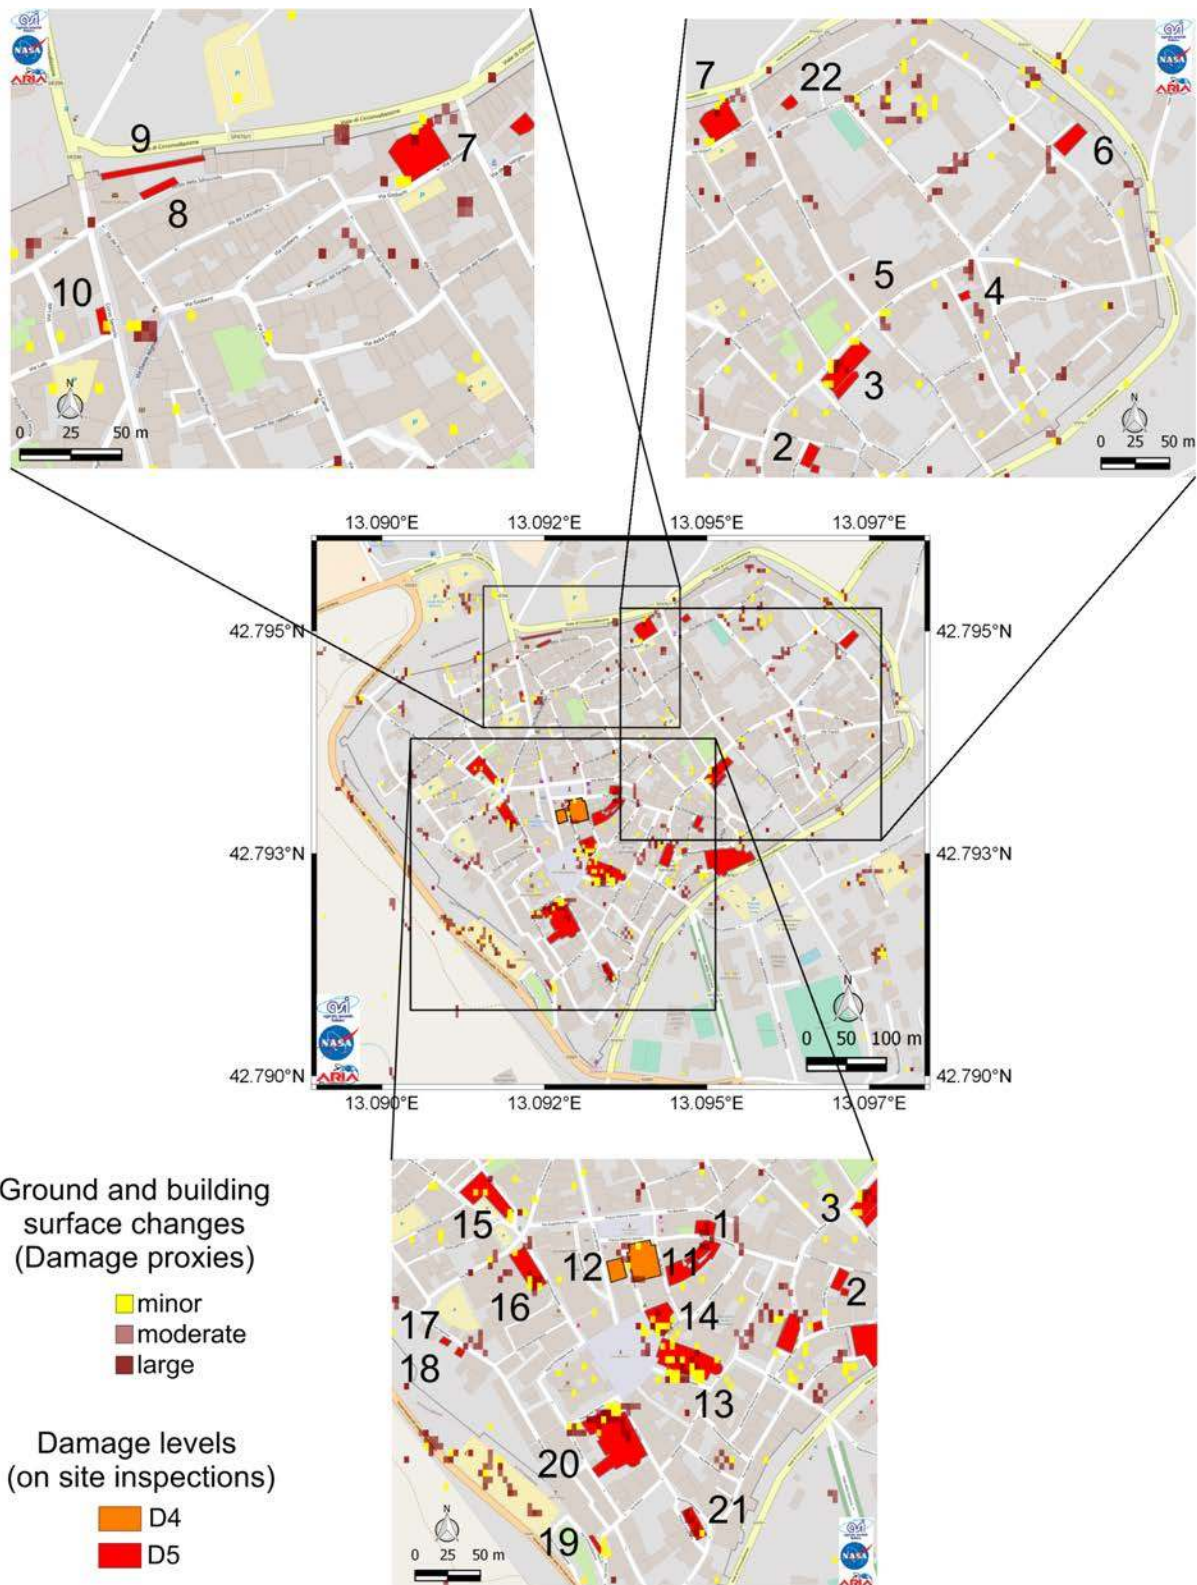
579 Figure 21 shows the DPM produced for the historical center of Norcia after the **M6.5** 30  
580 October event, that is, the end of the earthquake sequence, superimposed with 22 structures  
581 that were classified visually as completely collapsed (D5), and selected D4 structures.

582 By comparing the locations of these mapped structures and the damage zones from ARIA  
583 imaging, a good agreement was observed. In particular, for all structures with an assigned  
584 damage level of collapse (D5), the DPM accurately showed a concentration of red and dark  
585 red zones, representing areas in which substantial deformations occurred.

587 **Figure 21.** Damage proxy map of Norcia, along with the identification numbers of all structures with  
 588 assigned damage level D5 and selected structures with assigned damage level D4, from field  
 589 inspections and available high-quality on-site information and photos.
