LONG RANGE INSPECTION OF RAIL USING GUIDED WAVES - FIELD EXPERIENCE

P. Cawley¹, P. Wilcox², D.N. Alleyne², B. Pavlakovic², M. Evans², K. Vine² and M.J.S. Lowe¹
¹ RCNDE, Dept Mech Eng, Imperial College, London, UK ² Guided Ultrasonics (Rail) Ltd, 17 Doverbeck Close, Nottingham, NG15 9ER, UK

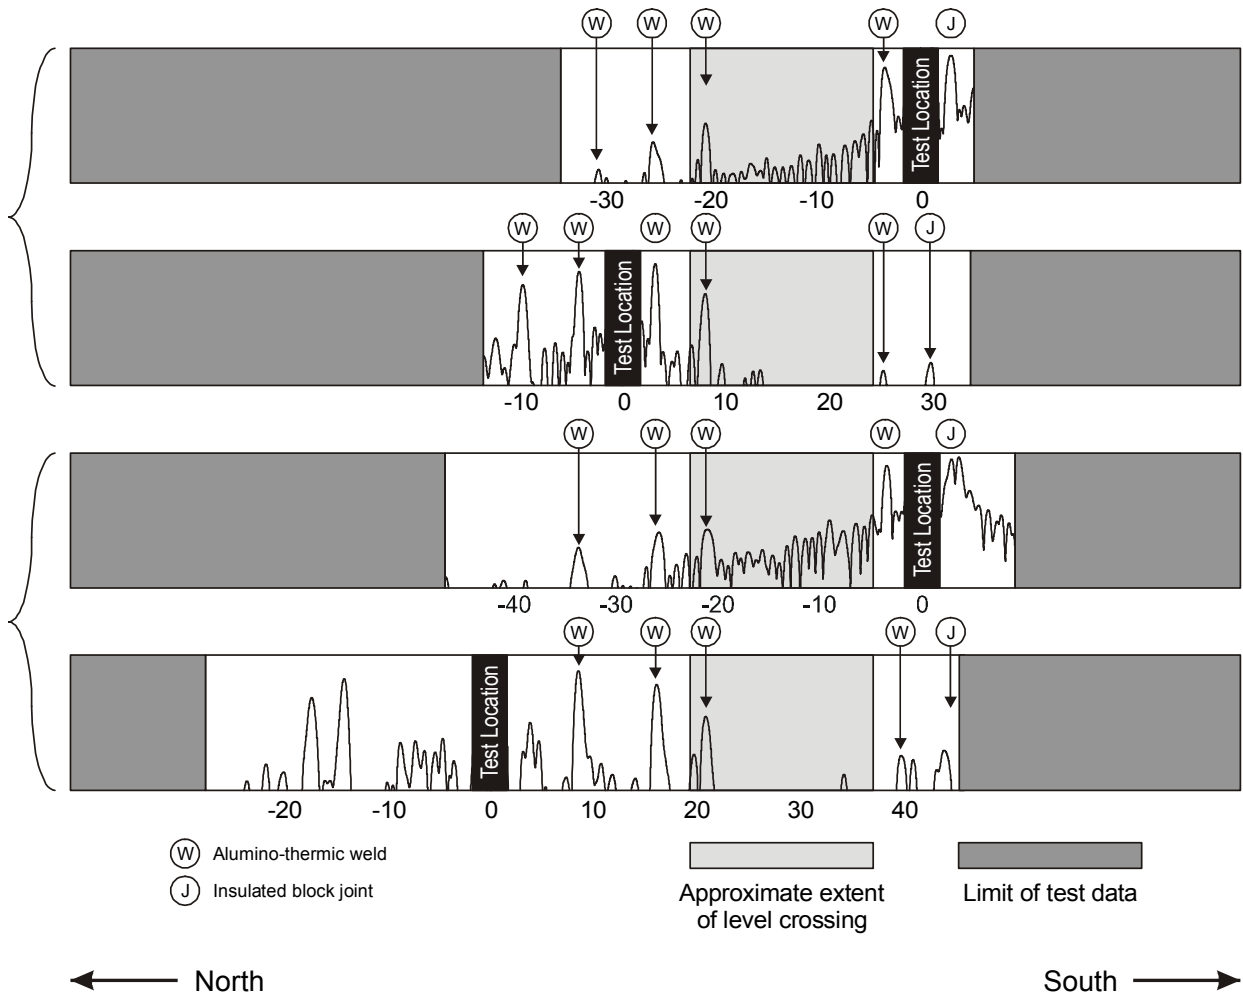
In the 'up' line results shown in Figure 4, signals corresponding to documented alumino-thermic welds and insulated block joints are clearly identifiable in all the results. The results from the rails on the 'up' line are reasonably clean and indicate the level of background coherent noise that may be expected on rail in good condition.

The decaying signals that are visible in the two results when the test location was on the south side of the level crossing are due to reverberations. The mechanism that causes these reverberations is not yet fully understood, but it is thought to be due to the relevant test locations being in-between two large reflectors (an alumino-thermic weld and an insulated block joint) that are in close proximity. These reverberation signals do not correspond to physical features in the rail.

Figure 4. Results obtained from the 'up' line at the level crossing. Distances from the test location are marked in metres.

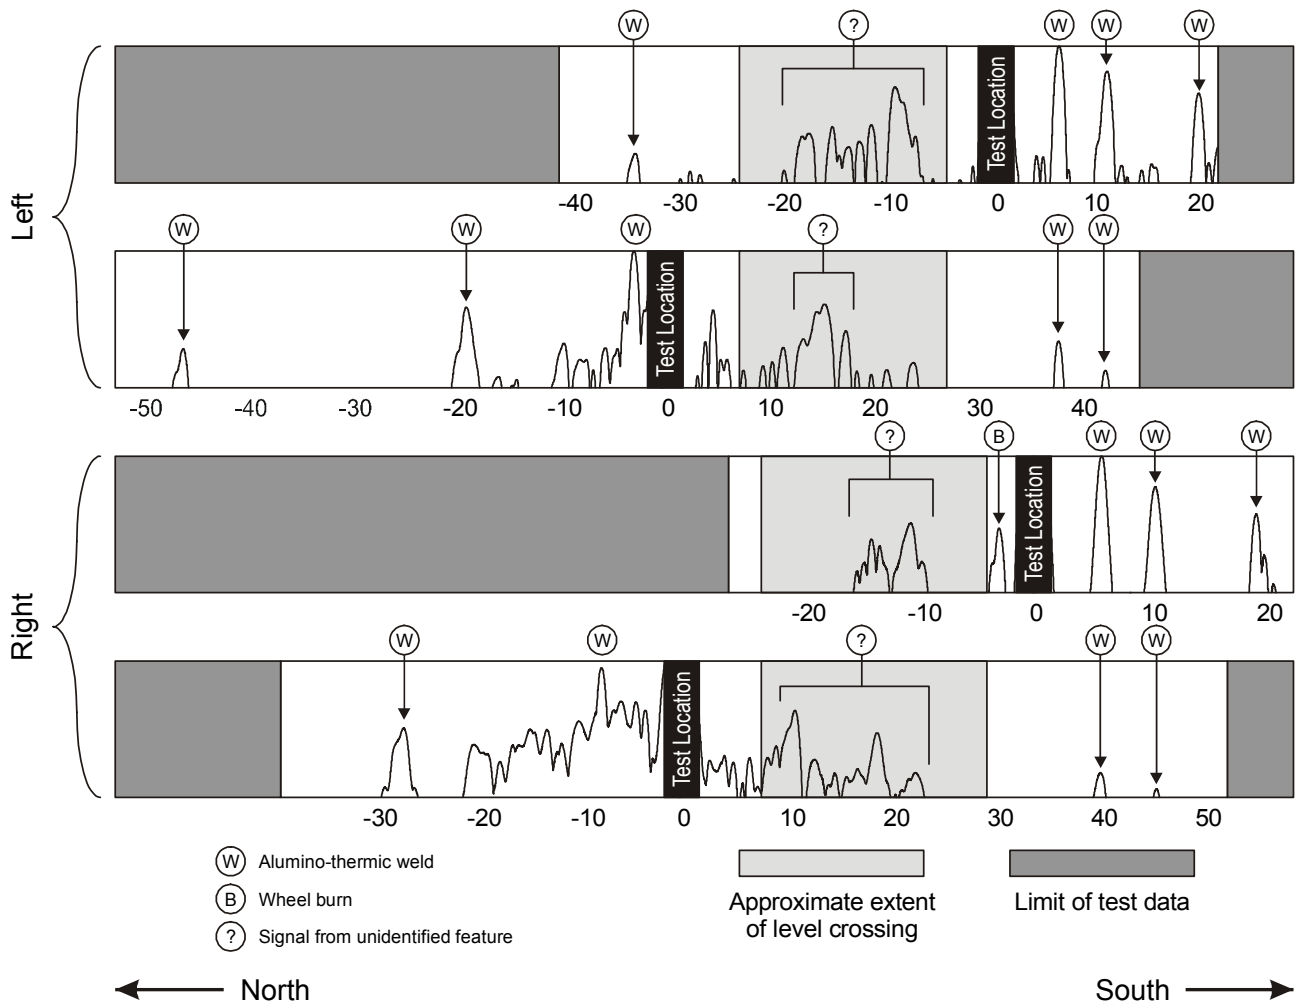
The results from the 'down' line shown in Figure 5 are markedly different from those obtained on the 'up' line. Again, signals from alumino-thermic welds are clearly visible but there are also numerous other distinct signals present that do not correspond to any documented features. When the right hand rail was tested from the south side of the level crossing, a signal was observed just before the rail entered the level crossing area (marked B in Figure 5). Visual inspection revealed that there was a wheel-burn at this location. There were several other wheel-burns in the vicinity on this line, but none of the others gave a significant G-Scan signal, hence indicating that this particular wheel-burn may have had greater transverse penetration of the rail than the others.

There are also a large number of signals present within the crossing on the 'down' line (marked '?' in Figure 5) that do not correspond to known features. The ragged nature of these signals is indicative of corrosion rather than man made features, and the reflection coefficient maps [1] suggest that many of these signals correspond to a loss of material in the foot of the rail. It is therefore reasonable to conclude that the rail on this line has experienced a moderate degree of foot corrosion. The rail on this line was visually observed to be somewhat older than that on the 'up' line.

Figure 5. Results obtained from the 'down' line at the level crossing. Distances from the test location are marked in metres.
