Management of Building Collapse in Nigeria: A Lesson from Earthquake-Triggered Building Collapse in Athens, Greece

In this study, aseismic investigation and retrofits of a collapsed residential building in the Olympic city of Athens in considered. Its aim is to investigate the causes of the collapse and provide mechanism(s) for strengthening the earthquake affected building with the aid of finite element programs-SAP and pi-DESIGN. Figure 1.0 show the ground floor plan produced with pi-DESIGN.

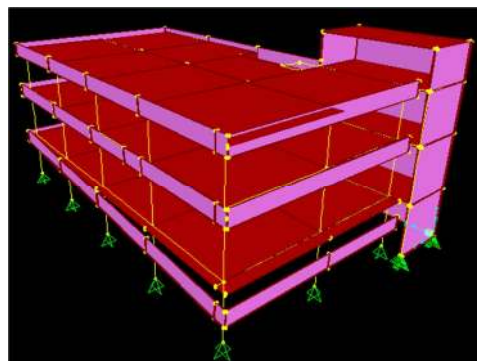
Figure 8. Deformed Shape of the Model

The deformed shape of the model corresponds to the exact mode of failure of the real structure and the deformation is the same as the one observed in the real structure.

The results from Figure 8, 9, and 10 shows that the structural displacements are concentrated at the ground floor with severe damages to the ground floor walls and the slab frame. We observed upward-down displacements of the ground floor slab frame and this shows that the seismic waves (vertical components) were not adequately absorbed by the upper floors. The second floor of the building lying immediately above the damaged floor was excessively reinforced. In other words, the stiffness of the second floor is too high compared to the first floor. Consequently, the seismic waves were reflected back causing high level of impacts and resulted to a decrease in the stiffness of the lower floor slabs and the load bearing columns. This in turn resulted to severe damages of the walls and the slab frame with little or no effects on the upper floors.

The behaviour of the collapsed building before strengthening was unsatisfactory and the failure of the structure can be attributed to its poor design. The distribution of the stiffness in the structure was not well taken care of and this is the basis of the observed damages that the building sustained when the earthquake occurred. The reduction in the stiffness and resulting friction of the ground floor slabs, and the load bearing columns were the main causes of the building collapse.

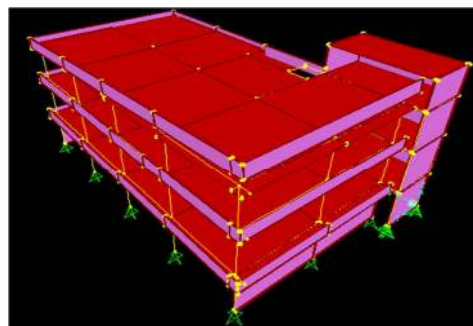
Figure 11. Deformed shape of the model

The results from Figure 11, 12, and 13 shows that the deformed shape of the model are different from the one observed earlier before strengthening. The stiffness of the basement has been increased and the behaviour of the structure is better than the one observed earlier. After strengthening, the ground floor including the basement was more stable than the upper floors and least displacements were observed at the ground floor.
