# MQXFA11 shipping incident report

US-HiLumi-doc-4341

Date: 08-08-2022

## US HL-LHC Accelerator Upgrade Project MQXFA11 shipping incident report

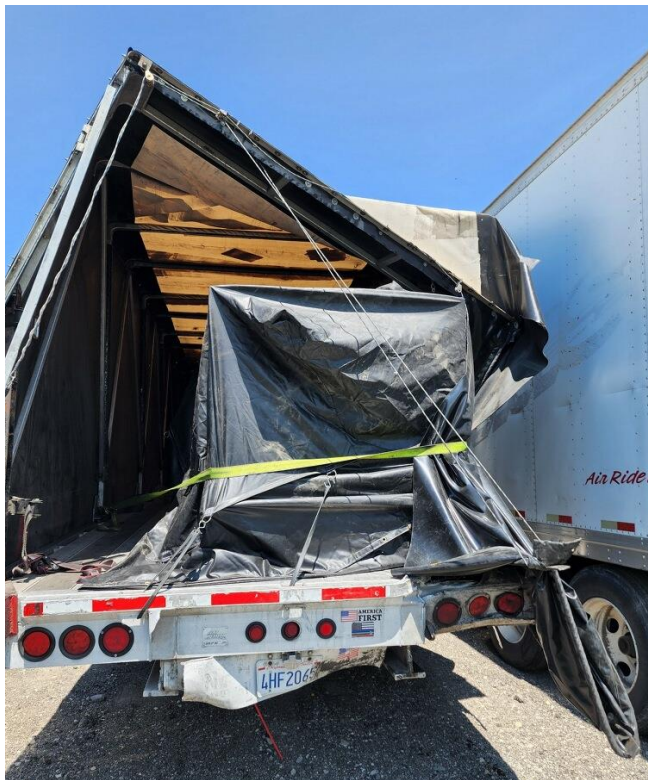
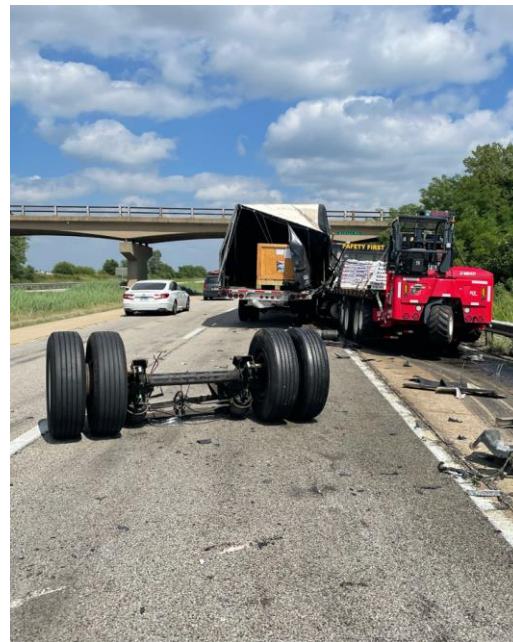
The main hit took place on the right back corner (see Fig. 1). During the incident the truck rear axle as displayed in Fig. 1 (right panel).

Figure 1: Pictures of the truck taken right after the incident.

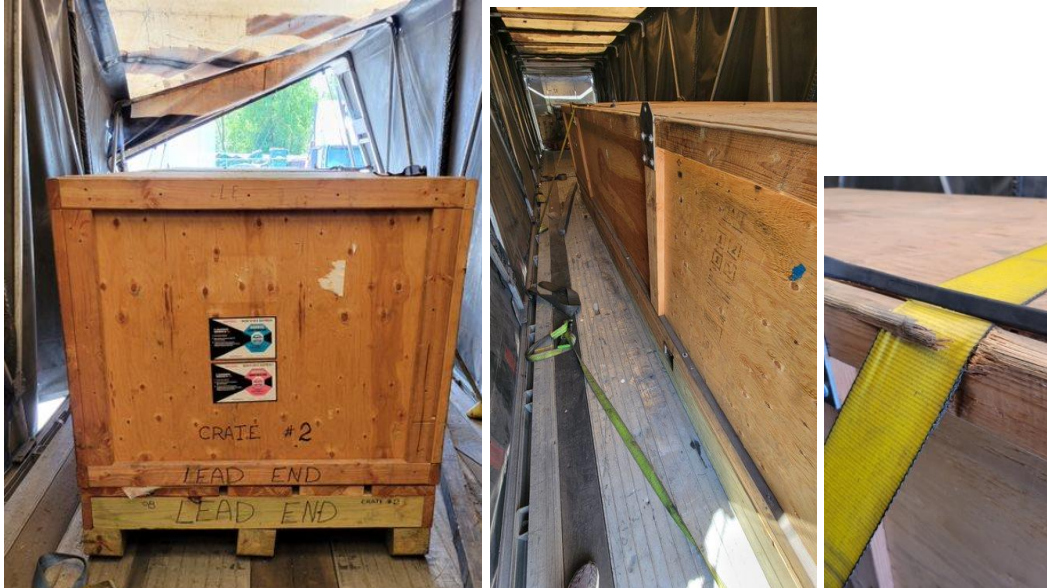
Figure 1: Left to right: Photo of the lead end of the crate/magnet taken after the incident from the cab end of the trailer; The yellow sling was found close to the metallic tab; detail of the yellow ling after the incident

The rear end of the crate was found shifted toward the passenger side of the trailer. One of the slings was broken and the crate moved backward 6-7' according to the position of the undamaged sling (see details in Fig. 1).

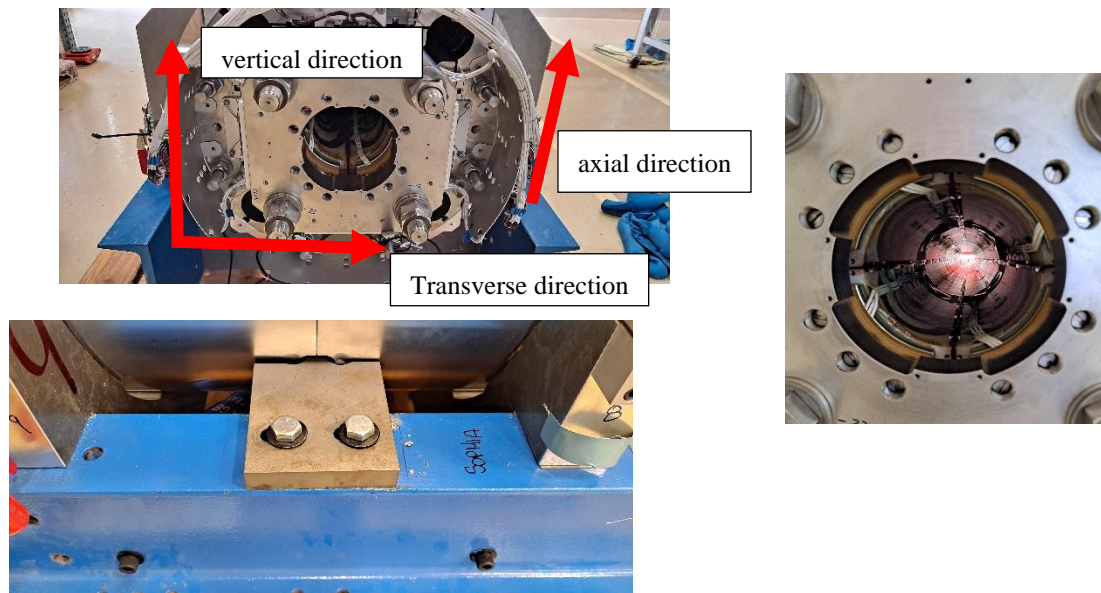
The magnet was found in very good conditions. In Fig.2 pictures of the end plate, the bore and the longitudinal stopper are displayed. There are no signs of damage.

Figure 2: Photos of the return end, magnet bore, and longitudinal stopper taken at FNAL during the visual investigation

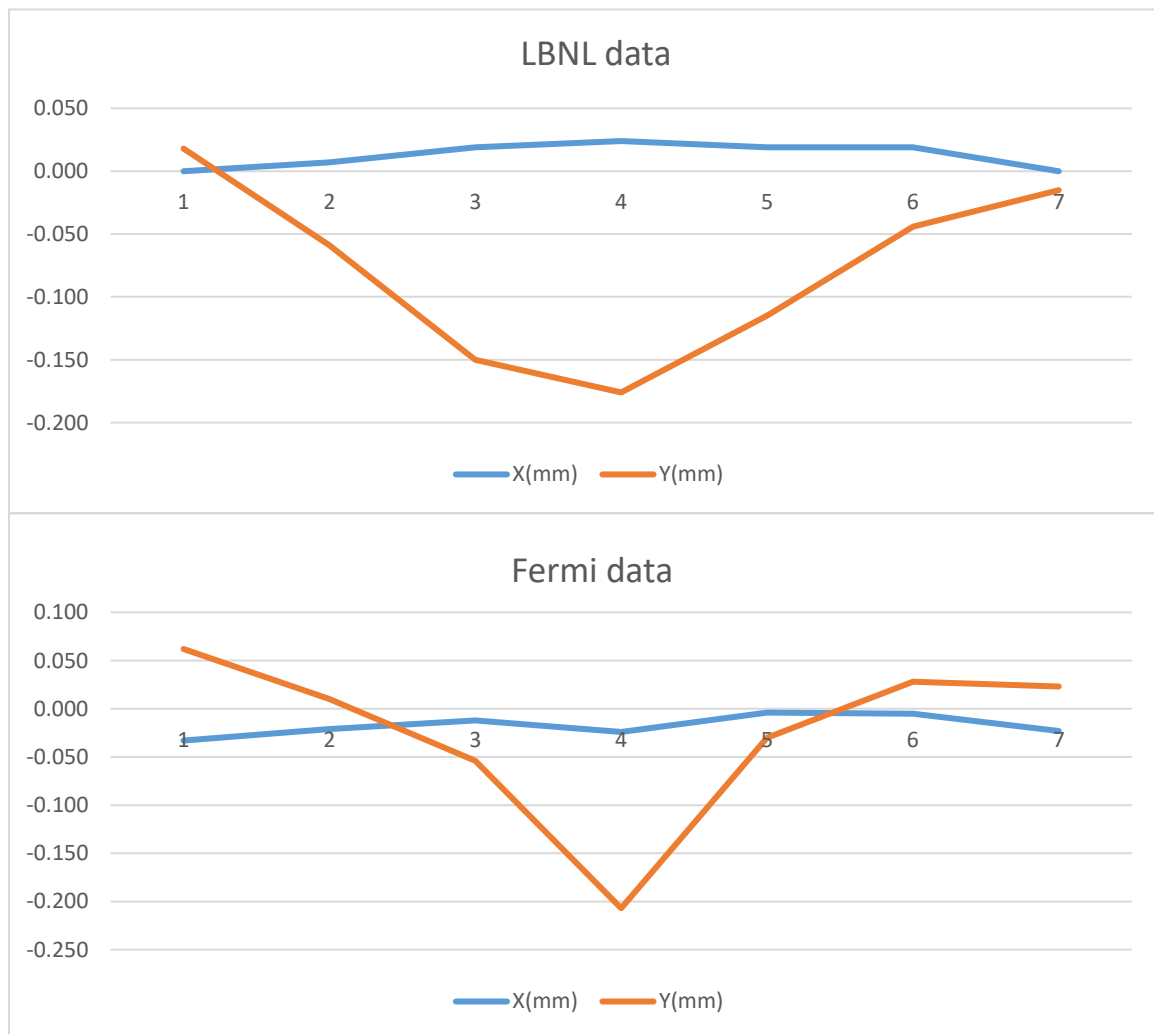
Finally, a metrology survey was performed to check the MQXFA11 straightness. The measurements are taken longitudinally in seven points. It is worth noticing that the measurements were taken with the magnet sitting on a table at LBNL and with the magnet sitting on the shipping fixture at FNAL. X and Y values indicates a point on the magnet circumference along the transverse direction and the vertical direction as defined in Fig. 4. Data taken at LBNL and FNAL are show in Fig. 3. The general behavior of the data is in good agreement as well as the maximum deflection along y.

Figure 3: Measurements of magnet MQXFA11 straightness along the vertical and transverse directions taken at LBNL and FNAL.

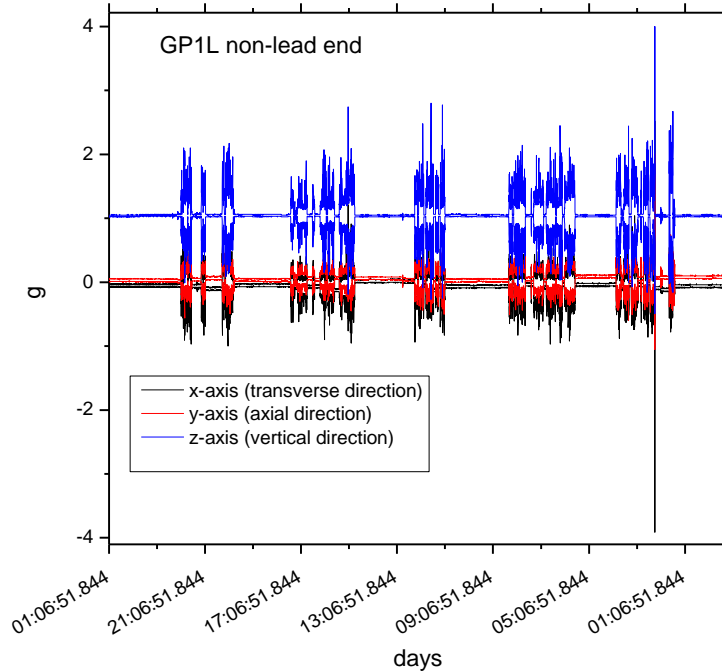
In Fig. 5 and 6, the lead end and the non-lead end shock snapshots of the entire trip is shown. The truck incident corresponds to the highest peaks observed in the two plots. it takes place on July 20<sup>th</sup> at 18:50 UTC. No data saturation is observed over the entire trip. The highest shocks (a little bit over 4g) are observed in the vertical and transverse

Figure 5: Snapshot of the shocks collected with the device installed on the non-lead end clamp

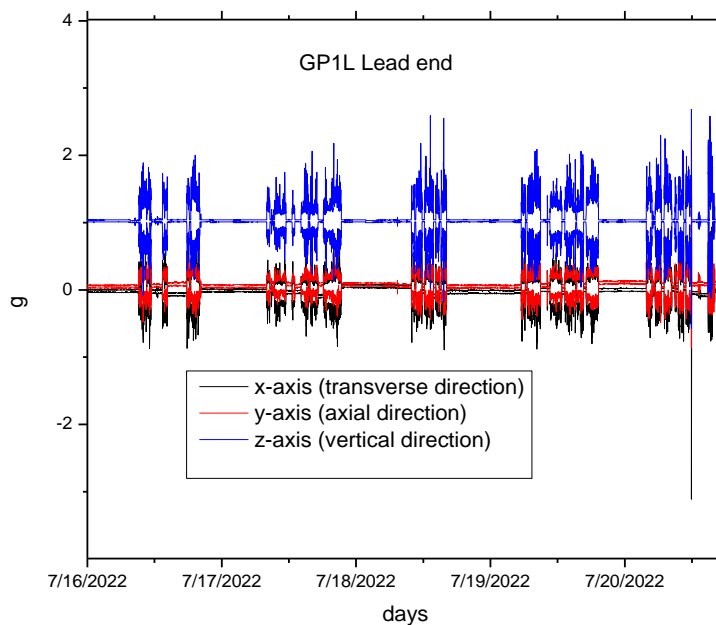
direction in the non-lead end device. No vertical high shock is observed on the lead and device.

Figure 6: Snapshot of the shocks collected with the device installed on the lead end clamp

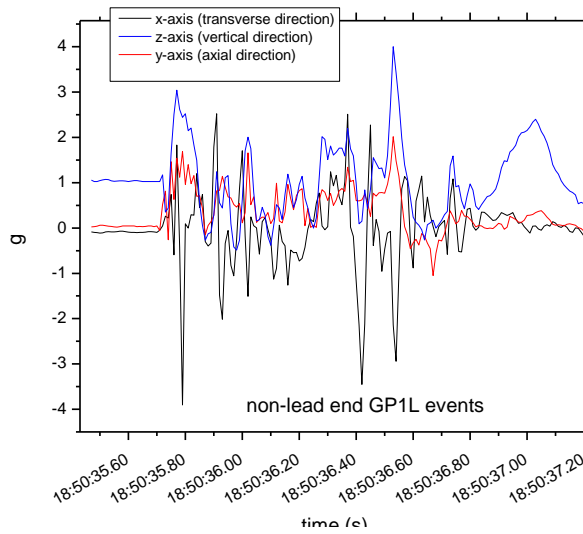
When  $g > 3g$  it is possible to record event with the GP1L device. The data are collected 0.3 s before and 0.7 s after the event. Each event is 1 sec long. Only two events above 3g were recorded during whole trip. Those events recorded the shocks during the accident. They occur one after the other in a two second timeframe. The two events are plotted together for each device (lead end and no- lead end) in Fig. 7 and Fig. 8. No shocks above 4g are recorded. Highest shocks are along the transverse and vertical direction which is consistent with the fact that the non-lead end of the crate moved a few inches away from the driver side

Figure 7: Two second event recorded by the non-lead end device. Event data are recorded when shocks are above 3 g.

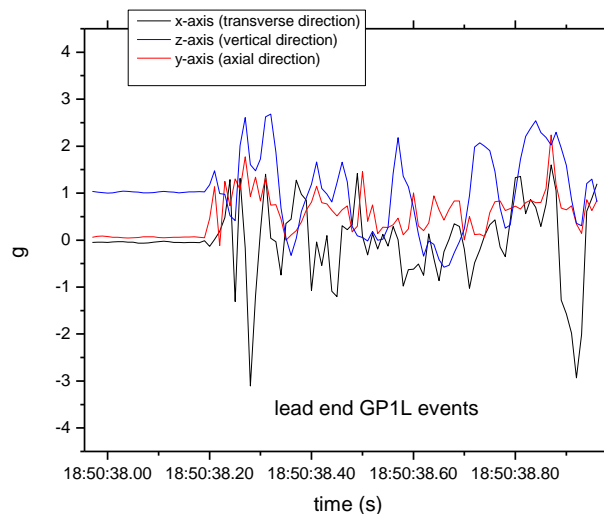
Figure 8: Two second event recorded by the lead end device. Event data are recorded when shocks are above 3 g.

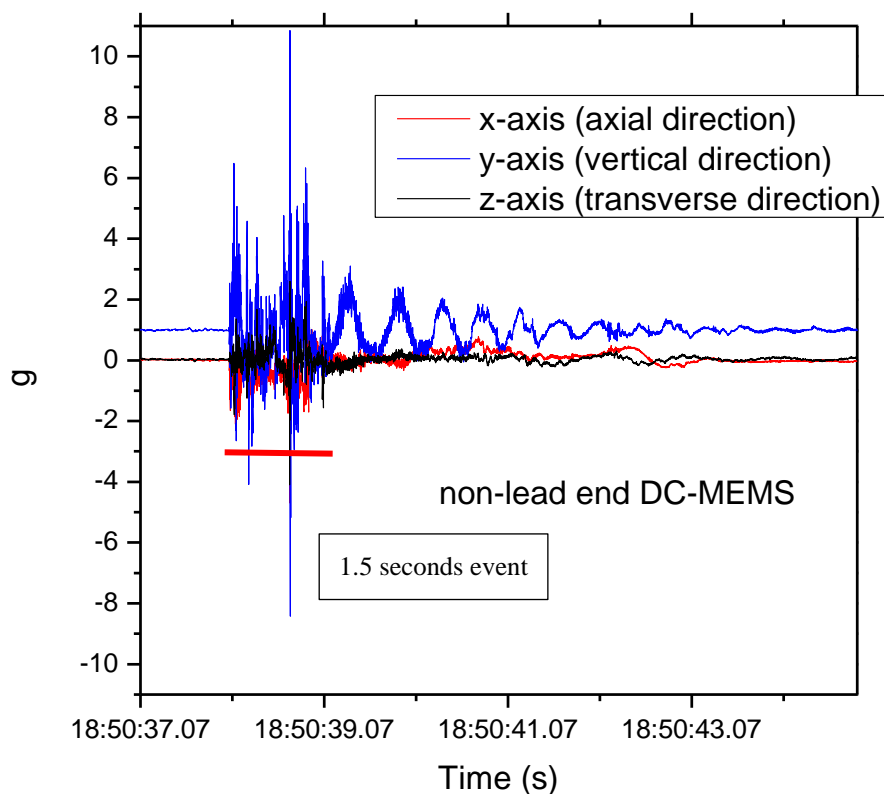
Each data set is 10 min long so the incident was captured in one data set. In Fig. 9 there is a snapshot of the shock vibrations collected during the accident with the DC-MEMS. The data are in good agreement with what is observed with the GP1L. Shocks above 3g cover a 1.5 s time window. The large oscillations observed afterwards are consistent with the incident dynamic and the detachment of the truck axle. The highest observed shock reaches 9 g along the vertical direction.

Figure 9: Shocks during the truck accident recorded by the DC-MEMS device installed on the non-lead end clamp

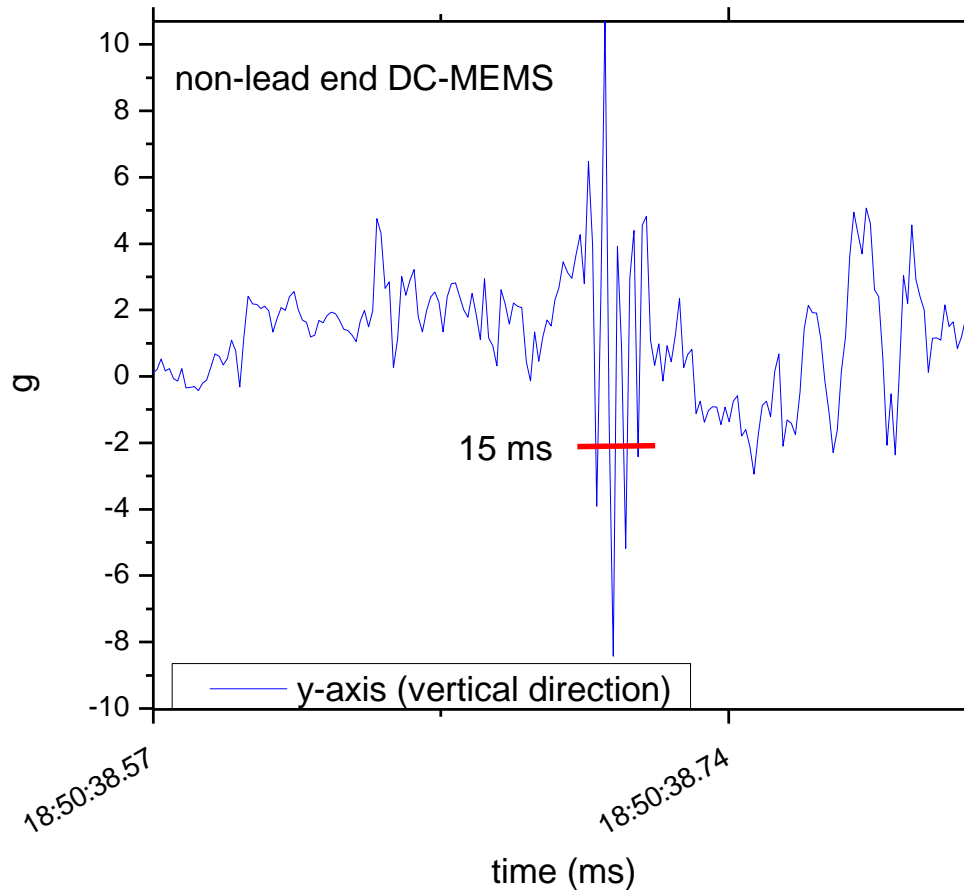
In Fig. 10 there is a zoom view of the highest recorded shocks. It is a high frequency oscillation that lasts around 15 ms. The highest peak (10g) is 2 ms long. The oscillation

frequency is around 500Hz. This event could not be properly captured by the GP1L since its sample rate is around 10 ms.

Figure 10: Zoom of the highest shocks region recorded during the truck accident by the DC-MEMS device installed on the non-lead end clamp

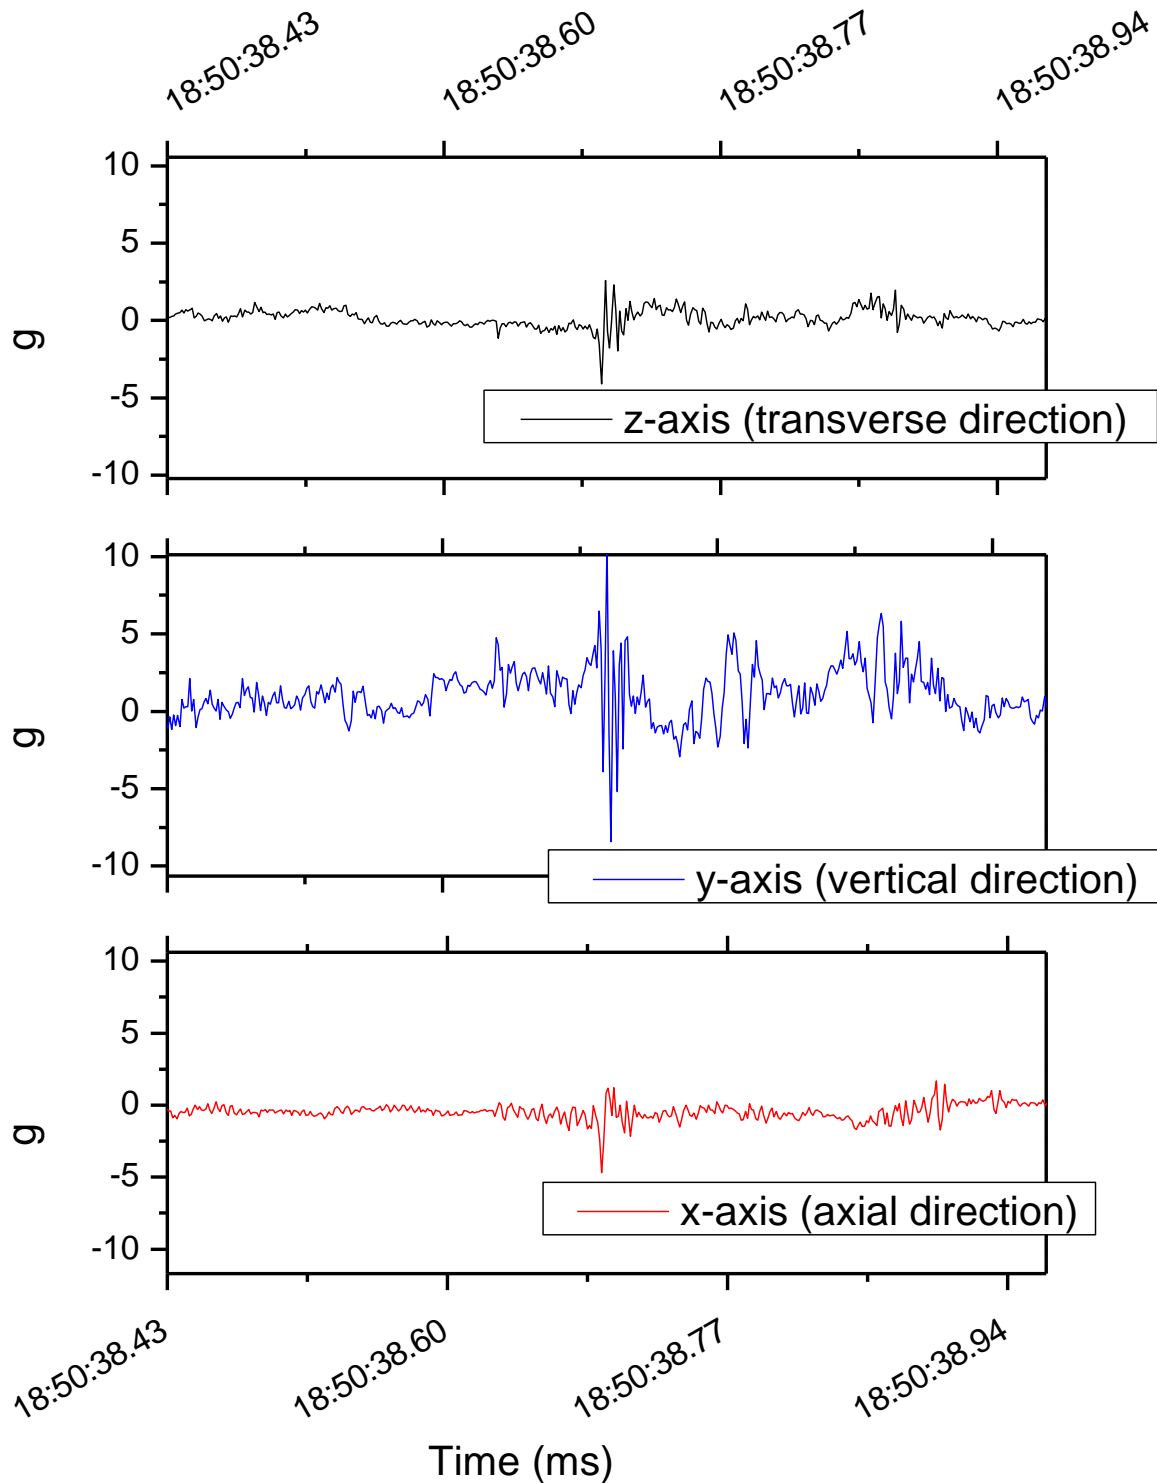
In the Fig.11, a shock data snapshot that covers 50 ms around the incident time is displayed for each DC-MEMS accelerometer direction. No shocks above requirements (5g) are observed along the transverse and axial direction.

Figure 11: Shocks data for each direction recorded by the DC-MEMS. No shocks above requirements are observed over the axial and transverse direction

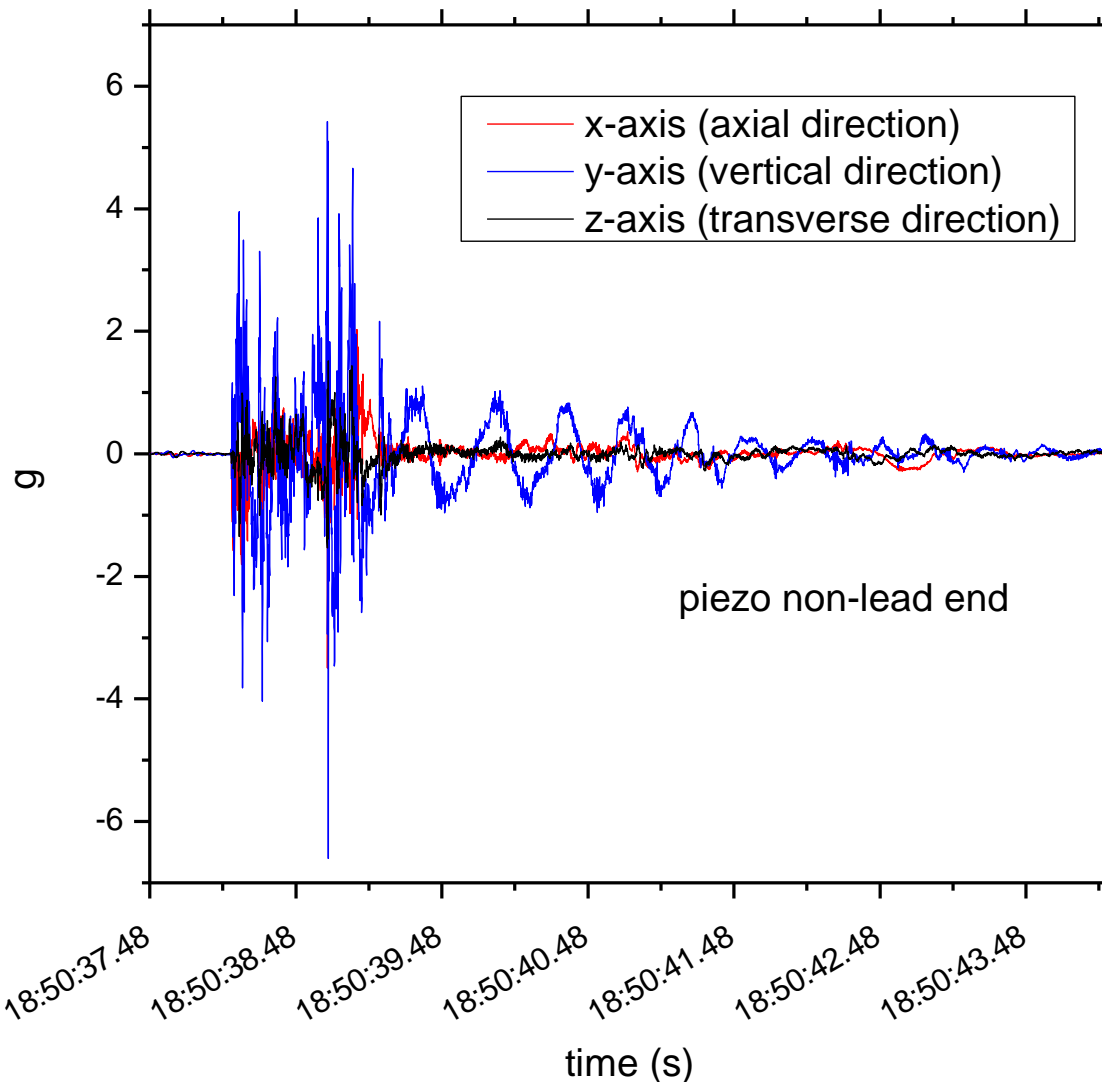
In Fig.12, the data collected with the piezo are shown. The highest shock is slight above 6 g in vertical direction. The difference between the Piezo and the DC-MEMS highest shocks value can be understood considering the actual bandwidth of those sensors. Sampling at 1000 Hz with the piezo, correspond to an antialiasing filter of  $1/5^{\text{th}}$  of the sample rate. The effective bandwidth is up to 200 Hz.

The DC-MEMS has a rough anti-aliasing filter, so data maybe be aliased. The anti-aliasing filter cutoff is  $1/2$  of the sample rate (500 Hz). The piezo-electric data are considered more reliable.

Figure 12: Shocks during the truck accident recorded by the Piezoelectric accelerometer device installed on the non-lead end clamp

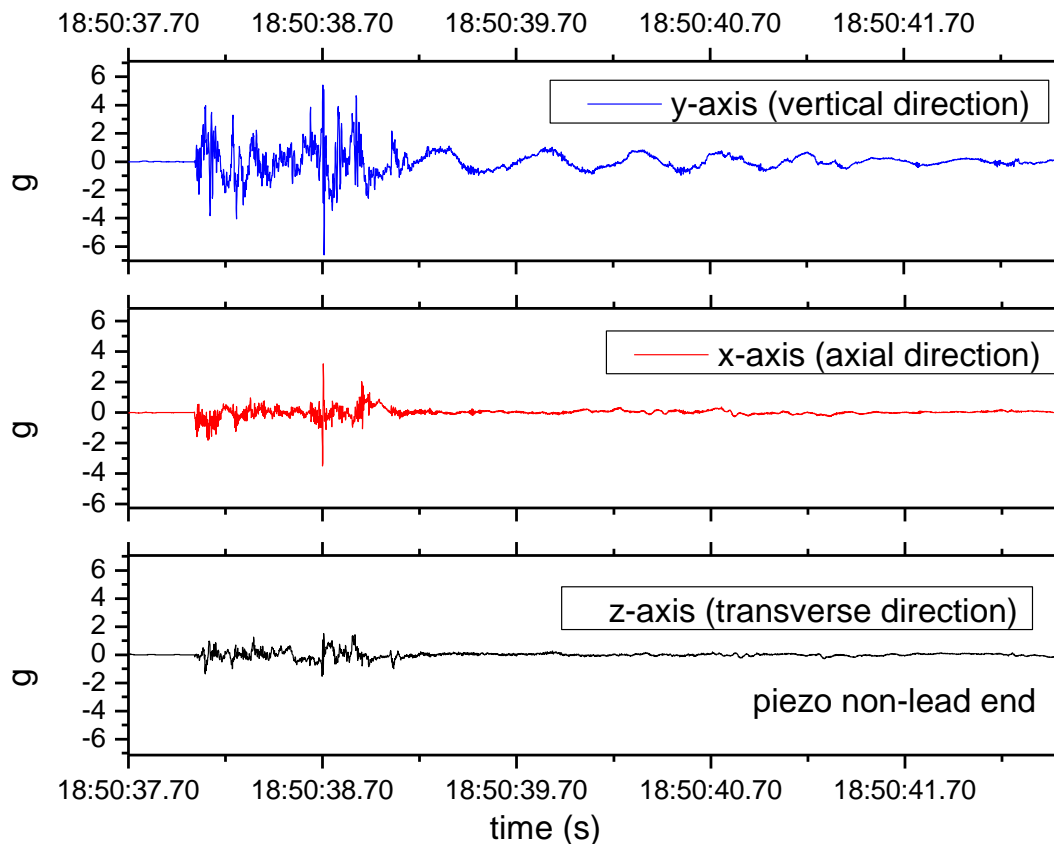
In Fig. 13, a shock data snapshot of 5 seconds is displayed for each piezo accelerometer direction. No shocks above requirements (5g) are observed along the transverse and axial direction.

Figure 13: A five second snapshot of the shocks collected with the piezo devices. Shocks above requirement are observed only along the vertical direction

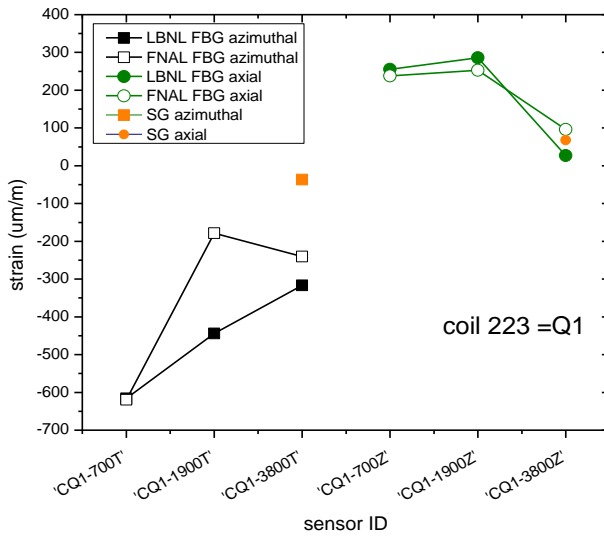
data collected at FNAL are in good agreement with what have been observed before shipment. There is only the azimuthal strain value measure at position 1900 on coil 223 that displays a significant deviation.

Figure 14: Comparison between azimuthal and axial strain data of coil 223 pole collected at LBNL and FNAL

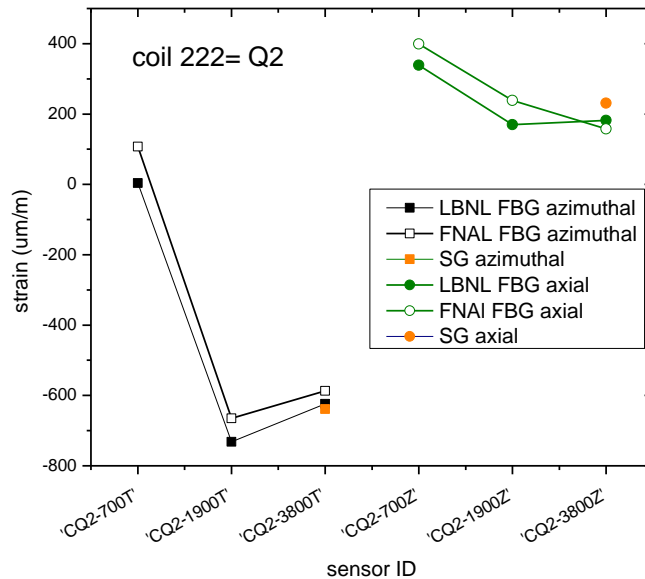
In Fig.14 and 15. a comparison between the FBG axial and azimuthal strain measured at LBNL and at FNAL is presented. The strain gauge data are also displayed. The strain

Figure 15: Comparison between azimuthal and axial strain data of coil 222 pole collected at LBNL and FNAL

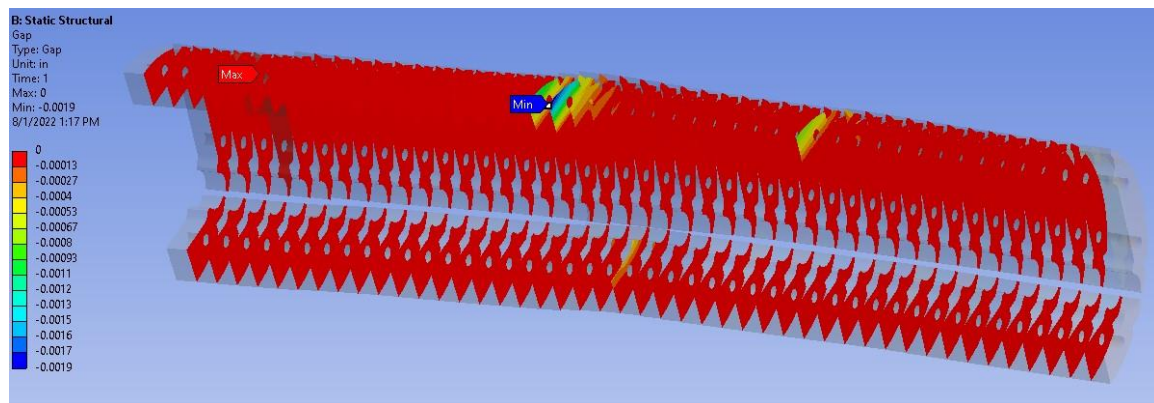
A very small gap between yoke blocks starts to form at 15g as displayed in Fig. 16. The size of the gap is 0.0019 in (48  $\mu$ m).

Figure 16: Yoke block gap forming with 15 g vertical load

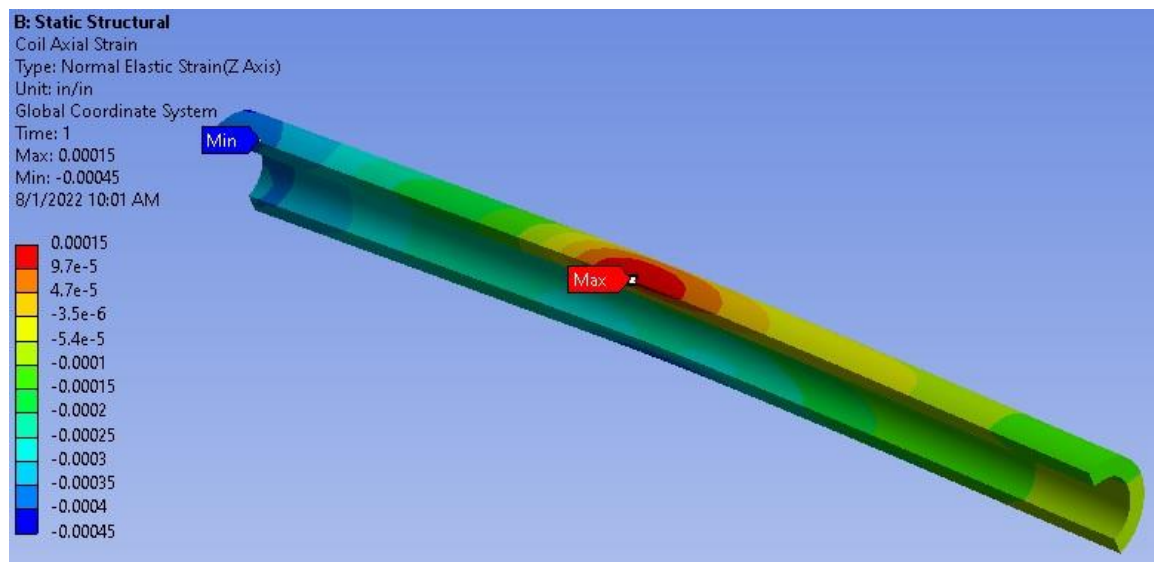
The maximum coil tensile strain is found in that area and it is around 150 microstrain, which is well below the threshold requirements (500 microstrain).

Figure 17: Tensile strain endured by the magnet structure

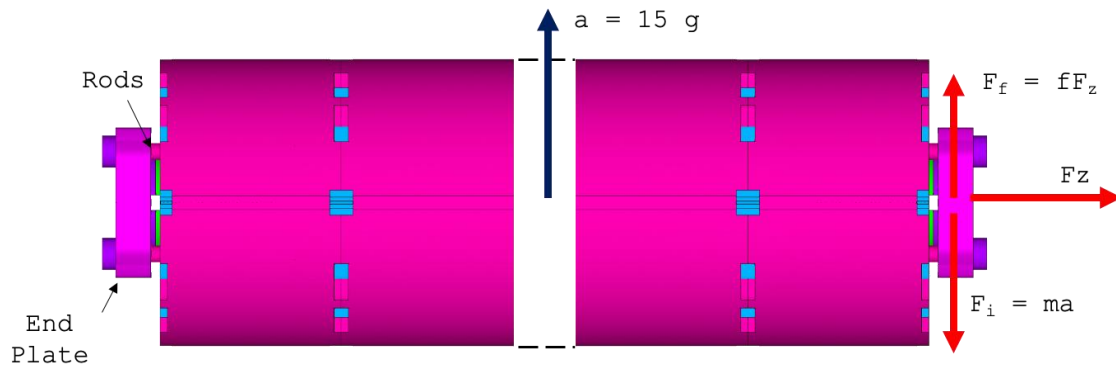
The magnet longitudinal prestress is applied by stainless steel rods, bolted to two end plates. The end plate transfers the load to the magnet via bullets. A longitudinal prestress of 0.7 MN is applied at room temperature. The relative motion between the magnet and the end plate is prevented by friction. With a conservative friction coefficient of 0.1, we can assume that the end plate system will be able to sustain an in-plane (x-y) force of 70 kN before slipping with respect to the magnet. We can also assume, conservatively, that the whole magnet underwent a vertical acceleration of 15 g during the accident. The total weight of the longitudinal loading system is equal to 203 kg, which correspond to an inertia force of 30 kN. Comparing this to the frictional force available we can compute a safety factor as follows:

Figure 18 – Schematic of the magnet and end-plate system under the inertia forces due to the accident.
