Canadian Geotechnical Journal, 13, 1, pp. 21-26, 1976-02

MUD CREEK BRIDGE FOUNDATION MOVEMENTS

Mud Creek Bridge foundation movements

M. BOZOUK

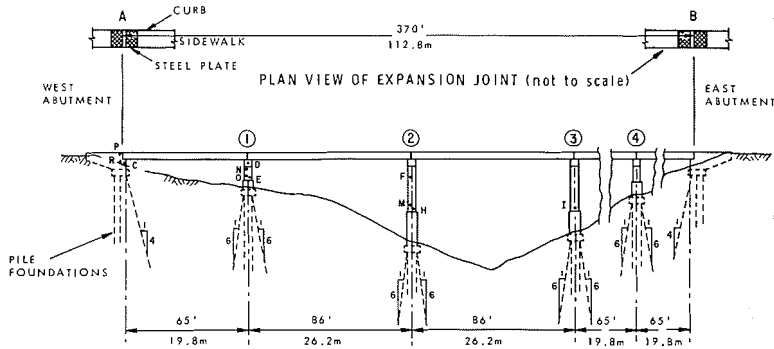
FIG. 2. Instrumentation of Mud Creek Bridge.

The surveys showed that the west abutment and Piers 1 and 2 did not remain vertical after construction. The maximum range of horizontal movement of the top pins relative to the lower ones for the period 1959 to 1973 is given in Table 1. The inclination of the west abutment varied from 0.76 mm west of vertical to 1.02 mm east, over a vertical distance of 5 ft (1.52 m). The angular rotation of Pier 2 was about the same, whereas that of Pier 1 was about five times as much as that of the abutment.

the established points from 1959 to 1973 showed that the west abutment and Pier 1 converged 0.70 cm, Piers 1 and 2 converged 1.77 cm, and Piers 2 and 3 converged 1.61 cm.

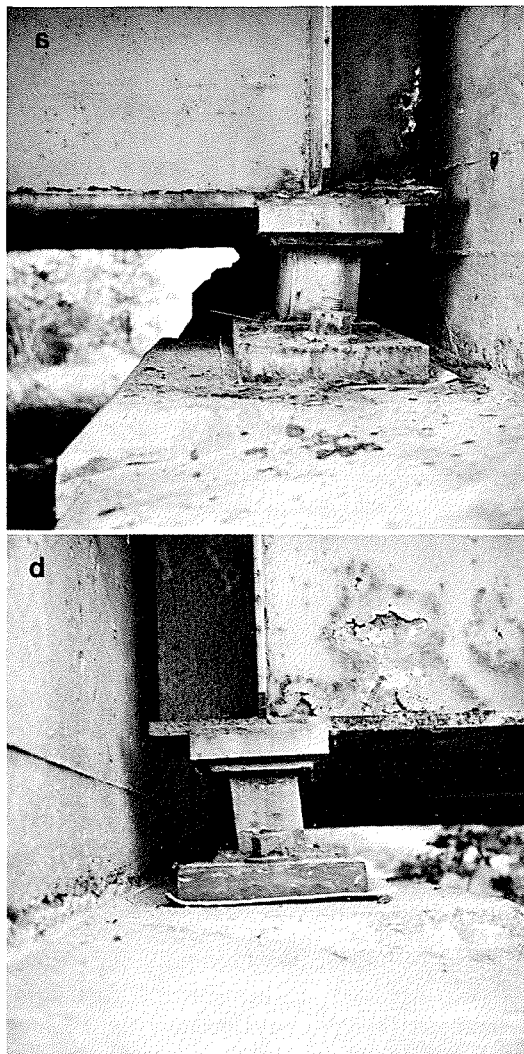
FIG. 3. Inclination of bridge bearings due to horizontal movements of the abutments. (a) Tilted bearing at southwest corner of bridge. (b) Tilted bearing at northwest corner of bridge.

A photograph of one of the bridge bearings (Fig. 3) taken in 1975 illustrates the magnitude of the abutment movements. The total convergence of the two abutments was almost 4 cm, causing the bearings to tilt about 10° from the vertical. The decrease in horizontal distance between abutments from 1959 to

The horizontal movement measured on Mud Creek Bridge is of the same magnitude as the 'creep' measurements reported by Mitchell and Eden (1972). As the bridge bearings functioned normally in cold weather, the movements could not be attributed to this cause. Furthermore, the applied loads from the approach embankments were insufficient to cause appreciable consolidation of the foundation soil, and the characteristic 'bump' often encountered when an approach fill settles relative to an abutment did not materialize at the site. Therefore, the settlement of the backfill and consolidation of the subsoil was also eliminated as a major cause. This left soil creep along the valley slopes as the principal cause of the foundation movements.

The principal cause of the horizontal foundation movements is soil creep occurring along the valley slopes, which in turn is related to the total annual precipitation for the area. The change in verticality or 'rocking' of the piers

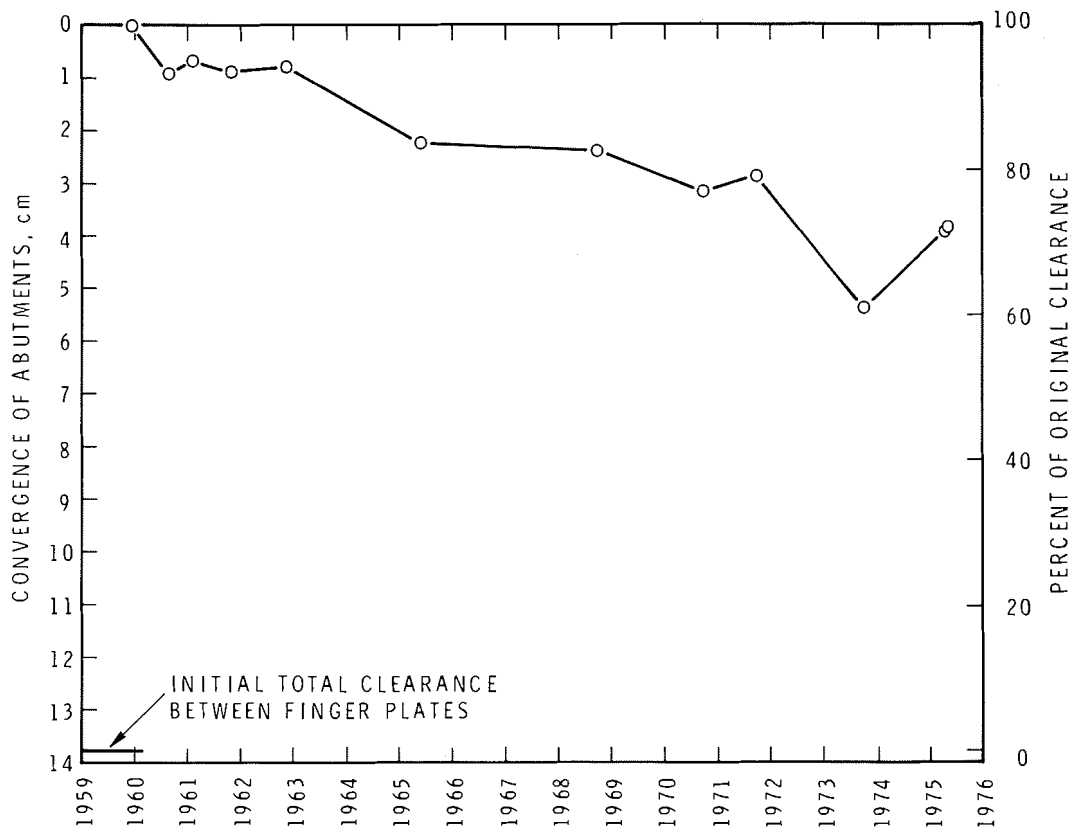
1975 is shown on Fig. 4. If this rate of convergence continued, the 13.77 cm of original clearance between finger plates would disappear in 40 to 50 years. The movements, however, are not regular with time. Comparing this figure with the total annual precipitation record in Fig. 5 (obtained from the weather station at the Ottawa International Airport, 8 mi (13 km) southwest of Mud Creek Bridge) showed that the larger movements occurred during periods of high precipitation. Prolonged periods of abnormally high precipitation could therefore accelerate the closure of the expansion joints. A wet period also precipitated the landslide that occurred in the west slope of the creek, north of the bridge, in the spring of 1973.

FIG. 4. Horizontal abutment movements at Mud Creek Bridge.
