Nondestructive Evaluation (NDE) of Composite-to-Metal Bond Interface of a Wind
Turbine Blade Using An Acousto-Ultrasonic Technique.

John H. Gieske and Mark A Rumsey
Sandia National Laboratories
Albuquerque, New Mexico 87185

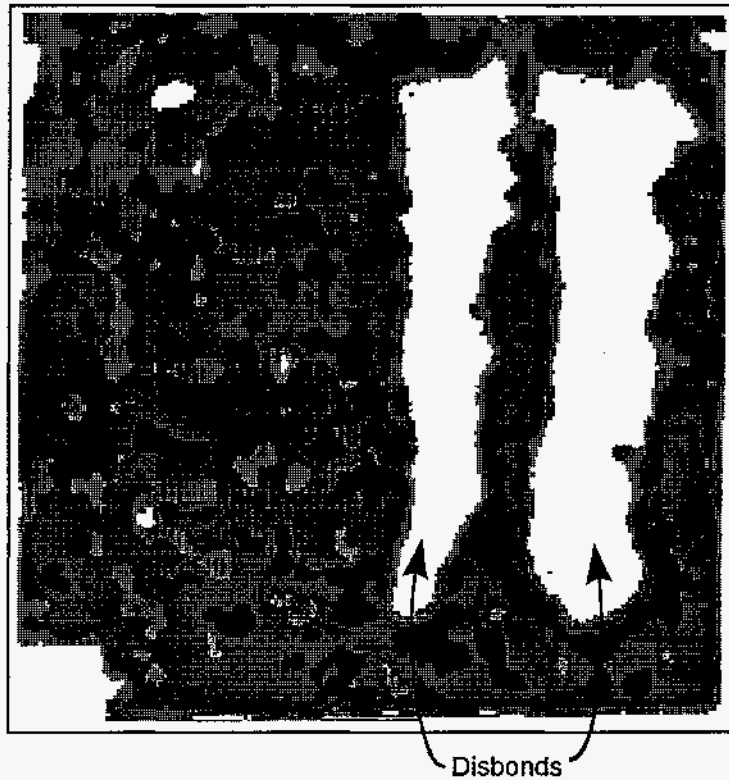
As an example, Figure 3 shows the ultrasonic C-scan results obtained with a TT technique for a 305 mm square test sample that had two strips of disbonds purposely manufactured into the test piece that consisted of the structural components of the fiberglass composite bonded to a steel plate. Adequate C-scan images of the same disbond areas could not be obtained with the pulse-echo or pitch-catch techniques. The results of Figure 3 were obtained with an automated ultrasonic data acquisition and display system using a water bath to couple the ultrasonic energy between the transducers and the test piece. However, water immersion techniques will not be appropriate for wind turbine blade examinations. In addition, the blade will be installed in a fixture or wind turbine where the inside surface of the turbine blade will not be accessible for application of an ultrasonic transducer for the TT technique. For these reasons, an acousto-ultrasonic (AU) inspection technique was developed. The AU technique would approximate the detection capability of the TT technique as near as possible.

Figure 3. C-scan image of the through transmission amplitude for a 305 mm square test sample of the composite bond and steel insert where 2 disbonds were constructed into the adhesive interface.

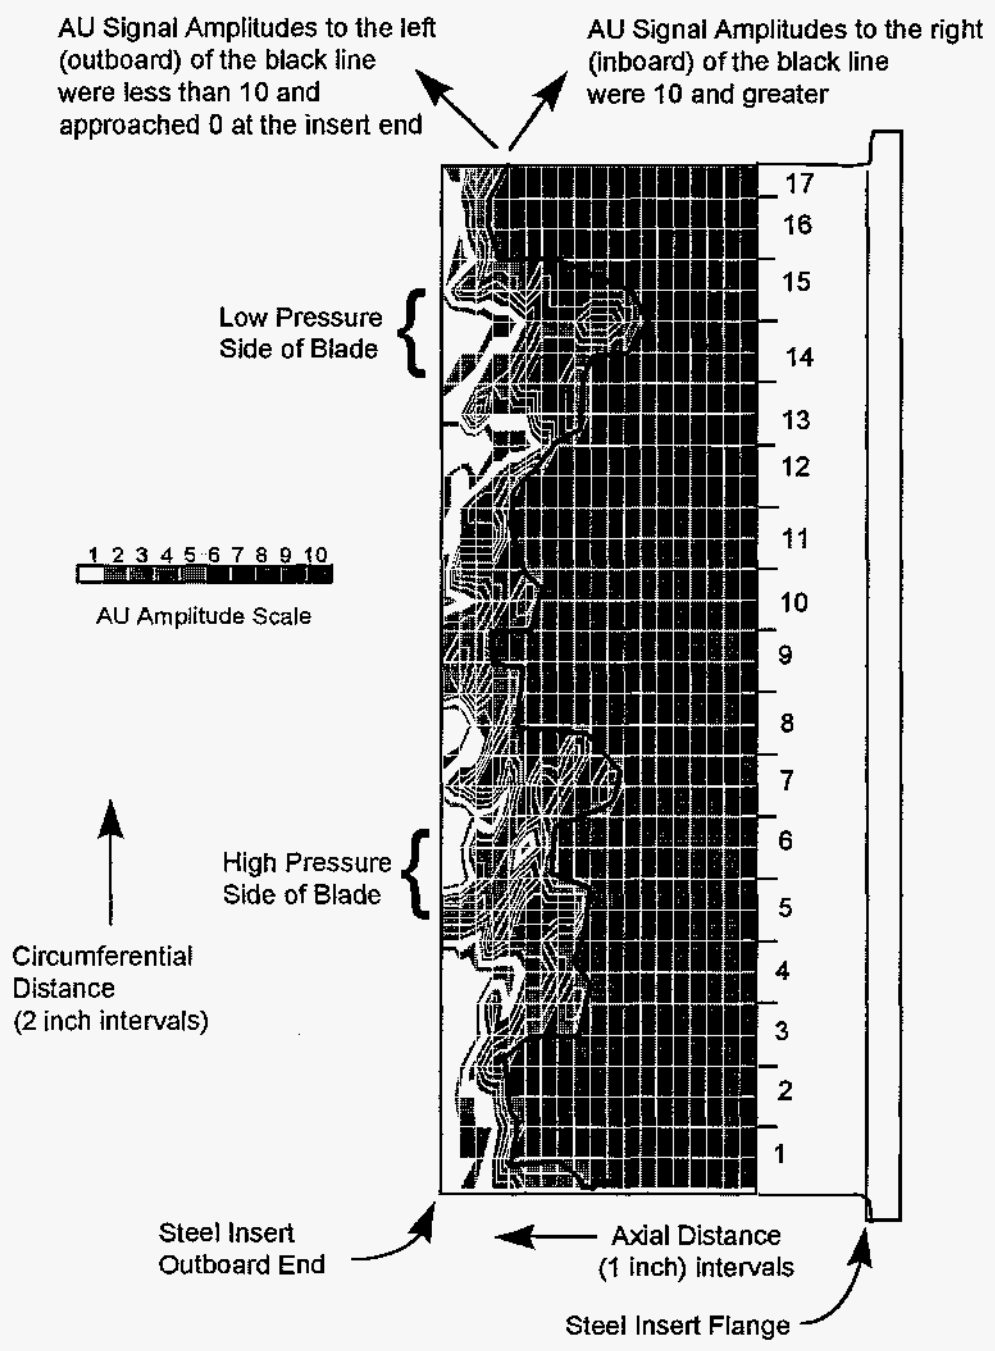
A color contour plot of the tabular data was made by entering the AU data into a Microsoft Excel spreadsheet. Figure 6 displays an equivalent gray scale mapping of the AU data over the steel insert area of the blade. The AU data in Figure 6 indicated that some damage was present at this stage in the fatigue cycle schedule near the high and low pressure sides of the blade as referenced in the sketch of Figure 5. Maximum loading occurs at the outboard end of the steel insert during the fatigue test and during the normal operation of the blade in these two areas. After the AU examination was performed, the blade was fatigue tested to failure. It is noted that the failure of the blade was expected and it did occur in these two areas of the blade.

Figure 6. Contour plot of the amplitude levels of acousto-ultrasonic signals taken around the root bond area at a steel insert of a wind turbine blade.

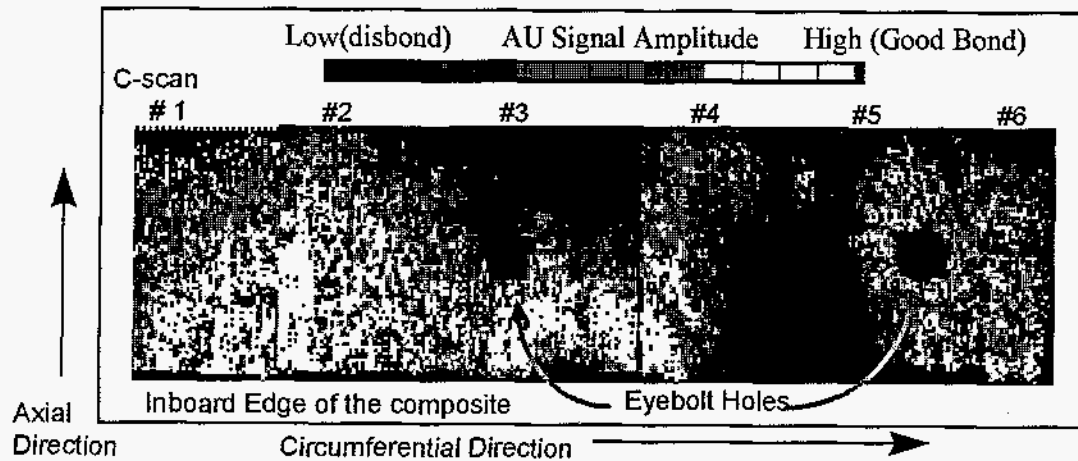
Figure 7(a) displays a montage of the 6 C-scan images collected around the entire circumference of the blade. The C-scan images of Figure 7(a) were rendered in a simple gray scale since the normal 16 color scale could not be reproduced in this publication. Some detail of the AU signal variations is therefore lost but an assessment of the disbonded area is clearly indicated in the gray scale images. The area of Figure 7(a) shown in black where a low AU signal amplitude was recorded indicated the area of disbond.

(a) Acousto-ultrasonic Amplitude C-scan Image of Entire Root Bond Area of the Steel Insert

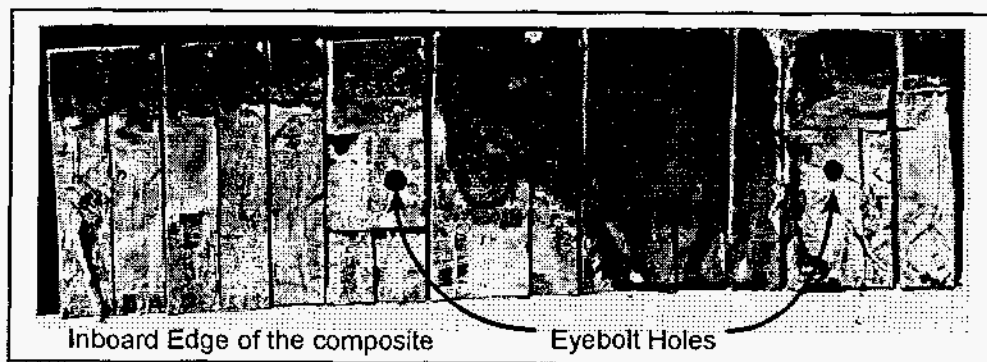
Figure 7(b) shows the corresponding visual examination of the bond interface of this blade by cutting the segments of the composite and removing them from the steel insert. The removed pieces of the composite were reassembled with the metal-to-composite bond interface facing outward. A photograph of the reassembled pieces is shown in Figure 7(b) where the bond failure is shown in black due to a dark metal oxide present on the adhesive surface of the failed area. A comparison of Figures 7(a) and 7(b) shows that the AU data correlated well with the disbond visually observed after removing the composite with the exception of two small areas. The area to the right of center in Figure 7(a) indicated an area of low AU signal but not completely disbanded. It is possible that the composite was held in compression against the metal surface so that a so-called kissing bond existed in this small area. Also, the area just above the left eyebolt hole in Figure 7(a) is shown in black because the metal path to the receiver was obstructed by the eyebolt hole. This area does not show a disbond in Figure 7(b).

(b) Photograph of Pieces of the Composite Removed from the Steel Insert Root Bond Area in Sections Placed Together in the Same Orientation as the above C-scan Image

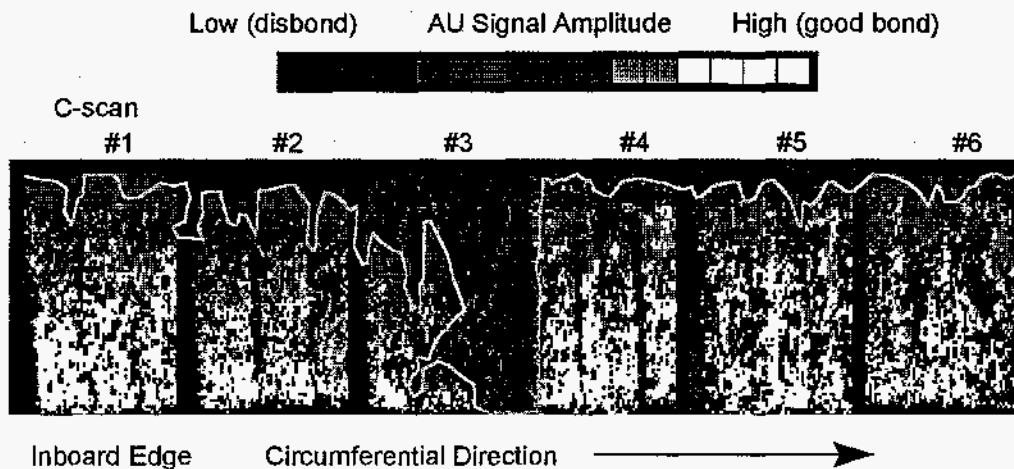
The steel insert area of a third blade was also examined with the PC data acquisition and display system. A manufacturing defect was suspected in this blade but the location and extent of the defect was not known. Figure 8(a) shows the montage of the 6 C-scans of the AU signal amplitude. The AU signal amplitude data was processed so that a black color was assigned to signal amplitudes below a given threshold value. The result is shown in Figure 8(b). The area of the defect is then clearly indicated in Figure 8(b) by the area in black. After the AU examination was made, a partial removal of the composite skin at the area of C-scan number 3 showed that a large void existed in one of the layers in the composite and the void area correlated well with the C-scan image number 3.

(a) Acousto-ultrasonic Amplitude C-scan Image for the Entire Root Bond Area of the Steel Insert for Turbine Blade #3

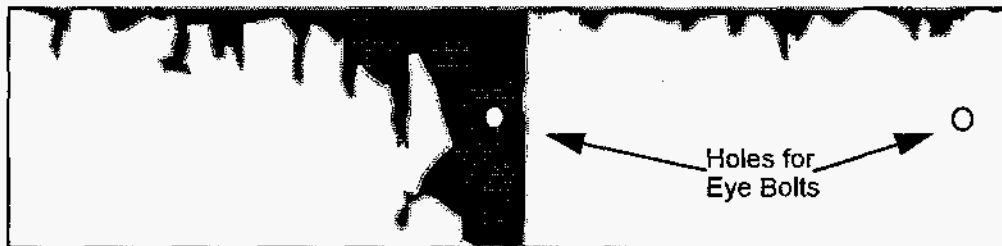
(b) Processed AU Signal Amplitude Showing All Signals Below a Threshold Value in Black
