Published on: 01 Dec 2014 - Progress in Photovoltaics (John Wiley & Sons, Ltd)

Observed degradation in photovoltaic plants affected by hot-spots

Miguel García , Luis Marroyo , Eduardo Lorenzo , Javier Marcos and Miguel Pérez

ABSTRACT

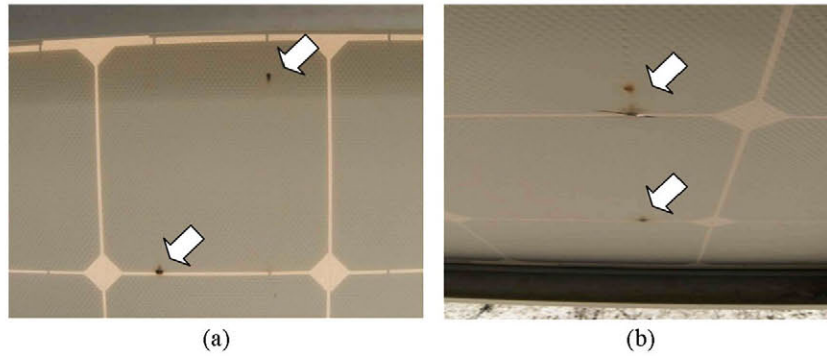
Contrary to former findings [6], the blackened points in this case were located over the two busbar tabs inside the cells (Figure 3). In some of these points, the TEDLAR backsheets were punctured, representing a risk of insulation failure (Figure 3.b).

Given the fact that the blackened points were randomly distributed on the affected generators, there is reason to think that there is no causal relation between the appearance of the localized heating phenomena and the PV generator shading.

Figure 3. Localized heating effects on the modules of the PV plant. The overheating were produced on the two busbar tabs inside each cell: (a) Blackened points in the TEDLAR and (b) Punctured TEDLAR.

In 2010, the problem grew to become more serious, with more than 17% of the generators with STC power outputs of below 90% of their nominal value. However, the module manufacturer, aware of the problem, replaced the affected modules. This explains the increase in the number of generators with an STC power output of over 95% of the nominal value in 2010, as shown in Figure 1.

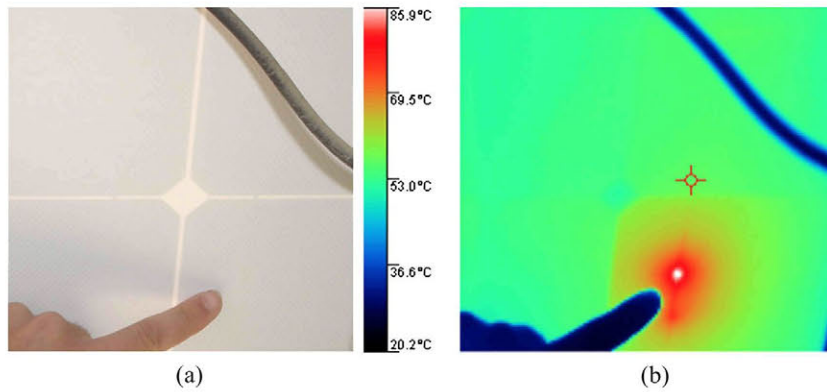
During an initial visual inspection of the modules, it was only possible to detect those localized heatings that had actually damaged the TEDLAR backsheet. However, a subsequent inspection of the plant using a thermal imaging camera made it possible to establish that there were some localized heatings that had reached temperatures close to 150 °C and also that there were a large number of localized heatings that had not yet damaged the TEDLAR. Figure 4 shows one of those localized heating not visible to the naked eye.

Figure 4. (a) Image of a module with a localized heating; (b) Thermal image of the module showing how it has a temperature over 85°C. The presence of the overheating is not yet visible to the naked eye.

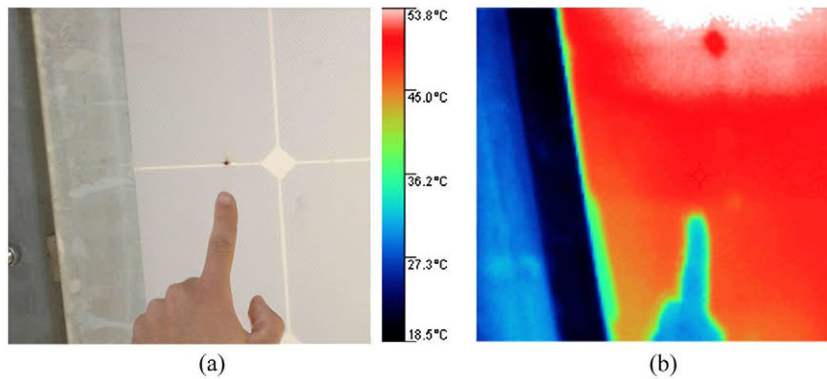
It was also observed how some of the blackened points in the TEDLAR, were no longer hot, as shown in Figure 5. In such cases, the corresponding bypass diode was frequently conducting.

Figure 5. (a) Image of the blackened point in the TEDLAR of one of the modules caused by a localized heating. The heat had punctured the TEDLAR. (b) Thermal image of the module in which the overheating does not show up.

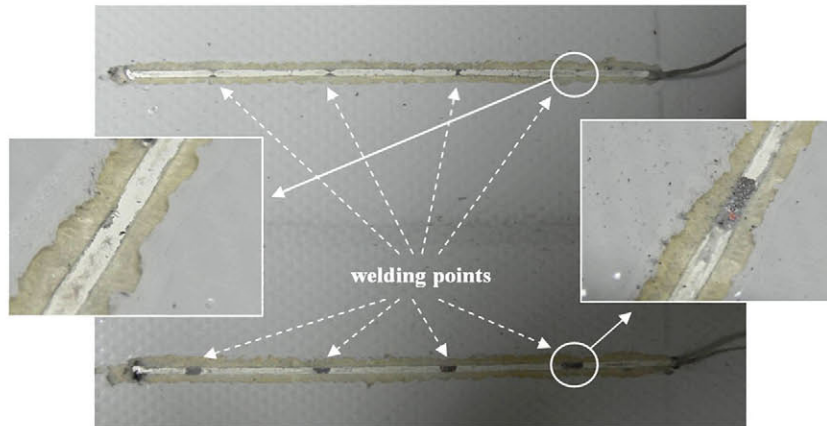
As a simple test to check the condition of the soldering in those cells affected by localized heatings, the busbar tabs were pulled out (once the TEDLAR and EVA layers had been removed). Figure 7 shows the analysis of the imprint left by the tabs: the only electrical contact between the tabs and the metal surface covering the back of the cells occurred at the solder joints. In these modules, there were four solder joints per tab. For the remaining points, the space between the tab and the conducting surface were filled by an encapsulant (electrical insulator). The solder joints for one of the two tabs pulled off (the upper tab) had a very small surface area, indicating a weak weld.

Interestingly, the overheating did not appear on the weakest solder joints but on those tabs that were better soldered (lower tab on Figure 7). To explain this fact, it should be borne in mind that the two collecting tabs are the only path for the current generated by the cell. If both tab solderings have the same electrical resistance, then the current will be divided equally between them. However, if one of these tabs has an abnormally high electrical resistance, then the current would tend to flow through the path with the lowest electrical resistance. The resistance of defective solder joints may be high enough to force almost all the current to pass through the strongest solder joints. This concentration of the current in small areas is responsible for the temperature increase in these areas and is therefore the cause of the hot-spots observed. This cause is different from the one found in other plants also experiencing soldering problems [6].

Figure 7. Imprints left by the busbar tab on the back of the cells after being pulled off by hand.

Weak solder joints were observed not only on cells affected by localized heating phenomena but also on cells that were apparently sound and even on cells of modules that had never been exposed to solar radiation. All the modules affected by localized heating phenomena were seen to have been manufactured between August and September 2004, whilst the least affected modules had been manufactured in some other month. This all suggests that the root cause was a manufacturing problem basically occurring during those 2 months.

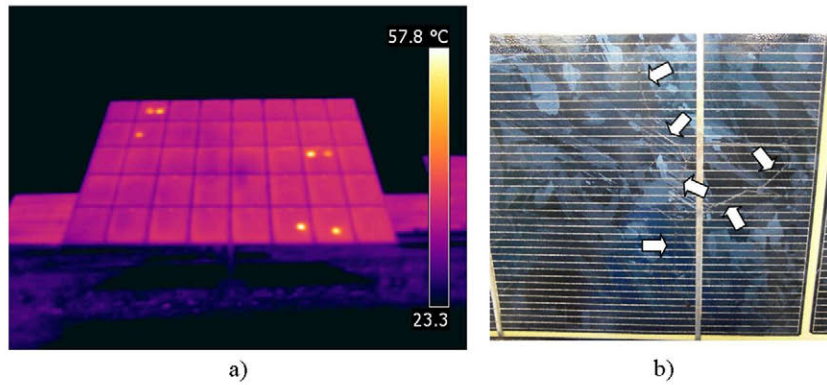
Figure 9. (a) Thermal image of a PV generator with five modules affected by hot cells and (b) Image of one of the hot cells (cracked cells).

(around 15 °C higher, with approximately 1000 W/m² irradiance), as shown in Figure 9.

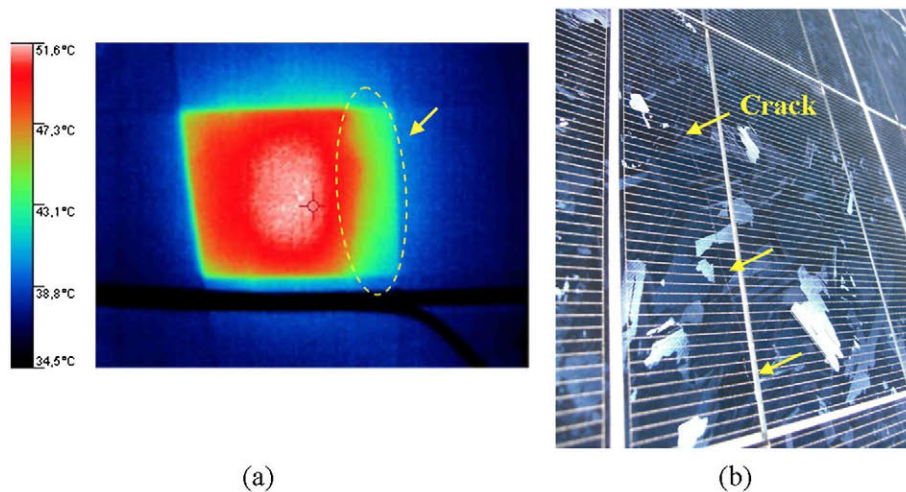
Given the fact that a thorough inspection revealed the presence of micro-cracks in a large number of hot cells (Figure 11b), it was decided to study the problem in greater detail.

Figure 11. (a) Thermal image and (b) Image of the front side of a cracked cell.
