Performance analysis of a 7-kW crystalline silicon generator after 17 years of operation in Madrid

Eduardo Lorenzo , Roberto Zilles , Rodrigo Moretón , Trinidad Gómez and Ainhoa Martínez de Olcoz

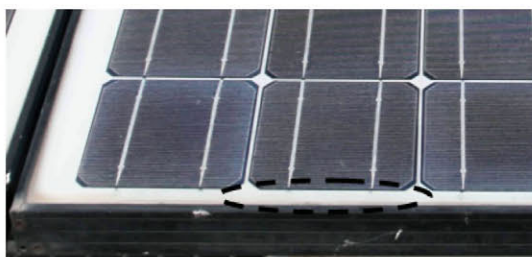
Figure 1. (a) General view of the installation. (b) Close-up view of a photovoltaic module. The 2-cm gap between the frame and the solar cells in the bottom part has effectively prevented soiling affecting the energy performance, as well as preserving the electrical insulation.

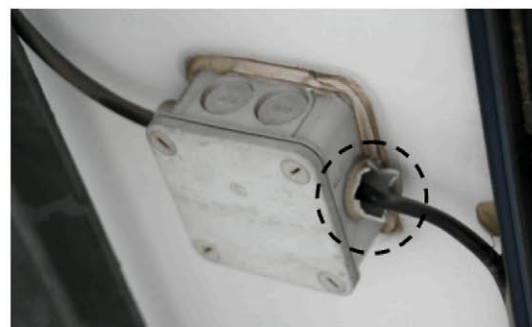
During the first 13 years of exposure to the elements, the only visual symptom of degradation appeared in the terminal boxes. In fact, although these boxes are IP65, they are not specifically designed for PV modules but for general electric installation purposes and they include several lateral holes with their corresponding cable grips. The degradation appeared in the form of cracks at these cable grips (Figure 2). However, it should be mentioned, on the one hand, that these pieces can be easily substituted by new ones and, on the other hand, that this kind of terminal box is not used any more in the PV industry, so that further in-depth comments are not required here.

Figure 2. Cracks in the terminal boxes appeared during the first 13 years of operation.

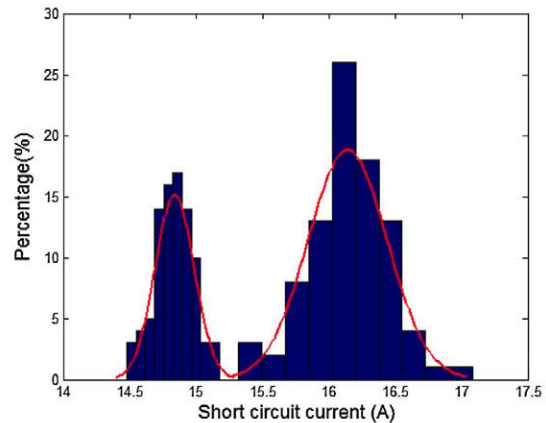
Figures 5–9 show the distribution of the main electrical parameters at the beginning and at the end of the period. All of them followed a normal distribution before the exposition. The short-circuit current and the open-circuit voltage keep their shape after the 17 years of outdoor exposition, whereas the fill factor and the maximum power follow now a Weibull distribution because of the presence of some outliers. It is worth noting that the skewness of the latter curves can translate to increasing mismatching losses [19].

Figure 5. Short-circuit current distribution before (ranging from 15.3 to 17.1A) and after (ranging from 14.5 to 15.2A) the 17 years of outdoor exposition.

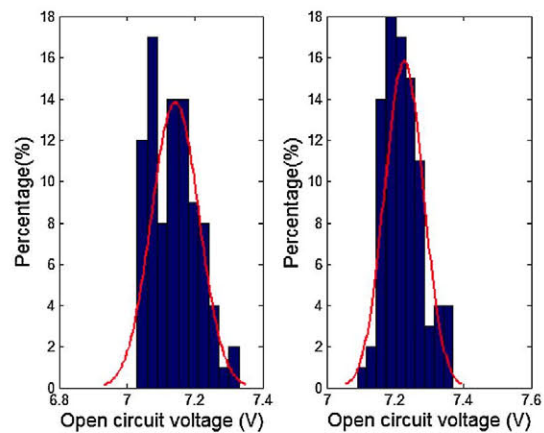
Figure 6. Open-circuit voltage distribution before (right) and after (left) the 17 years of outdoor exposition.

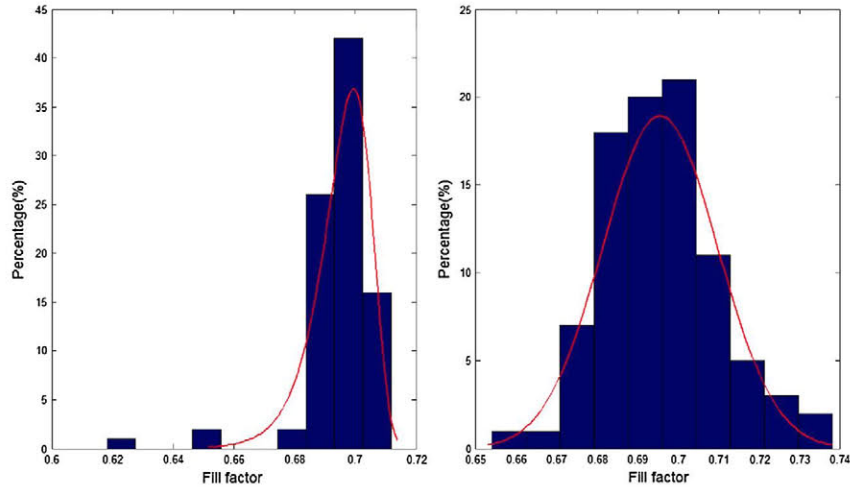
Figure 7. Fill factor distribution before (right) and after (left) the 17 years of outdoor exposition.

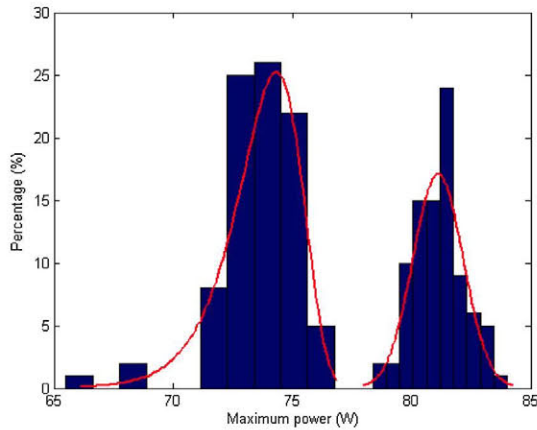
Figure 8. Maximum power distribution before (ranging from 78.4 to 84.0) and after (ranging from 65.5 to 76.8) the 17 years of outdoor exposition.

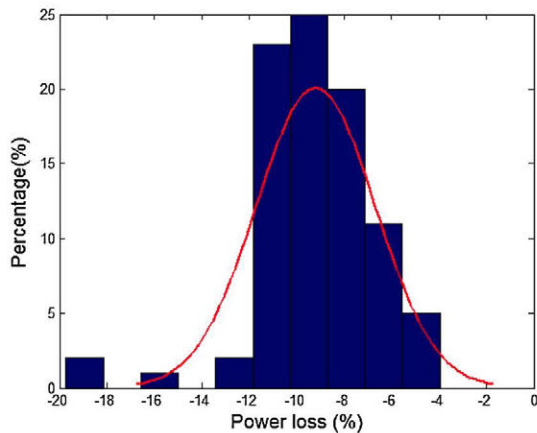
Figure 9. Degradation rate distribution, referred to the power loss.
