Performance of buildings during the 2001 Bhuj earthquake

Jag Mohan Humar, David Lau, and Jean-Robert Pierre

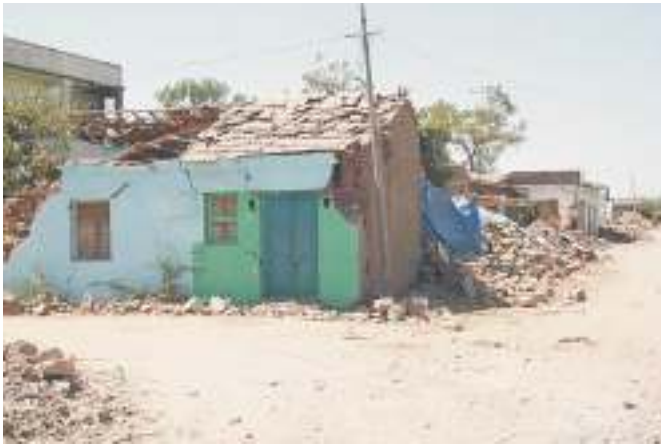
Fig. 5. A village house in Kachchh; stone masonry with Manglore tile roof.

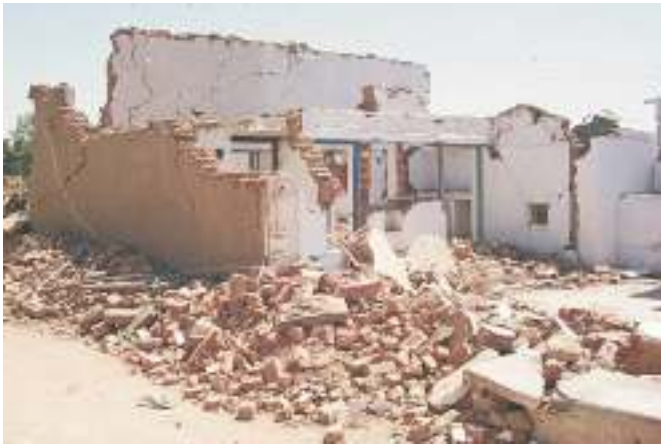
Fig. 6. Destruction of heavy stone masonry walls that had no reinforcement and were not tied to each other.

The performance of masonry buildings in the Kachchh region was very poor. No reinforcement had been provided in any of the buildings. The walls were not tied to each other or to the floors and roofs. Most buildings used large-size, heavy stone blocks, either undressed or rough dressed. The roof construction of wooden logs and Manglore tiles was very heavy. All of these factors made the buildings very vulnerable to damage during earthquake, leading to widespread destruction. As would be expected, the worst performance was that of random rubble construction in mud mortar. In

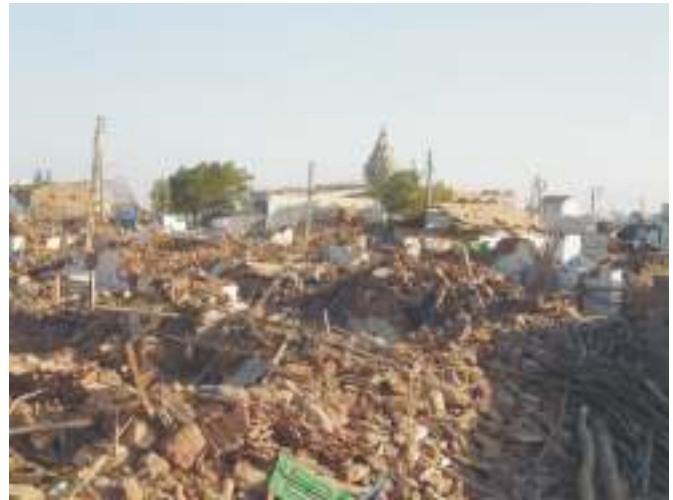
Fig. 7. Virtually complete destruction of masonry buildings in a village in Kachchh.

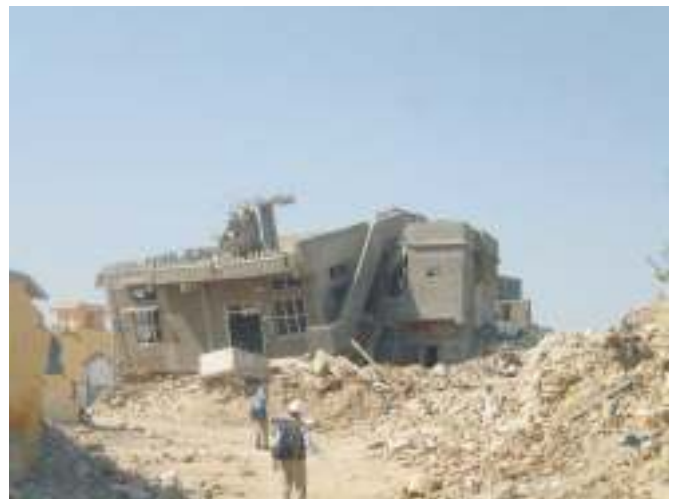
Fig. 8. A scene of destroyed load bearing masonry buildings in the town of Anjar.

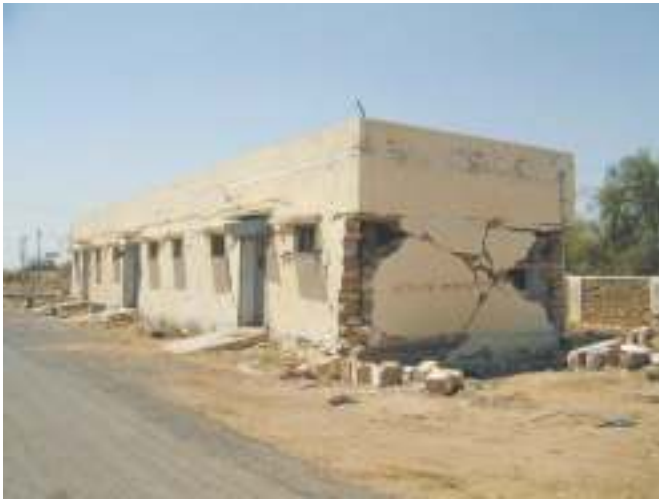
Fig. 9. Damaged control room building at the Samkhiali substation.

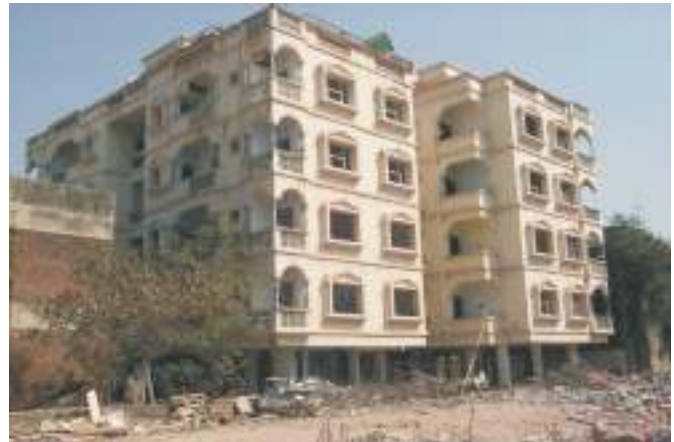
Almost all buildings with open first storey suffered some damage. In some cases the buildings collapsed, while in some others the damage was so severe that the buildings had to be written off. At the time of our visit, which is about 7 weeks after the earthquake, the rubble from the collapsed building had been cleared but the severely damaged buildings had not been pulled down. Repair work was in progress in some of the private buildings that had suffered repairable damage. A typical example of a framed building with open first storey is shown in Fig. 10, which shows what was once a complex of four identical five-storey blocks. Each block had a reinforced concrete frame construction with an open first storey and brick infill walls in upper storeys. Two of the four blocks, which were located in the foreground of the picture, completely collapsed killing several residents. The other two blocks that are seen standing in the picture suf-

Fig. 10. A block of damaged reinforced concrete frame buildings in Ahmedabad with open first storey and brick masonry infills.

fered severe damage. The owners have decided to pull them down. Temporary supports have been provided to the buildings in their lowest storey so that the useful contents of the buildings could be salvaged.

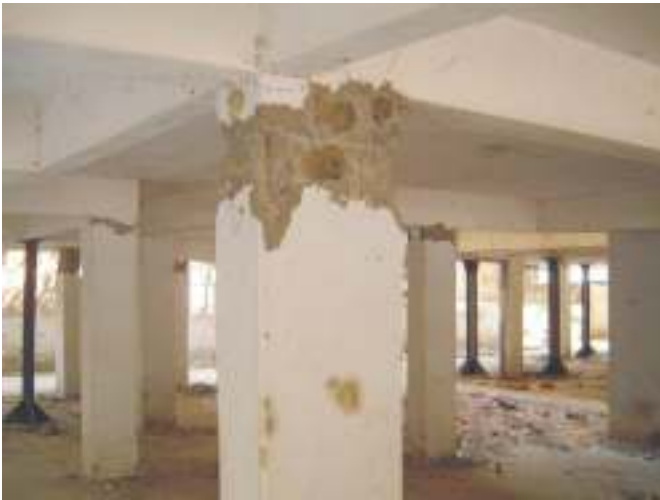
Figures 11 and 12 show details of the damage suffered by the first-storey columns. The columns are 225 mm by 375 mm in size. The longitudinal reinforcement consists of six 15 mm diameter torsteel bars. The hoops are of 6 mm plane bars spaced at 200 mm with 90° hooks. Given the local practice, it is unlikely that the confining reinforcement extends into the beam-column joint. The open first storey combined with the rather slender column size has caused hinging of most columns at their junction with the beams in the first floor above ground. The columns have a low ductility capacity because of inadequate confining reinforcement and absence of proper hooks. The situation is aggravated by the fact that according to the local practice concreting of the columns is stopped at about 200–250 mm below the soffit of the beam and a construction joint is provided at that level. The concrete in this region of 200–250 mm is poured along with the beam and usually has a poor bond with the rest of the column. This makes the hinge region even more vulnerable. The construction joint can be clearly seen in Figs. 11 and 12.

Fig. 11. Damage suffered by the open first storey columns in concrete frame building.

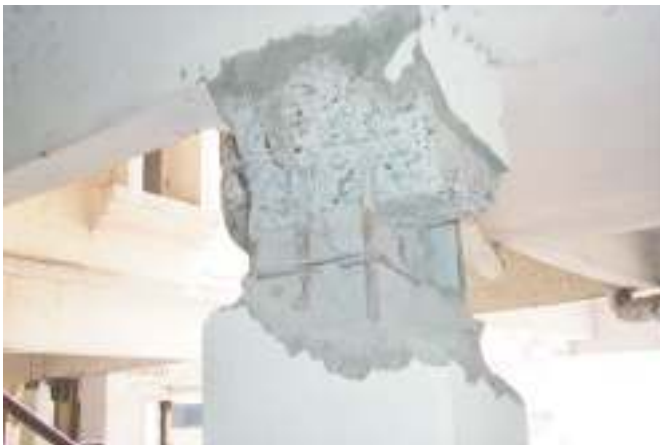
Fig. 12. The hinge in a first storey column showing the steel reinforcement.

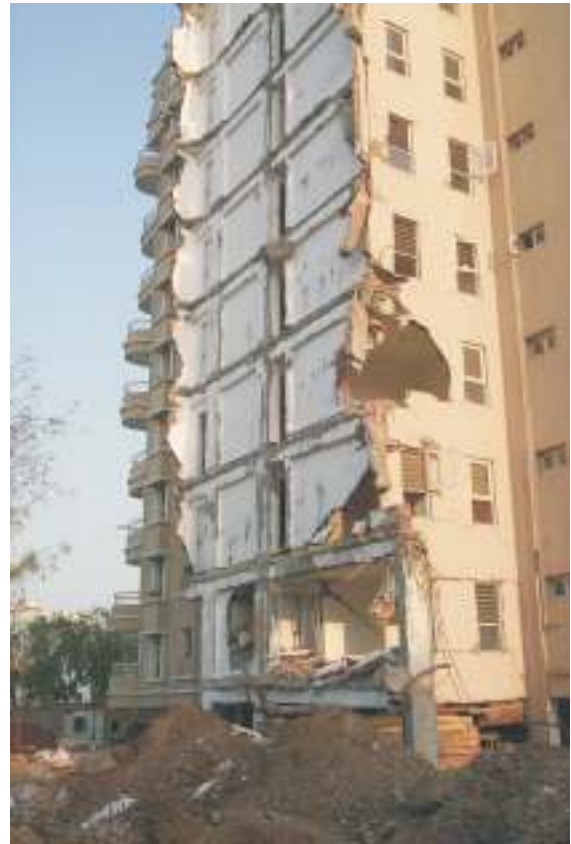
Any number of examples can be cited of the damage suffered by the open first storeys in multistorey reinforced concrete buildings in Ahmedabad. A particularly tragic case was of a ten-storey building known as Shikhara. The building was in the shape of an H. It had been completed only recently and was not fully occupied. One of the open arms of the H collapsed during the earthquake causing the death of 89 persons. Details of the building are shown in Figs. 13 and 14. The collapse was evidently caused by the failure of the columns in the open first storey. The first-storey columns in parts of the building that remain standing are severely damaged. Attempts have been made to repair these columns, as shown in Fig. 14, but the residents are unwilling to return to the building.

Fig. 13. One wing of the Shikhara building detached itself from the building and collapsed.

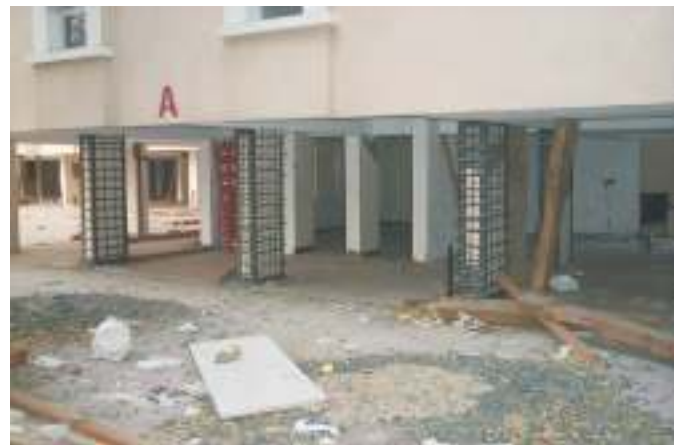
Fig. 14. Repairs to damaged columns in the first storey of the Shikhara building.

The technique used for repairs to the columns of the first storey can be observed from Fig. 14. The columns are being prepared for concrete jacketing. In the present case they have been encased in four vertical angle sections, one at each corner. The angles are tied together by welding hori-

zontal steel bars. Forms will be erected around this assembly and concrete will be poured from an open space at the top of the forms to complete the concrete jacket. We observed a similar technique being used for the repair of many damaged columns. For low-rise buildings and smaller columns, a reinforcing cage of longitudinal bars and hoops is placed around the column before concreting. However, in all cases the concrete jacket is not tied to the column foundation or to the beams above. It is evident that while the jacketing may restore the vertical load carrying capacity of the columns it does not improve the resistance to earthquake loads.

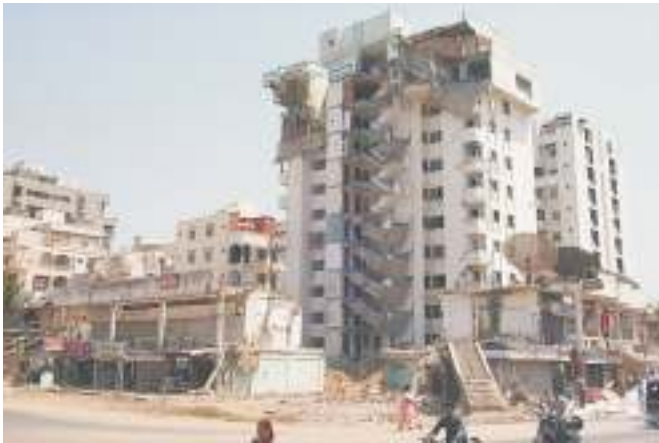
Figures 15 and 16 show some details of the damaged building. An observation of the remaining parts of this building indicates that the most likely cause of the collapse was

the soft first storey. The masonry infills in the upper stories of the building make the building stiff, attracting significantly higher earthquake forces. The high shears imposed on the first-storey columns have caused damage to the visible hinge regions at the top of the columns, as well as shear failure in some of the columns, as seen in Fig. 16.

Fig. 15. The portion of the Mansi building that collapsed detached itself from the block seen in the foreground; the other block in the background is still standing, but its first-storey columns are heavily damaged.

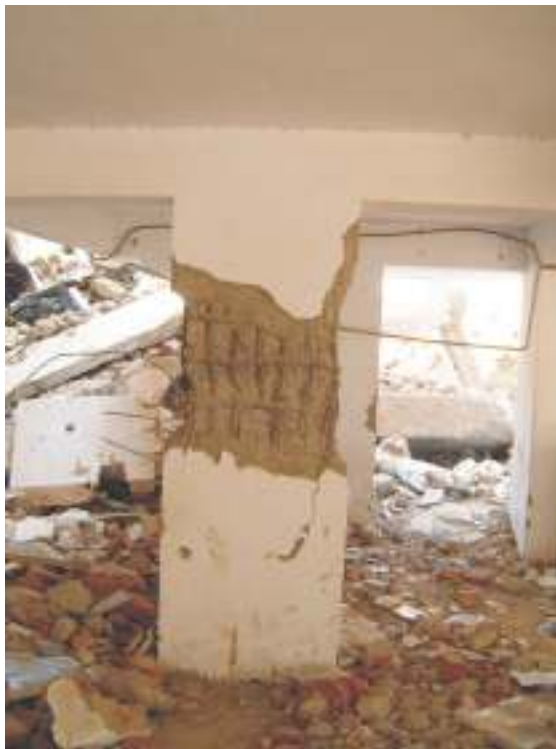
Fig. 16. Shear failure of a first-storey column in the Mansi building.

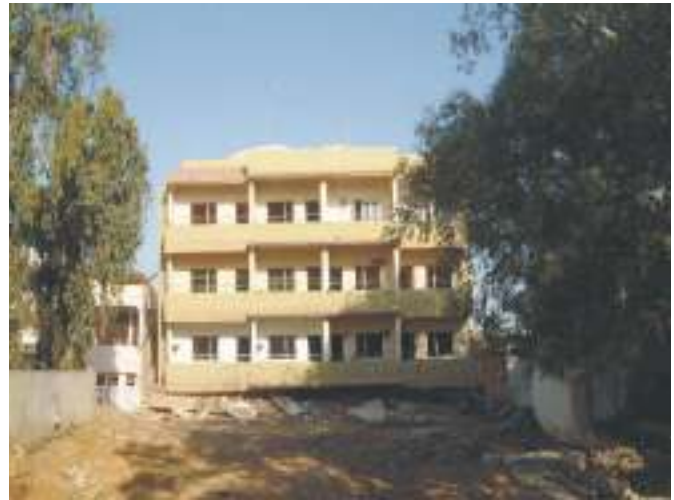
Figure 17 shows the collapsed open first storey of a four-storey concrete frame building in Bhuj in which the upper

Fig. 17. The open first storey of this building in Bhuj was crushed bringing the upper three storeys down.

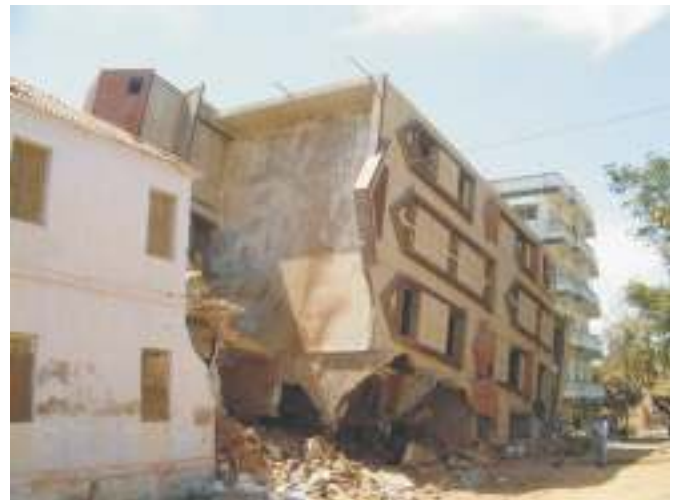
Fig. 18. The columns on one edge of the open first storey of this building in Bhuj collapsed bringing the building down on its side.

storeys have come down as a rigid body. Figure 18 shows a similar building also in Bhuj. In this case the columns on one side of the building failed and the building came down to rest on its side. Figure 19 shows some columns in the first storey of a building in Anjar. The loss of concrete cover and the lack of sufficient hoop reinforcement have caused the columns in the open storey to be severely damaged in the hinge region.

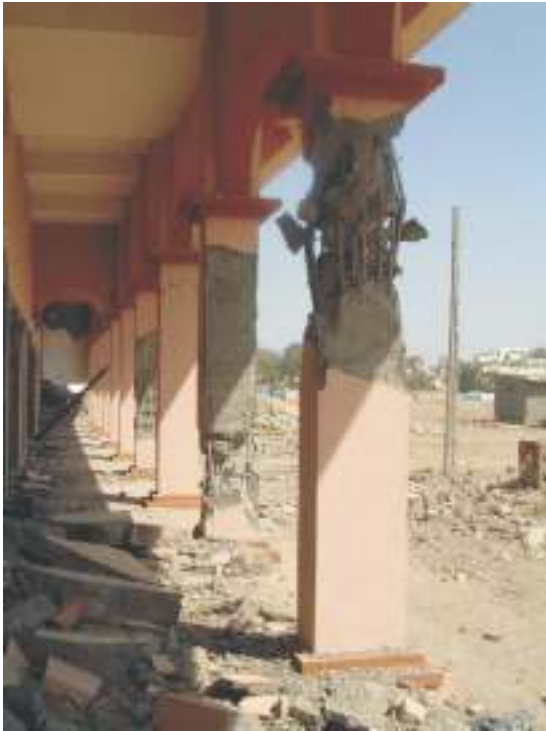
Fig 19. Failure of column through plastic hinging and buckling of longitudinal reinforcement due to loss of concrete cover and insufficient hoop reinforcement.

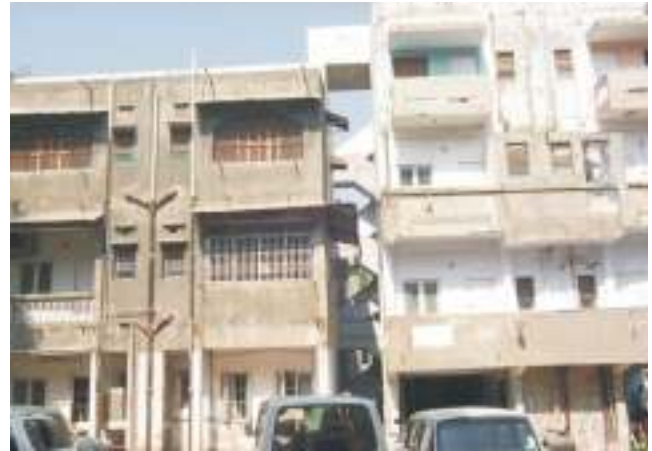
Figure 20 shows an interesting example of two buildings located in the Maninagar district of Ahmedabad. The buildings stood side-by-side and were connected by a staircase. The three-storey building on the left was of concrete frame with infill panels extending throughout the height in most of the column bays. It sustained the earthquake with minor damage. The four-storey building on the right had an open first storey, which suffered severe damage in the earthquake as seen in Fig. 21. Evidently the right-hand building leaned against the building on the left, which supported it and prevented it from collapse. The support was provided through the interconnecting staircase, which was damaged in the process as seen in Fig. 22.

Fig. 20. Two adjoining buildings in Maninagar; the interconnecting staircase allowed the building on the left to support the building on the right.

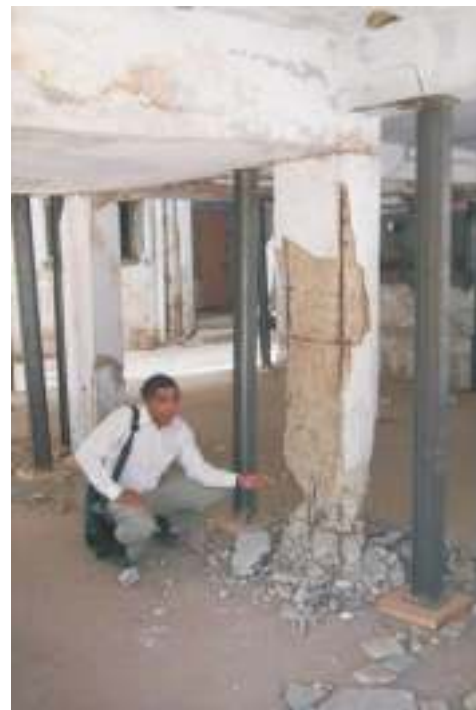
Fig. 21. The damaged first storey of the building on the right-hand side of Fig. 20.

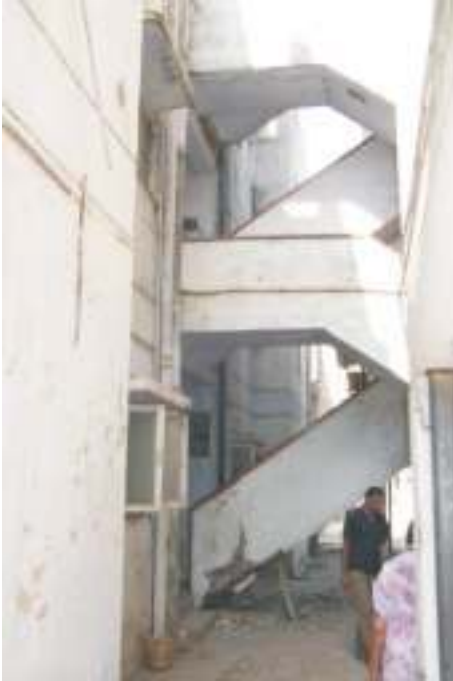
Fig. 22. The staircase interconnecting the two buildings in Fig. 20 allowed the building on the right to be supported by the building on the left.

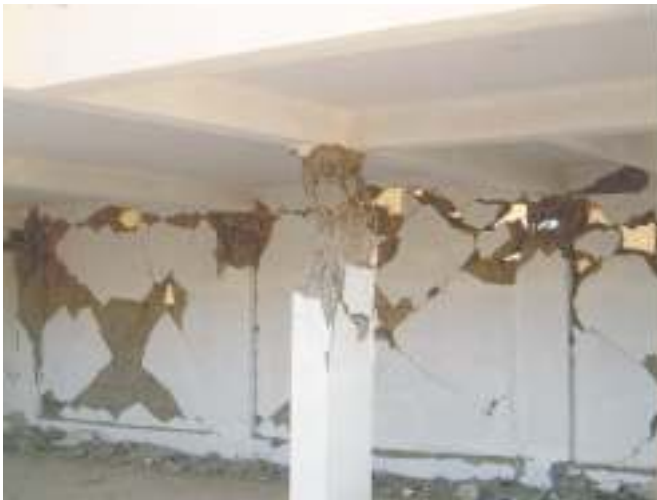
Figure 23 shows the first storey of a building in Anjar. The columns of this soft storey were heavily damaged in the hinge regions as seen from the figure. However, it appears that a few infill walls at this level protected the building against total collapse. Interaction between the columns and the walls damaged the latter quite severely as evidenced by

the large shear cracks in the wall panels. However, the panels did not fall out of their plane. It may be noted that the infill panels had no reinforcement, nor were they tied to the boundary elements.

Fig. 23. The hinge regions of the columns in the open first storey of this building in Anjar are heavily damaged; complete collapse of the building was prevented by the presence of a few infill walls, which although heavily damaged remained in their place.

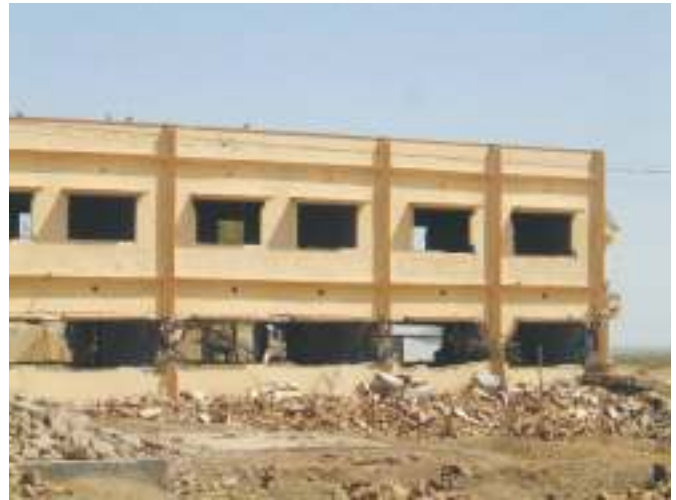
short column failures were evident following the Bhuj earthquake. Figures 24 and 25 show the failure of short columns in a school in Bhachau for sight-impaired children. The columns are restrained in one direction by partition walls built in stone blocks, but were unrestrained in the other direction. As will be noted from Fig. 25 the columns are quite slender and are reinforced by just four longitudinal Torsteel bars 15 mm in diameter and have widely spaced hoops of 6 mm plain steel bars.

Fig. 24. Failure of reinforced concrete short columns in a school in Bhachau.

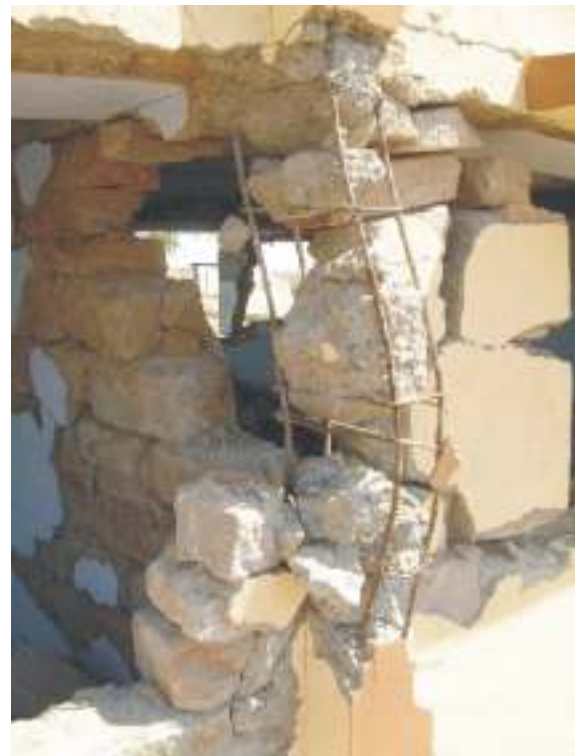
Fig. 25. Details of the short columns in the building shown in Fig. 24.

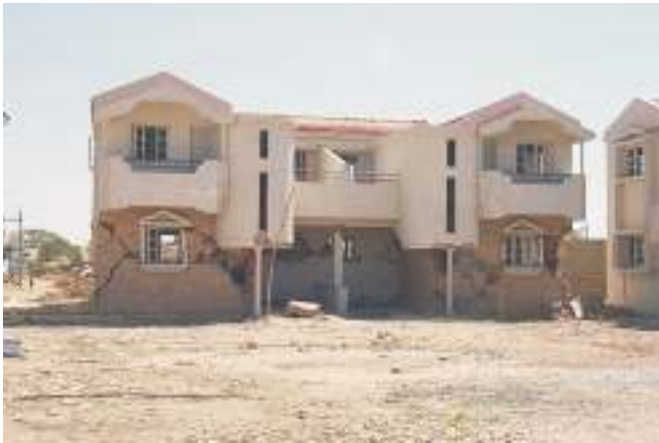
Figure 26 shows one of a row of newly built semi-detached houses in the town of Samkhiali near Bhachau. The developers had just finished constructing the bungalows, which were not yet occupied. As will be seen from Fig. 26, the fronts of the houses are open for a large portion of the first storey to provide space for parking. A very slender circular column (Fig. 27) supports the staircase leading to the floor above ground. A masonry perimeter wall at the back of the first storey provides considerable stiffness in its plane, creating a large torsional eccentricity. This eccentricity combined with an open floor and very slender supporting col-

Fig. 26. Row of semi-detached houses in Samkhiali; note the open spaces in the first storey, the masonry infill wall at the back, and the slender columns supporting the front of the building.

umns made the structure very vulnerable. All of the houses in the complex suffered extensive damage, and some actually crumbled.

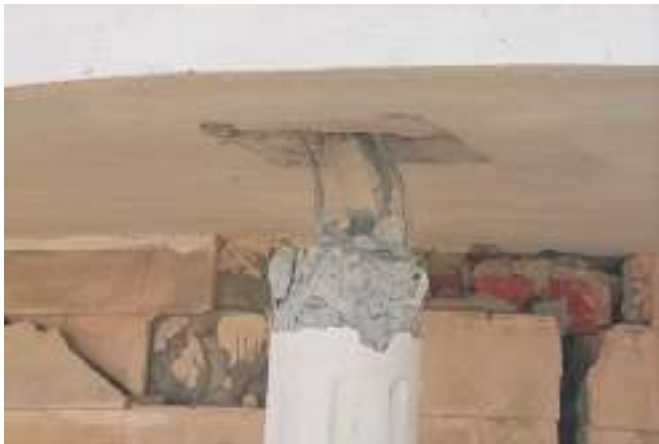
Fig. 27. Details of the column supporting the front of the building shown in Fig. 26.

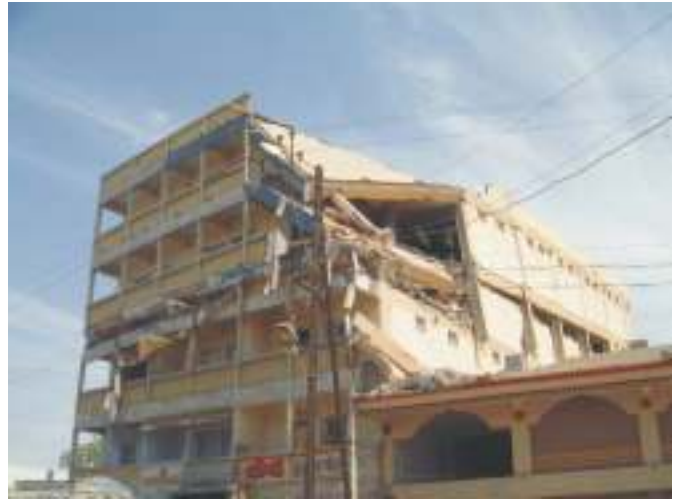
As another example refer to the six-storey reinforced concrete frame building shown in Fig. 28. The first three storeys of this building had been built earlier, the remaining three storeys being added subsequently. Evidently the connections between the structural columns of the two parts were not adequate and led to shear failure of columns at the junction.

Fig. 28. The fourth storey of this six-storey building in Bhuj collapsed bringing the topmost two storeys down and causing more extensive damage to one corner of the building.

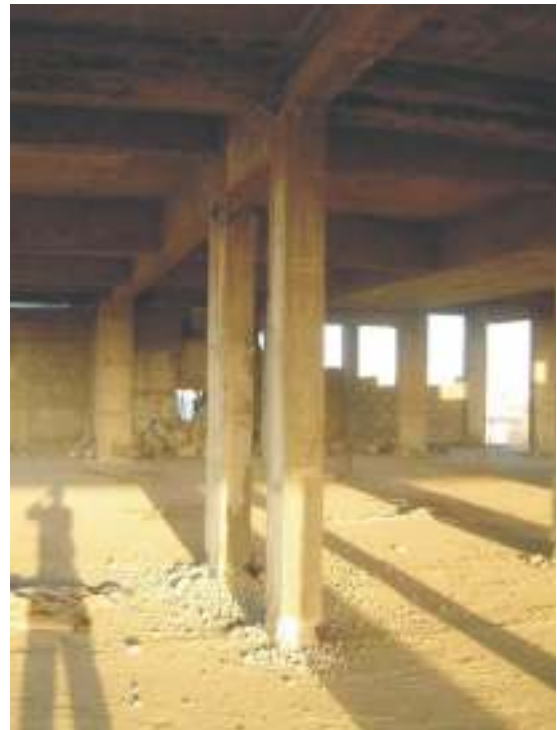
Previous observations have shown that a change in stiffness across the height of the building constitutes a location of weakness. An example of this is provided by the damage suffered by the building of Hotel Abha in Bhuj. At the time of the earthquake the first three storeys of the building had been completed, including the masonry infill walls. The concrete frame structure for the upper floors had been constructed, but the walls had not been built. During the earthquake the concrete columns at the transition between the completed portion and the bare concrete frame suffered damage as seen from Fig. 29. The columns, however, had

Fig. 29. Damage suffered by the columns in the partially completed upper floor of the Abha building in Bhuj.

sufficient ductility to sustain the displacement imposed by the earthquake.

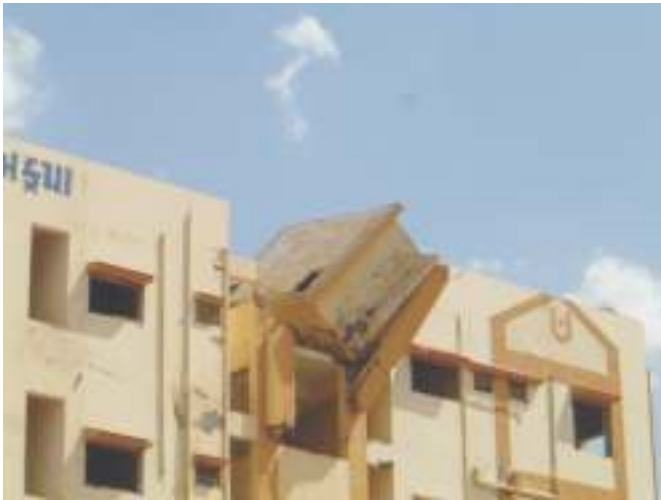
In the concrete frame residential buildings in Gujarat it is a common practice to place a water storage tanks at the top of the building. The tank is constructed in reinforced concrete and is usually supported by short concrete columns projecting above the roof level. The storage capacity of the tank depends on the size of the building but is of the order of 20 to 25 000 L. Many of these tanks were filled with water at the time of the earthquake. In many instances the sup-

Fig. 30. A water tank supported by four short columns projecting above the roof collapsed during the earthquake.

porting columns were unable to sustain the large seismic shear and failed. An example is presented in Fig. 30.
