## **Performance of posttensioned seismic retrofit of two stone masonry buildings during the Canterbury earthquakes**

### **Abstract**

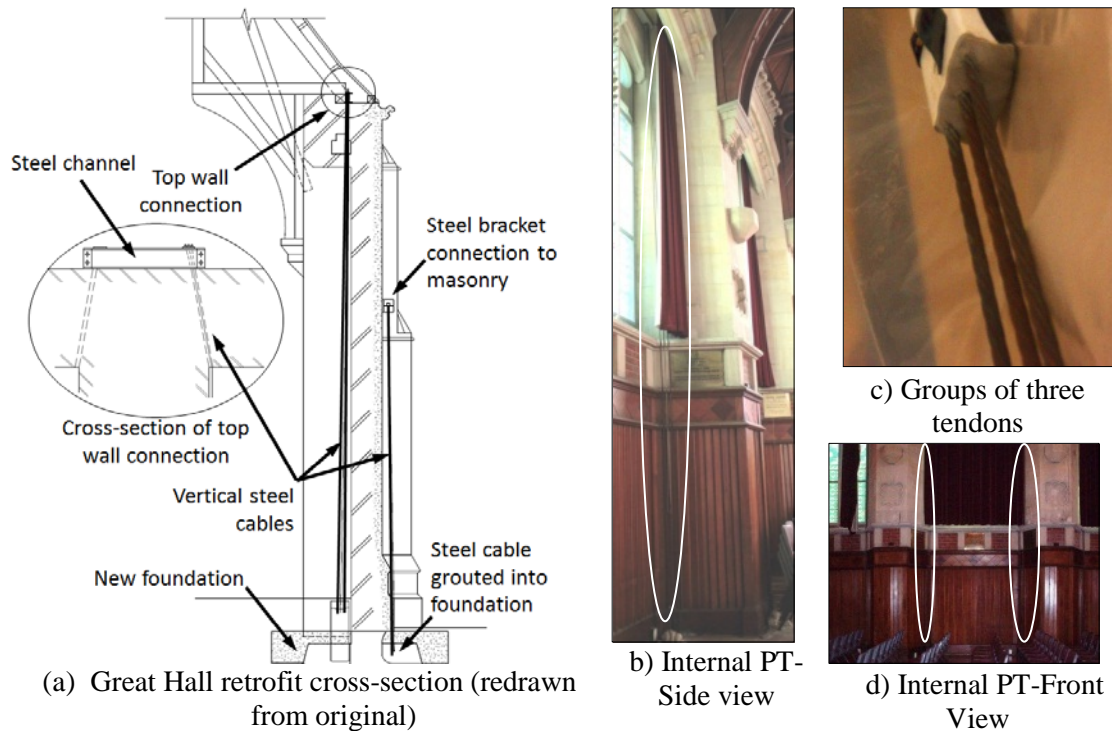
Figure 6: Great Hall retrofit cross-section and condition of the interior posttensioning within the Great Hall following the Canterbury earthquakes

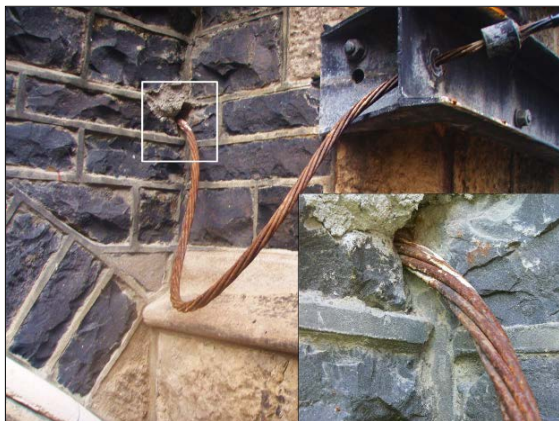
(a) Corrosion of PT steel (after tendon had been released to enable strengthening works)

External damage to the College Hall during the 22 February 2011 event was restricted to the east side of the building, as well as around the dominant window feature on the North face. The damage was consistent with insufficient connection between the roof and the gables, reduction and lack of diaphragm stiffness (Figure 8), as well as differential movement between jointed structures on the east side of the building. Damage was also sustained to the turret during the September earthquake, which was subsequently removed prior to February 22. During the first earthquake in September 2010 the posttension tendons were approximately 26 years old and in most cases a minor to moderate extent of corrosion was observed, as indicated in Figure 7a. The condition of the tendons across the site ranged from

minor surface flecking to significant loss of cross section, dependant on the location within the structure and the environmental exposure. The exterior west side of the building where the posttension tendons were applied performed well, with almost no damage except the failure of one tendon. The cross-section of the failed tendon was significantly reduced at the point of failure, most likely due to the design of the lower anchorage effectively creating a pond around the tendon during wet conditions (Figure 7b), resulting in constant wetting and drying causing corrosion and deterioration of the tendon. Similar damage to the tendons was identified along the length of the wall, but because inspections were only undertaken post-earthquake, it is unknown whether the failed tendon ruptured as a result of the earthquake or had already failed due to the section reducing to an area that was unable to sustain the imposed prestress. Giving consideration to the exposure of the tendons, a limited warranty to such a design would be granted given the current stringent durability requirements. Therefore, for a long-term solution, some further form of protection would be necessary, and given the 26 year old age of the tendons it is concluded that they performed well in the environmental conditions that they were exposed to.

Due to the favourable performance of the posttension tendons, the existing seismic retrofits are in the process of being renewed. The tendons of the Chemistry building are being replaced with stainless steel material to prevent corrosion and the tendons of the Great Hall are being removed from sight and instead ducts are being drilled within the wall to install new tendons, thus preserving the architectural characteristics, protecting the tendons from environmental conditions, and satisfying the elevated post-earthquake seismic improvement criteria for historic buildings in Christchurch.

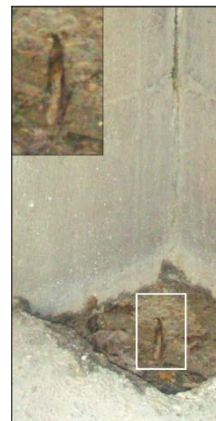
remained intact, with the vertical tendon that failed being part of the College Hall retrofit and being the southern external tendon on the 4th buttress from the northern side of the building. Damage surveys were completed on the TAC complex after the February 2011 earthquake. The damage to the Chemistry building was significant due to failure of the tower above the main entrance, which was subsequently removed. External damage to the Chemistry building was primarily to gables and the main tower, with some minor superficial cracking and loss of stonework at Level 1. As the tower had only received nominal securing, this outcome was to be expected. Gables also performed poorly due to inadequate connection to the roof and low stiffness of the adjacent strengthened flexible diaphragm. The overall structure performed well, particularly at ground level where the posttensioning was applied. Nearly all of the stone damage, broken windows and minor cracking occurred during the 22 February 2011 earthquake due to greater peak accelerations which exceeded current design levels.

(b) Area where pond of water was able to form around failed tendon

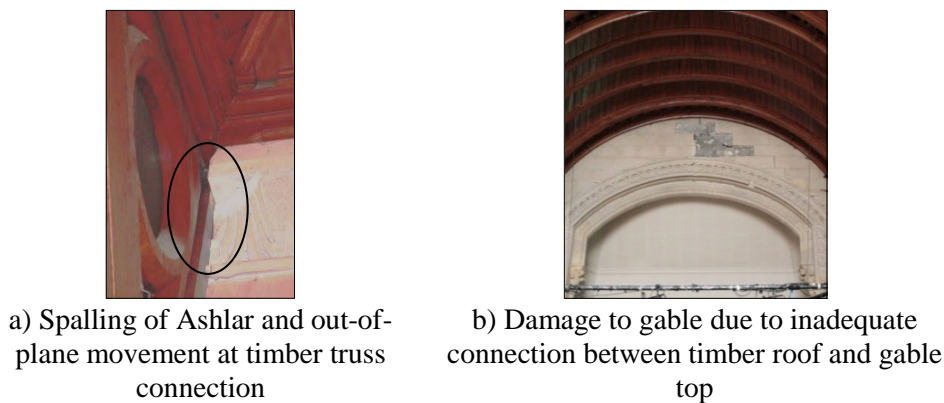
Internal damage to the College Hall was generally sustained at level 1 or above, suggesting that the PT was effective in preventing damage at lower levels. Again, the damage was restricted to where the timber roof trusses connected to the walls (Figure 8), as well as in locations where adjoining extensions had been added on. Apart from some slight movement of one window on the retrofitted side of the building, little damage was evident, which can be attributed to the successful performance of the posttension retrofit.

Figure 8: Damage to interior of the Great Hall

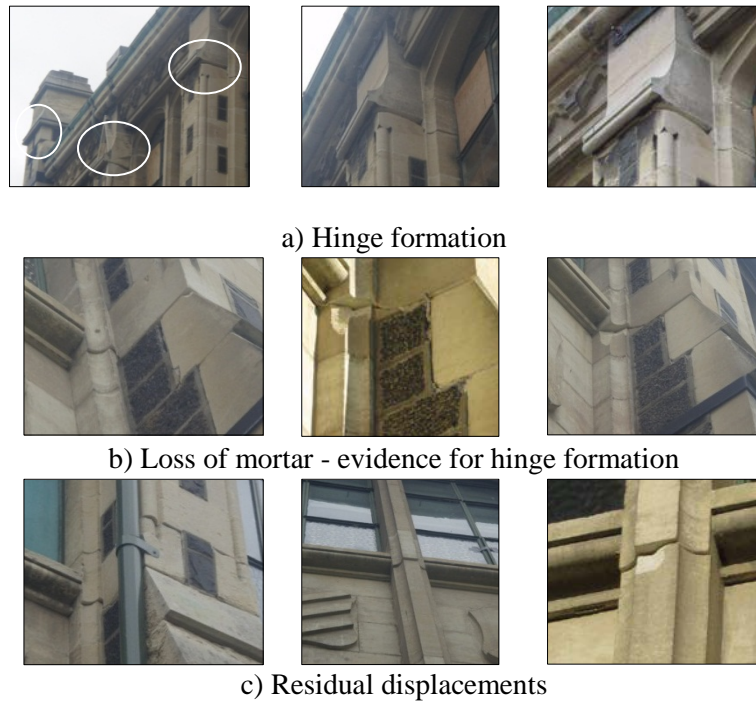
Quantifying the performance of the posttension retrofit is difficult, but by comparing the damage to the retrofitted Chemistry building with that of the un-retrofitted Engineering building, key advantages of the posttensioning can be identified. The Engineering building is of similar pier/spandrel construction with a slightly different aspect ratio, but overall provides the best comparison available at the Arts Centre site. A visual comparison of the Chemistry building versus the Engineering building can be seen in Figures 9. The Engineering building suffered from out-of-plane movement indicated by the formation of hinges due to rocking at the top and bottom of the second level (Figures 9a and 9b respectively). At the Chemistry building no evidence of hinge formation at the piers as is evident for the Engineering building. The mortar of the Chemistry building is still intact, indicating that the posttension tendons limited tensile forces that developed in the masonry, minimising any hinging between the masonry units and mortar as shown in Figure 9. Unlike the retrofitted Chemistry building, there was also significant permanent deformation of the second level of the Engineering building as shown by the large overhang in Fig 9c. No identifiable permanent deformation at

Figure 9: External failures of the Engineering building

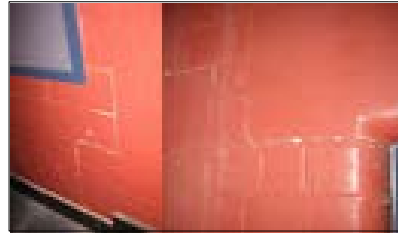
Figure 10 shows the damage to the interior of the Engineering building, again highlighting the out-of-plane rocking and differential movement that occurred throughout the unretrofitted building. Although the Chemistry building also suffered some internal cracking, the extent of the damage and therefore repairs needed was minimal compared to that of the Engineering building. Based on observations alone it can be concluded that the retrofit of the Chemistry building provided improvements in the out-of-plane loading direction as well as addressed in-plane deficiencies as initially intended with the retrofit design scheme.

d) Ground floor - evidence of differential movement, spalling of mortar and residual displacement common at this level
