01 Oct 2011

## Post-earthquake Reconnaissance Report on Transportation Infrastructure Impact of the February 27, 2010, Offshore Maule Earthquake in Chile

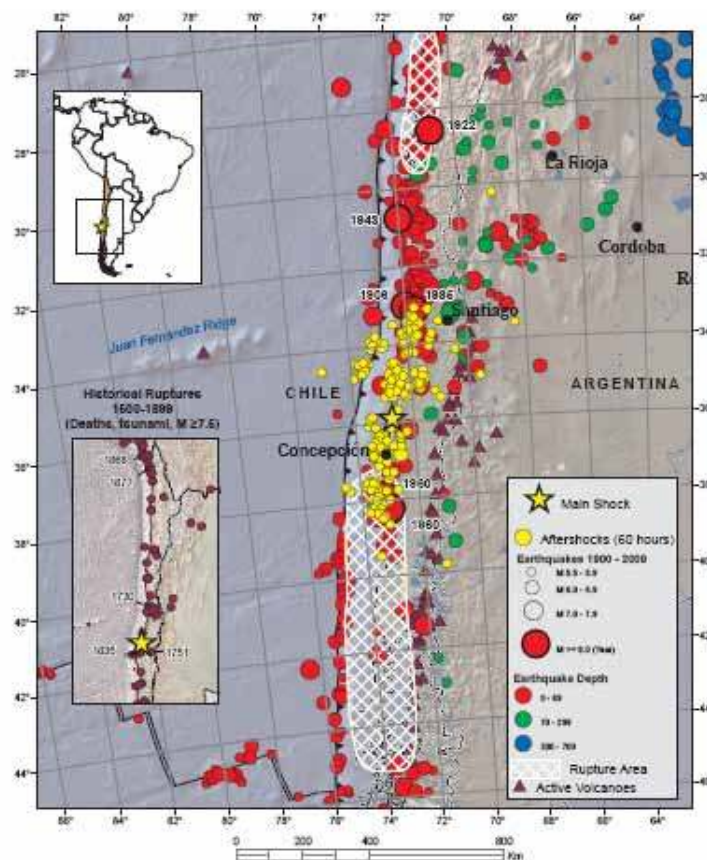
Figure 4. Map. Historic seismicity for Chile.<sup>(1)</sup>

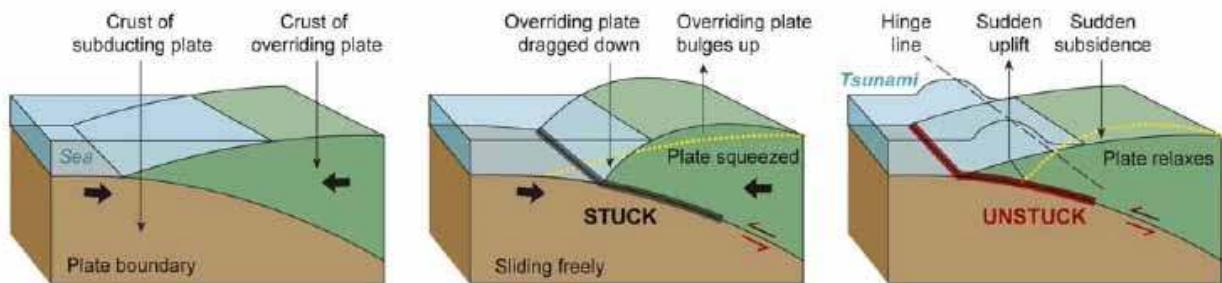
**Figure 5. Illustration. Conceptual diagram of a subduction zone earthquake.**<sup>(2,4)</sup>

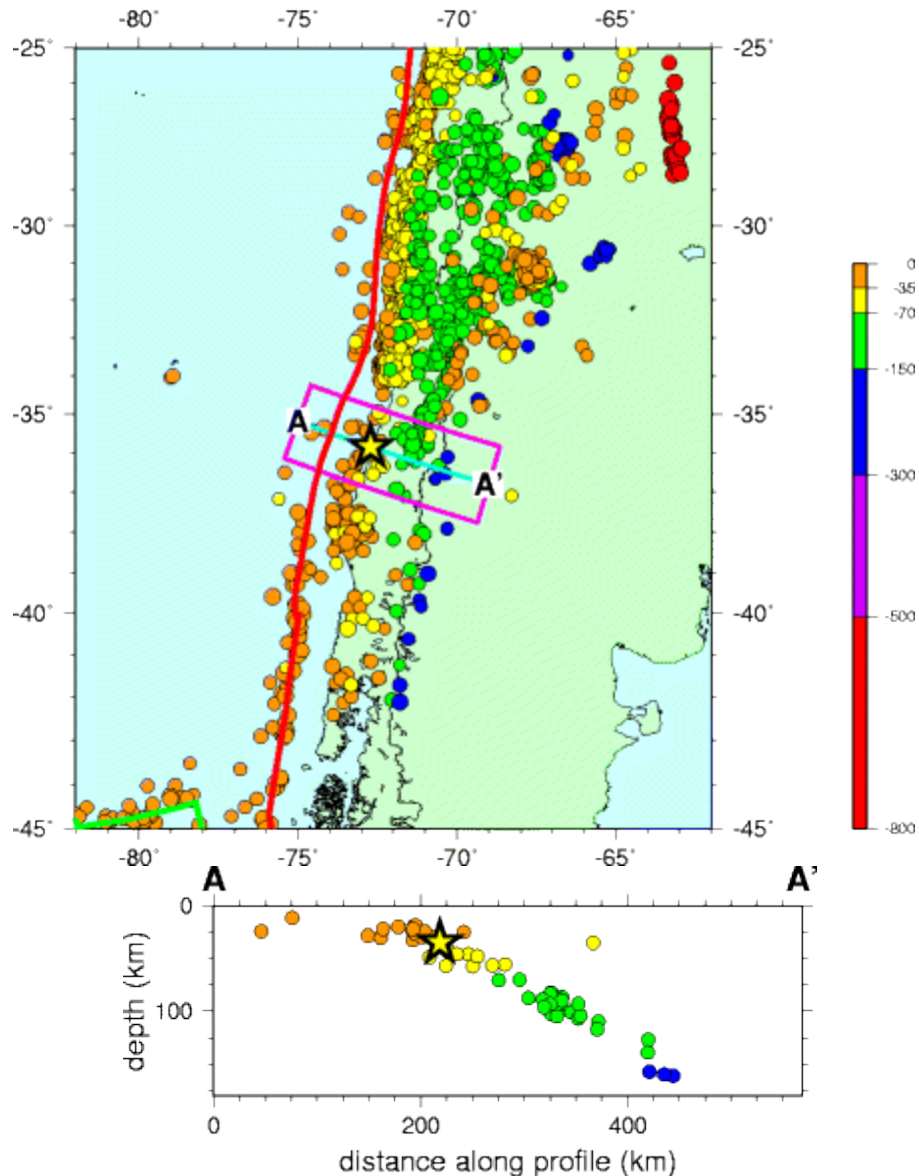
Another key aspect of this type of earthquake is the tendency of such an event to produce many strong aftershocks as the plates adjust to the sudden change in stresses following rupture. The aftershocks themselves can produce a significant hazard to the structures and facilities damaged by the main shock, as well as to the people within or near the partially damaged structures. Figure 4 and figure 6 show maps illustrating the number and distribution of aftershocks, some of which approached M7.0. The cross section of the aftershock locations as a function of depth and distance in figure 6 illustrates the location of the rupture surface. The hypocenter of the main shock is marked with a star.

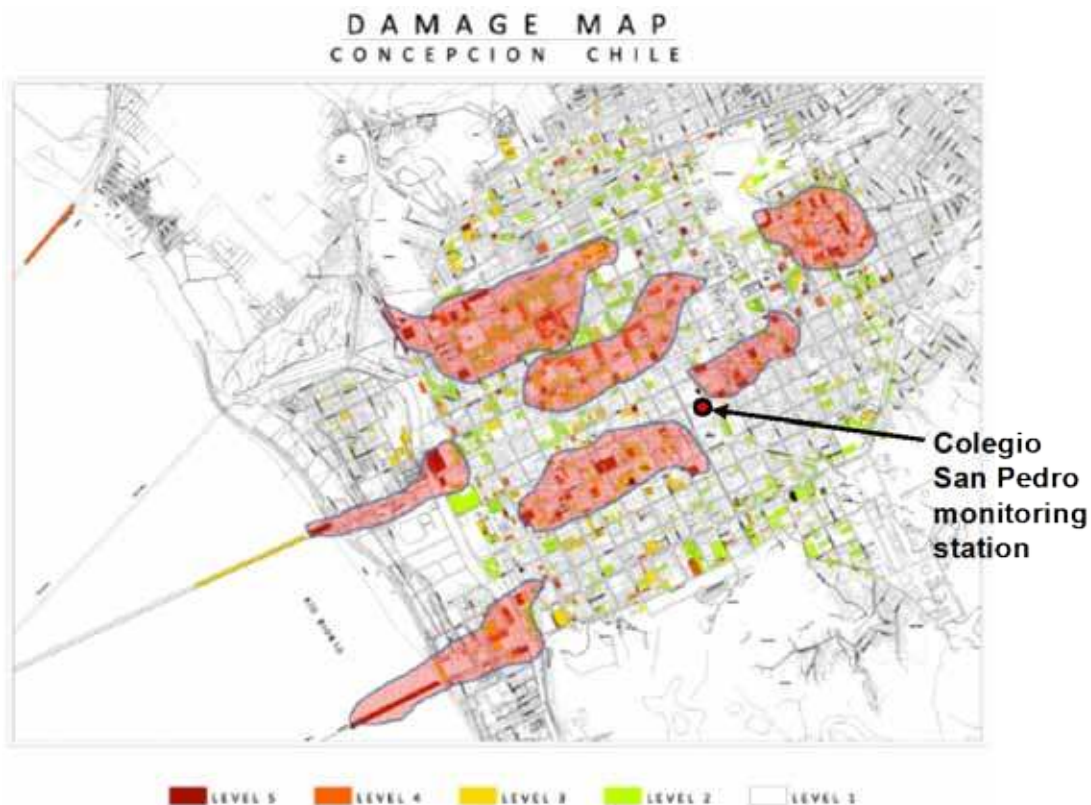
**Figure 21. Map. Damaged sections in downtown Concepción.**<sup>(2)</sup>

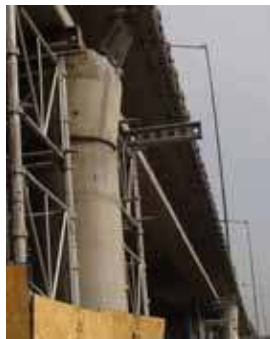
**Figure 23. Photo. Damage to eastbound Independencia bridge.**

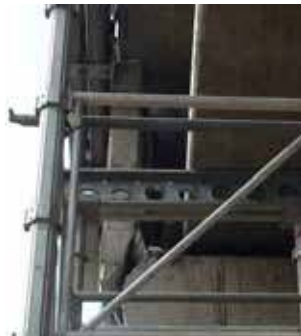
**Figure 24. Photo. Curtain wall at east abutment of eastbound Independencia bridge.**

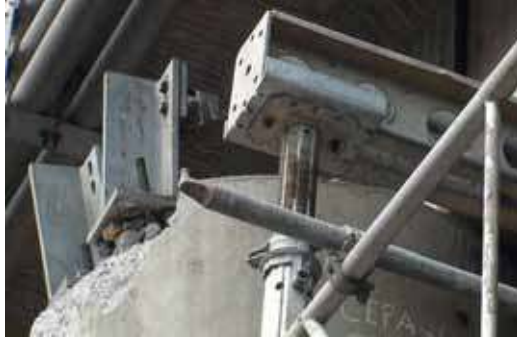
Figure 25. Photo. Damage to steel stoppers on eastbound Independencia bridge.

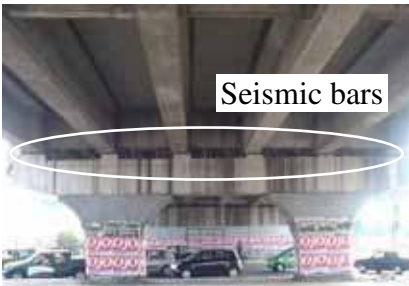
**Figure 27. Photo. Typical flared wall pier of westbound Independencia bridge.**

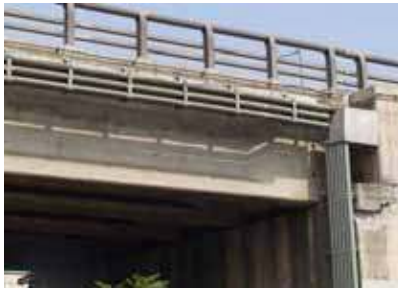
**Figure 29. Photo. Shear key damage at abutment of westbound Independencia bridge.**

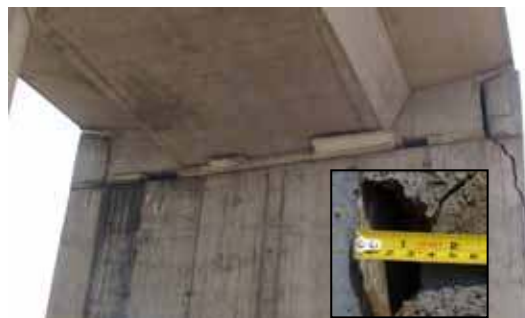
**Figure 33. Photo. Shear key damage at entrance ramp abutment.**

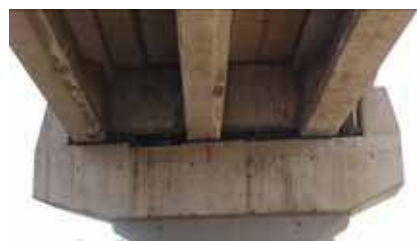
**Figure 34. Photo. Flared wall pier of exit ramp from westbound Independencia bridge.**

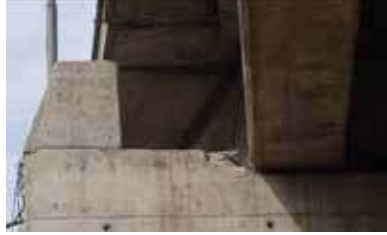
**Figure 35. Photo. Close-up of damage to exit ramp from westbound Independencia bridge.**

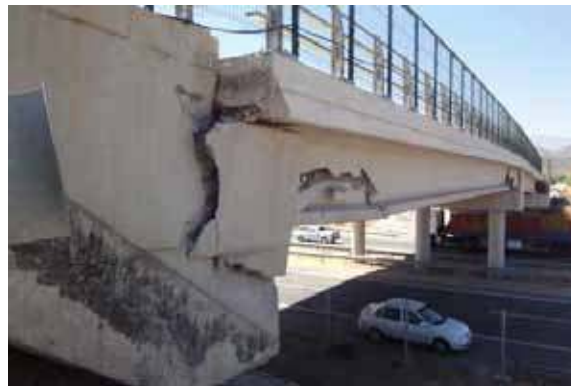
**Figure 36. Photo. Curtain wall shear failure at abutment of Chada bridge.**

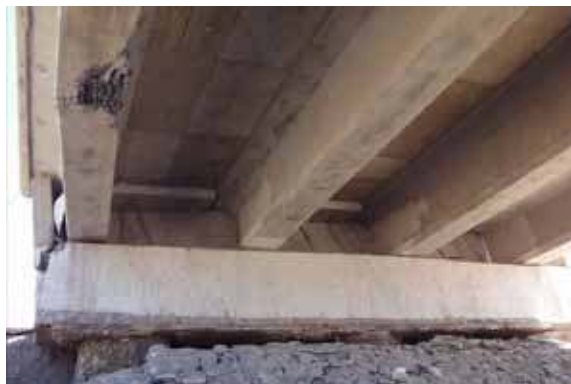
**Figure 37. Photo. Bottom flange damage to Chada bridge.**

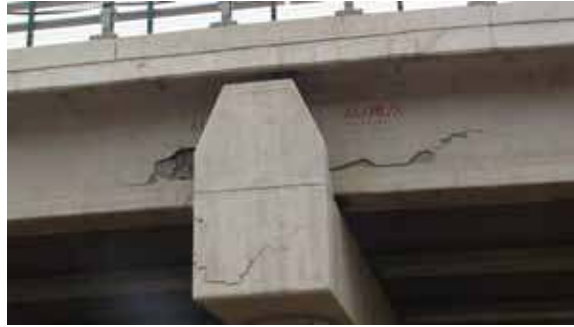
**Figure 38. Photo. Curtain wall damage at bent of Chada bridge.**

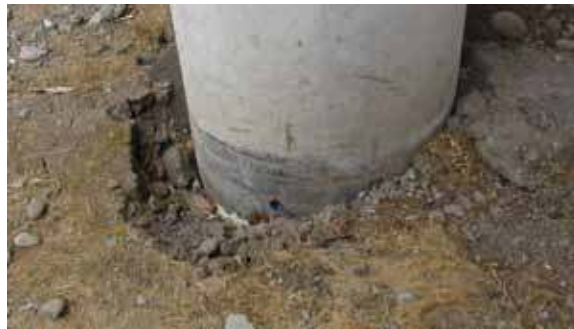
**Figure 39. Photo. Soil separation from column of Chada bridge.**

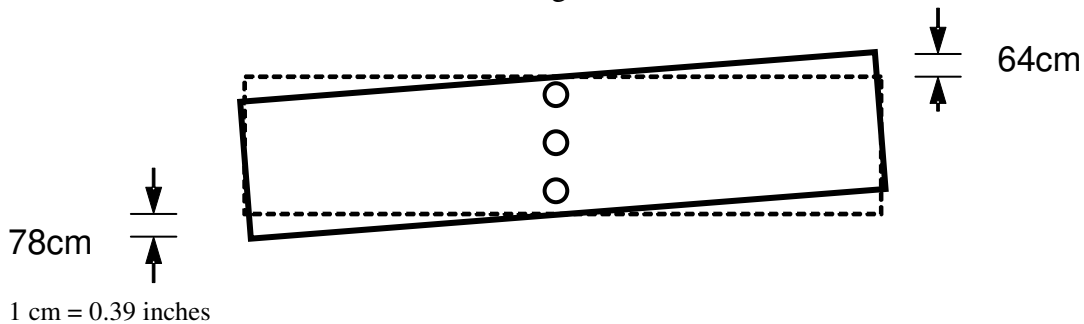
**Figure 40. Illustration. Plan view of superstructure rotation of Chada bridge.**

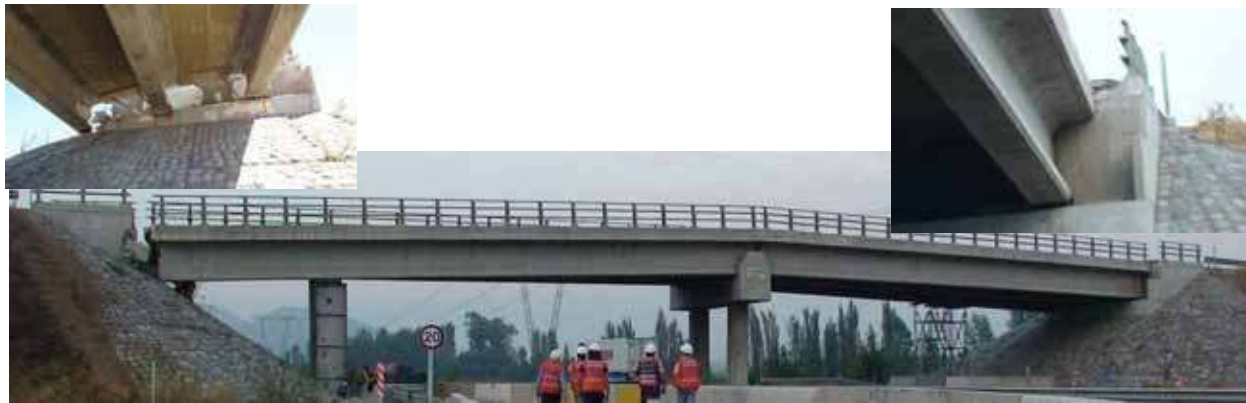
**Figure 41. Photo. Las Mercedes bridge and girder unseating at abutments.**

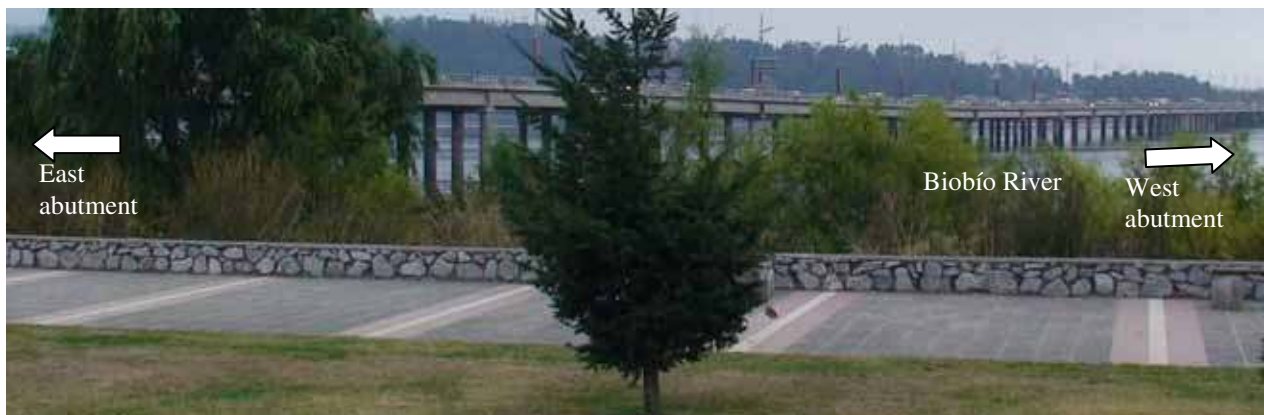
**Figure 42. Photo. Llacolen bridge looking south-southwest.**

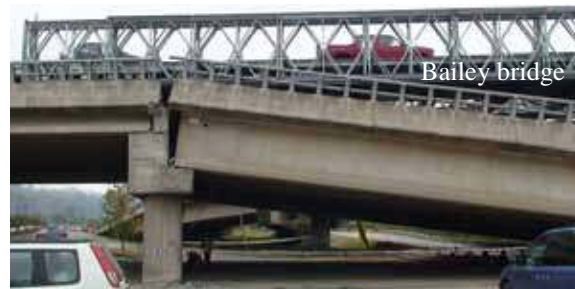
**Figure 43. Photo. Unseated simply supported span in eastern approach to Llacolen bridge.**

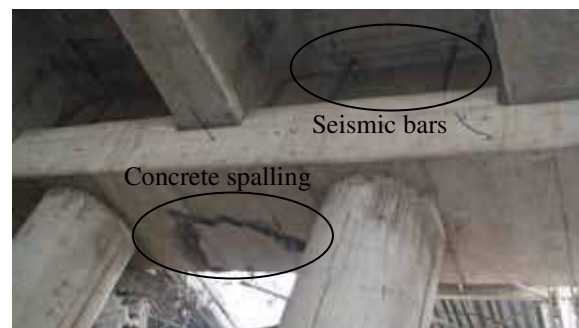
**Figure 45. Photo. Concrete spalling beneath cap beam of eastern approach to Llacolen bridge.**

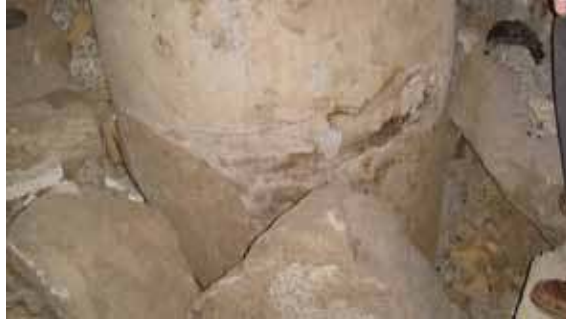
**Figure 46. Photo. Flexural cracks at the level of rip rap on eastern approach to Llacolen bridge.**

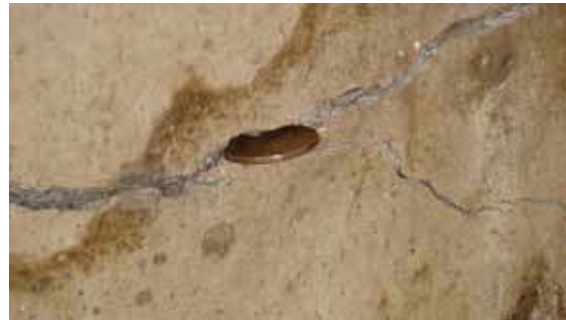
**Figure 47. Photo. Close-up view of cracks at the level of rip rap on eastern approach to Llacolen bridge.**

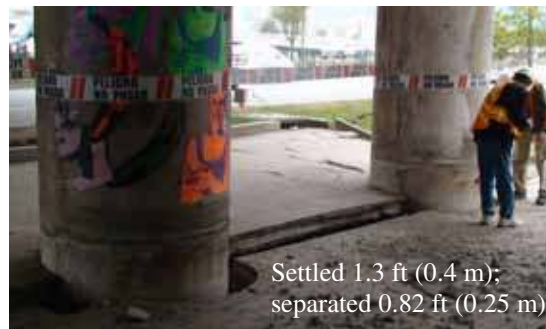
**Figure 48. Photo. Ground settlement and lateral movement of eastern approach to Llacolen bridge.**

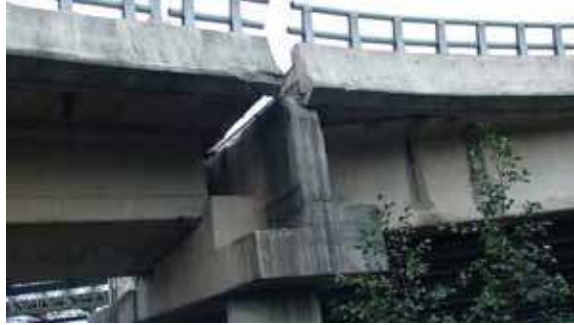
**Figure 49. Photo. Exterior face of westbound ramp to Llacolen bridge at the river end.**

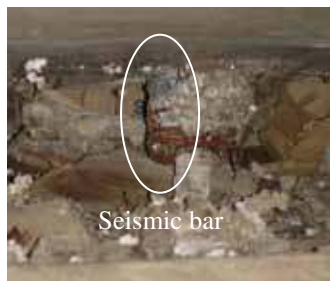
**Figure 52. Photo. Seismic bar condition on westbound ramp to Llacolen bridge.**

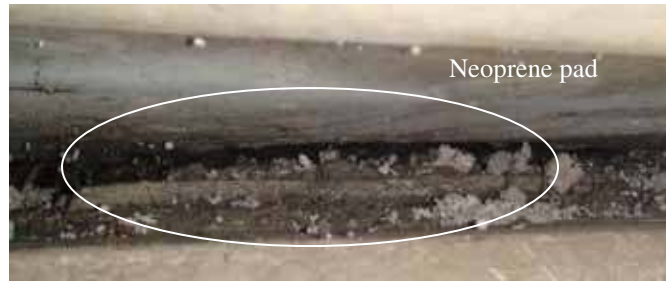
**Figure 53. Photo. Neoprene pad degradation on westbound ramp to Llacolen bridge.**

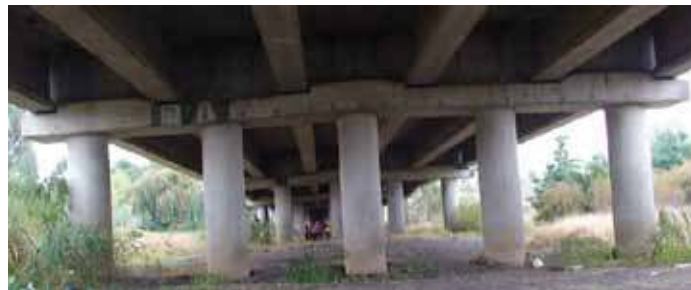
**Figure 54. Photo. Columns with soil marks indicating ground settlement at west end of Llacolen bridge.**

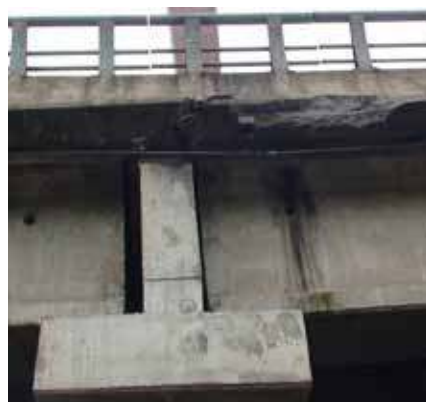
**Figure 56. Photo. Spalling in deck slab at west end of Llacolen bridge.**

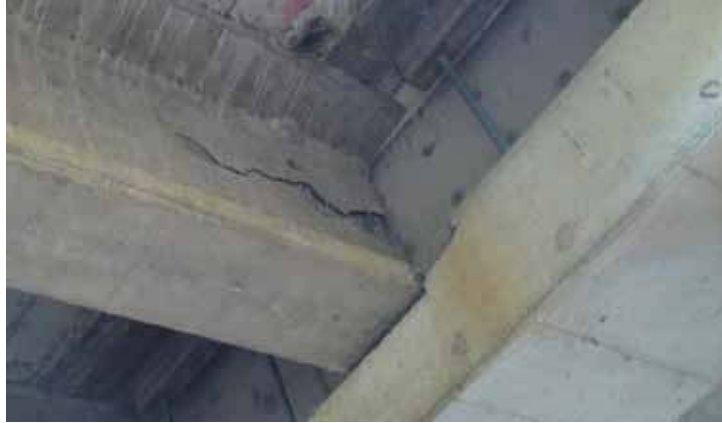
**Figure 57. Photo. Horizontal crack in web of end girders at west end of Llacolen bridge.**

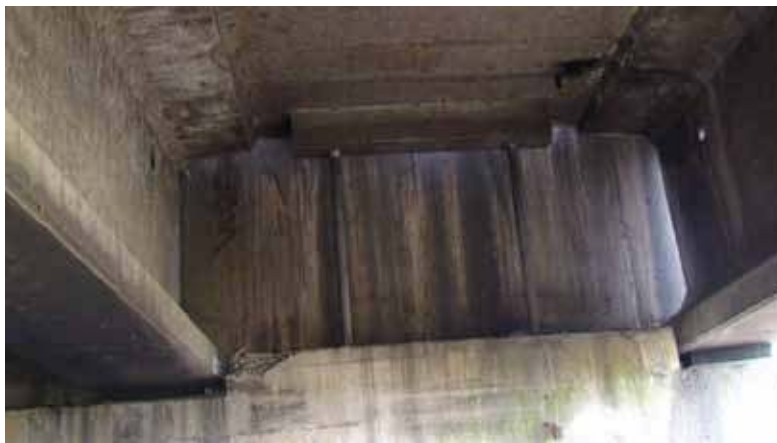
**Figure 58. Photo. Spalling of shear key at southwest abutment of Llacolen bridge.**

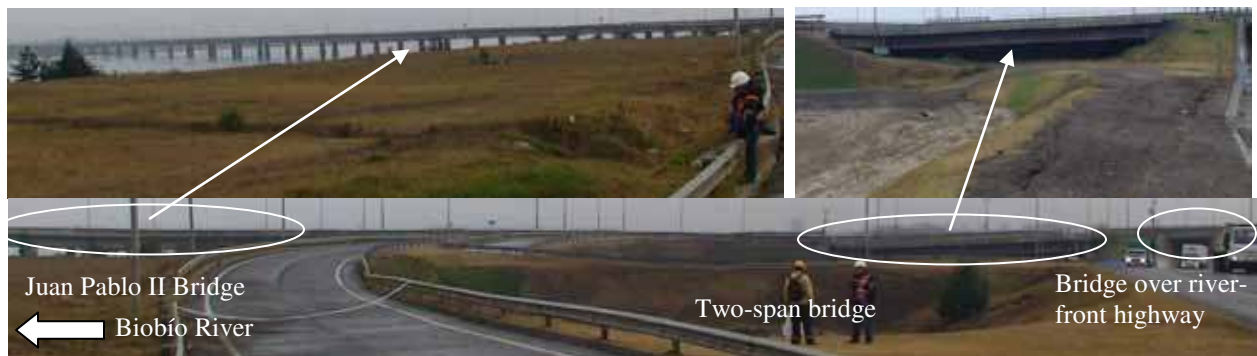
**Figure 59. Photo. Approaches to Juan Pablo II bridge.**

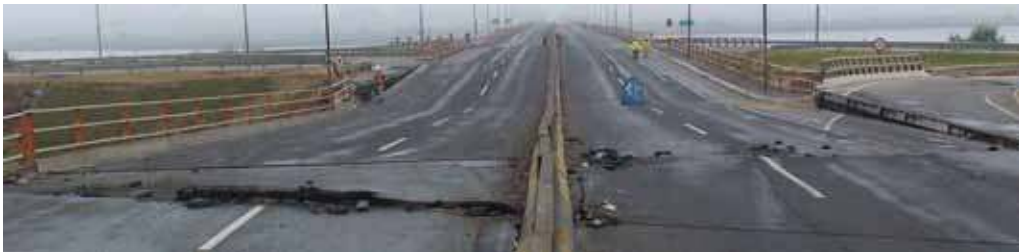
**Figure 60. Photo. Southwest view of northern approach to Juan Pablo II bridge, facing Biobío River.**

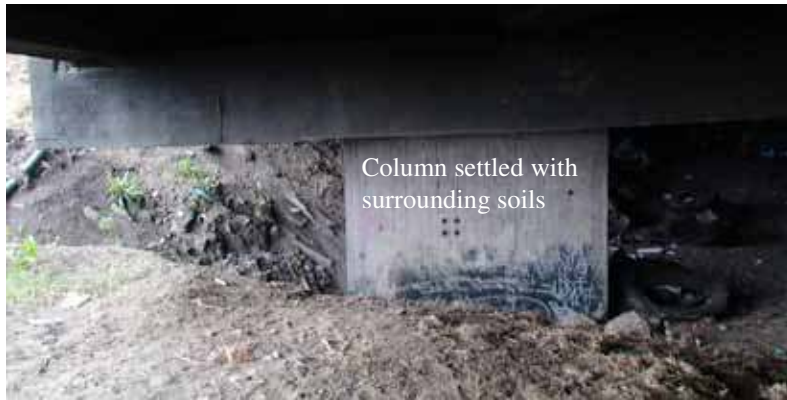
**Figure 63. Photo. Column settlement under approach to Juan Pablo II bridge (cracks on far side).**

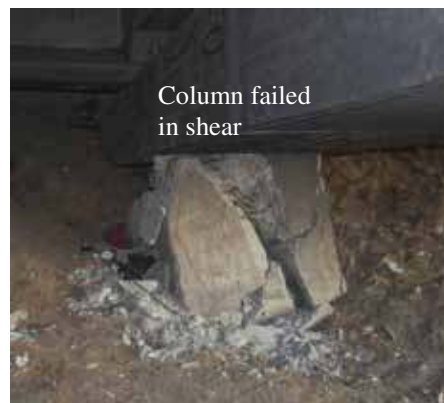
**Figure 64. Photo. Reduced column height due to shear failure under approach to Juan Pablo II bridge.**

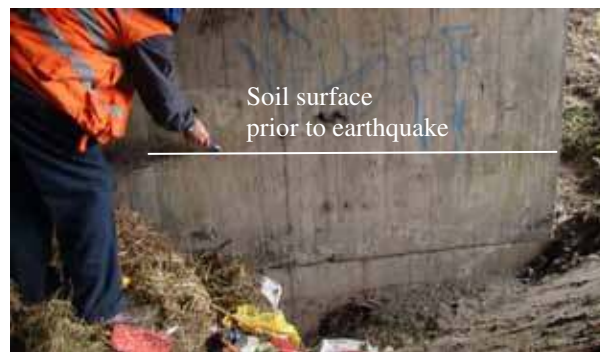
**Figure 65. Photo. Soil surface on far side of undamaged column under approach to Juan Pablo II bridge.**

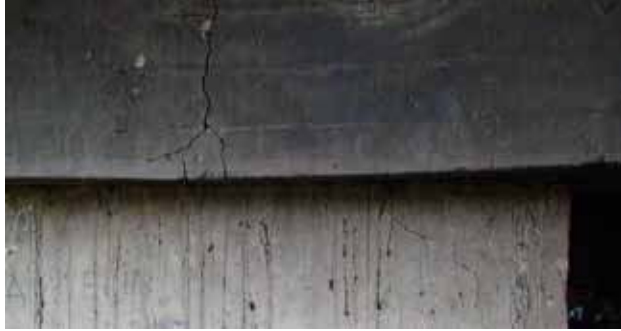
**Figure 66. Photo. Cracks on far side of undamaged column under approach to Juan Pablo II bridge.**

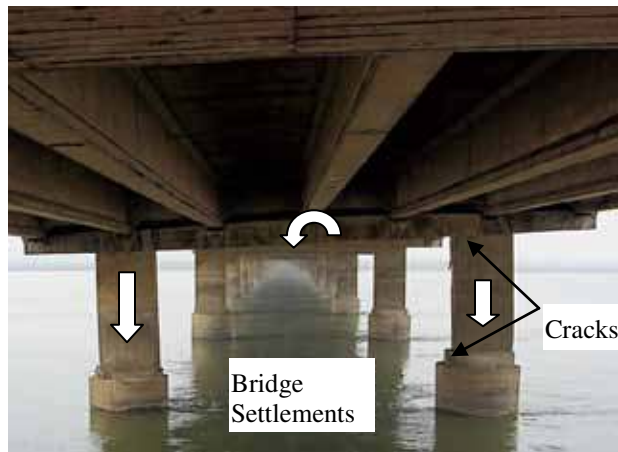
**Figure 67. Photo. Differential settlement underneath first span over water at northern end of Juan Pablo II bridge.**

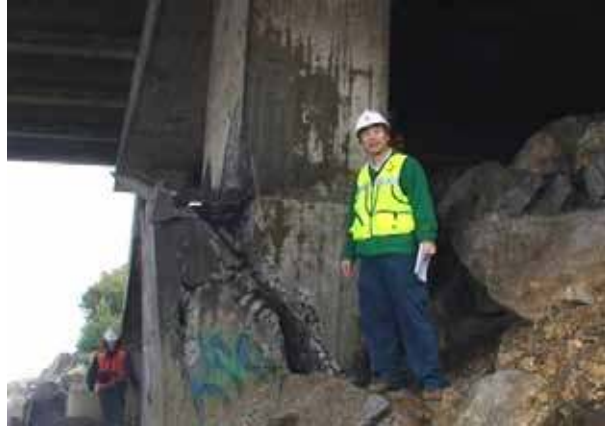
**Figure 68. Photo. Shear failure in upstream column at northern end of Juan Pablo II bridge.**

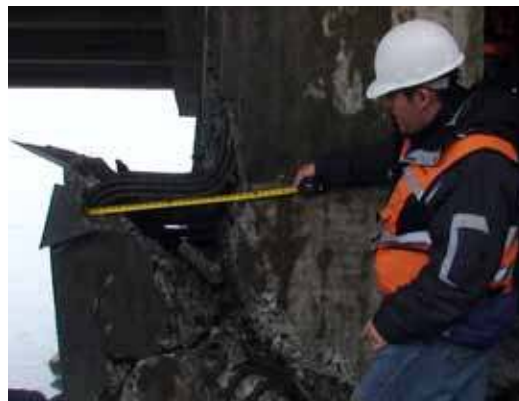
**Figure 69. Photo. Front face of failure plane at northern end of Juan Pablo II bridge.**

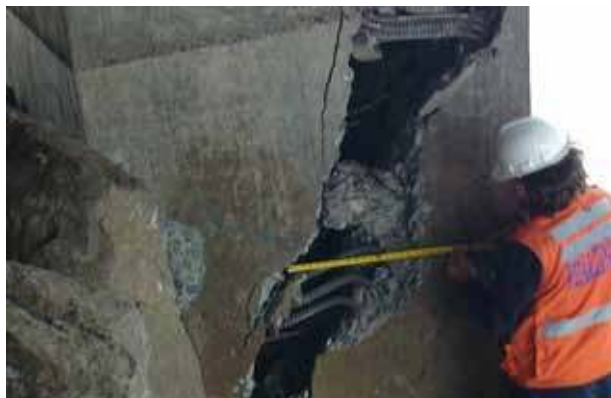
**Figure 70. Photo. Back face of failure plane at northern end of Juan Pablo II bridge.**

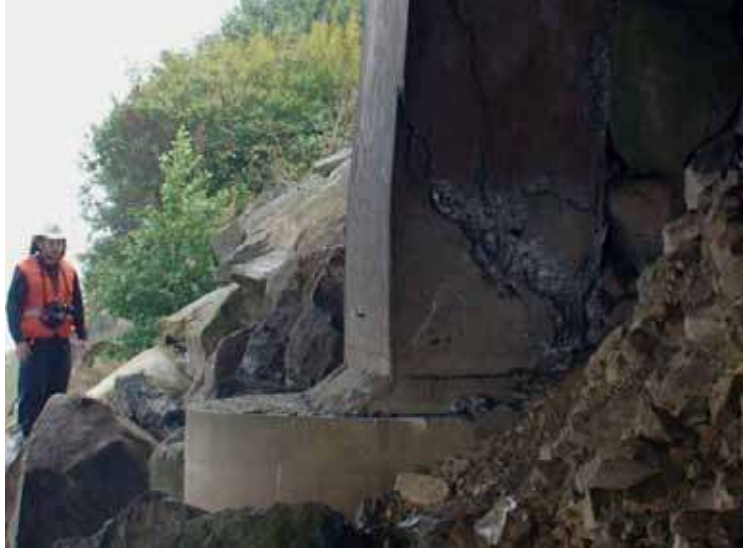
**Figure 71. Photo. Shear failure in downstream column at northern end of Juan Pablo II bridge.**

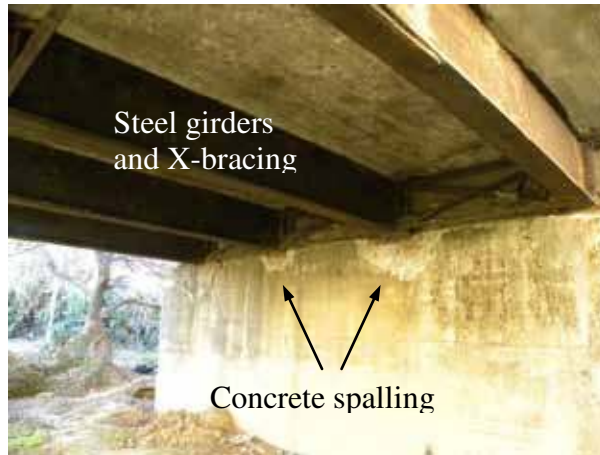
**Figure 78. Photo. Abutment damage beneath west Ramadillas bridge.**

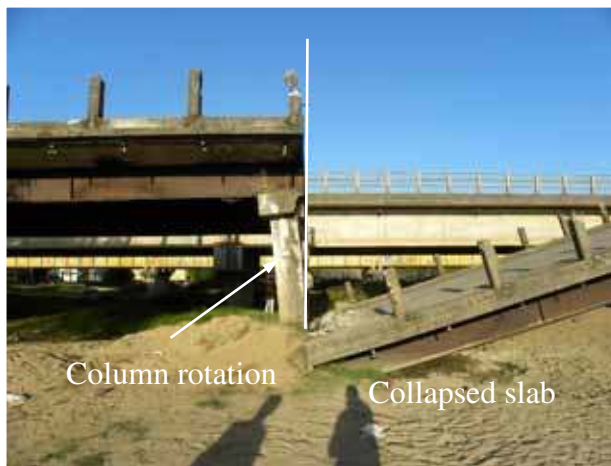
**Figure 79. Photo. Pier rotation in collapsed span of west Ramadillas bridge.**

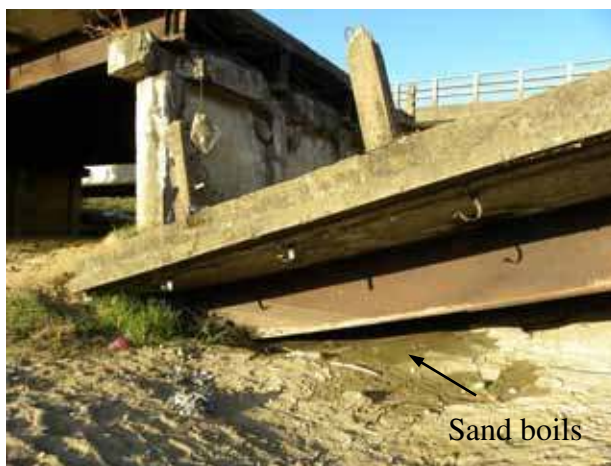
**Figure 80. Photo. Sand boils near collapsed span in west Ramadillas bridge.**

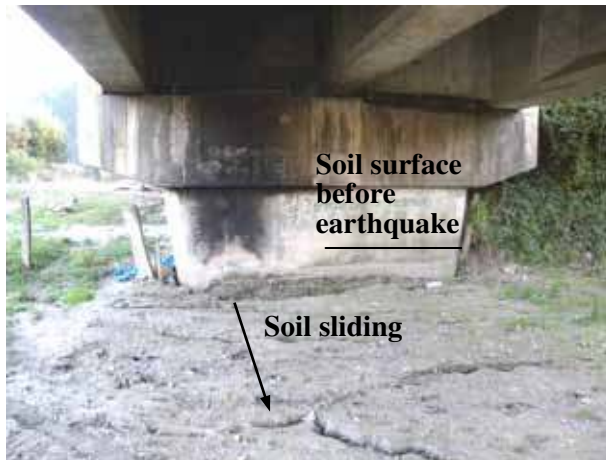
**Figure 81. Photo. Settlement at south abutment under east Ramadillas bridge.**

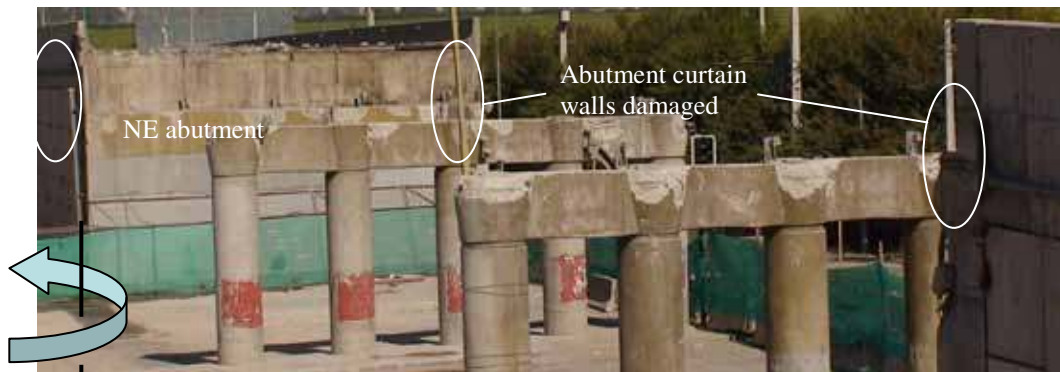
**Figure 89. Photo. Miraflores bridge after removal of superstructure.**

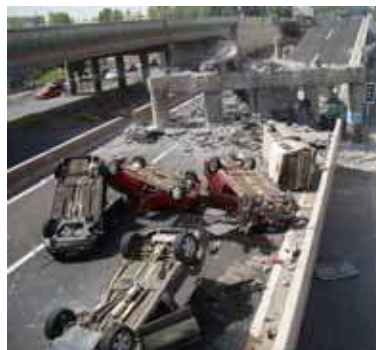
At the Lo Echevers bridge site, two parallel bridges had spans of 91.3, 119.1, and 91.3 ft (27.84, 36.32, and 27.84 m). As shown in figure 92 and figure 93, the southwest-bound bridge suffered minor damage while the northeast-bound bridge collapsed. The bridges did not have end diaphragms and appeared to have had an S-shaped superelevation. Each three-span precast prestressed girder bridge had five discontinuous girders and a continuous deck slab. The abutments and two intermediate piers were skewed approximately 33 degrees. Each girder was supported on a neoprene pad and a concrete pedestal at both ends. The girders were restrained by a pair of steel stoppers with 0.4- and 2-inch (10- and 50-mm) gaps for vertical and horizontal motions. Details of the steel stoppers are shown in figure 26.

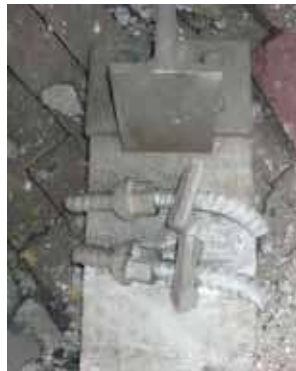
**Figure 94. Photo. Failure of a steel stopper on Lo Echevers bridge.**

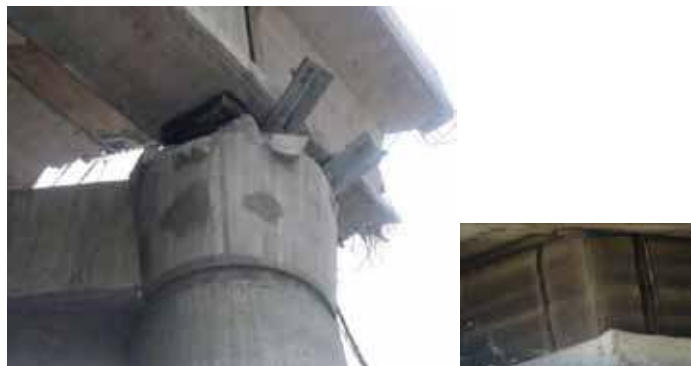
**Figure 95. Photo. Displaced elastomeric bearing on Lo Echevers bridge.**

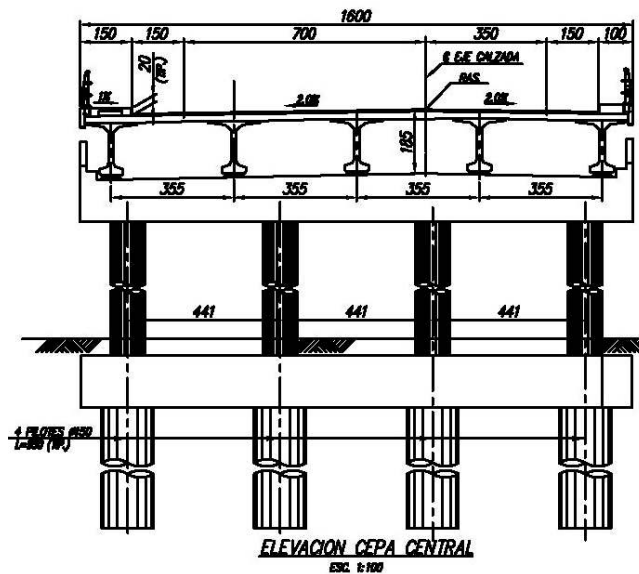
Figure 96. Illustration. Intermediate bent details for Romero bridge.

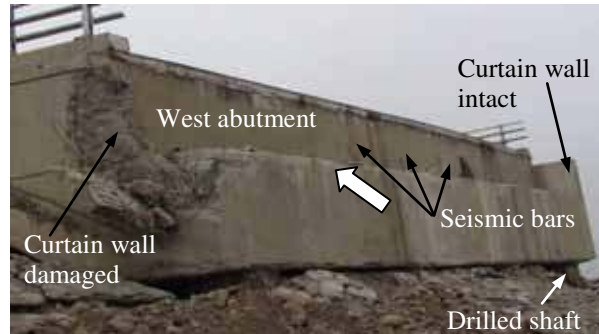
**Figure 98. Photo. Seismic bars at west abutment of Romero bridge.**

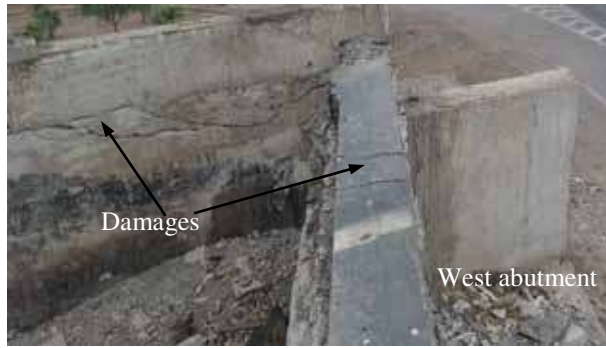
**Figure 101. Photo. Back wall and wing wall damage at west abutment of Romero bridge.**

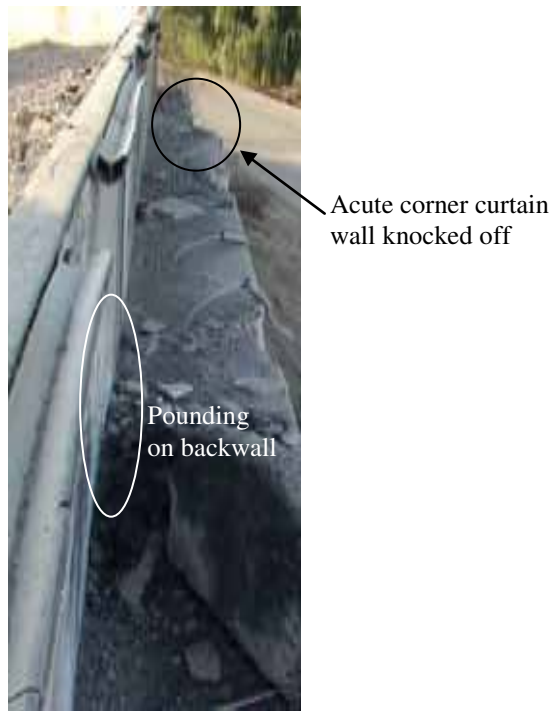
**Figure 104. Photo. Damage at north abutment of Route 5 overcrossing at Hospital.**

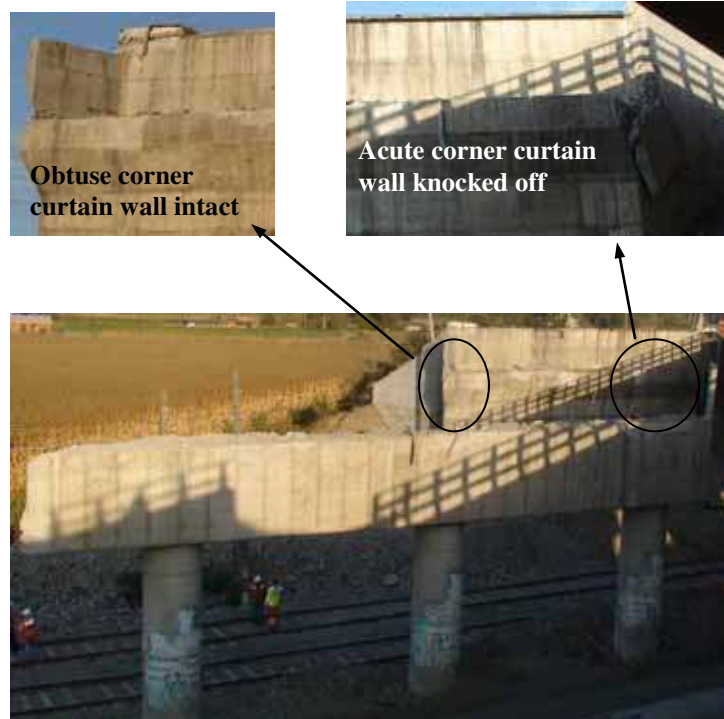
**Figure 105. Photo. Damage at south abutment of Route 5 overcrossing at Hospital.**

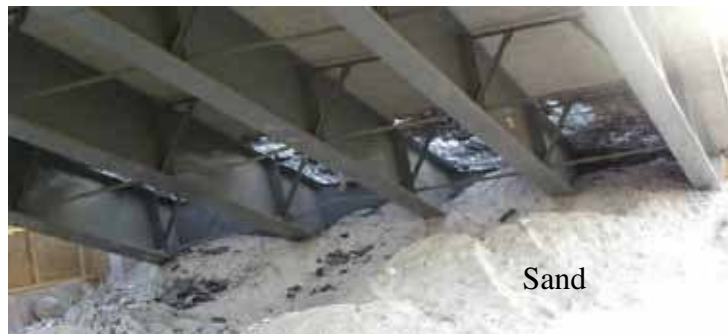
**Figure 111. Photo. West span of Quilicura railway overcrossing lowered onto sandbank.**

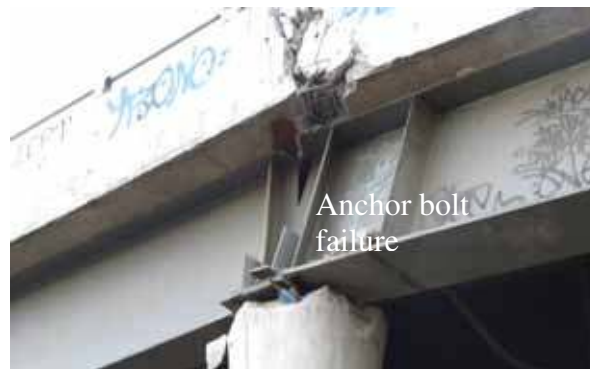
**Figure 112. Photo. Damage to anchor bolts on Quilicura railway overcrossing.**

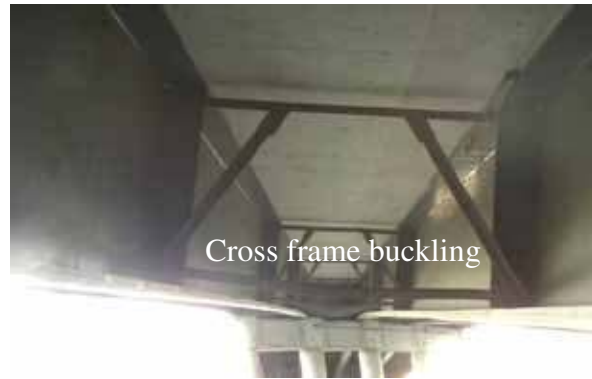
**Figure 113. Photo. Damage to cross frame on Quilicura railway overcrossing.**

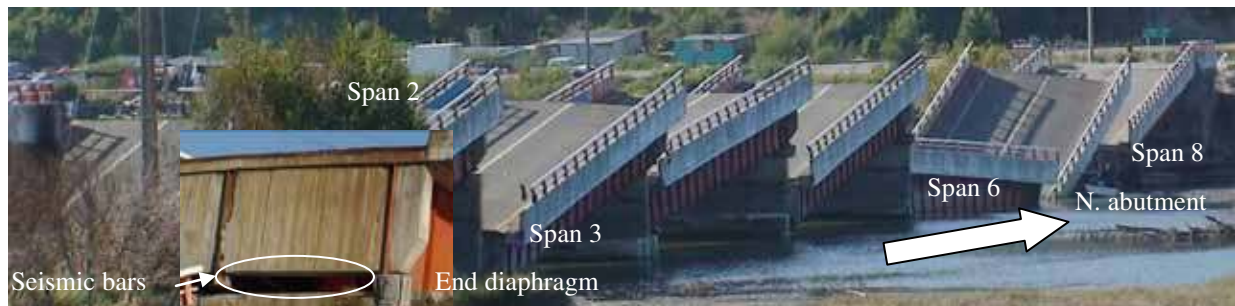
**Figure 114. Photo. Unseating at southern ends of each span of Tubul bridge.**

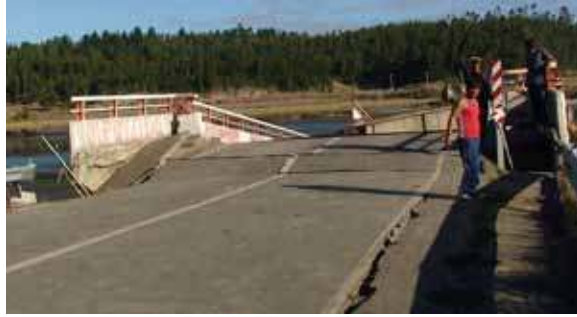
**Figure 116. Photo. Buckling of pavement at north abutment of Tubul bridge.**

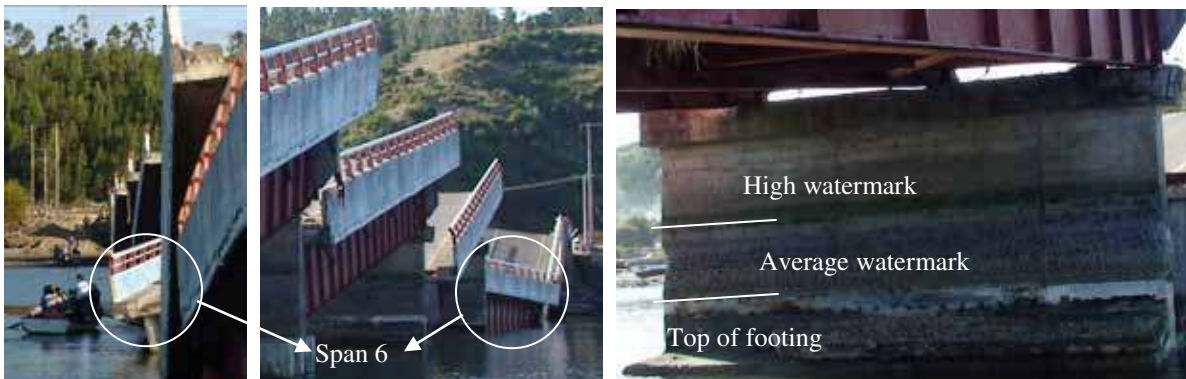
**Figure 117. Photo. Span 6 of Tubul bridge, unseated at north end during an aftershock.**

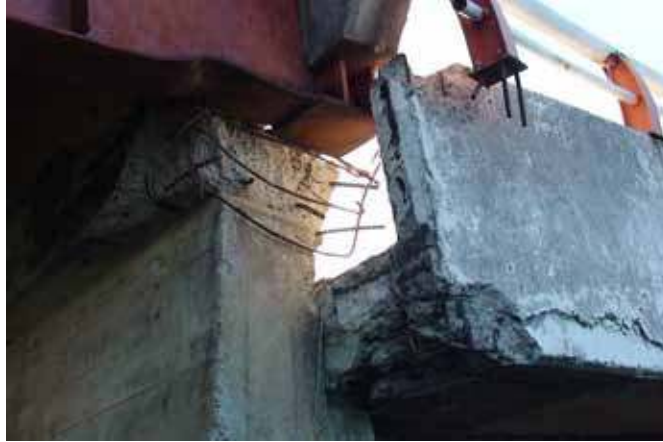
**Figure 118. Photo. Bottom flange buckling and concrete spalling on Tubul bridge.**

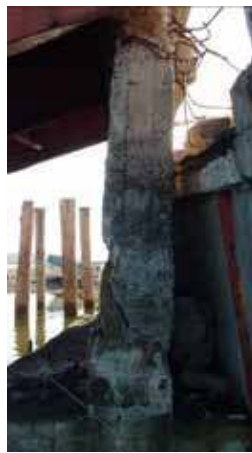
**Figure 119. Photo. Shear crack in Tubul bridge.**

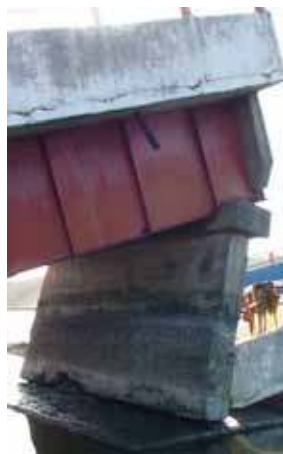
**Figure 120. Photo. Tilting wall pier on Tubul bridge.**

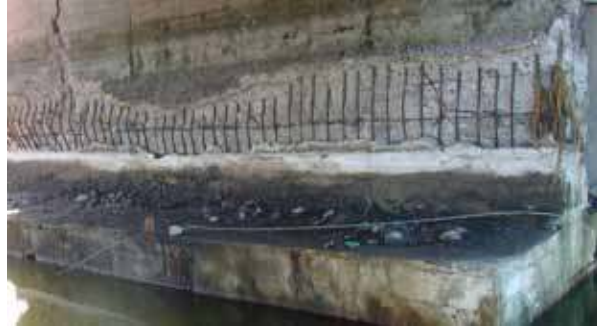
**Figure 121. Photo. Spalling due to shear action and vertical crack in Tubul bridge.**

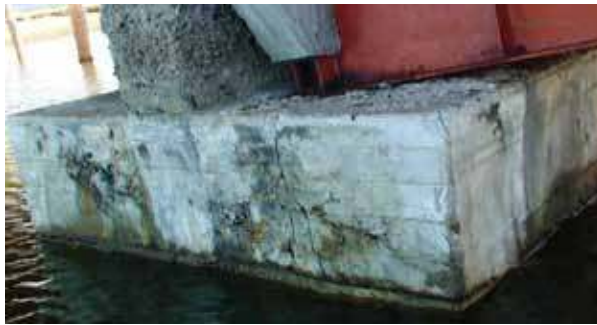
**Figure 122. Photo. Crack in footing of Tubul bridge.**

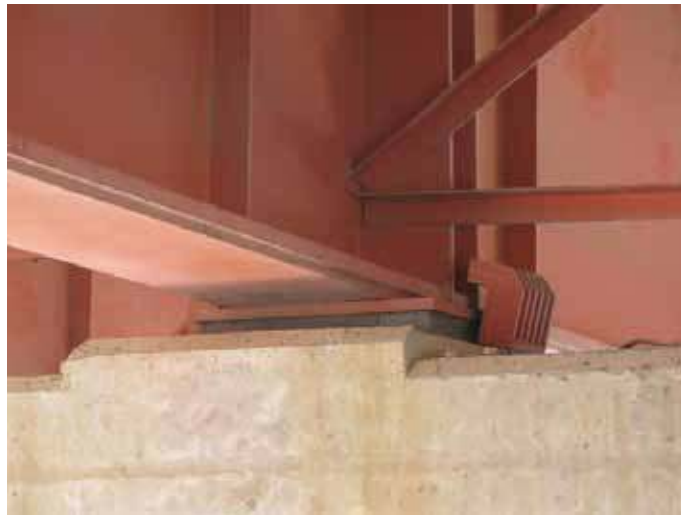
**Figure 124. Photo. Elastomeric pad and stopper over bent on Cardenal Raúl Silva Henríquez bridge.**

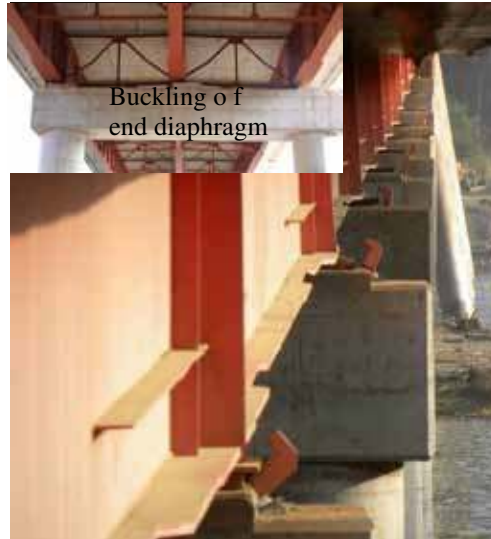
**Figure 125. Photo. Girder offset and cross frame buckling on Cardenal Raúl Silva Henríquez bridge.**

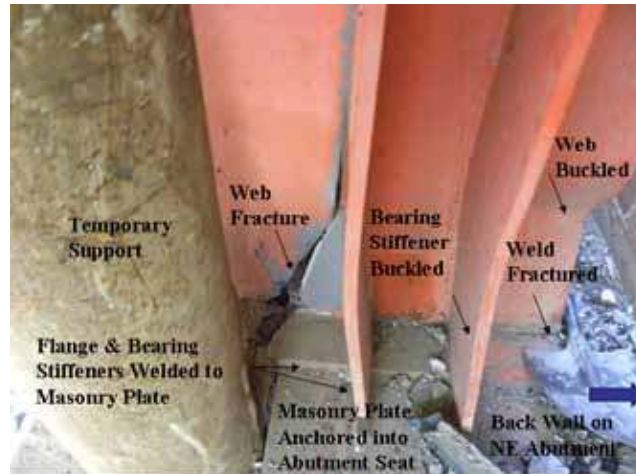
**Figure 127. Photo. Girder damage at northeast abutment of Cardenal Raúl Silva Henríquez bridge.**

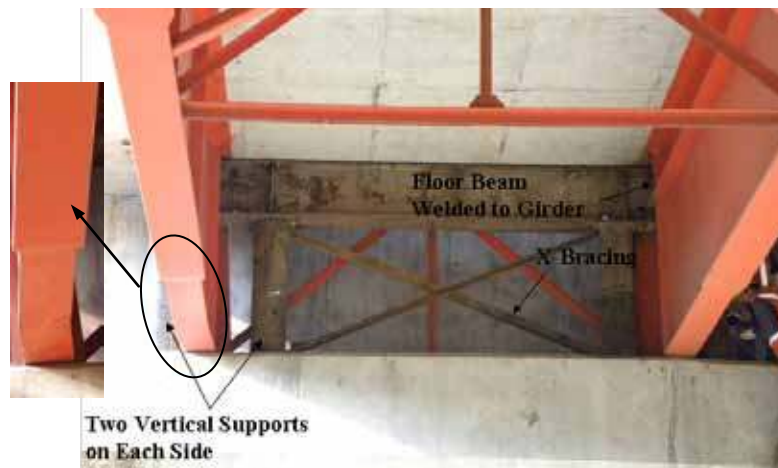
**Figure 128. Photo. Temporary repair at northeast abutment of Cardenal Raúl Silva Henríquez bridge**

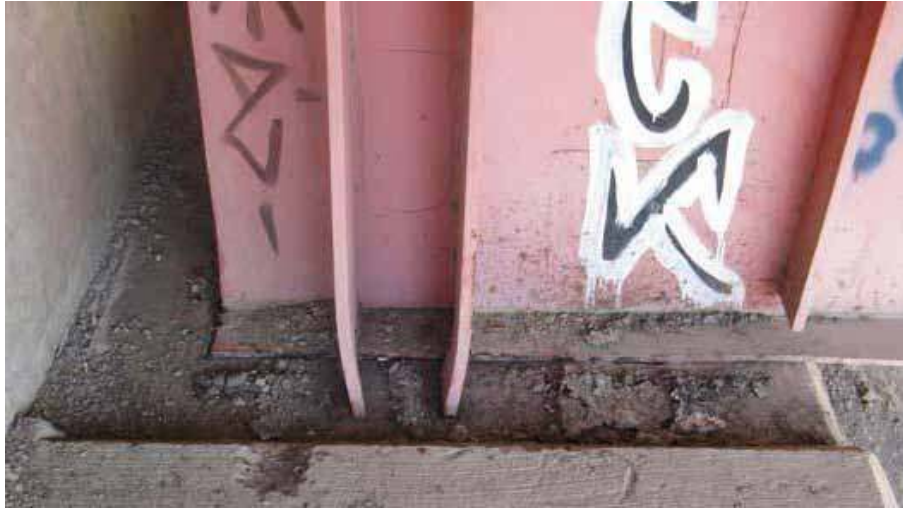
Although the details are similar, the damage to the girders at the southwest abutment was not as severe as at the northeast abutment and was limited to the buckling of the bearing stiffeners. The reason for this difference is probably that the fillet welds connecting the girder flanges and bearing stiffeners to the masonry plates failed during the earthquake and large longitudinal loads were not attracted to this abutment (see figure 132 through figure 134).

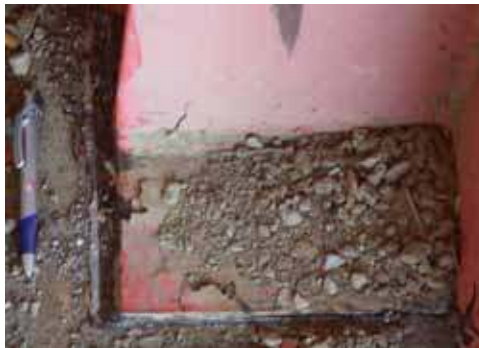
**Figure 132. Photo. Fillet weld fractures at the girder-to-abutment connection on the Cardinal Raúl Silva Henríquez bridge.**

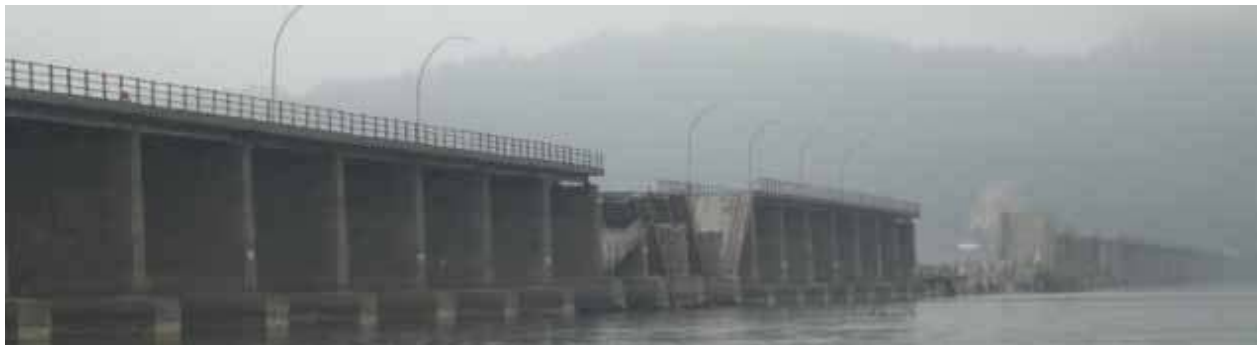
**Figure 135. Photo. Collapsed spans in Biobío River bridge.**

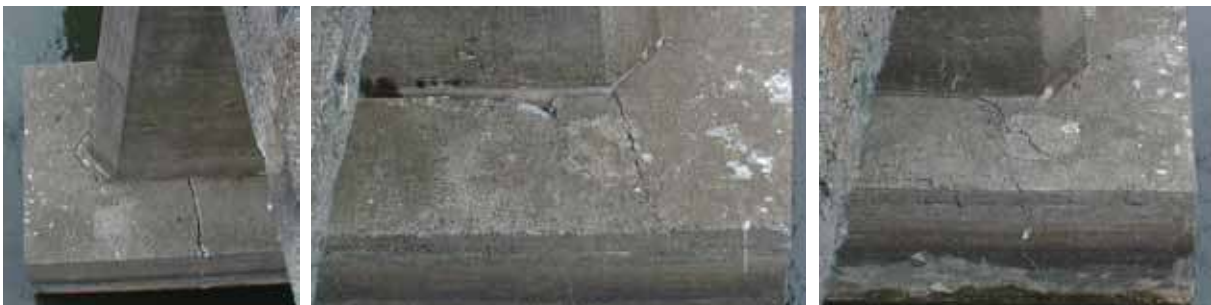
**Figure 139. Photo. Cracks in pile caps of Biobío River bridge.**

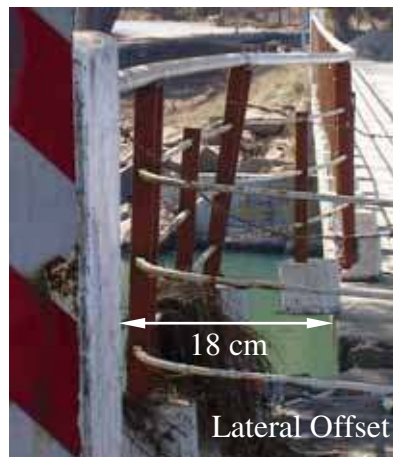
**Figure 144. Photo. Offset in handrail on south abutment of Pichibudis bridge.**
