01 Oct 2011

## Post-earthquake Reconnaissance Report on Transportation Infrastructure Impact of the February 27, 2010, Offshore Maule Earthquake in Chile

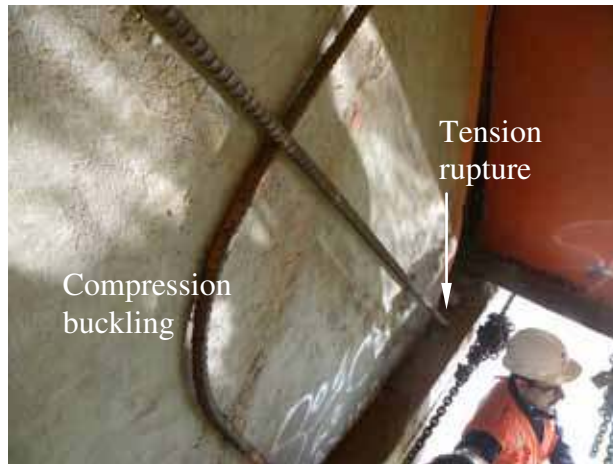
**Figure 145. Photo. X-braces damage in south abutment of Pichibudis bridge.**

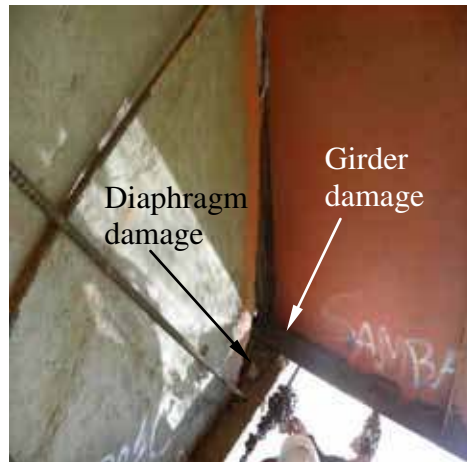
**Figure 146. Photo. Diaphragm crushing in south abutment of Pichibudis bridge.**

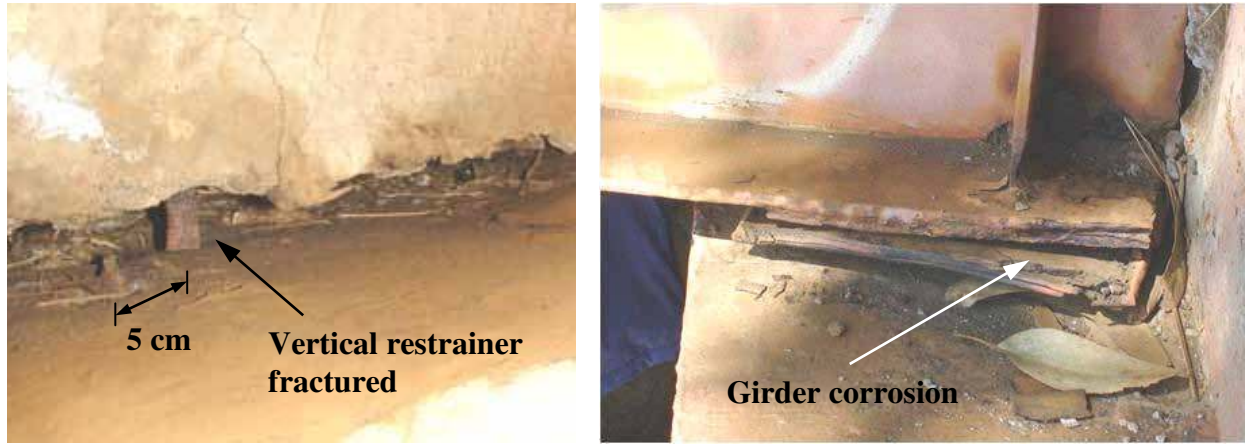
**Figure 147. Photo. Damage on south abutment due to corrosion in Pichibudis bridge.**

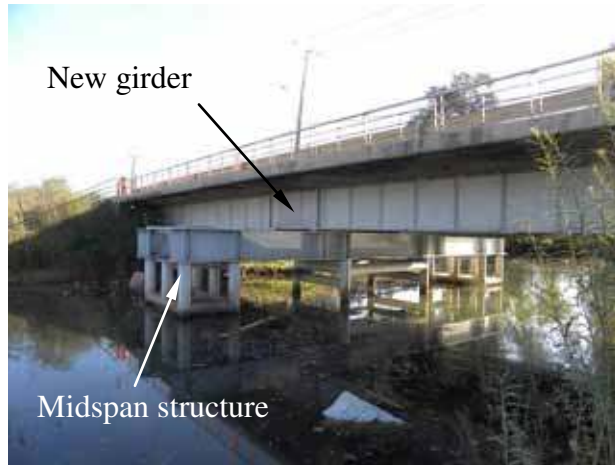
**Figure 149. Photo. Side view of El Bar bridge.**

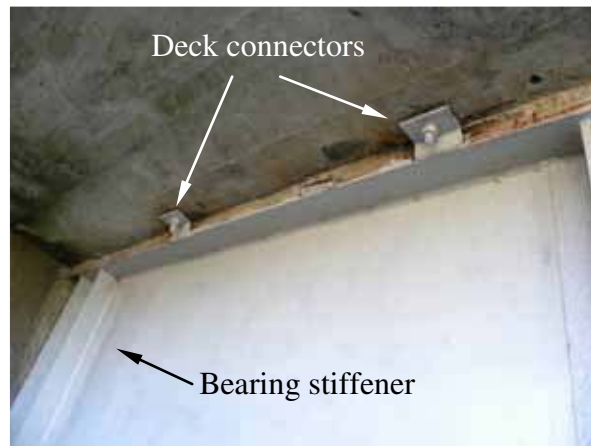
**Figure 151. Photo. Retrofit deck connections on El Bar bridge.**

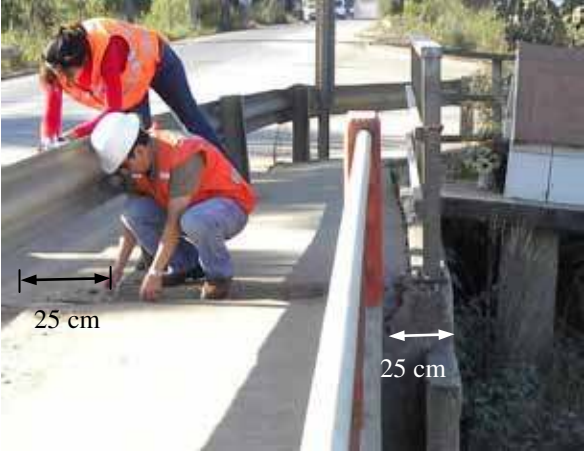
anchored to the abutment seat using vertical restraining bars (seismic bars). Earthquake damage observed at this support included large deformations in the rebar of the X-brace system (tension yielding and compression buckling), lateral deformation of the seismic restrainers, and concrete crushing of the original abutment back wall (see figure 154 and figure 155).

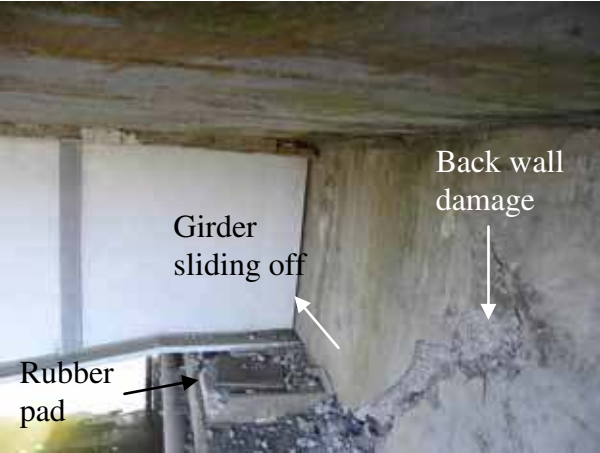
**Figure 153. Photo. Damage at south abutment of El Bar bridge.**

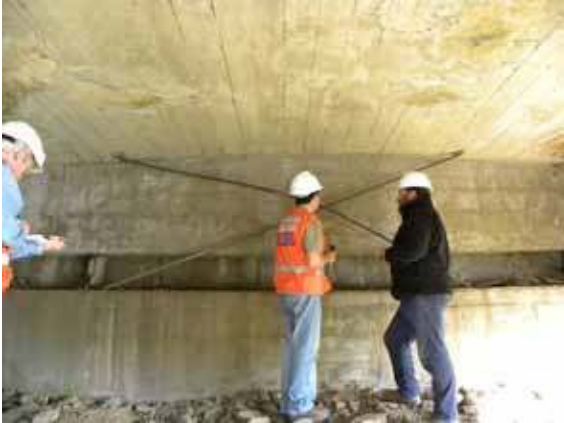
**Figure 154. Photo. Damage to rebar X-brace system on north abutment of El Bar bridge.**

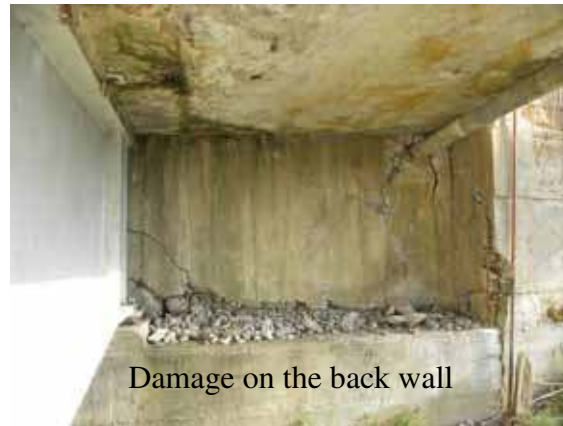
**Figure 155. Photo. Damage to north abutment back wall of El Bar bridge.**

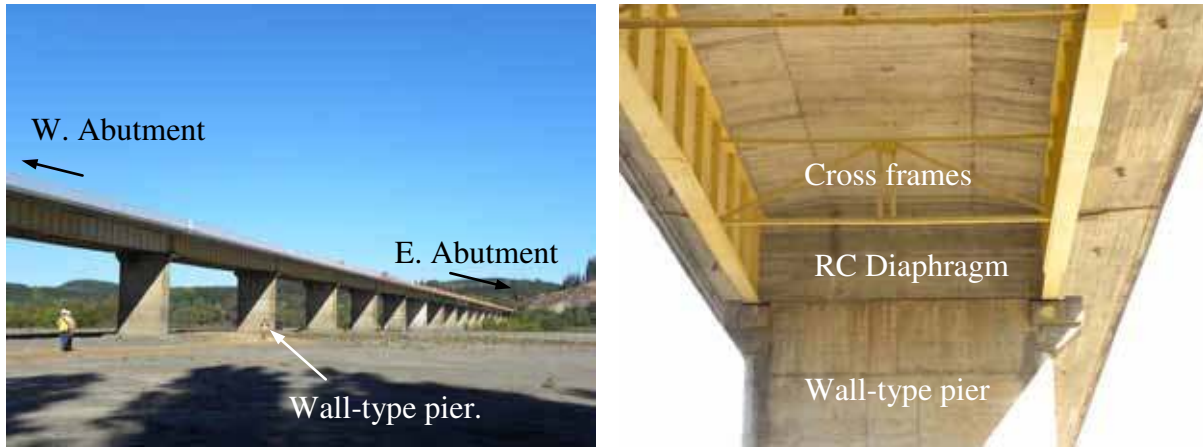
**Figure 157. Photo. Side view and superstructure details for Itata River bridge.**

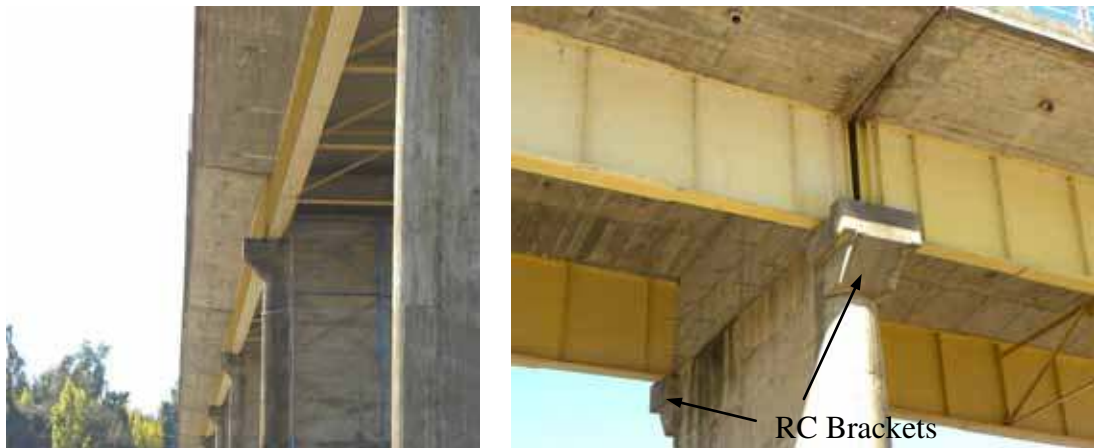
**Figure 158. Photo. Girder supports at each pier of Itata River bridge.**

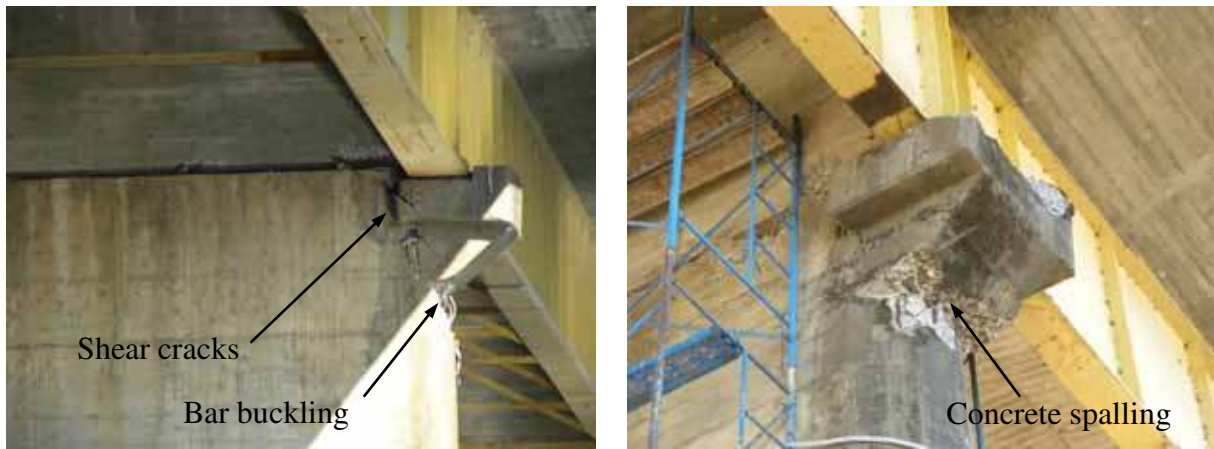
**Figure 159. Photo. Damage to girder supports of Itata River bridge.**

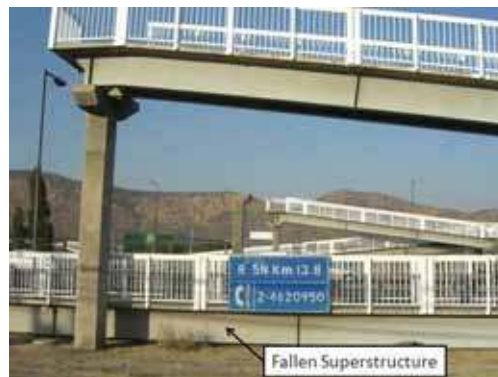
**Figure 160. Photo. Damaged Route 5 pedestrian bridge.**

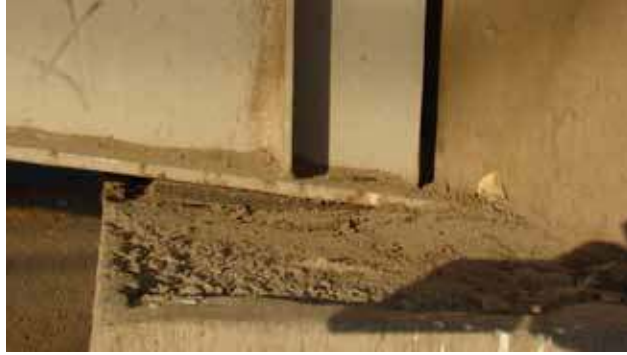
**Figure 161. Photo. Steel girder on neoprene pad at abutment of Route 5 pedestrian bridge.**

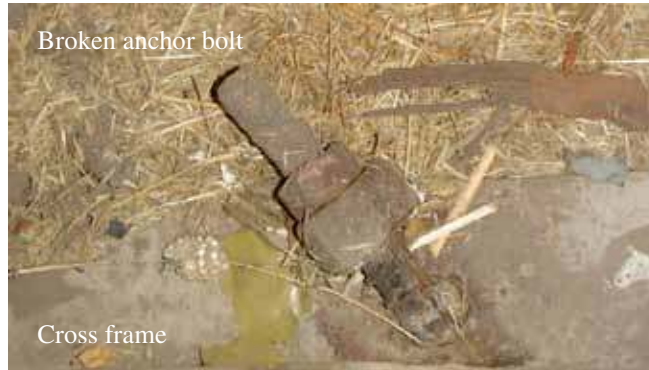
**Figure 163. Photo. Anchor bolt failure (shear and pull out) on Route 5 pedestrian bridge.**

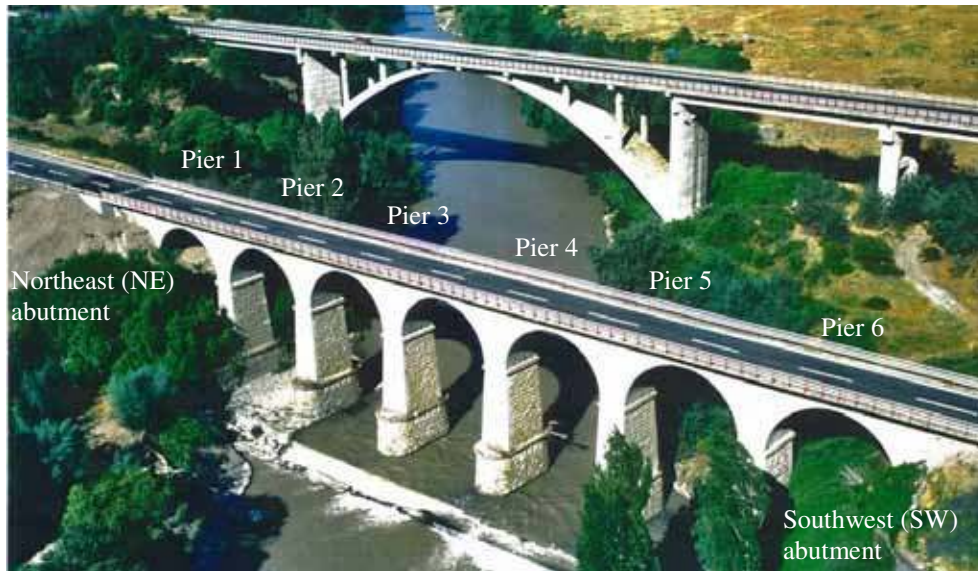
**Figure 164. Illustration. Highway bridges crossing Claro River before earthquake.**

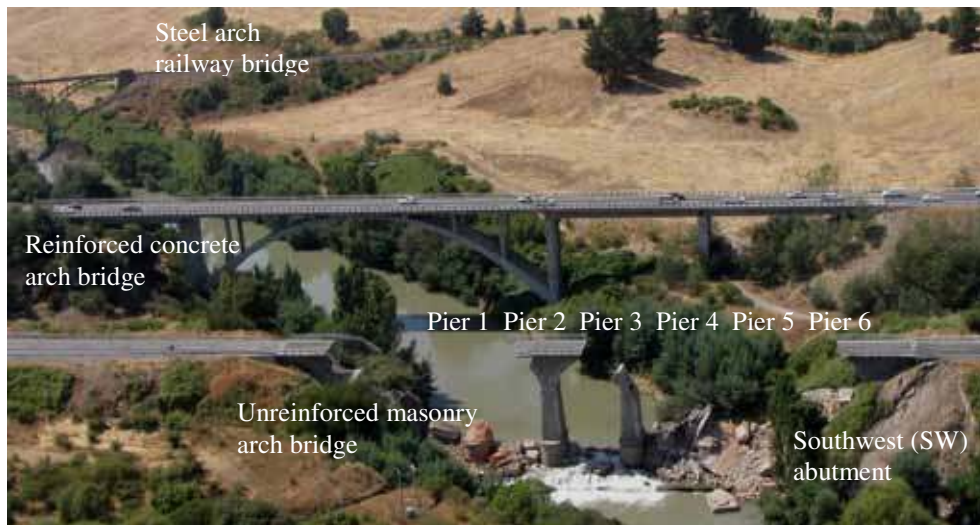
**Figure 165. Photo. Collapse of masonry arch bridge at Claro River.**

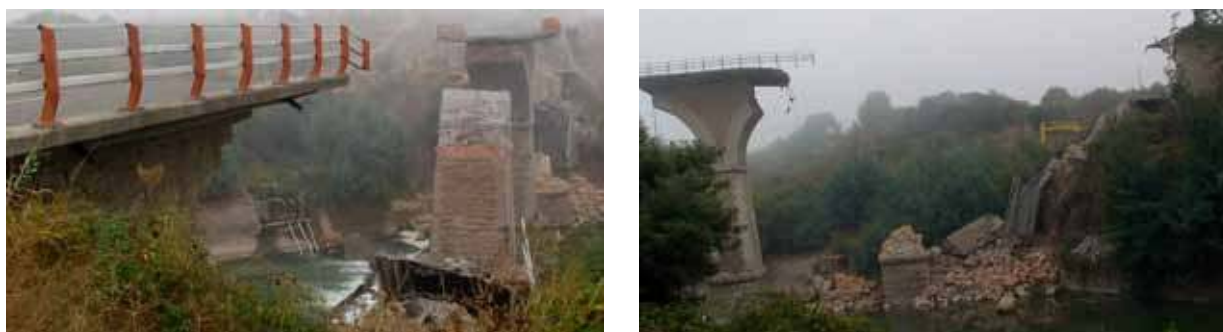
**Figure 166. Photo. Close-up view of collapsed bridge at Claro River.**

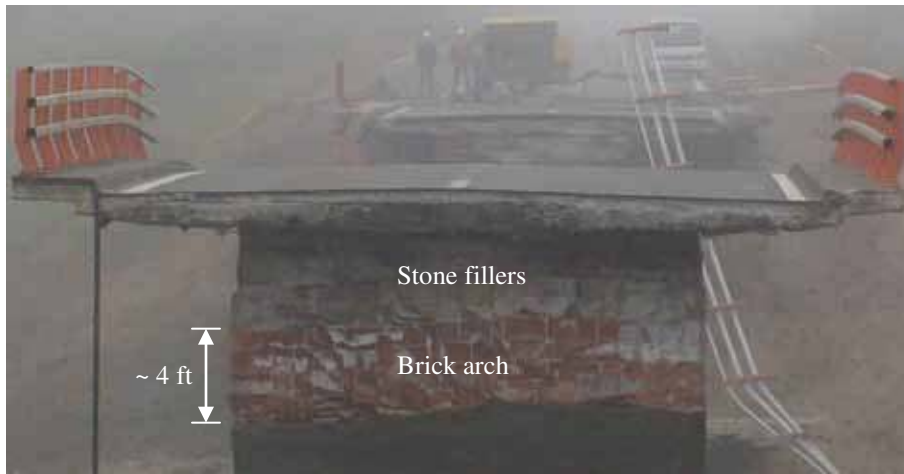
Figure 167 through figure 169 show details of various components of the bridge. The deck slab was approximately 8 to 10 inches (203 to 254 mm) thick, and the arch crown was approximately 4 ft (1.2 m) thick. The ribs and piers were constructed from solid brick with some stone fill above the brick ribs, as shown in figure 167 and figure 168, and faced with stone blocks or plastered with cement to give the appearance of stonework. Close inspection of the piers found some cracks between the bricks and stone facades, possibly due to shaking, but, in general, the masonry was in excellent condition. The foundations of the bridge were most likely made of stone blocks and seemed to have experienced little or no damage during the earthquake (see figure 169).

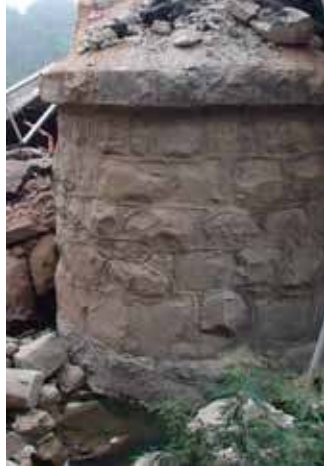
**Figure 169. Photo. Foundation of Claro River bridge.**

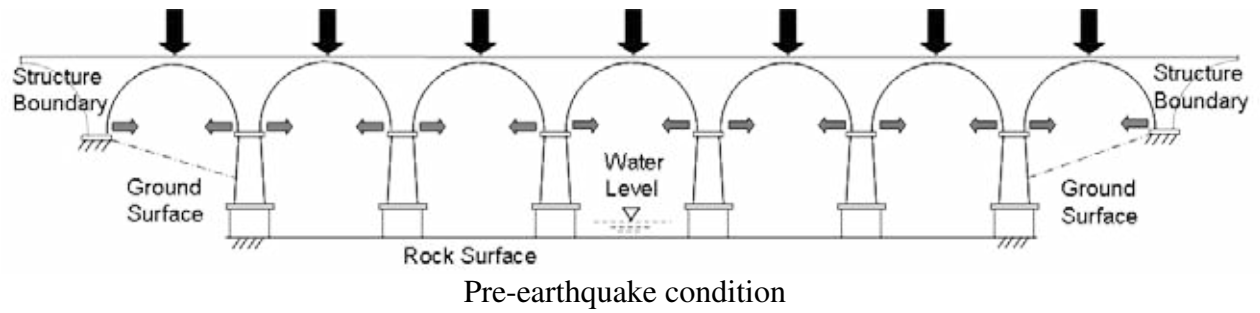
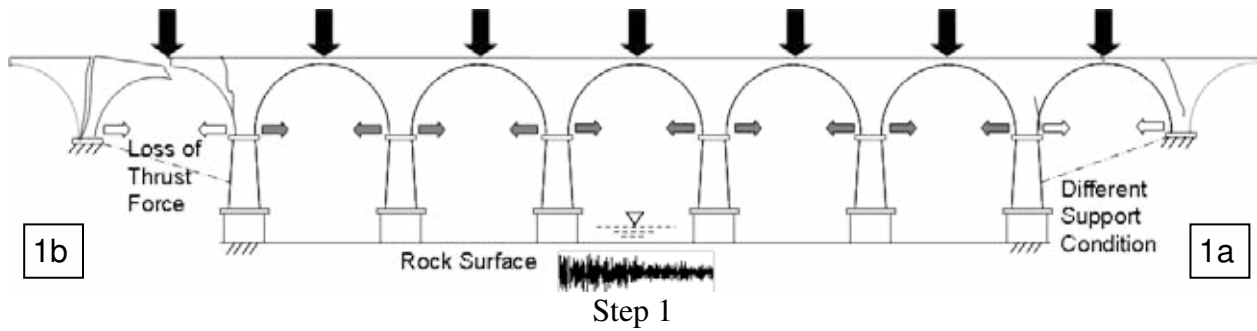
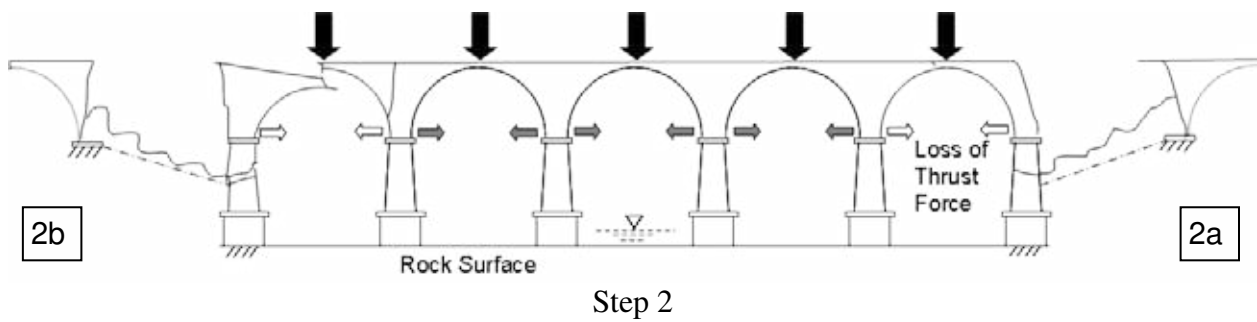
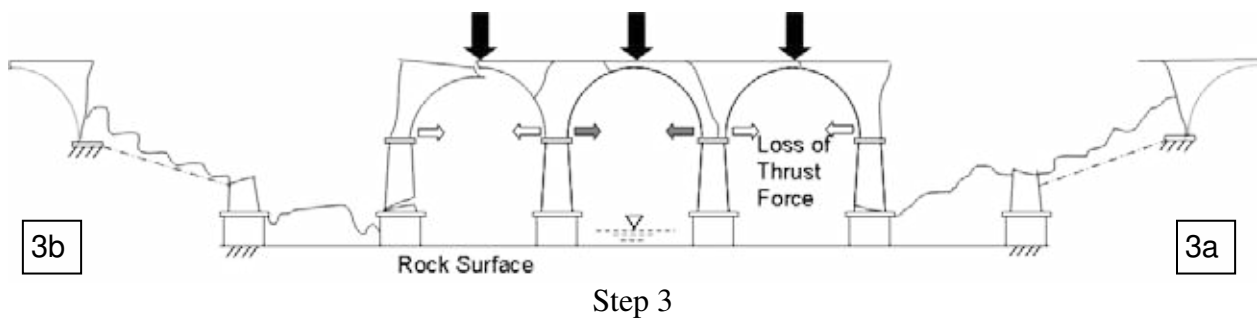
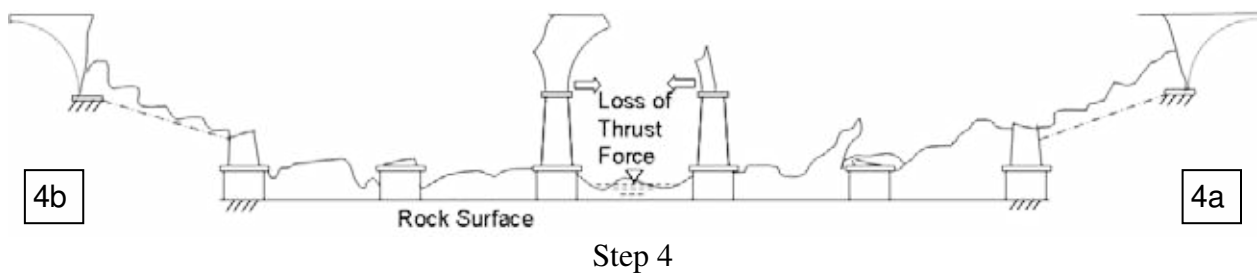
Figure 170. Illustration. Scenario for the progressive collapse of Claro River bridge.

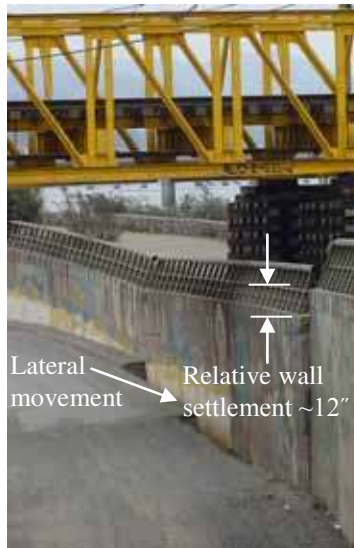
**Figure 178. Photo. Settlement behind retaining wall on Chepe railroad bridge.**

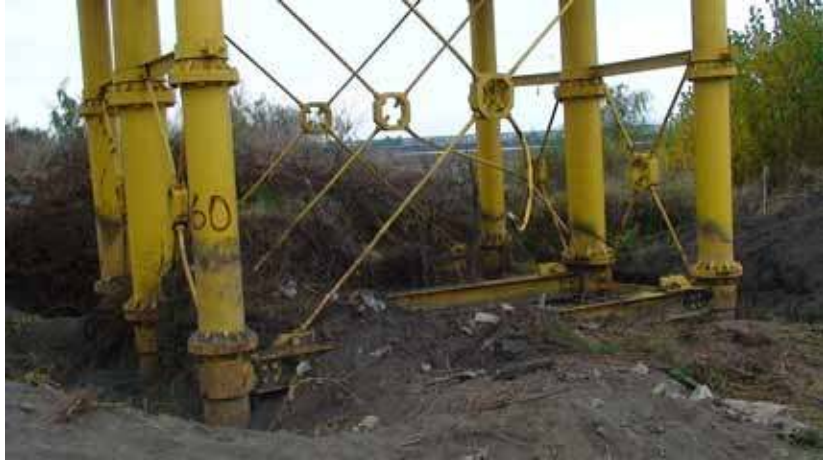
**Figure 179. Photo. Ruptured cross bracing at south end of Chepe railroad bridge.**

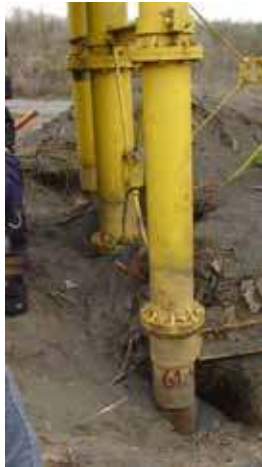
**Figure 180. Photo. Fractured steel piles at south end of Chepe railroad bridge.**

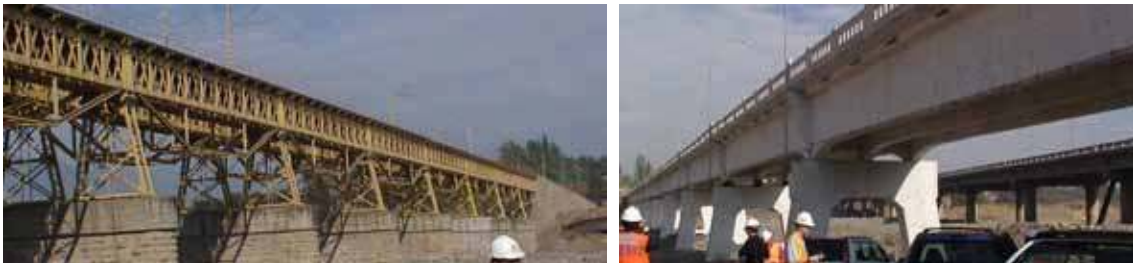
**Figure 181. Photo. Three parallel bridges crossing Maipú River south of Santiago.**

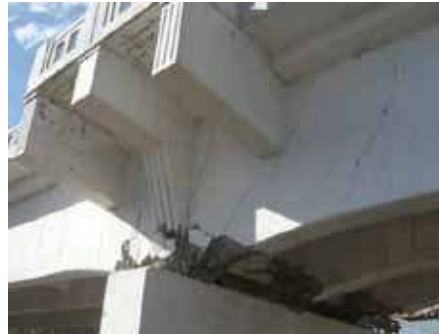
**Figure 182. Photo. Crushing of haunches at pier 3 of Maipú River bridge.**

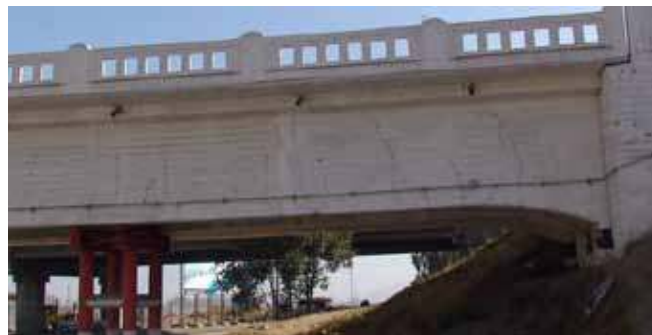
**Figure 183. Photo. Shear cracks at span 1 of Maipú River bridge.**

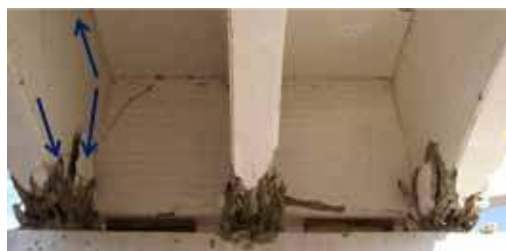
**Figure 184. Photo. Longitudinal and vertical seismic forces in haunches at pier 3 of Maipú River bridge.**

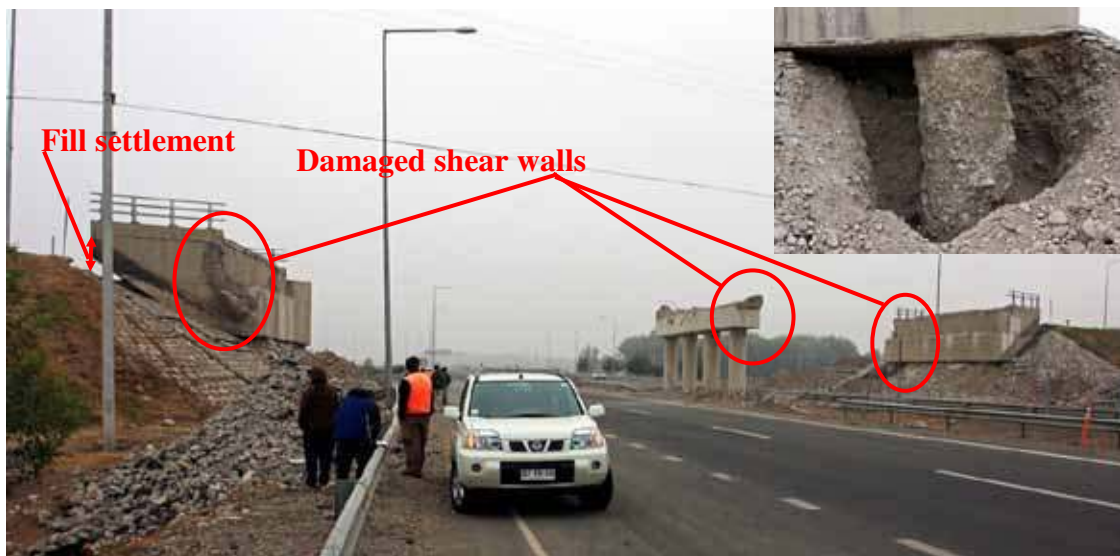
**Figure 185. Photo. Damage at Romero bridge and shaft foundation supporting abutment (collapsed superstructure removed).**

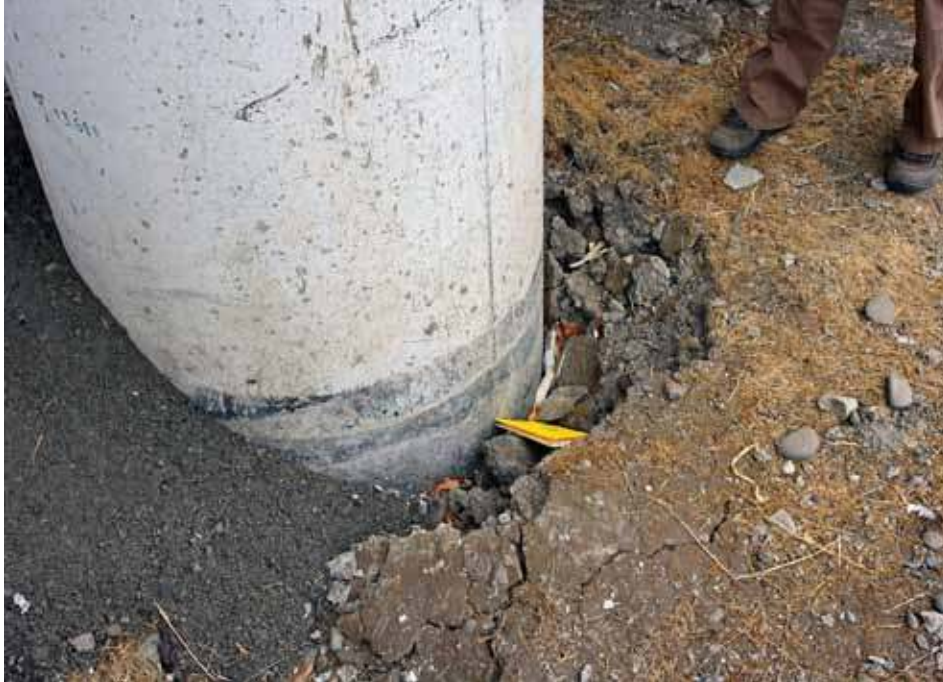
**Figure 186. Photo. Interior pier of Chada structure with 5.8- to 7.8-inch (150- to 200-mm) gap in soil transverse to bridge centerline.**

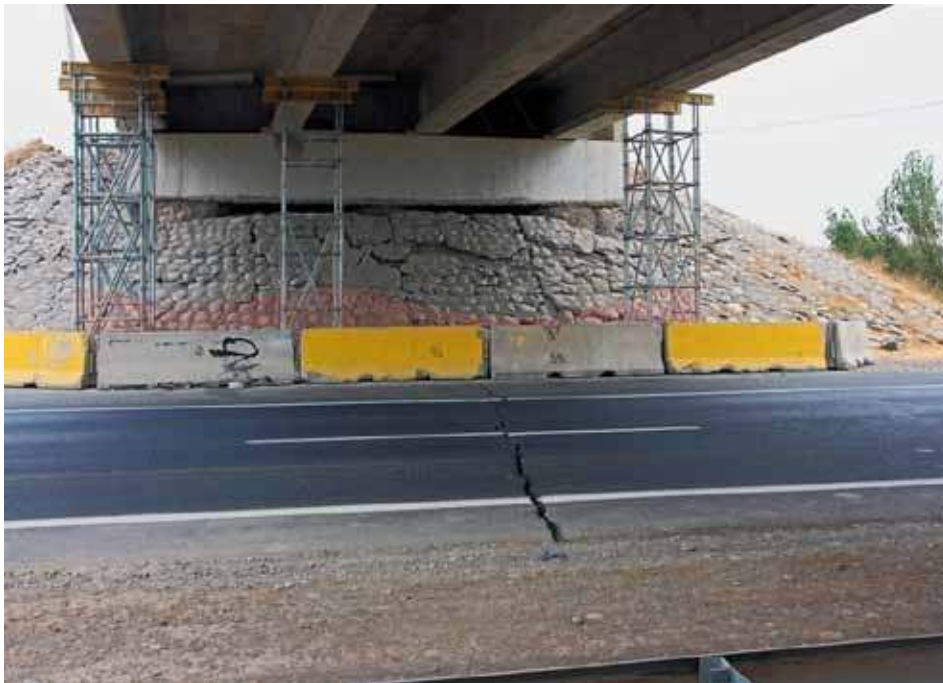
**Figure 187. Photo. East abutment of Chada structure showing large pavement crack directly below bridge centerline.**

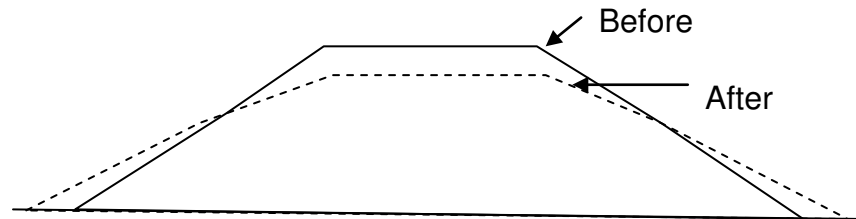
**Figure 188. Illustration. Fill slumping observed for bridge sites 7 and 8.**

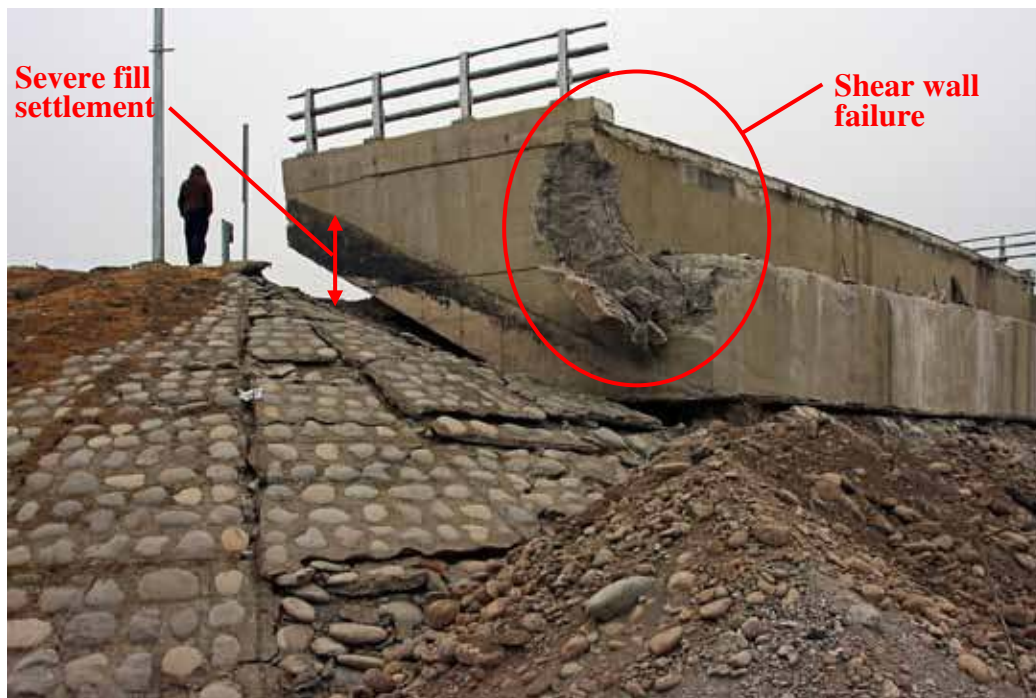
**Figure 189. Photo. Fill slumping observed at Romero bridge.**

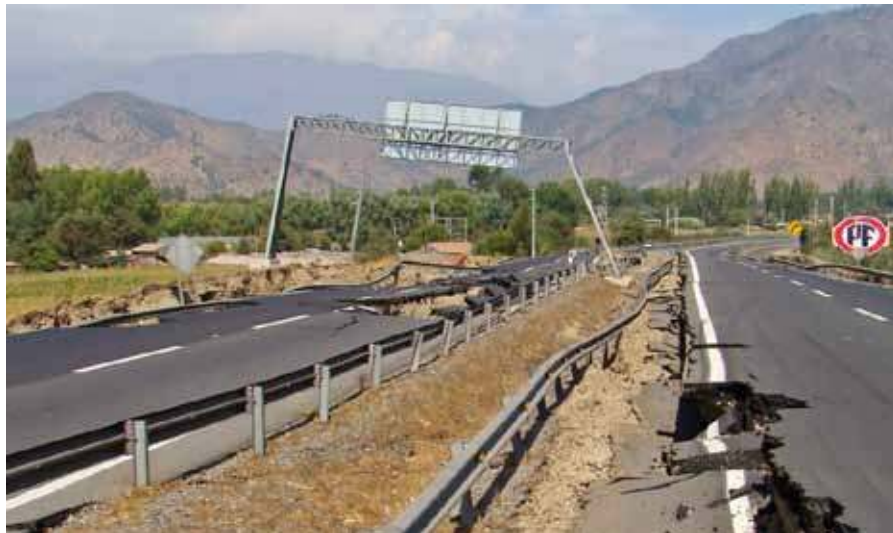
**Figure 190. Photo. View of roadway fill failure from abutment of Route 5 railway crossing at Hospital.**

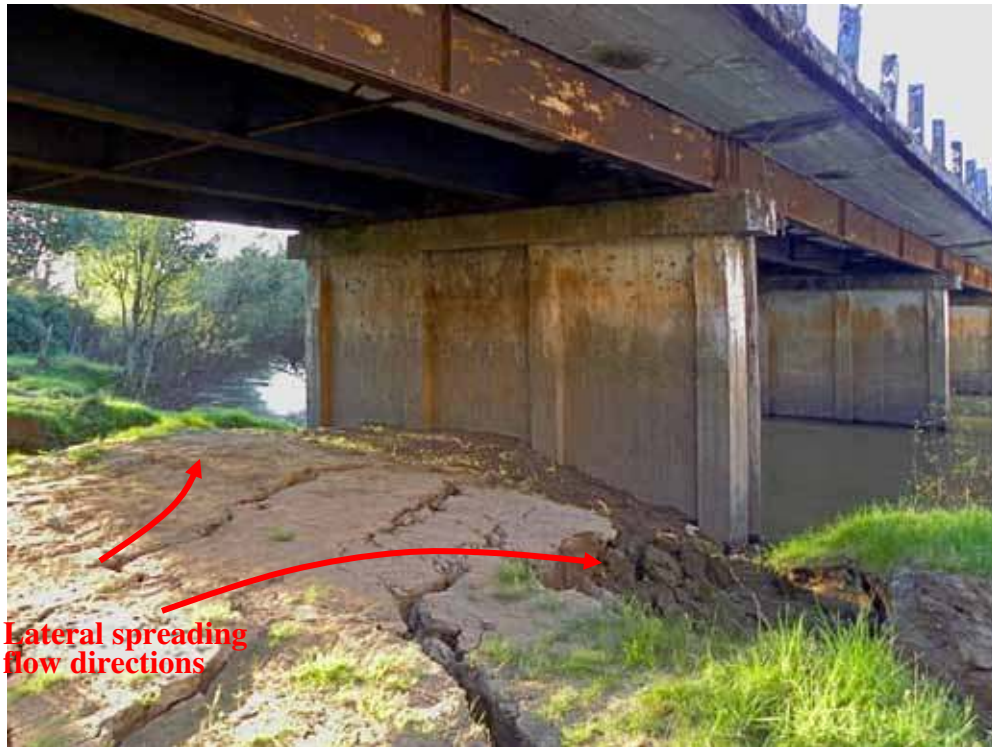
**Figure 194. Photo. Lateral spreading and ground failure at old Ramadillas bridge.**

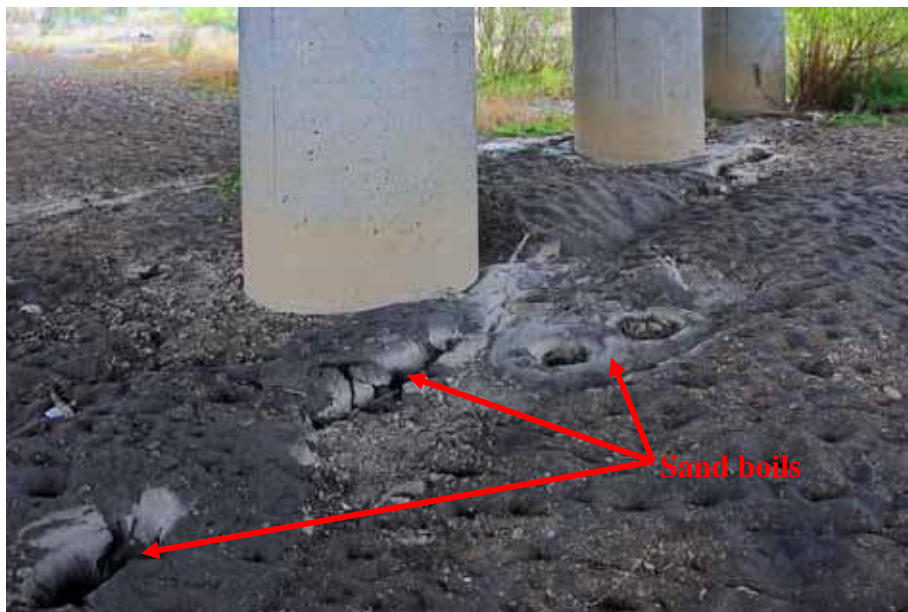
**Figure 195. Photo. Sand boils at southwest end of Llacolen bridge.**

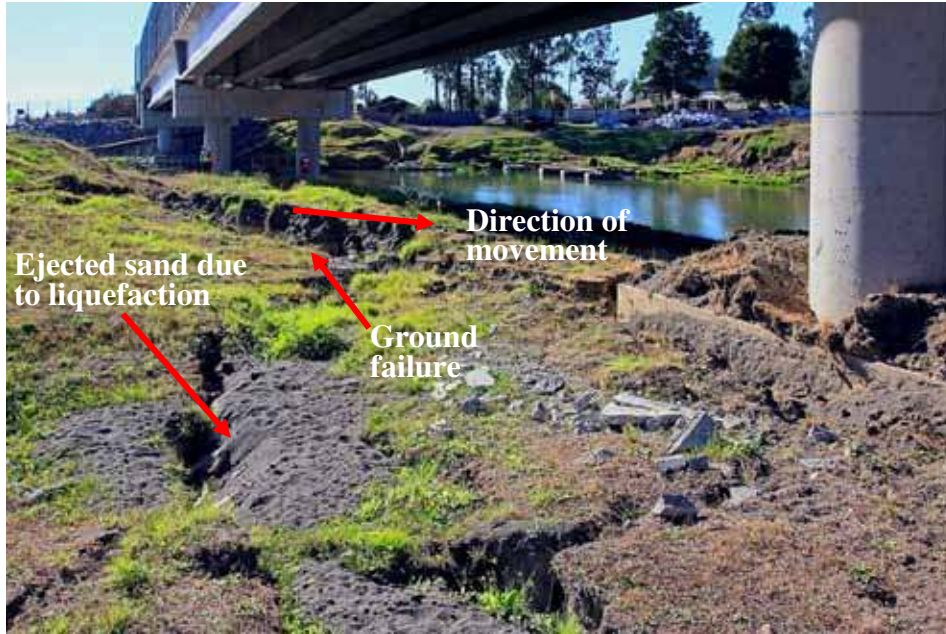
**Figure 196. Photo. Ejected sand due to liquefaction and ground failure at La Mochita bridge.**

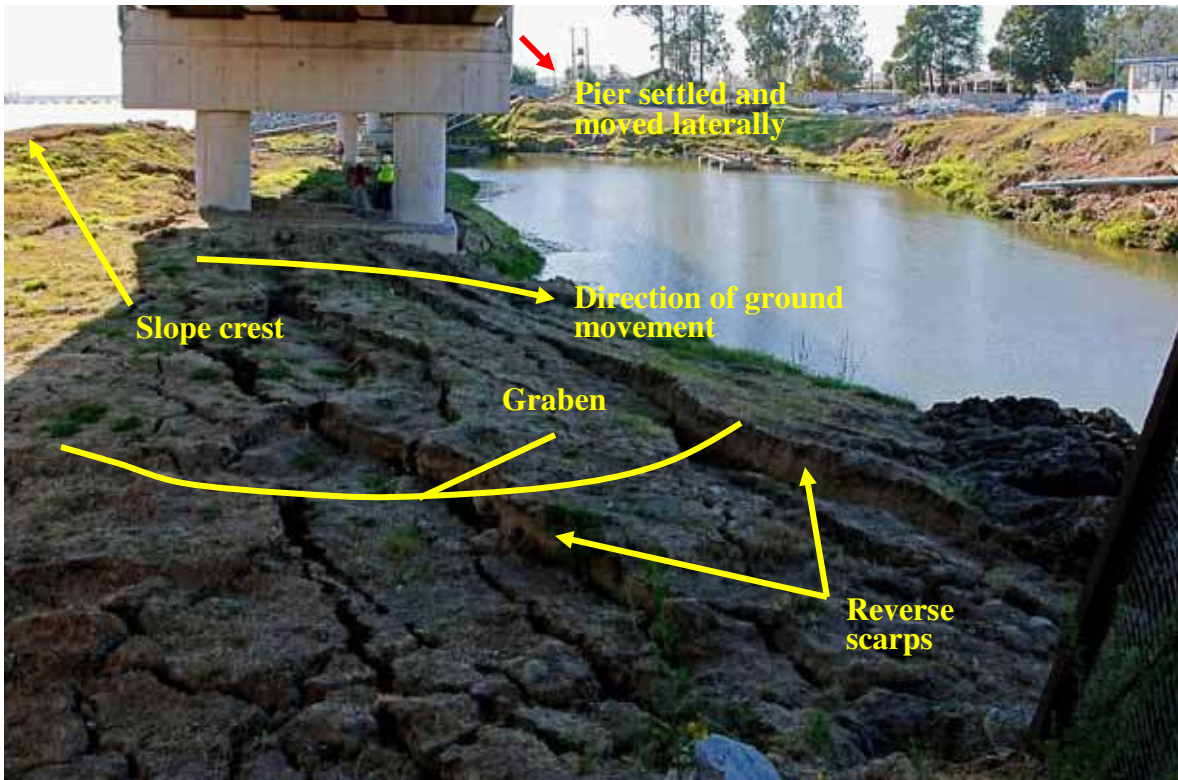
**Figure 197. Photo. Severe ground failure at La Mochita bridge.**

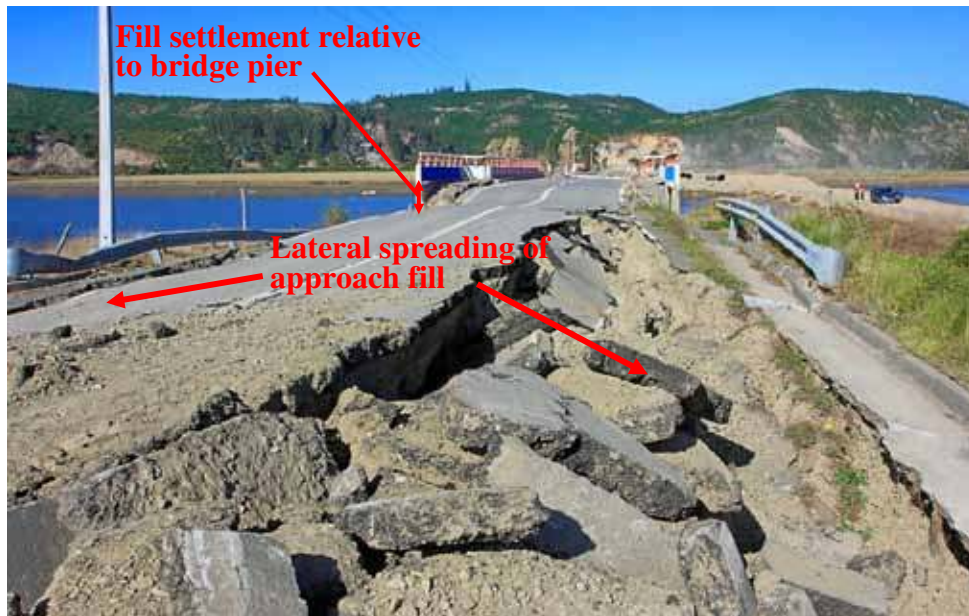
**Figure 198. Photo. Lateral spreading and ground failure at Raqui 2 bridge.**

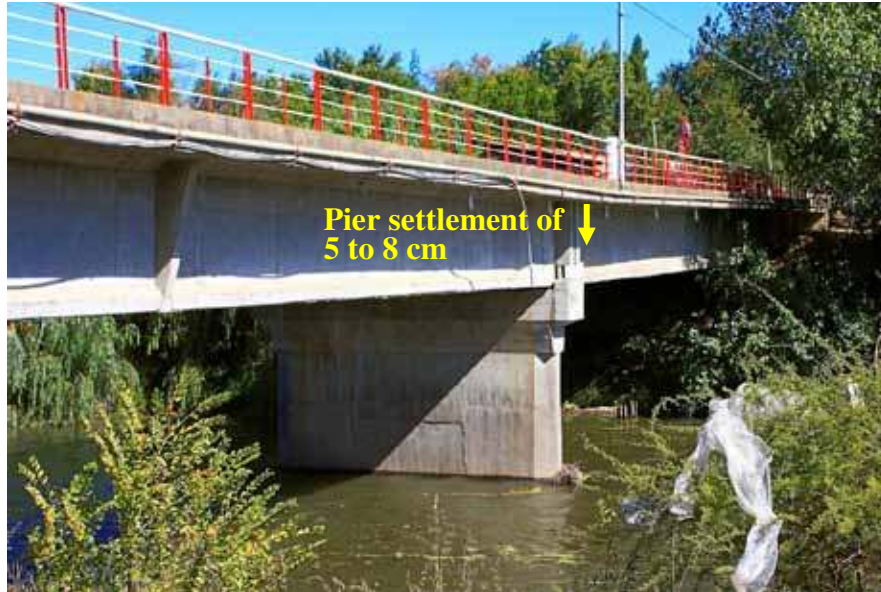
Figure 199 shows an example in which a center pier in the middle of the river settled (about 1.9 to 3.1 inches (50 to 80 mm)), but, because of the water in the river, no specific evidence of liquefaction could be observed. It is likely that liquefaction is the cause of this kind of effect on the bridge, although it is also likely that the liquefied layer is not extensive because the amount of deformation in the foundation is relatively small.

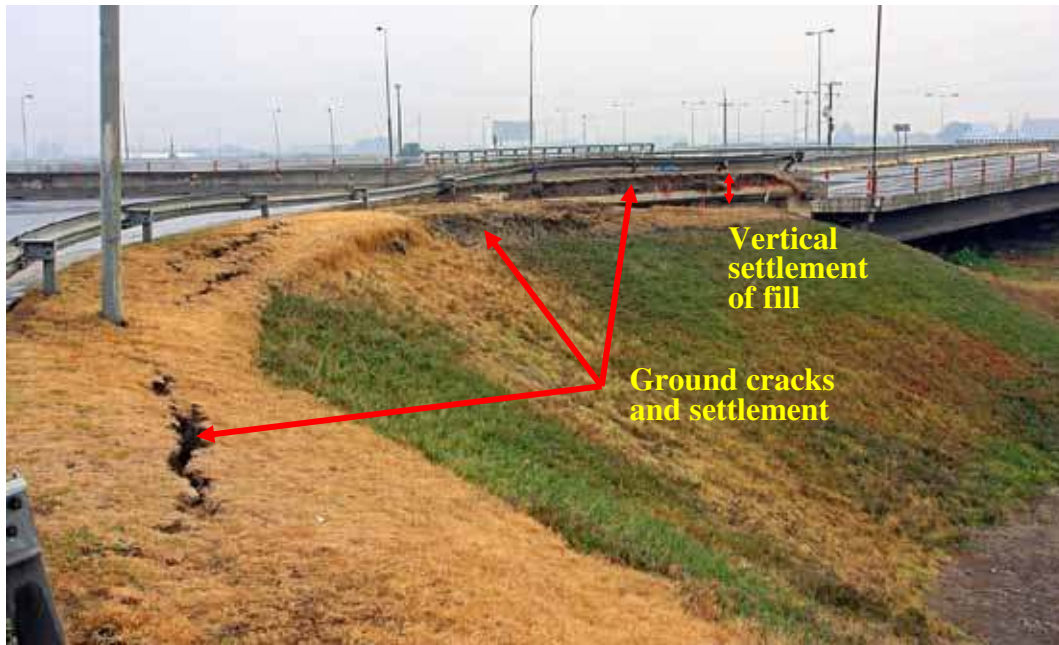
**Figure 200. Photo. Ramps at Juan Pablo II bridge where existing ground was improved with DDC.**

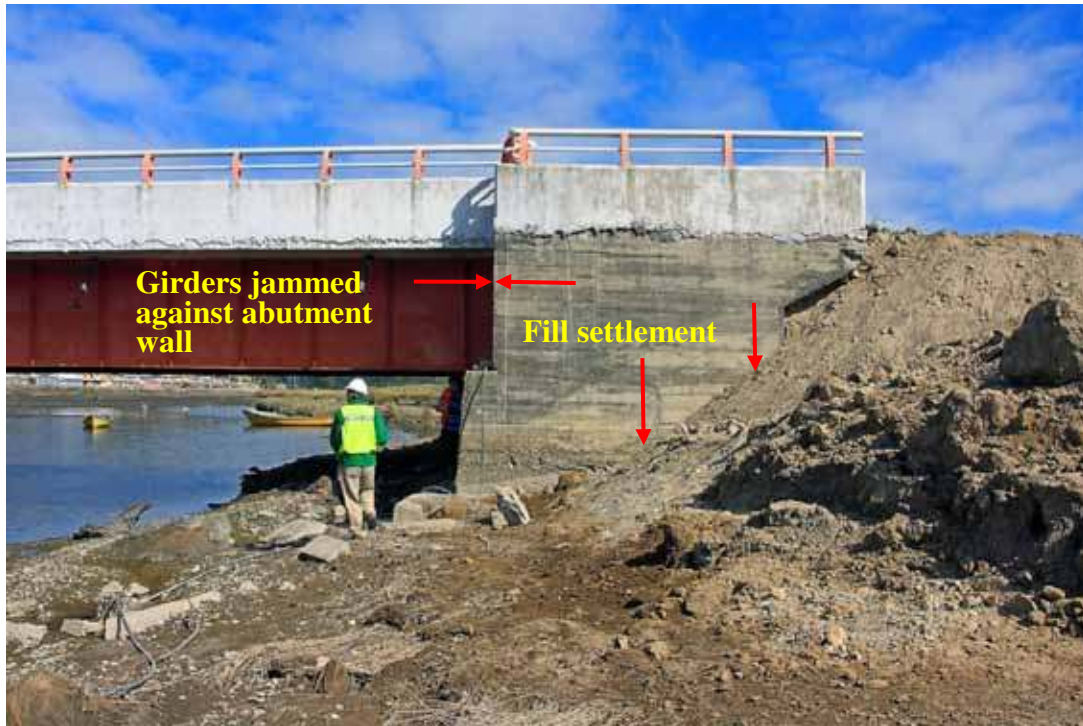
**Figure 205. Photo. Abutment fill settlement at northwest abutment of Raqui 1 bridge.**

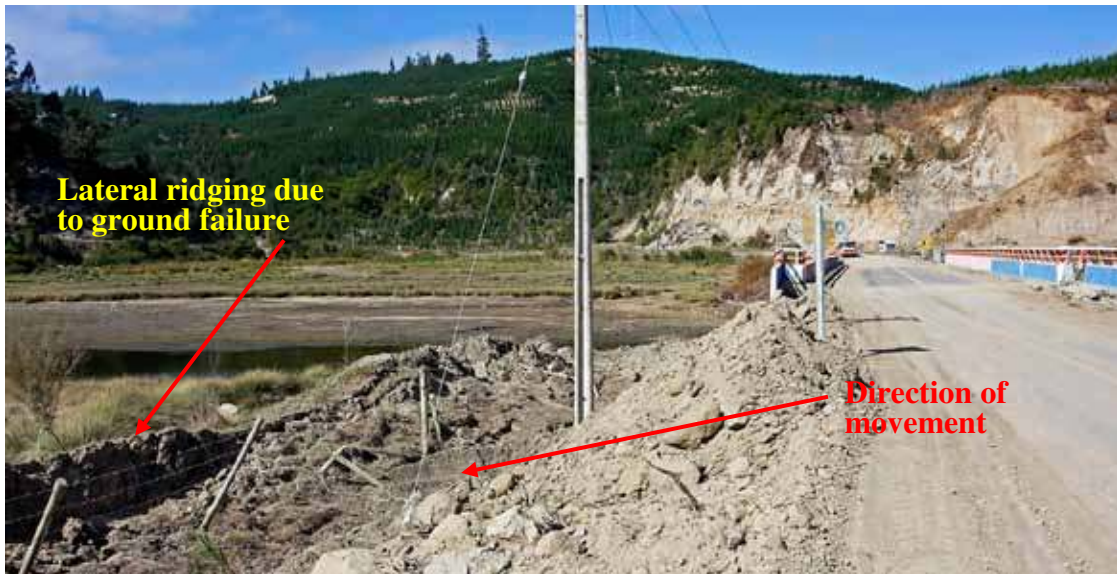
**Figure 208. Photo. Evidence of ground failure perpendicular to roadway centerline at northwest approach of Raqui 1 bridge.**

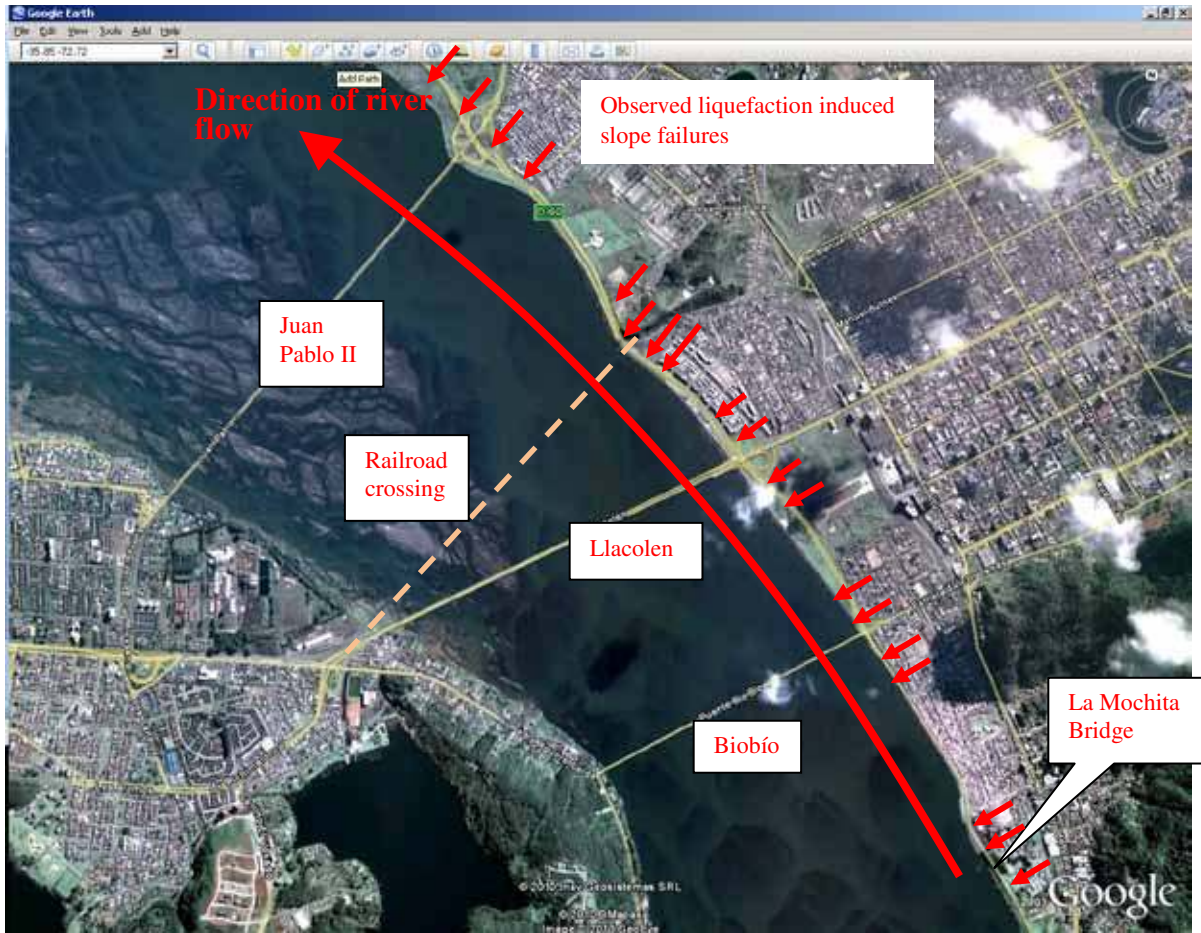
© Google, Inav/Geosistemas SRL, DMapas, and GeoEye

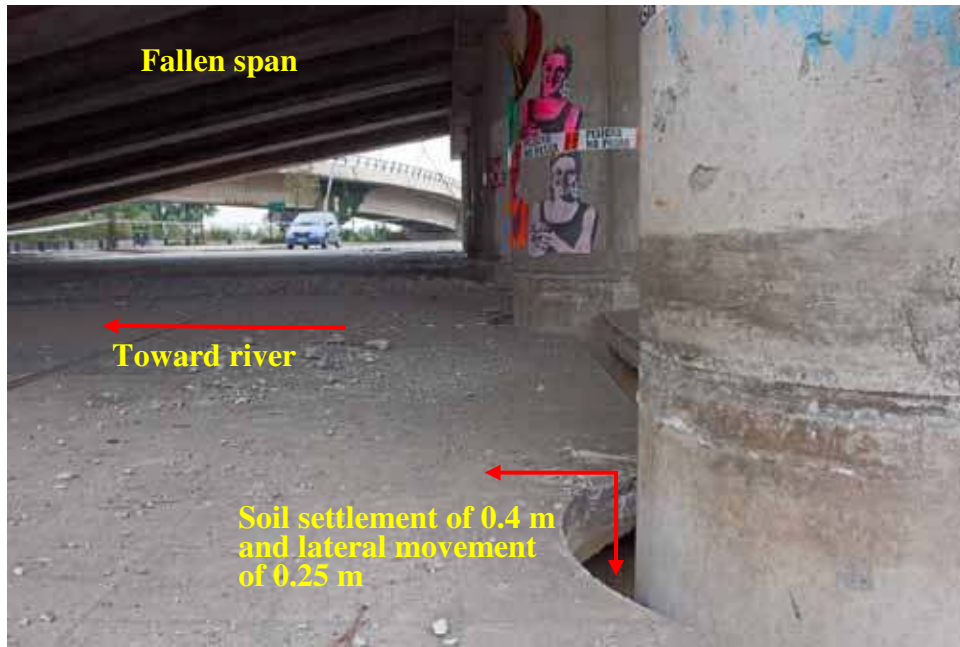
**Figure 213. Photo. Settlement and lateral ground movement of interior pier at northeast end of Llacolen bridge.**
