01 Oct 2011

## Post-earthquake Reconnaissance Report on Transportation Infrastructure Impact of the February 27, 2010, Offshore Maule Earthquake in Chile

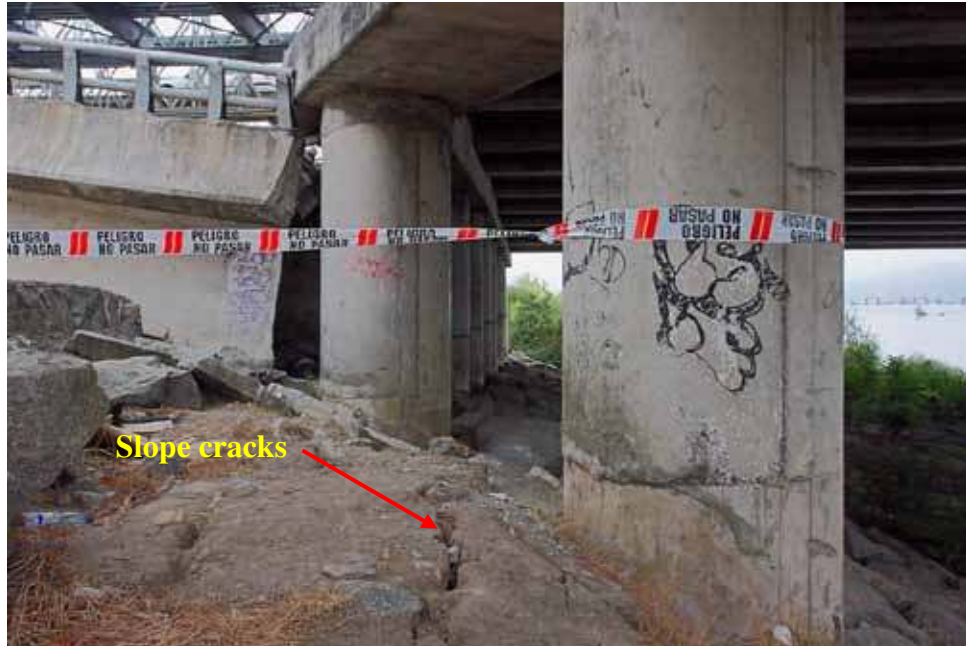
**Figure 214. Photo. Lateral ground and foundation movement at interior pier and fallen span at northeast end of Llacolen bridge.**

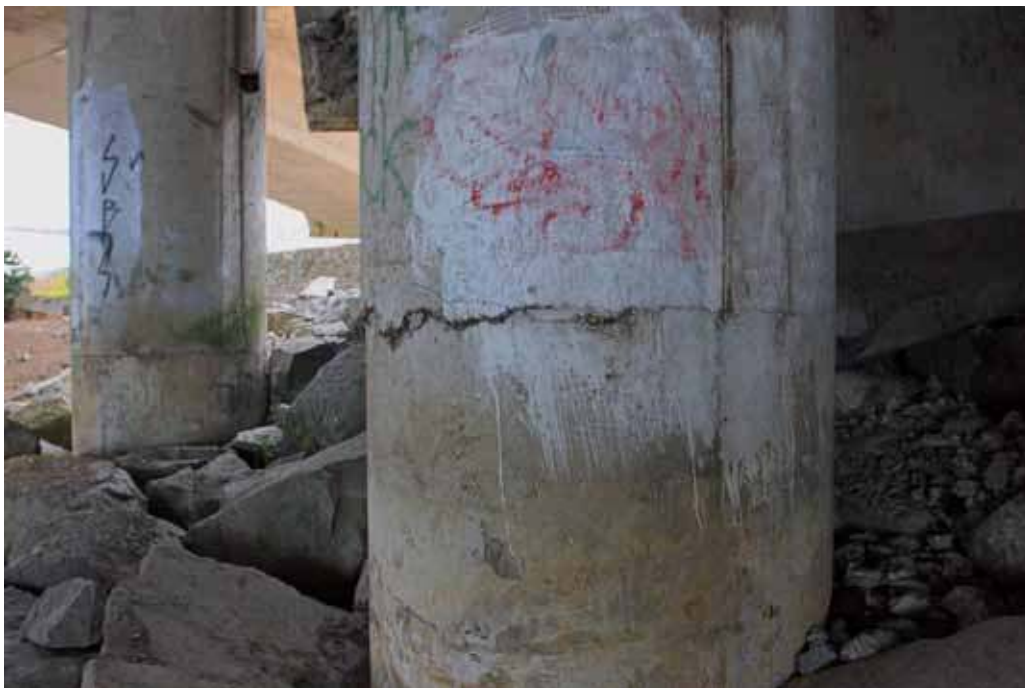
**Figure 215. Photo. Close-up of cracked column at northeast end of Llacolen bridge.**

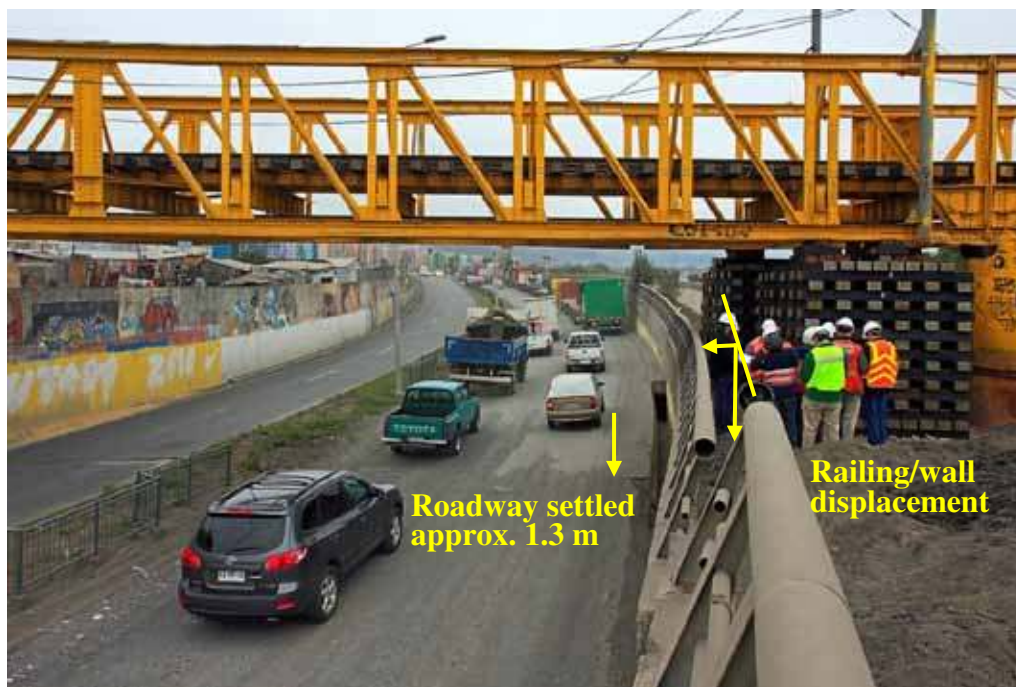
**Figure 216. Photo. Wall settlement due to slope movement and instability caused by liquefaction at northwest end of Chepe railroad bridge.**

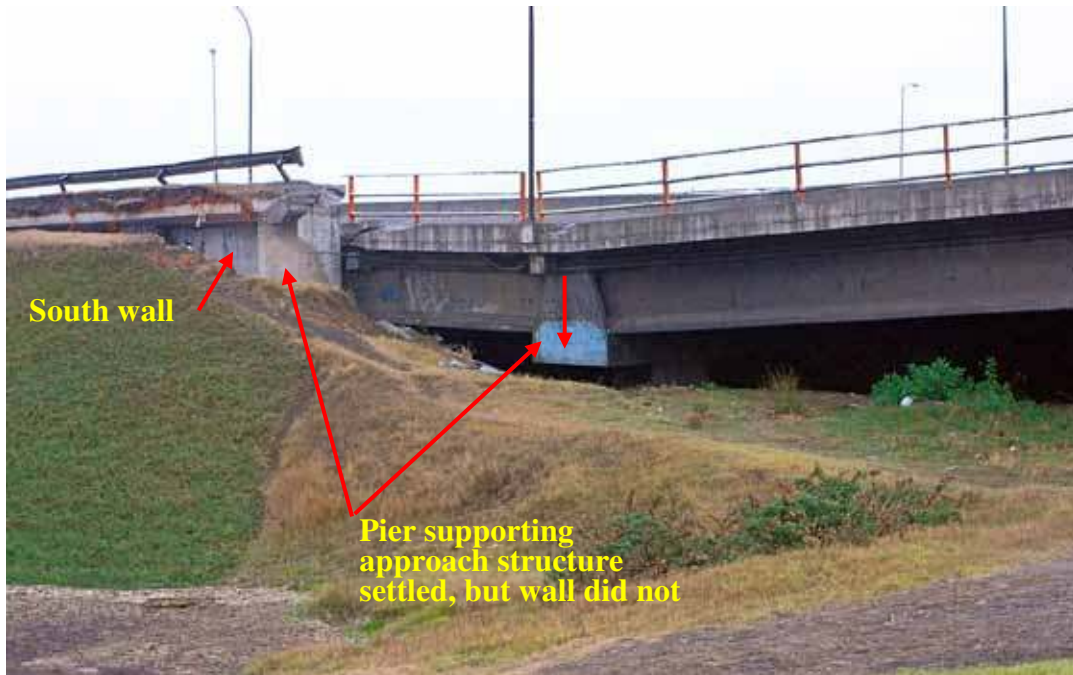
**Figure 217. Photo. Settlement of approach structure for Juan Pablo II bridge.**

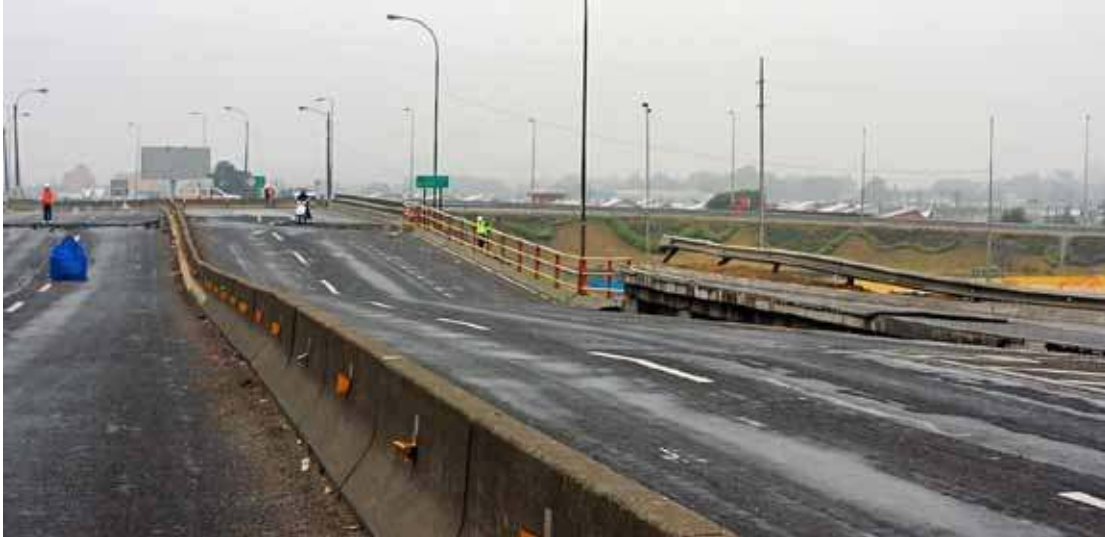
**Figure 219. Photo. Roadway settlement due to settlement of approach structure pier foundations for Juan Pablo II bridge.**

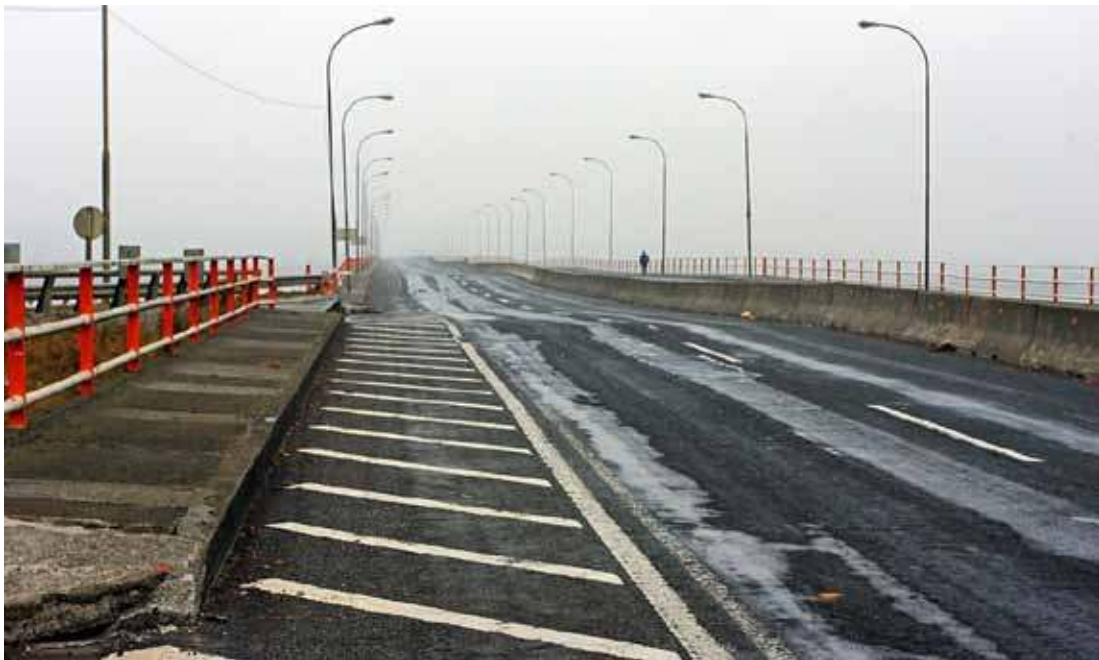
**Figure 220. Photo. Roadway settlement due to settlement of mainline pier foundations for Juan Pablo II Bridge.**

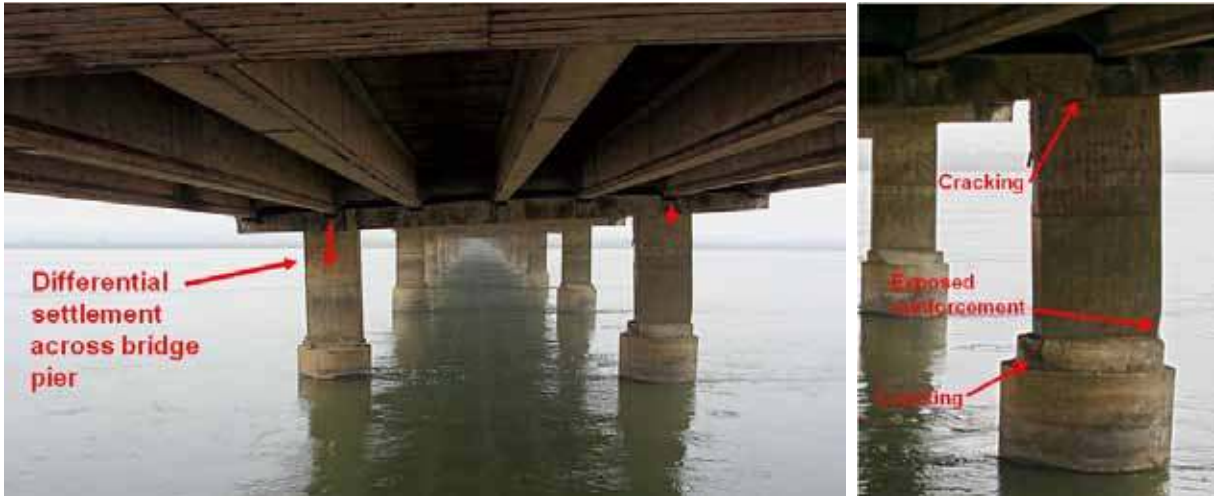
**Figure 221. Photo. Liquefaction-induced differential settlement of mainline pier foundations supporting Juan Pablo II bridge.**

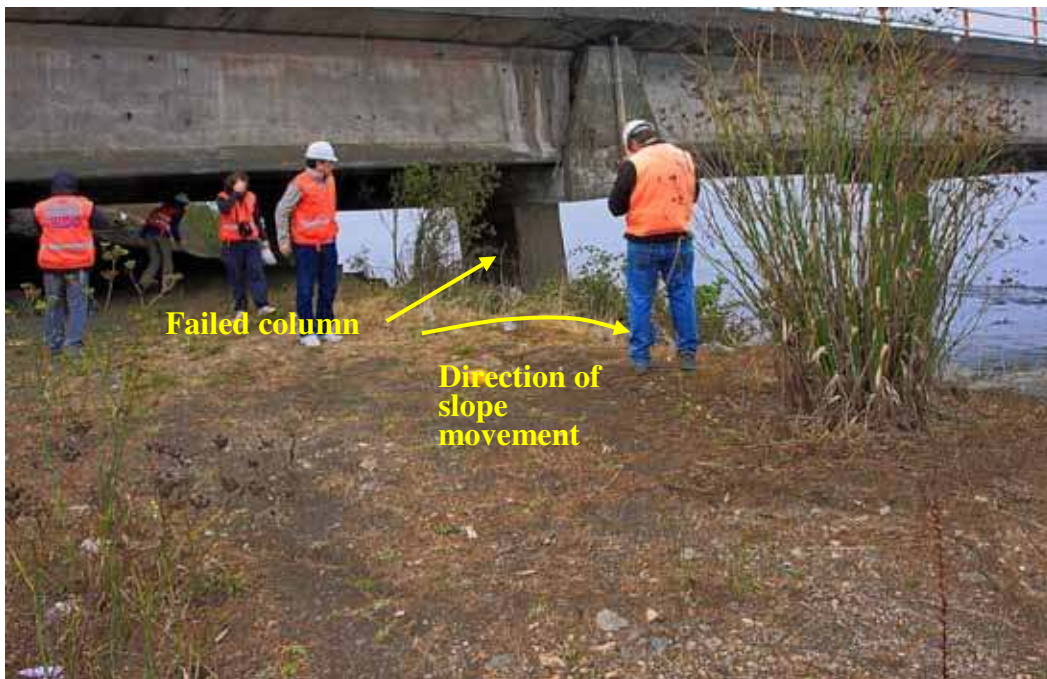
**Figure 222. Photo. Damage to pier columns for mainline Juan Pablo II bridge.**

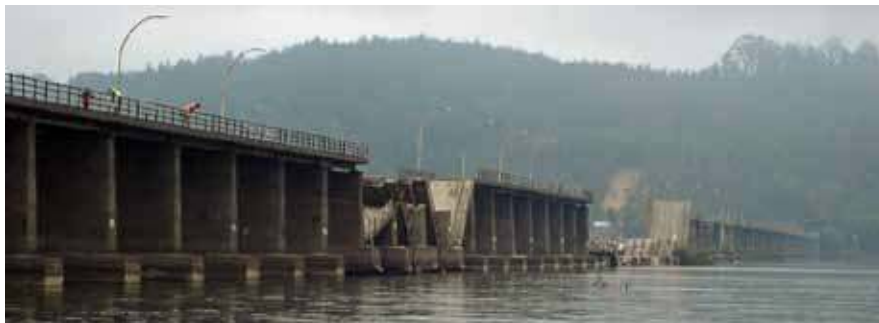
**Figure 223. Photo. View of collapsed spans from northeast river bank of Biobío River.**

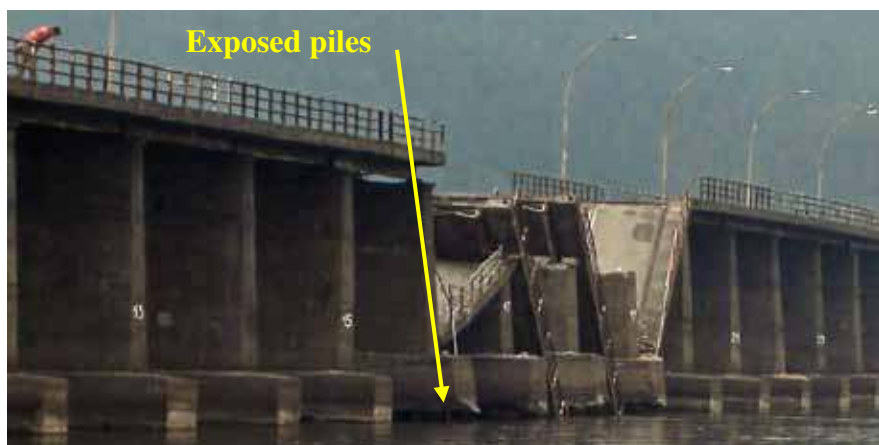
**Figure 224. Photo. Close-up of old Biobío River bridge showing exposed pile foundations.**

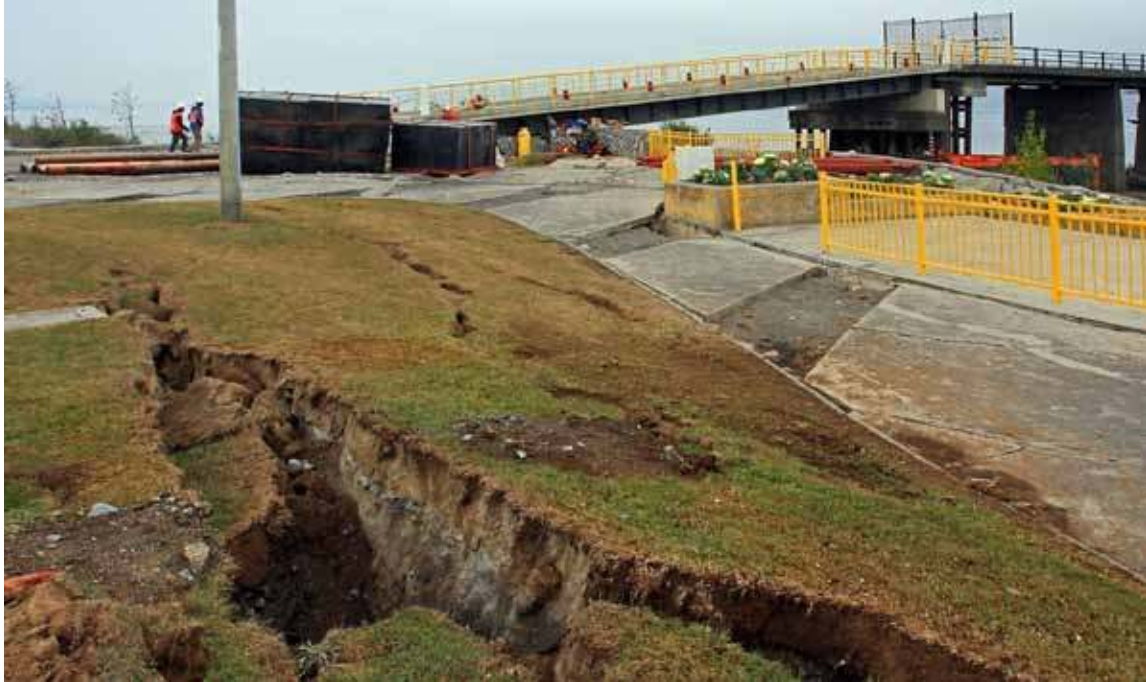
Figure 225. Photo. Ground failure near northeast abutment of old Biobío River bridge.

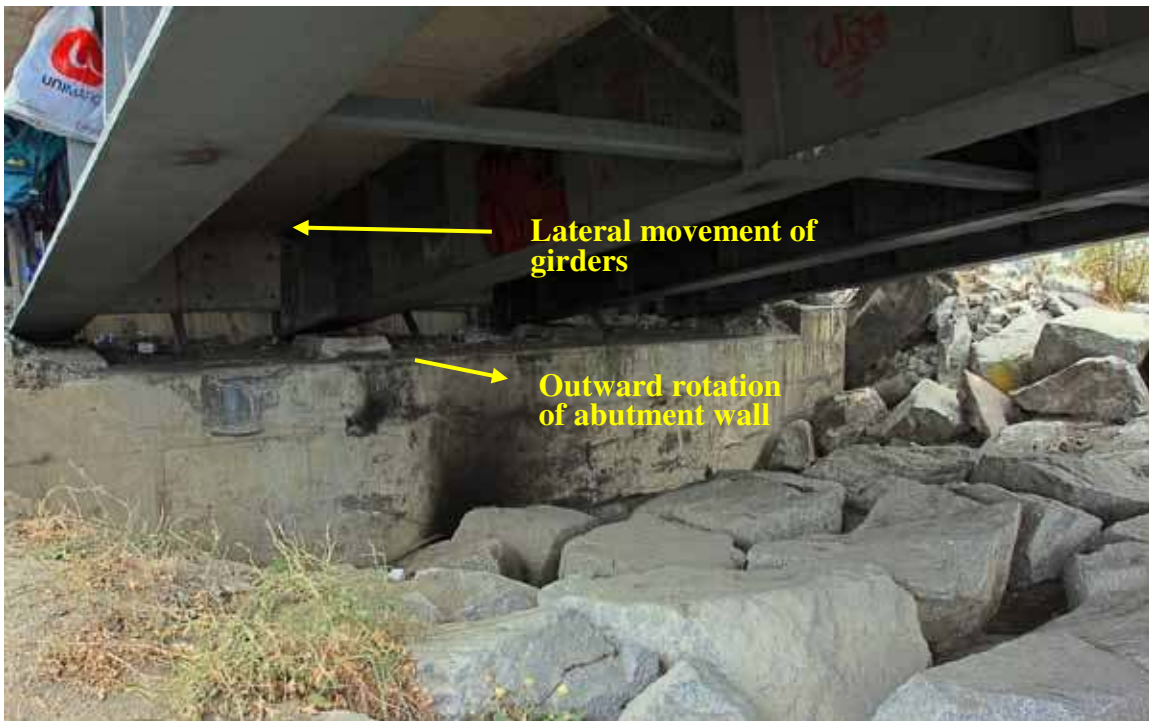
Figure 226. Photo. Tilting of northeast abutment pier wall of old Biobío River bridge.

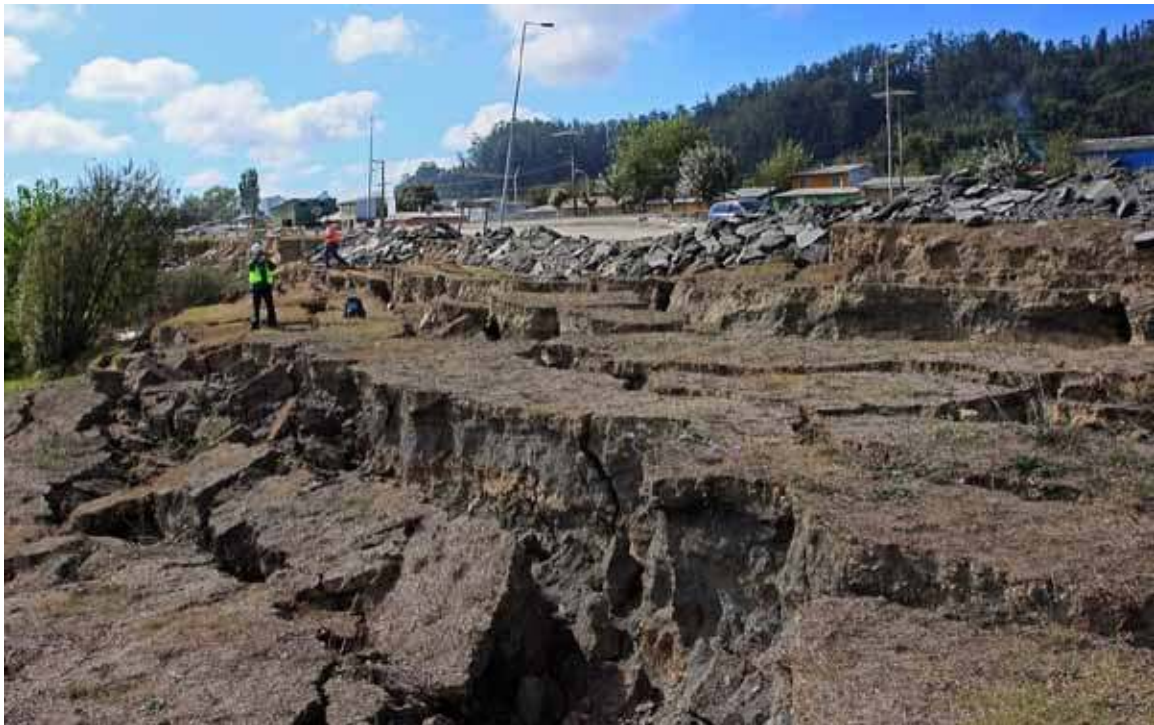
**Figure 227. Photo. Ground failure of north approach fill for La Mochita bridge.**

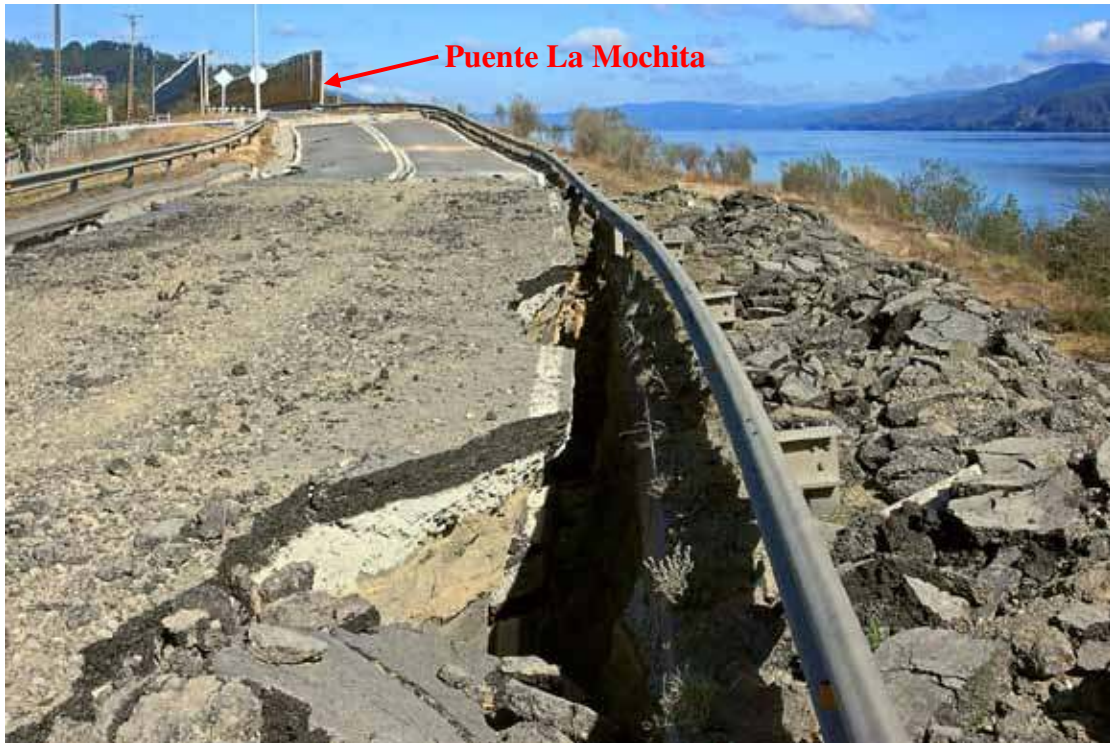
**Figure 228. Photo. La Mochita bridge north approach fill liquefaction-induced ground failure.**

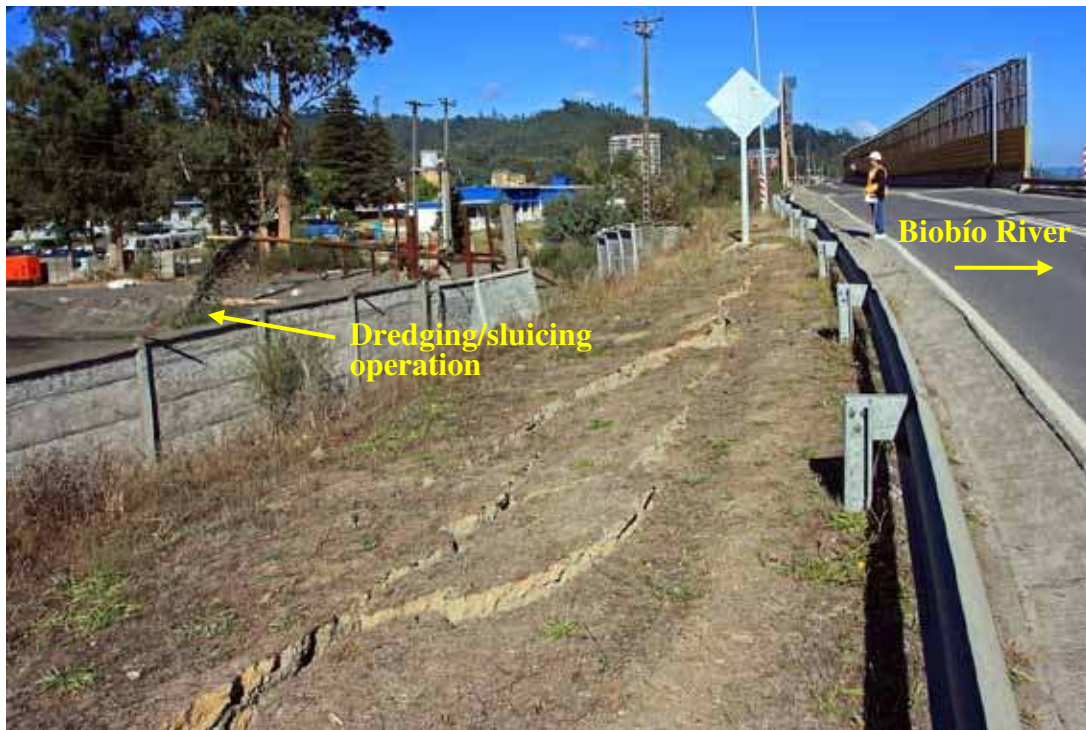
**Figure 229. Photo. La Mochita bridge north approach fill and edge of dredging pit.**

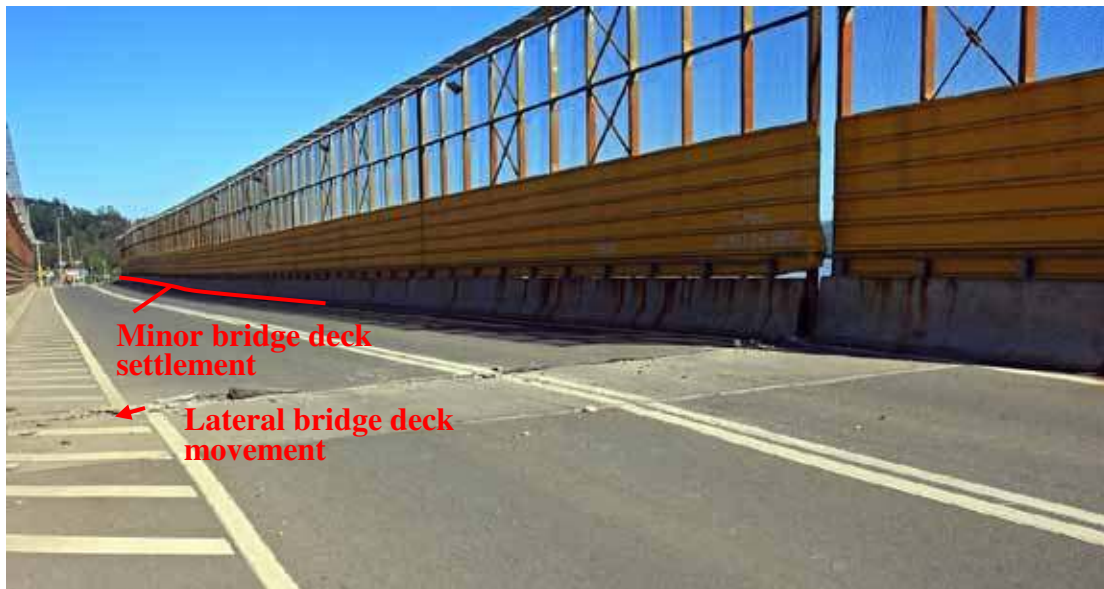
**Figure 230. Photo. La Mochita bridge deck and girder lateral movement.**

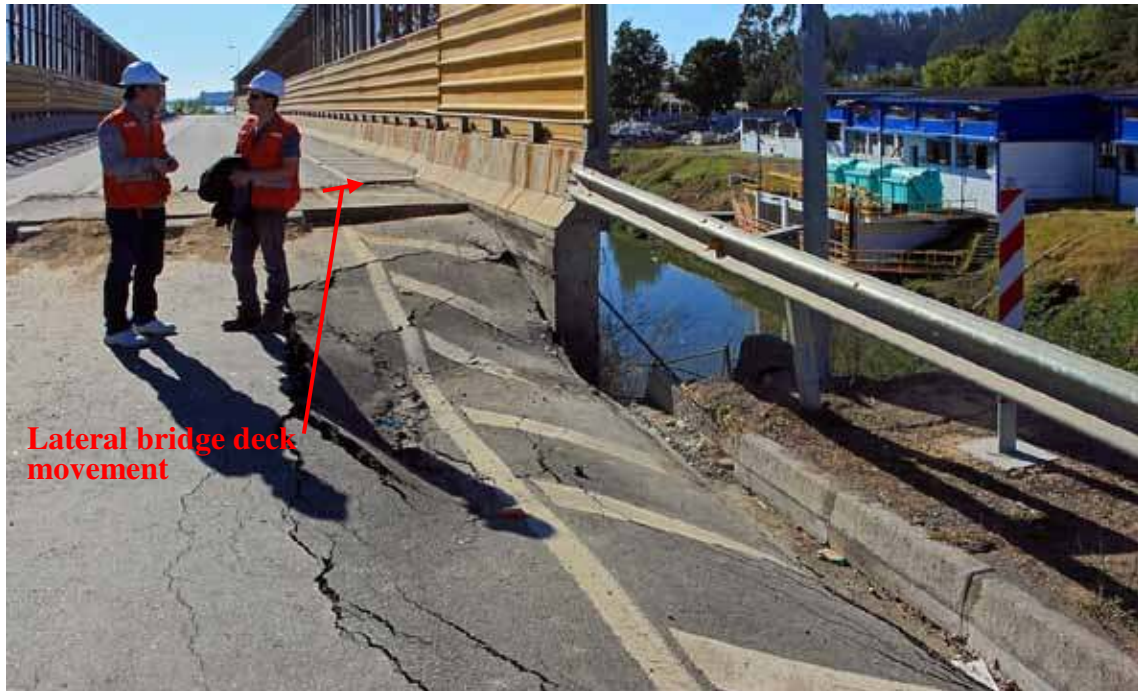
**Figure 231. Photo. La Mochita bridge deck and girder lateral movement and approach fill settlement.**

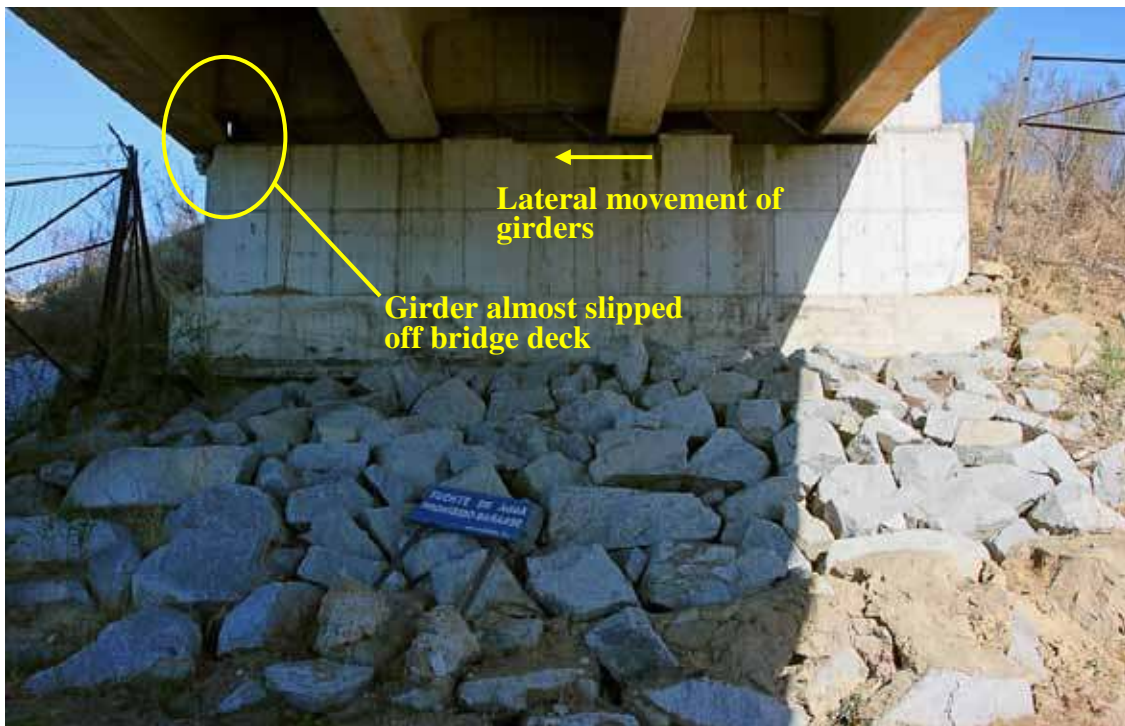
**Figure 232. Photo. La Mochita bridge lateral bridge deck and girder at south abutment.**

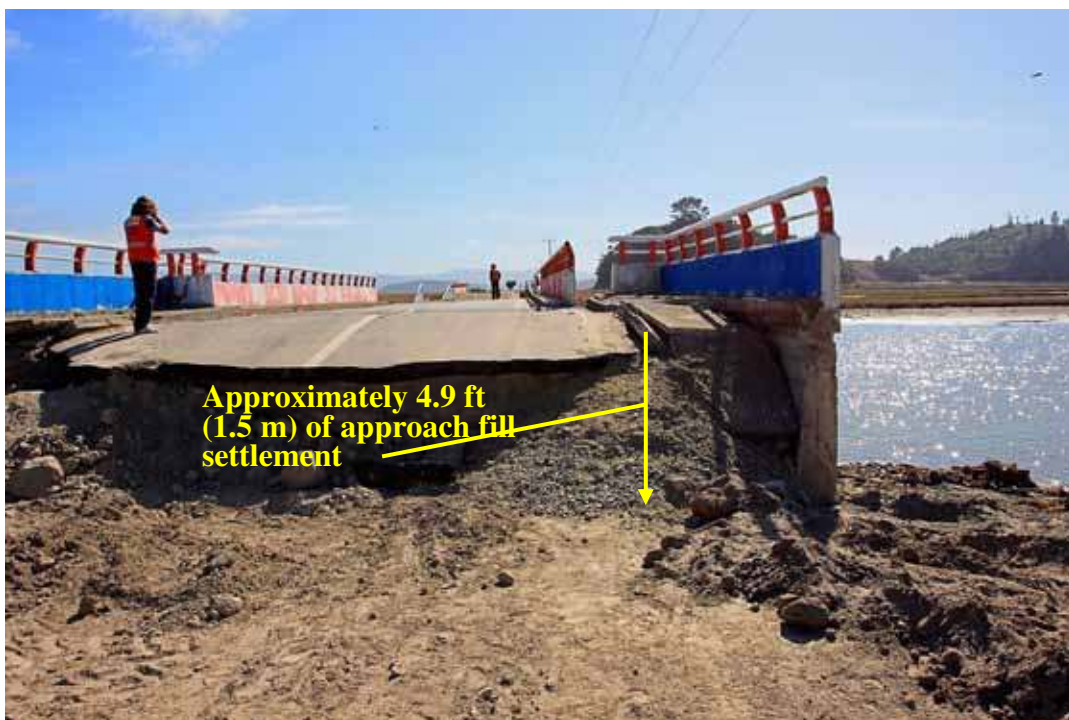
**Figure 233. Photo. Southeast approach fill damage at Raqui 2 bridge.**

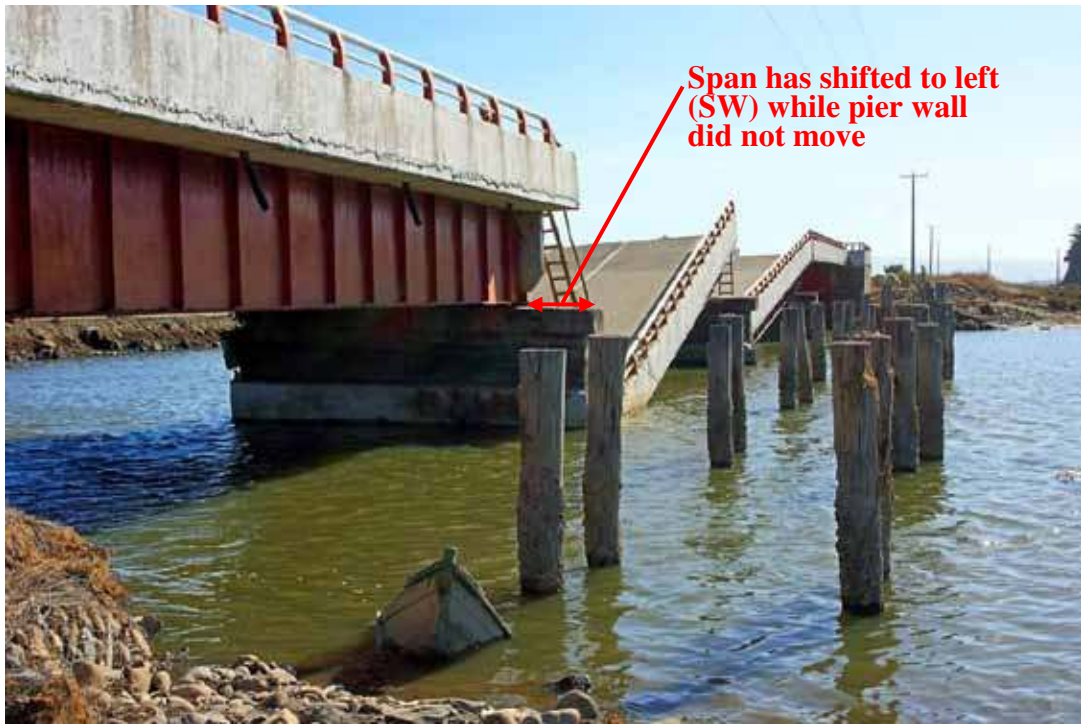
Span has shifted to left (SW) while pier wall did not move

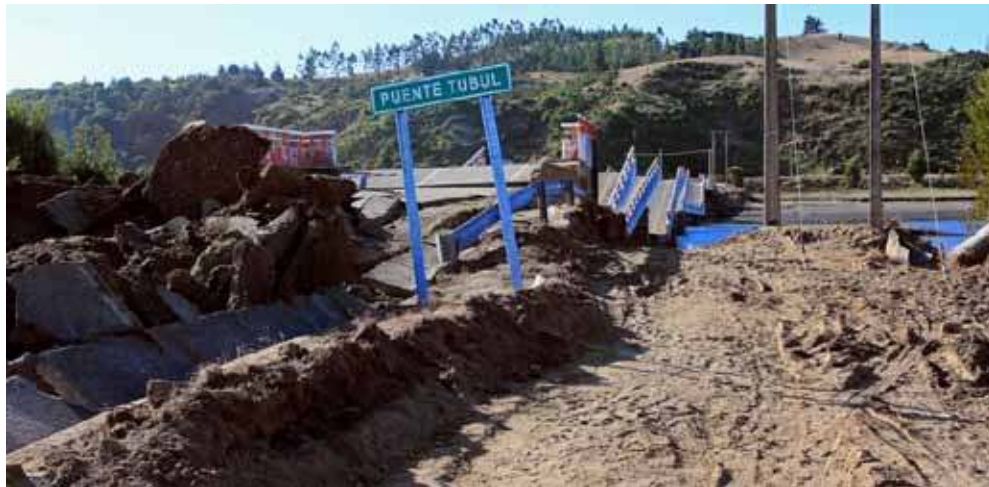
**Figure 236. Photo. South approach fill damage and collapsed spans at Tubul Bridge.**

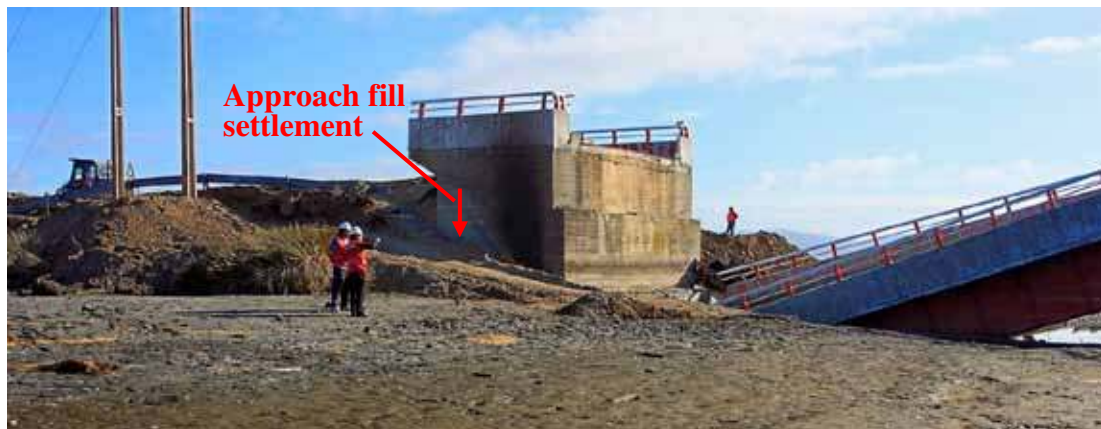
**Figure 237. Photo. Settlement of fill beside the south abutment of Tubul bridge.**

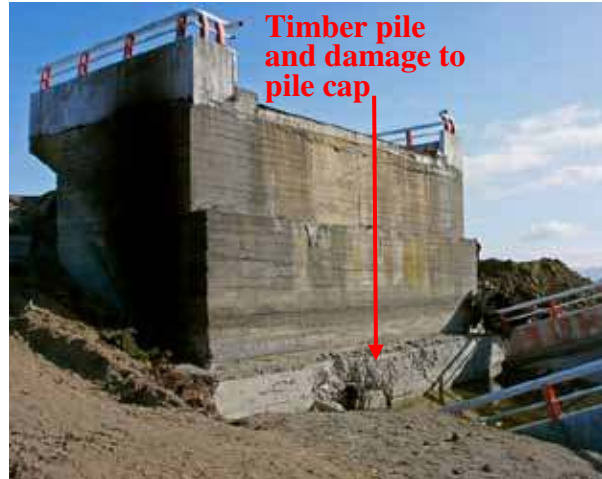
**Figure 238. Photo. Overview of damage to south abutment of Tubul bridge.**

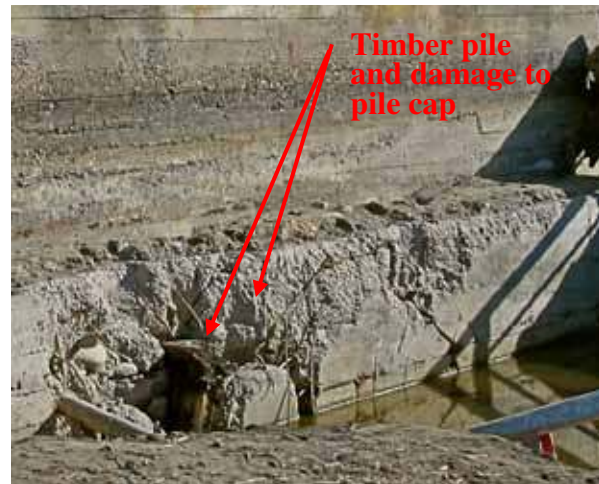
**Figure 239. Photo. Close-up of exposed pile and pile cap damage on south abutment of Tubul bridge.**

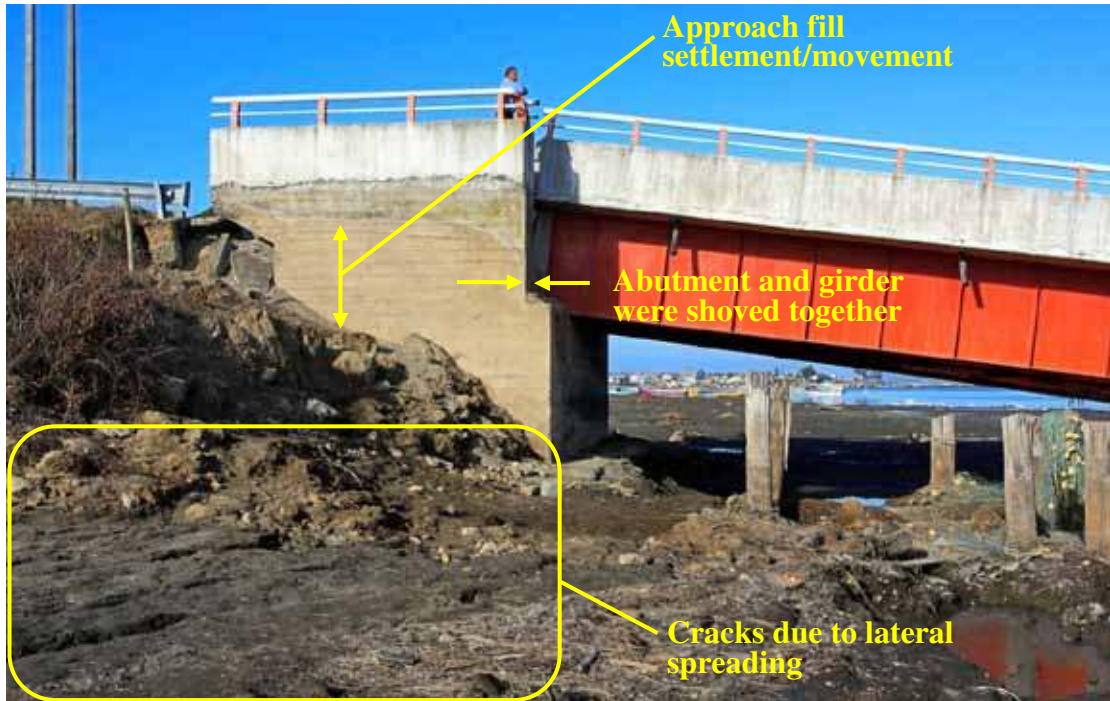
**Figure 240. Photo. Overview of Tubul bridge north abutment.**

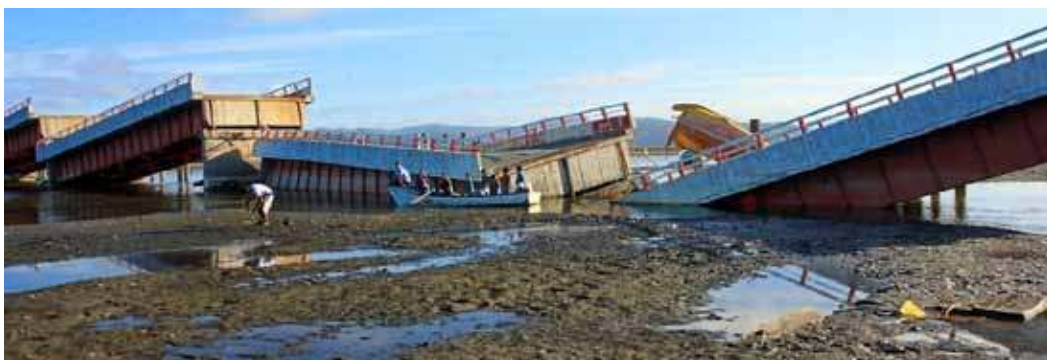
**Figure 241. Photo. Tubul bridge collapsed spans and substructure.**

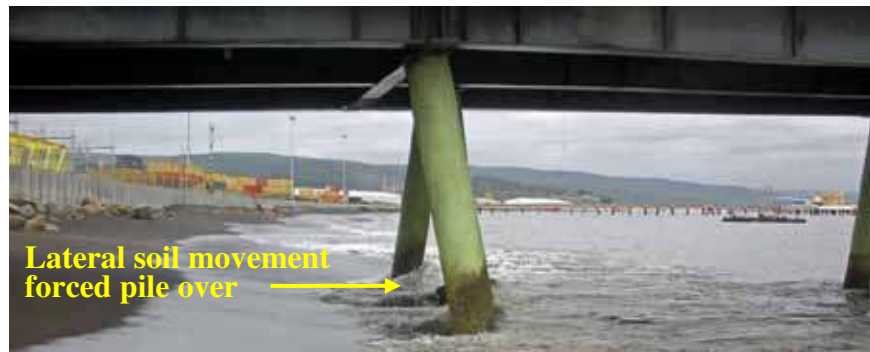
**Figure 242. Photo. Puerto de Coronel Muelle foundation displacement and bending.**

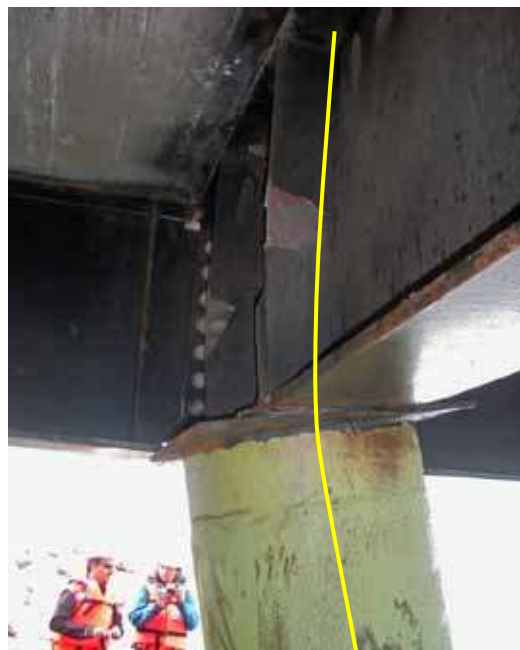
**Figure 243. Photo. Close-up of Puerto de Coronel Muelle foundation displacement and bending.**

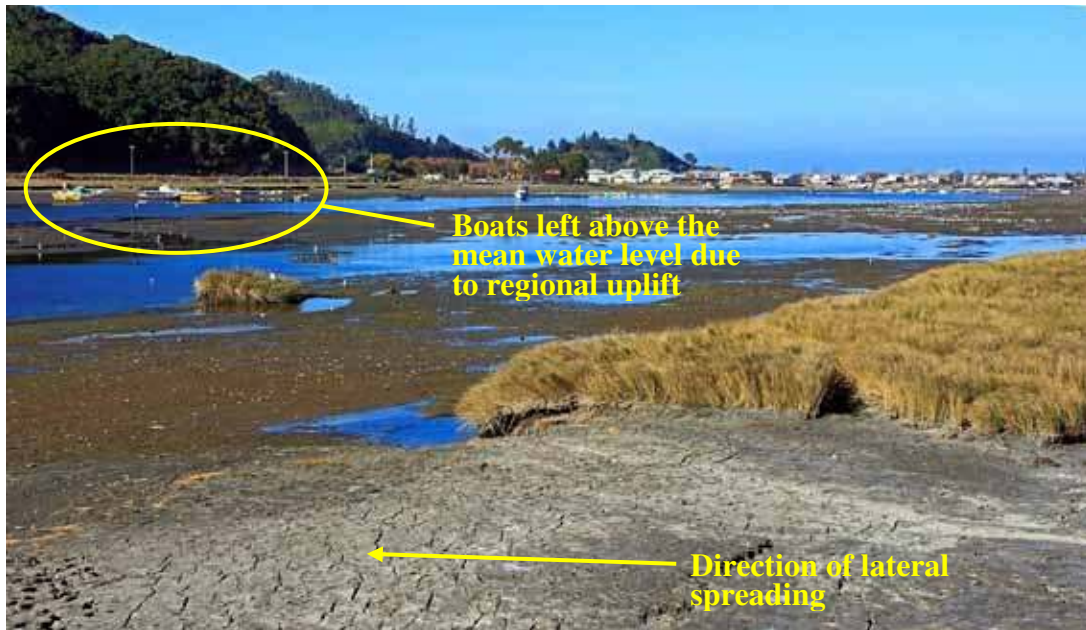
**Figure 244. Photo. View northeast from Tubul bridge south abutment showing areas left dry and boats left above the new mean water level.**

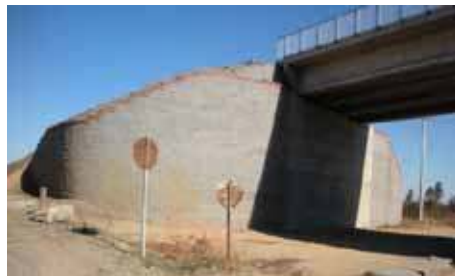
**Figure 260. Photo. Retaining wall at Muros Talca (SW).**

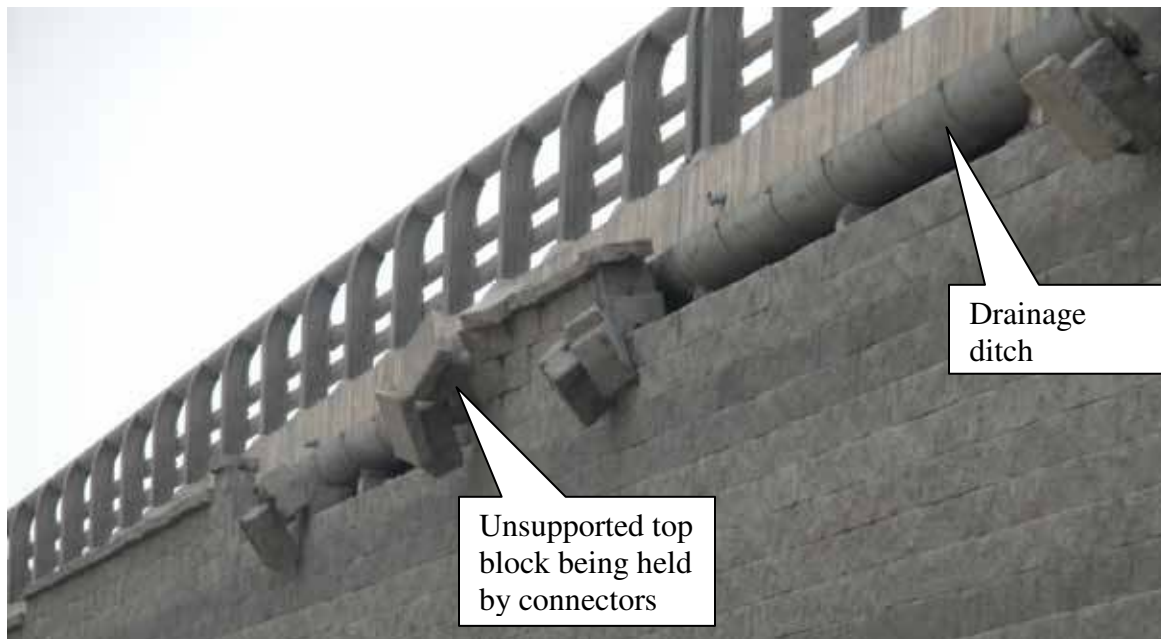
**Figure 261. Photo. Toppling of coping at Américo Vespucio/Independencia.**

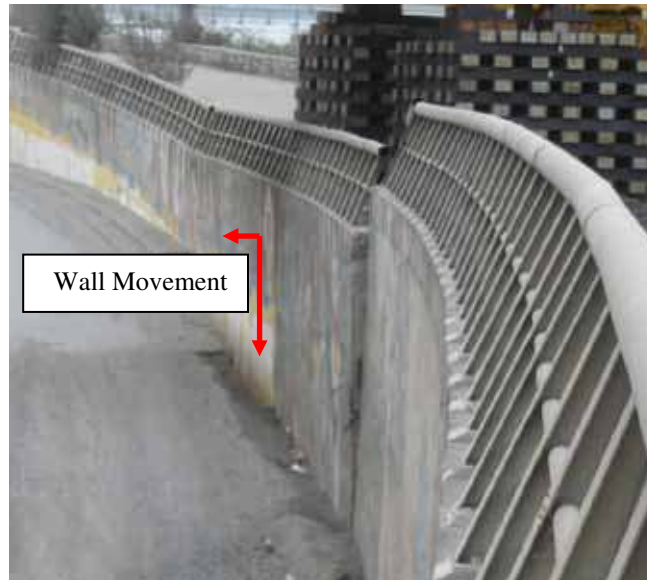
**Figure 262. Photo. Wall movement near Chepe railroad bridge due to lateral spreading and settlement.**

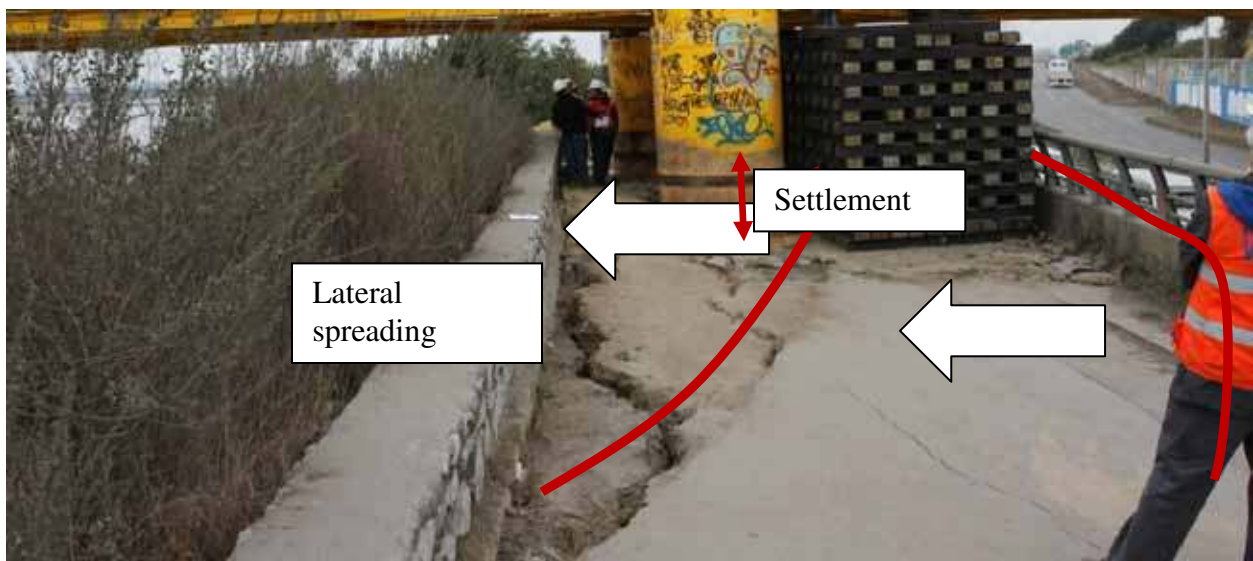
**Figure 263. Photo. Wall settlement and rotation due to lateral spreading and settlement.**

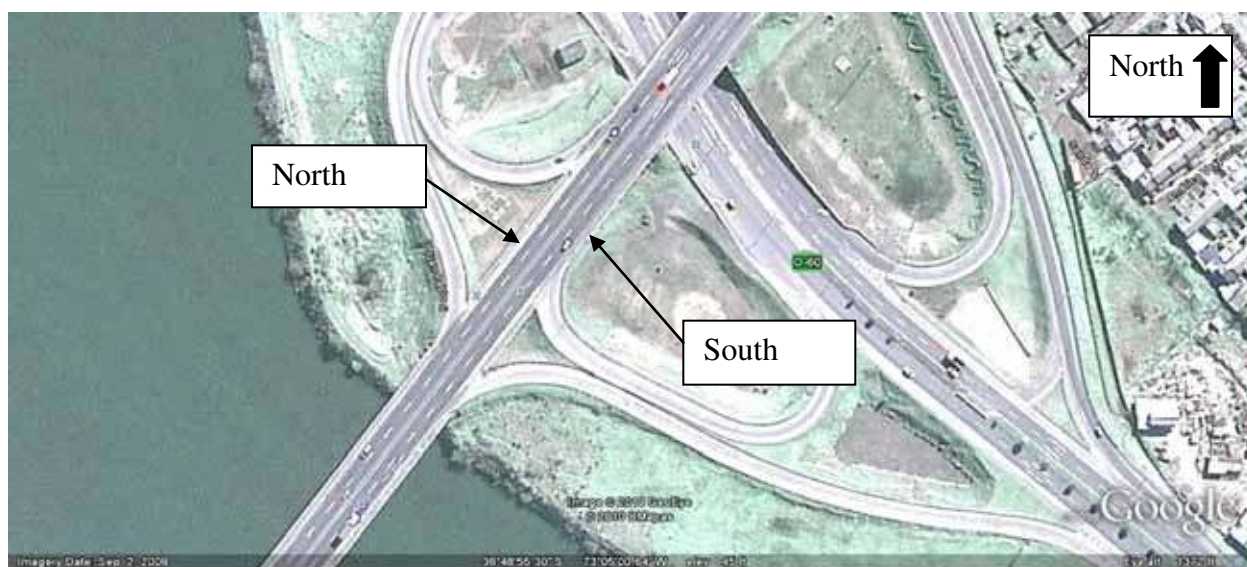
© Google, GeoEye, and DMaps

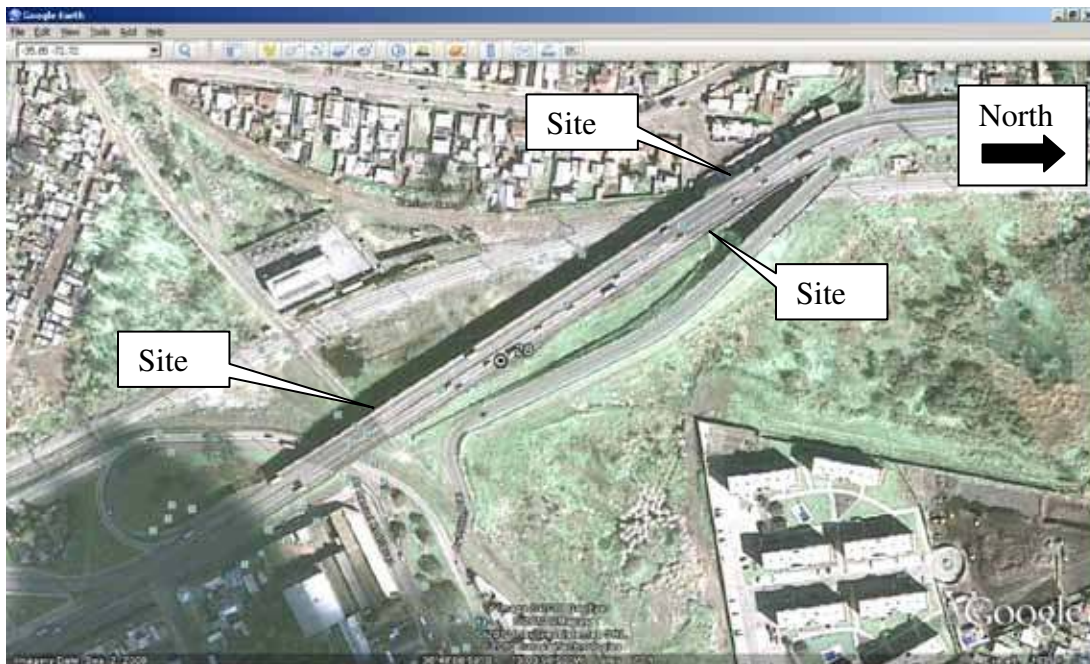
© Google, GeoEye, DMapas, Inav/Geosistemas SRL, and Europa Technologies

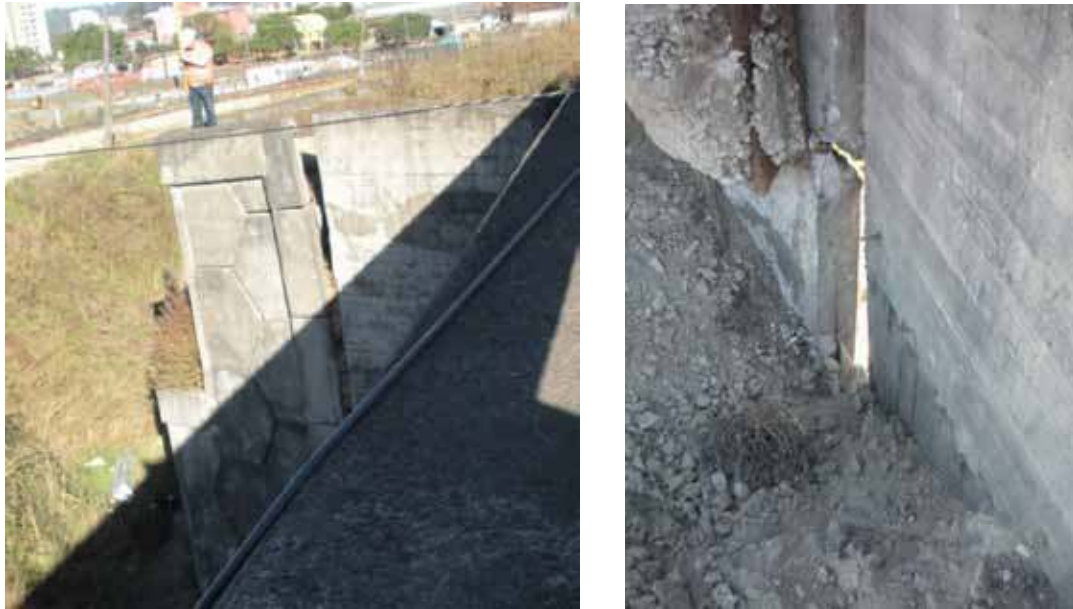
**Figure 267. Photo. Tiered wall corner tilting outward at wall site 28A.**
