01 Oct 2011

## Post-earthquake Reconnaissance Report on Transportation Infrastructure Impact of the February 27, 2010, Offshore Maule Earthquake in Chile

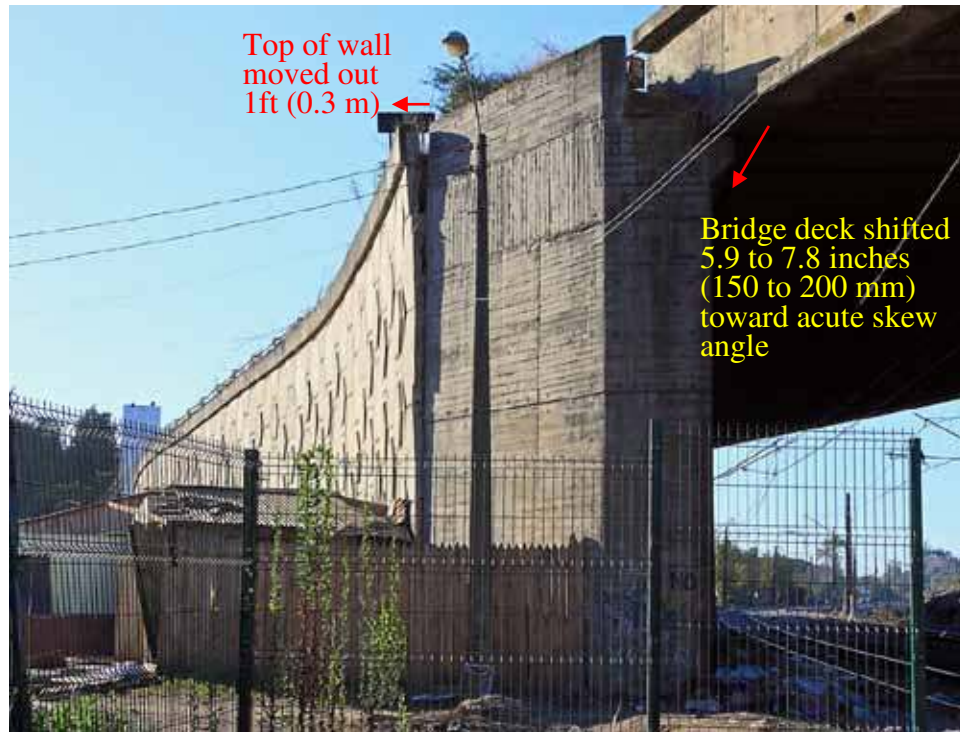
**Figure 268. Photo. Wall corner tilting outward at wall site 28B.**

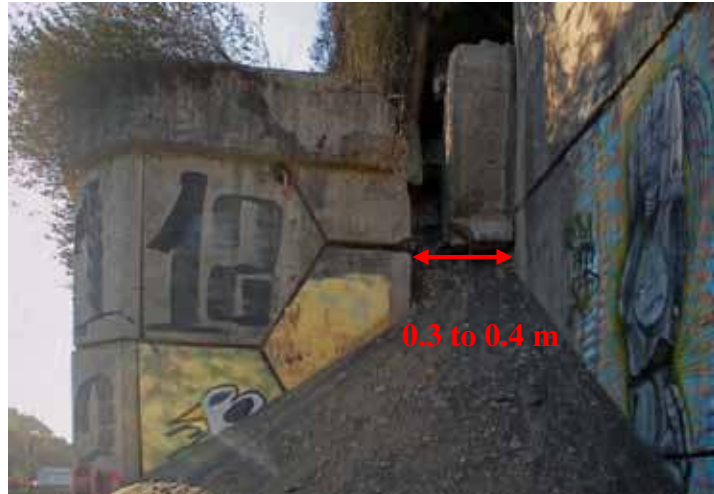
**Figure 269. Photo. Lateral movement of lower wall top at wall site 28C.**

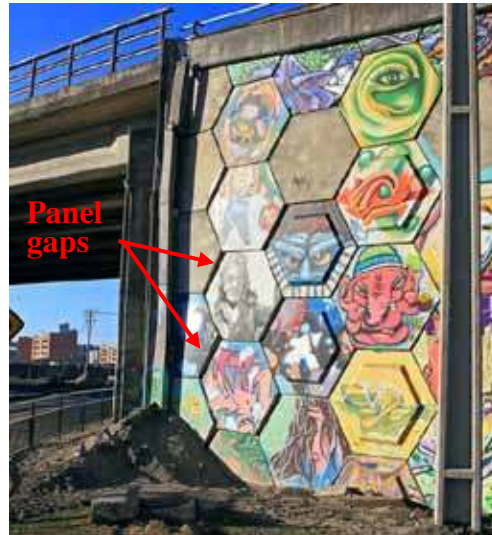
**Figure 272. Photo. Differential settlement at wall site 28C.**

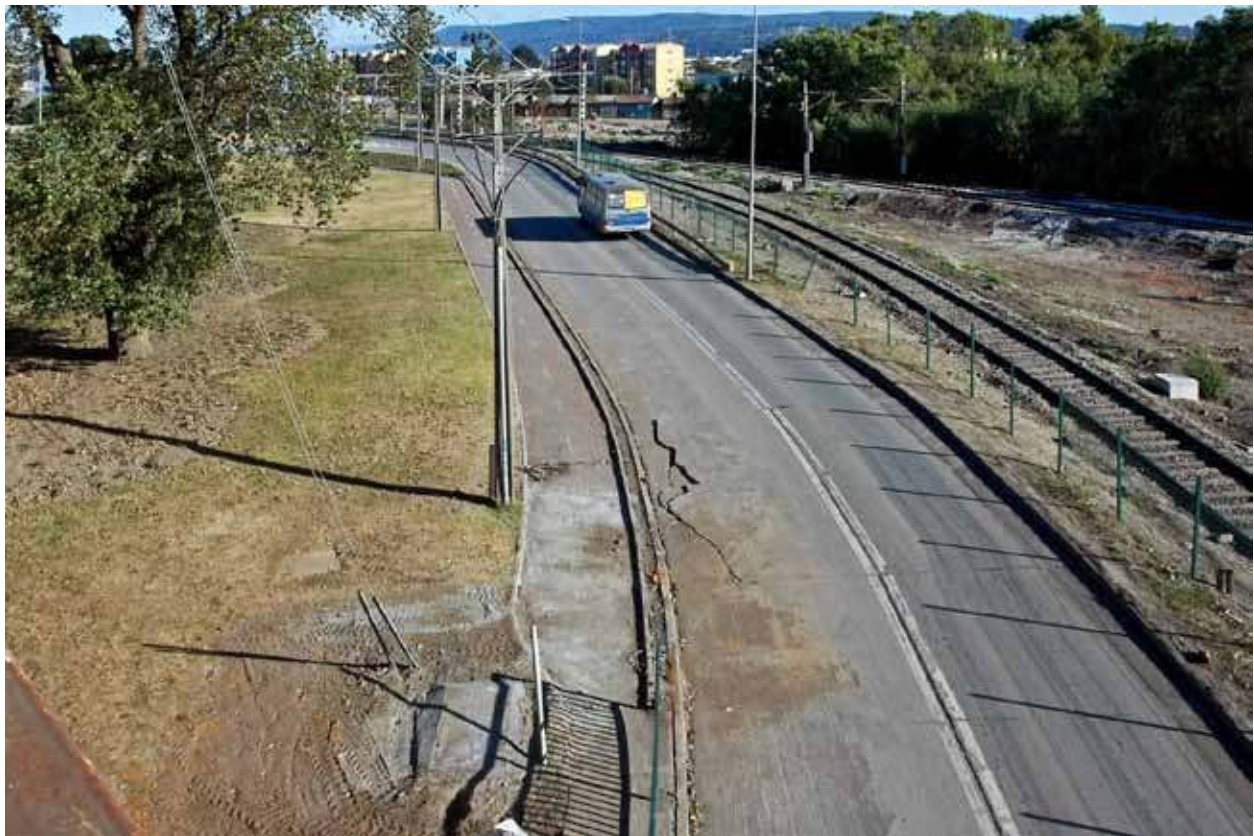
**Figure 273. Photo. Possible liquefaction features near wall site 28C.**

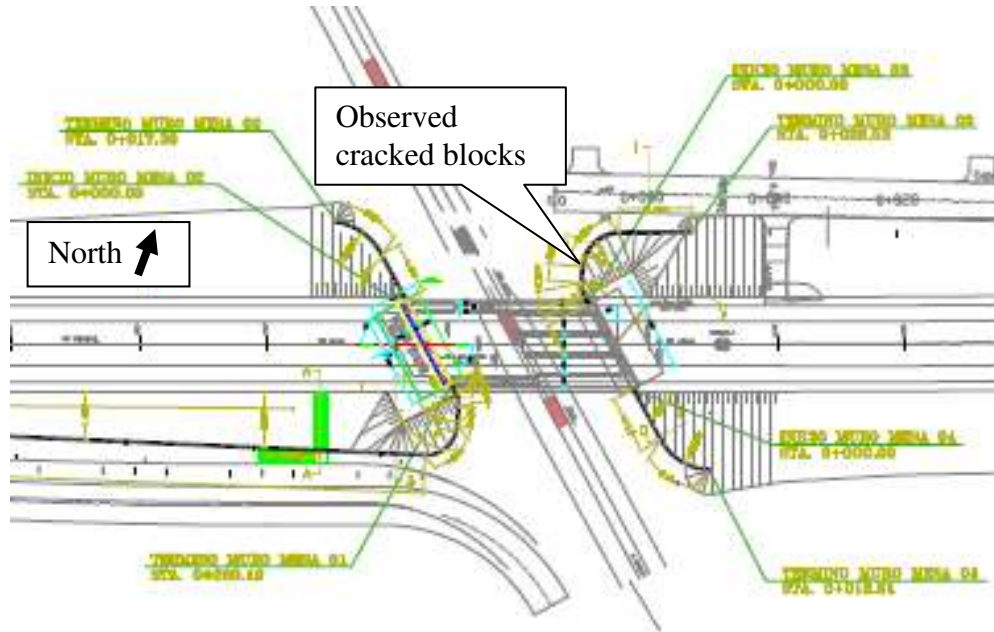
**Figure 274. Illustration. Plan view of wall at Muros Talca.**

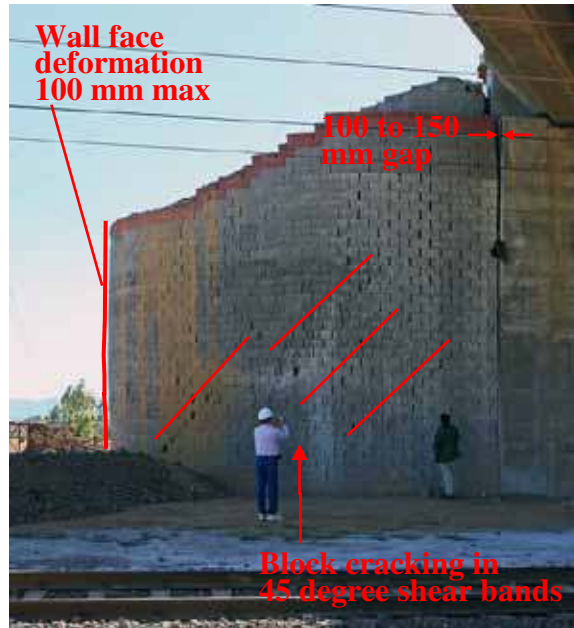
**Figure 276. Photo. Wall with cracked block pattern at Muros Talca.**

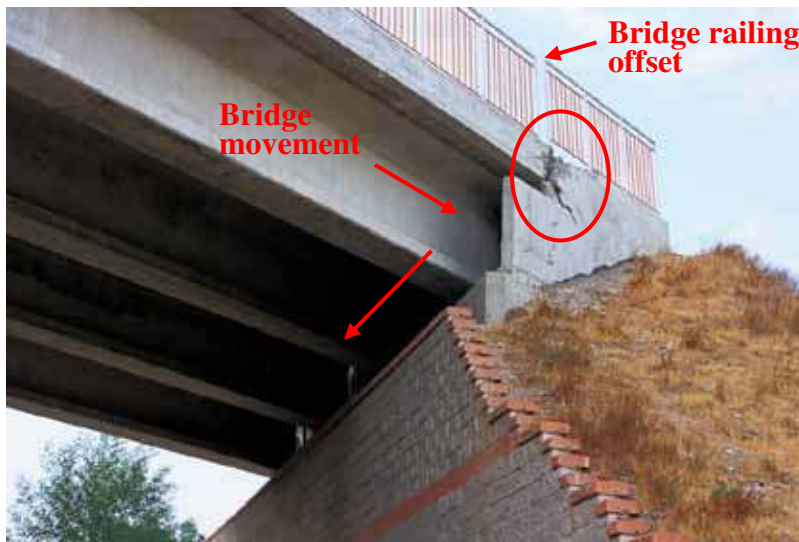
**Figure 277. Photo. Bridge supported on footing on top of block-faced geogrid wall at Estribo Francisco Mostazal.**

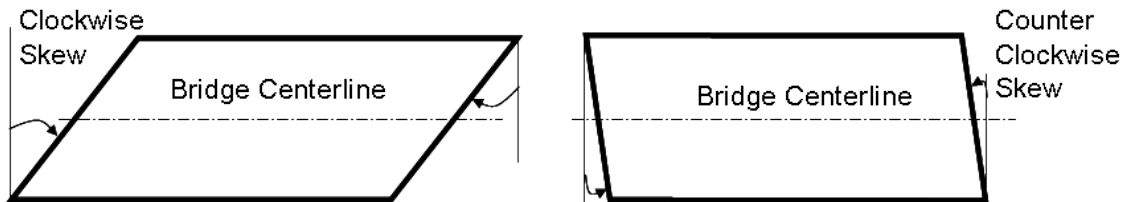
**Figure 278. Illustration. Notations on skew direction.**

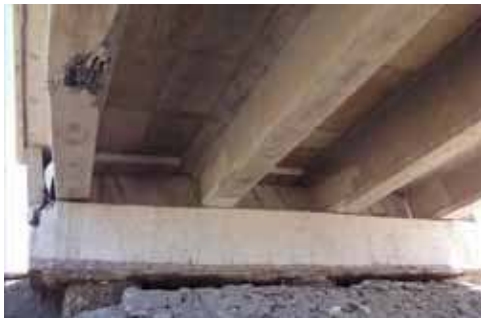
**Figure 281. Photo. Exterior girder damage at Chada bridge, no diaphragms.**

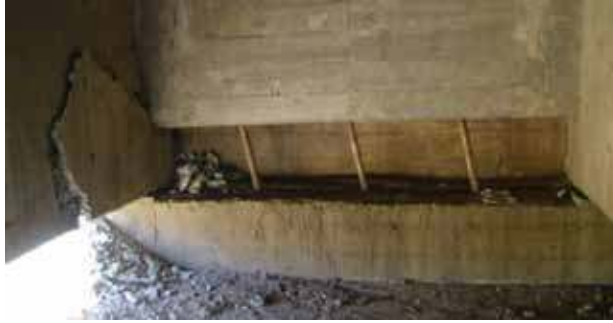
**Figure 282. Photo. Exterior girder damage at San Nicolás bridge, partial diaphragms.**

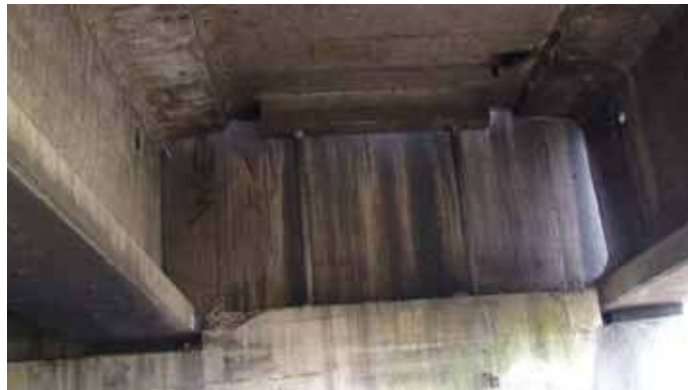
**Figure 283. Photo. Exterior girder damage at west abutment of Llacolen bridge, concrete teeth.**

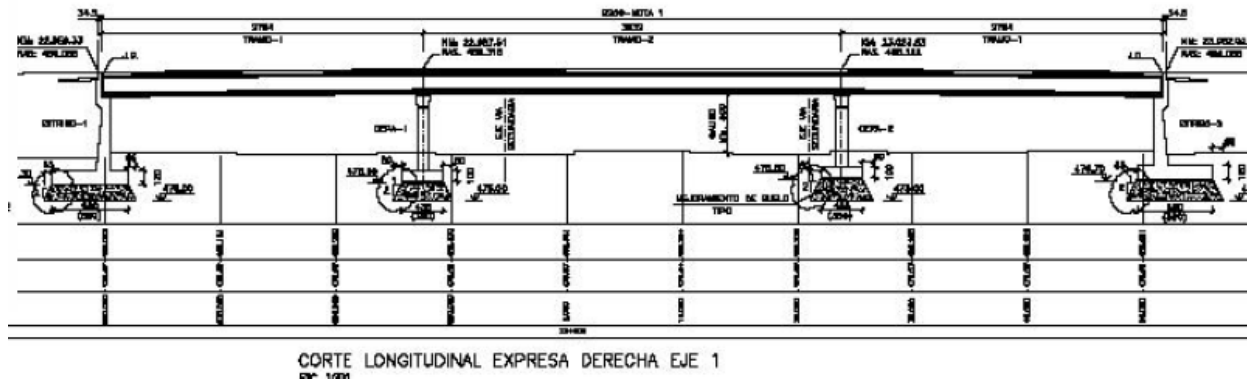
**Figure 287. Illustration. As-built bridge plan for site 2.**

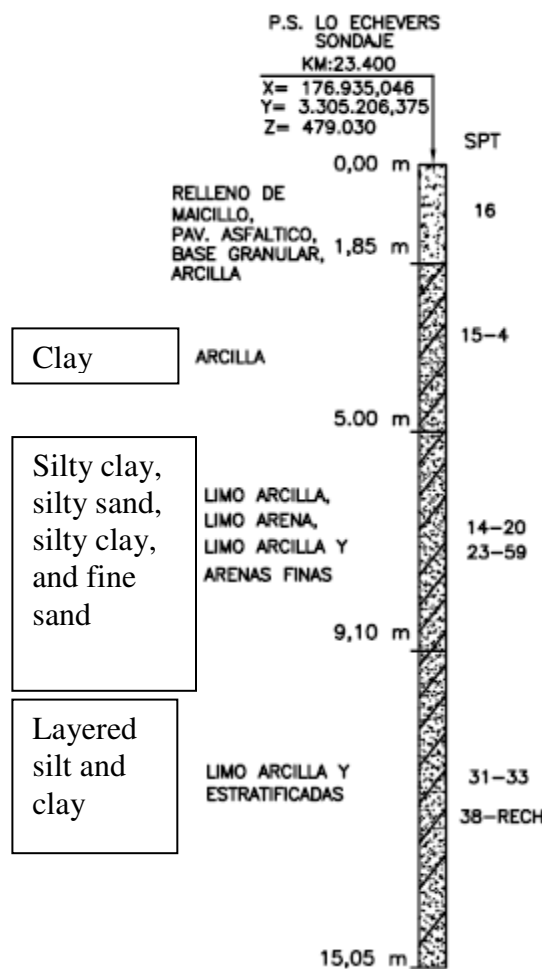
Figure 289. Illustration. Boring log at site 2.
