Rapid Assessment of Buildings Affected by Earthquake: Case Study in Pidie Jaya, Aceh, Indonesia

Aldrin Febriansyah^{1*}, Rianto², Ari Kusuma Wardana², Ekha Rifki Fauzi³

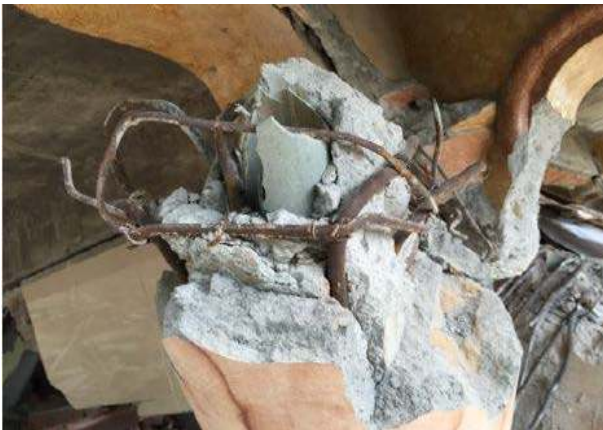
Figure 1. Moderately damage, planting pipes for the disposal of water located in the building column

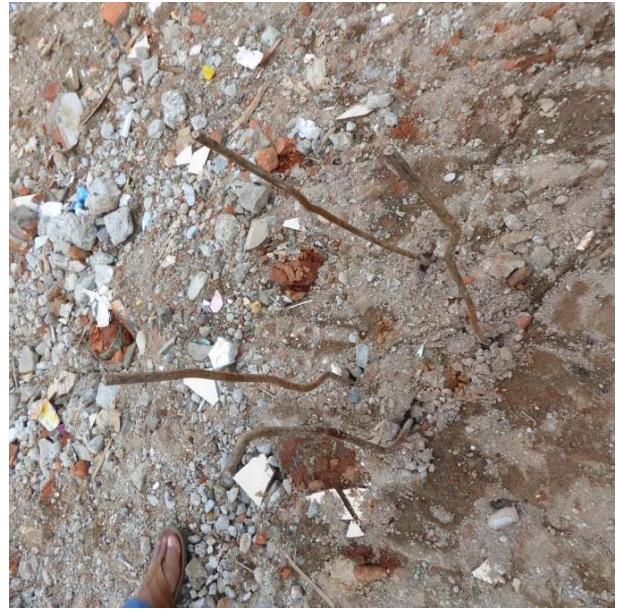
Figure 2. Heavily damage, use of column frame iron with a size that does not comply with regulatory standards

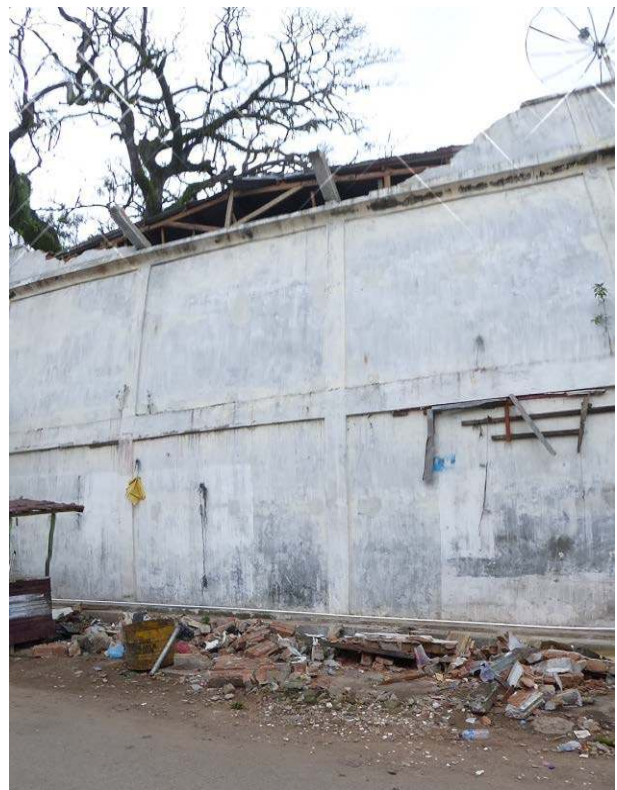
Figure 3. Mildly damaged, crumbling building walls that are not reinforced by the frame

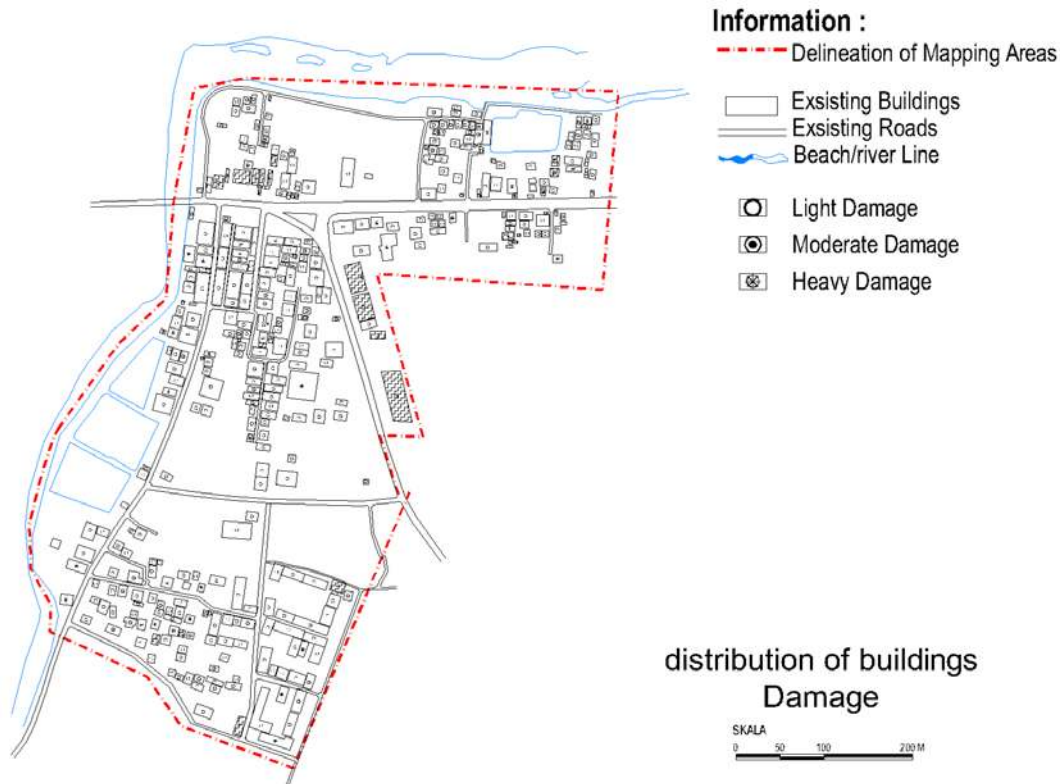
Figure 6. Buildings Damaged

The picture above maps the category of building damage, divided into minor loss, moderate loss, and massive loss. The result is that most of the 1st-floor buildings with settlement functions suffer minor damage. While the 2nd and 3rd-floor buildings with shop and trade functions only experienced moderate loss and only a few buildings. The majority of minor damage to residential structures do not meet government earthquake-resistant building regulations [28]–[30].

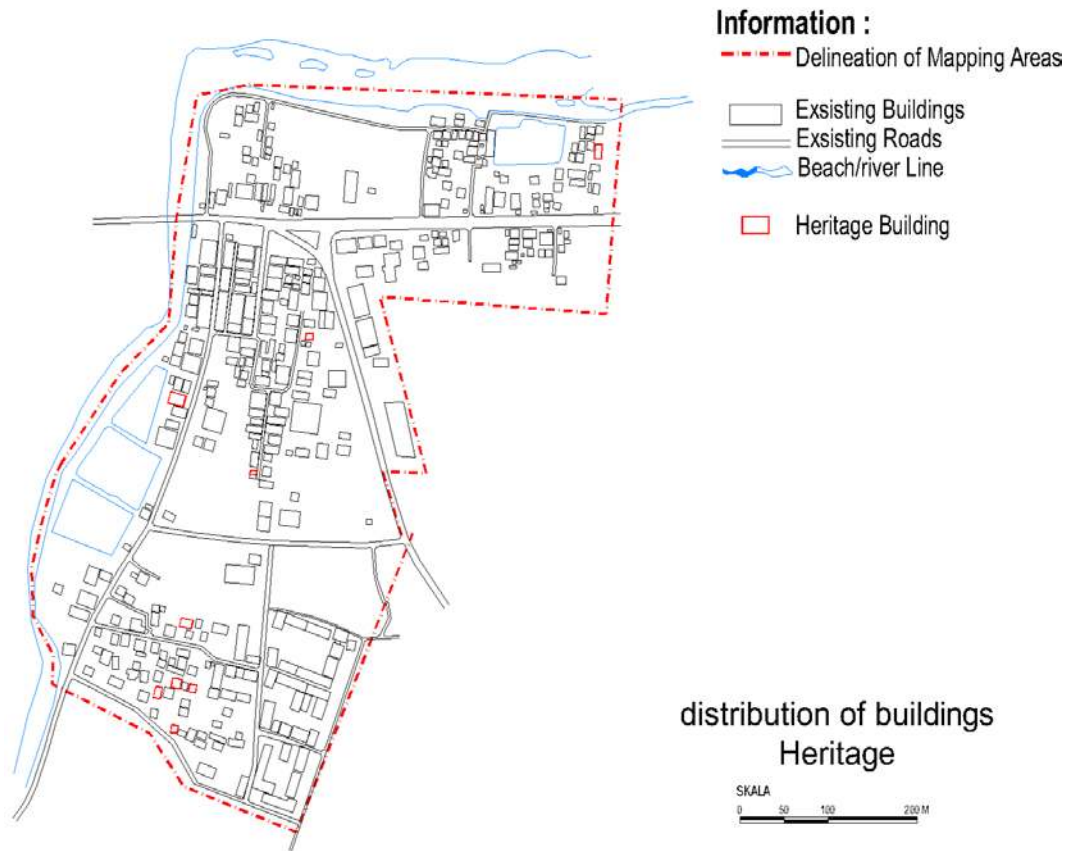
Figure 7. Heritage buildings

The picture above is a mapping of heritage buildings with age above 50 years. It found that the earthquake did not damage heritage buildings with traditional structures (wood and bamboo). Those 9 (nine) heritage building is a one-story residential building. This finding is a further question of why buildings with traditional structures can withstand the earthquake [22], [31].
