## Repair evaluation of concrete cracks using surface and through-transmission wave measurements

D.G. Aggelis, T. Shiotani \*

*Research Institute of Technology, Tobishima Corporation, 5472 Kimagase, Noda, Chiba 270-0222, Japan*

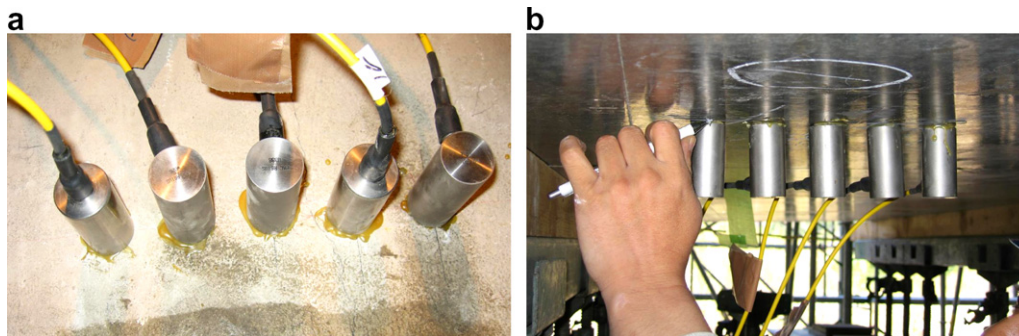
Fig. 3. (a) Photograph of sensor arrangement of the upper side and (b) excitation using lead break and sensor at the down side.

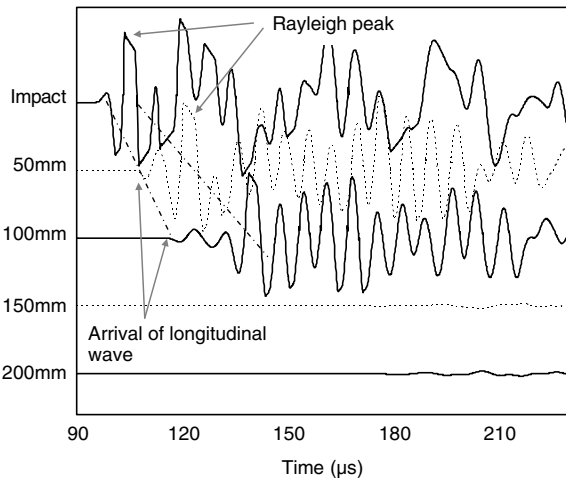
When the same sensor configuration was used to measure a portion containing a crack, different trends were observed, as shown in Fig. 6. The first three waveforms, collected before the crack, are quite clear, while after the crack the waveforms are hardly visible. This shows that a very small part of energy is transmitted through the crack. In Fig. 7a the same waveforms are depicted, with the two waveforms after the crack magnified by a factor of 20. It is obvious that no peak corresponds to the Rayleigh velocity of the material. Plotting the arrival time vs distance using the peaks closest to the expected time for the two last waveforms, results in weaker correlation as seen in Fig. 7b. Therefore, it seems that the Rayleigh wave does not survive after the crack, due to the discontinuity.

Fig. 6. Waveforms of surface measurements at different propagation distances for concrete with crack at 125 mm.

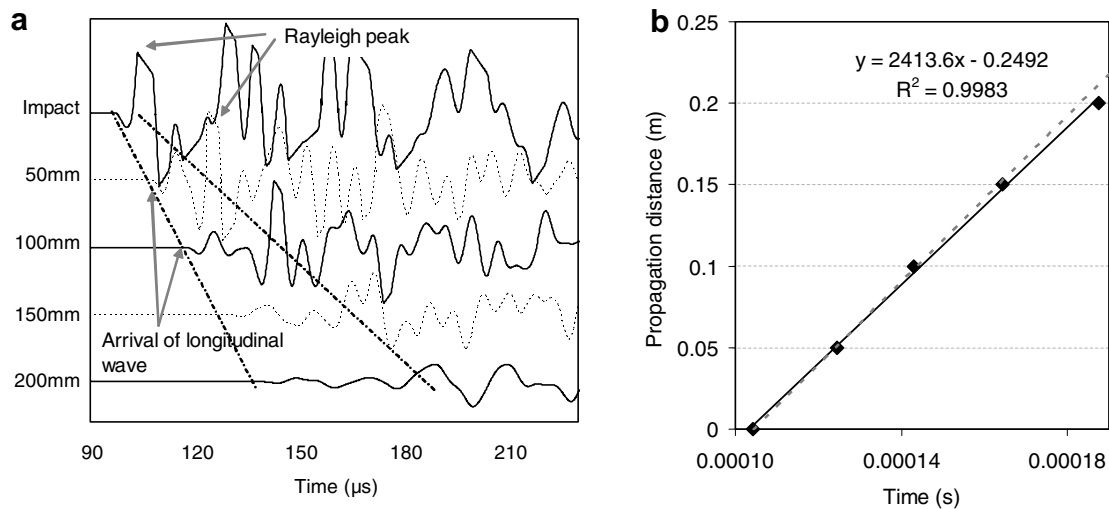
It is obvious that more energy is transmitted than before repair. The Rayleigh peaks can be distinguished due to their larger height after the initial P-wave arrivals even at the measurement points after the crack. Moreover, in Fig. 8b the correlation is almost as strong as the sound case of Fig. 5b, verifying that these peaks correspond to surface waves. Nevertheless, the velocity is calculated at 2414 m/s, about 250 m/s lower than the corresponding velocity of the sound material, most likely due to the propagation through the layer of epoxy inside the crack. This means that the last two points, corresponding to propagation of 150 mm and 200 mm are somewhat delayed. Indeed, excluding these points from the correlation, see the dashed grey line of Fig. 8b, leads to a velocity of 2605 m/s and an even higher correlation coefficient,  $R^2 = 0.9994$ . The lower velocity of 2414 m/s is certainly attributed to the repaired crack situation although the crack width is very small. As mentioned earlier, the crack width at the top was measured at 0.2 mm and the receiver array covered a space of 200 mm. Consid-

In any case, the above results are a certain indication that the surface layer was filled in significant degree, to allow Rayleigh waves to propagate. Rayleigh measurements were repeated on the opposite side (bottom), and similar results were observed. Accordingly the propagation was restored showing that the epoxy material was sufficiently injected into the whole thickness of the structure although it was impregnated only from the upper surface.

Fig. 8. (a) Waveforms of surface measurements at different propagation distances for concrete with epoxy filled crack at 125 mm and (b) correlation plot of distance to Rayleigh peak arrival time.

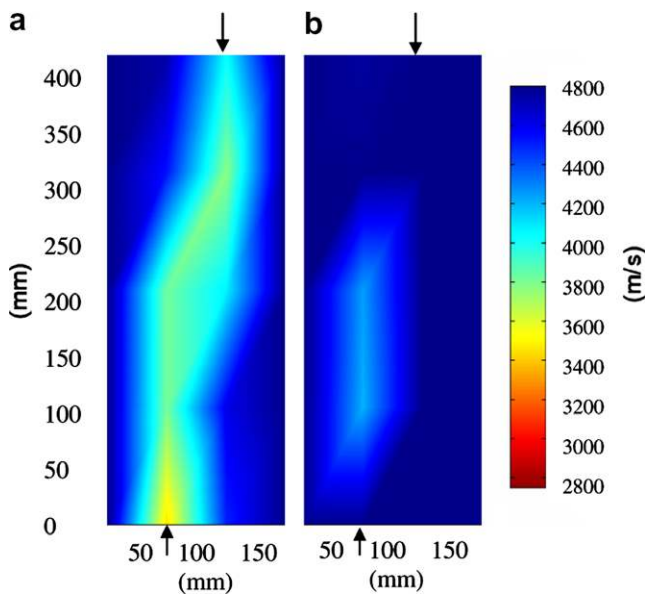
Applying this procedure to the cross section containing a crack before repair, it was quite visible that there was a significant discontinuity in the interior. In Fig. 11a one can observe the tomogram of the crack in hand. The yellow<sup>1</sup> colored area corresponds to a velocity of around 3500 m/s, being greatly influenced by the through-the-thickness crack. The tomography result gives also an insight of the internal pattern of the crack, due to the loop

Fig. 11. Velocity tomograms of the vicinity of the crack (a) before and (b) after repair. The arrows correspond to the actual position of crack openings.

procedure employed for the calculation of the shortest path traveled in any case [40]. Indeed in the specific case, the top and bottom openings of the crack differ by 50 mm in horizontal distance. As seen, for some areas the crack decreased the apparent velocity to 70% of the intact state velocity.

In Fig. 11b, one can observe the tomogram of the same cross section after injection with epoxy. It is seen that wave propagation is facilitated and only some small tracks indicate the existence of crack that could be due to the fracture process zone that expands some cm from both sides of the crack, as mentioned earlier. Comparison of the image before and after, makes obvious that whatever discontinuity was initially present, was almost eliminated after repair, implying that the impregnation was successful. Most of the previously troublesome area seems thus eliminated, while a small remaining track of the discontinuity is related to a velocity of around 4200 m/s, 84% of the intact state, which is much elevated compared to the before repair situation. The same tomography procedure was applied to other cracks exhibiting in any case the much improved condition after impregnation.

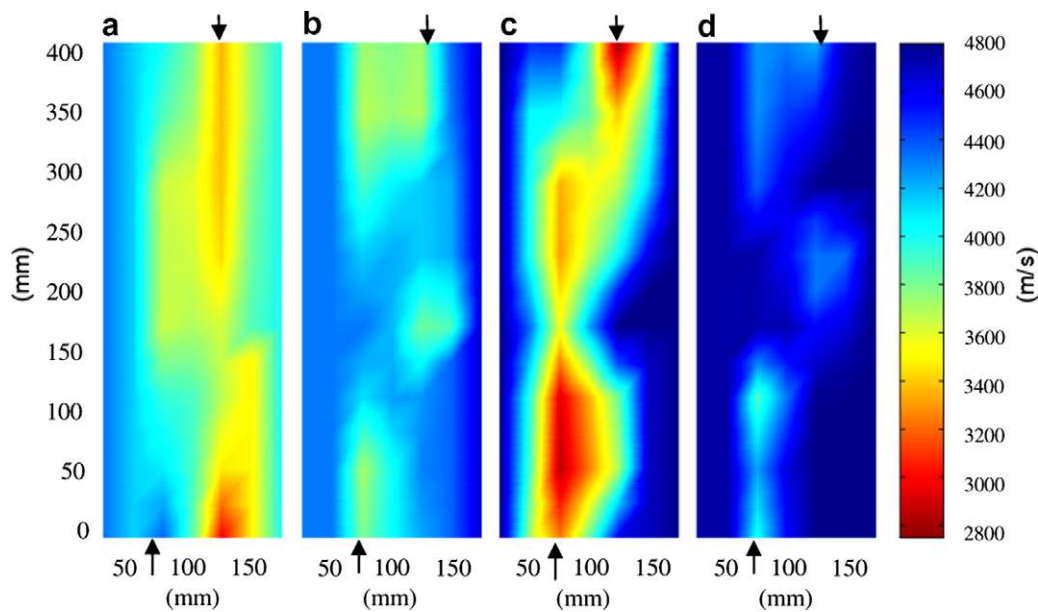
Fig. 13. Velocity tomograms of the vicinity of the crack for (a) 10 kHz before repair, (b) 10 kHz after repair, (c) 100 kHz before repair, and (d) 100 kHz after repair. The arrows correspond to the actual position of crack openings.

the defect, since as mentioned above, the crack in this case was not exactly vertical, but slightly inclined. Also, as the color variation implies, the difference of maximum to minimum for Fig. 13a is 31%, while for Fig. 13c the difference is 49%. This shows that, propagation at higher frequencies is more sensitive to the damage than lower frequencies. The interaction between inhomogeneity parameters, such as size and content, with stress wave velocity and attenuation is not easy to understand. However, in the specific case of this continuous through-the-thickness defect, the velocity of higher frequencies is more sensitive and therefore, appropriate for assessment of the repair effect. It is possible that much shorter wavelengths could interact more strongly with the crack thickness (or the epoxy layer after repair) leading to more accurate results. The inherent difficulty of this case, however, lies to the larger attenuation that makes the propagation of high frequencies troublesome.
