# Report on the Loss of the Mars Polar Lander and Deep Space 2 Missions

JPL Special Review Board

22 March 2000

JPL D-18709

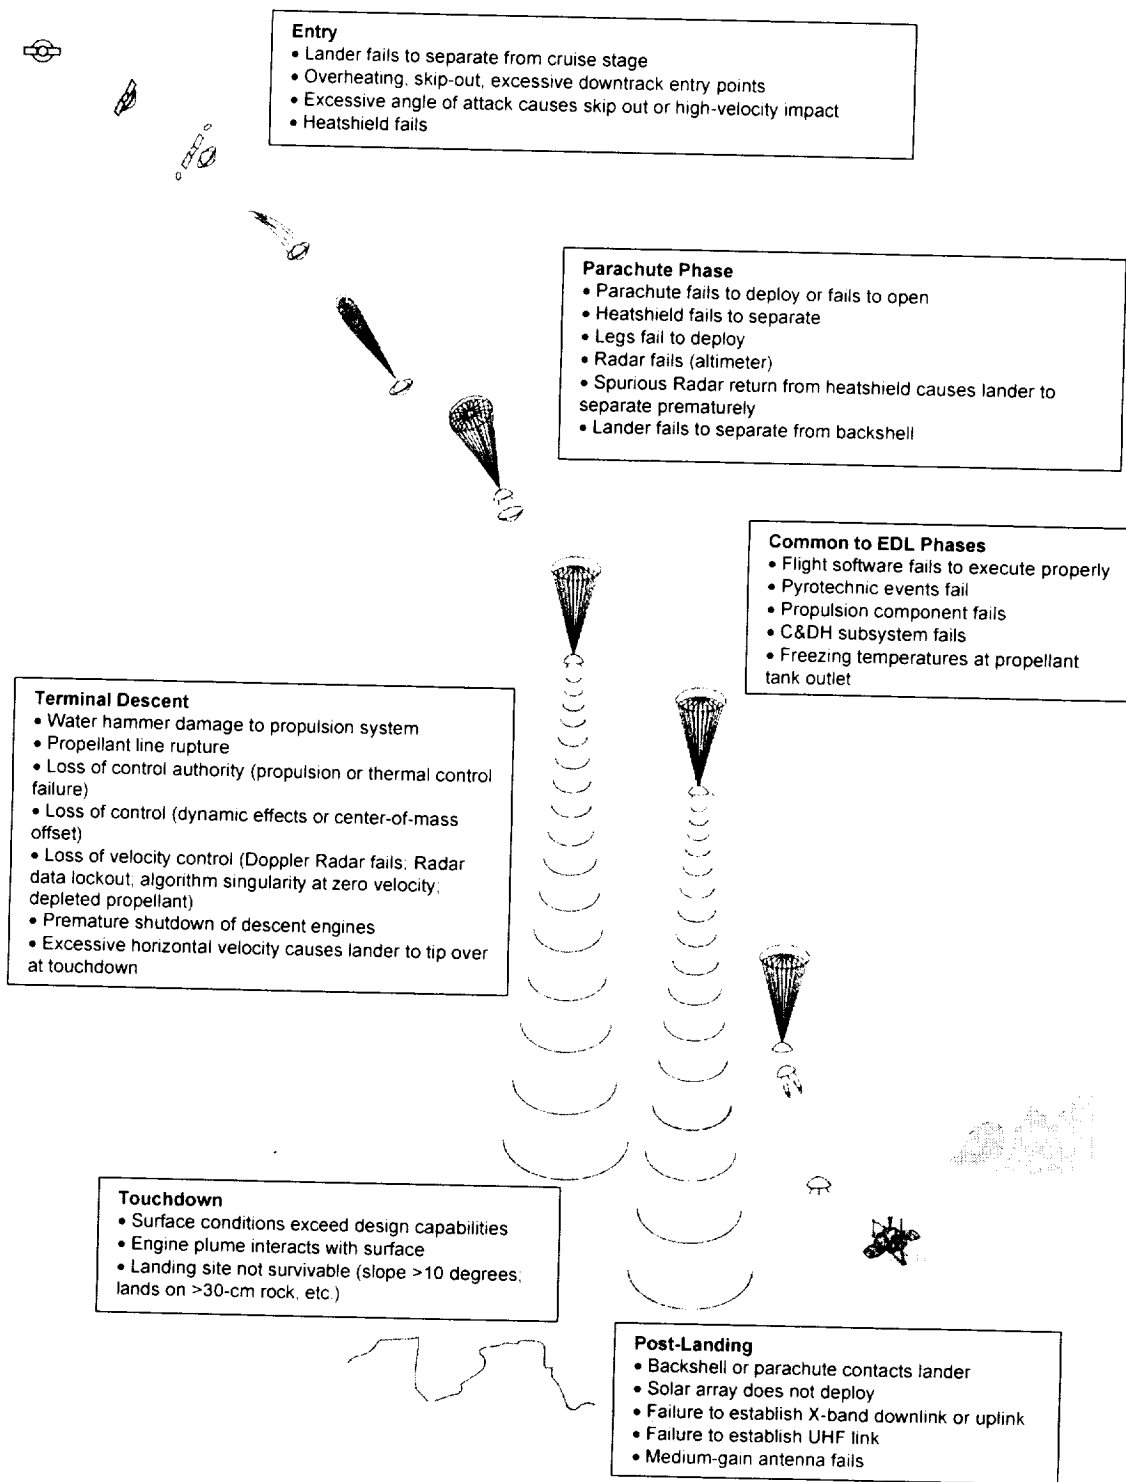
**Figure 6-1. MPL Entry, Descent, and Landing (EDL) Sequence with Potential Failure Modes**

Figure 6-1 depicts the MPL EDL sequence and shows potential failure modes.

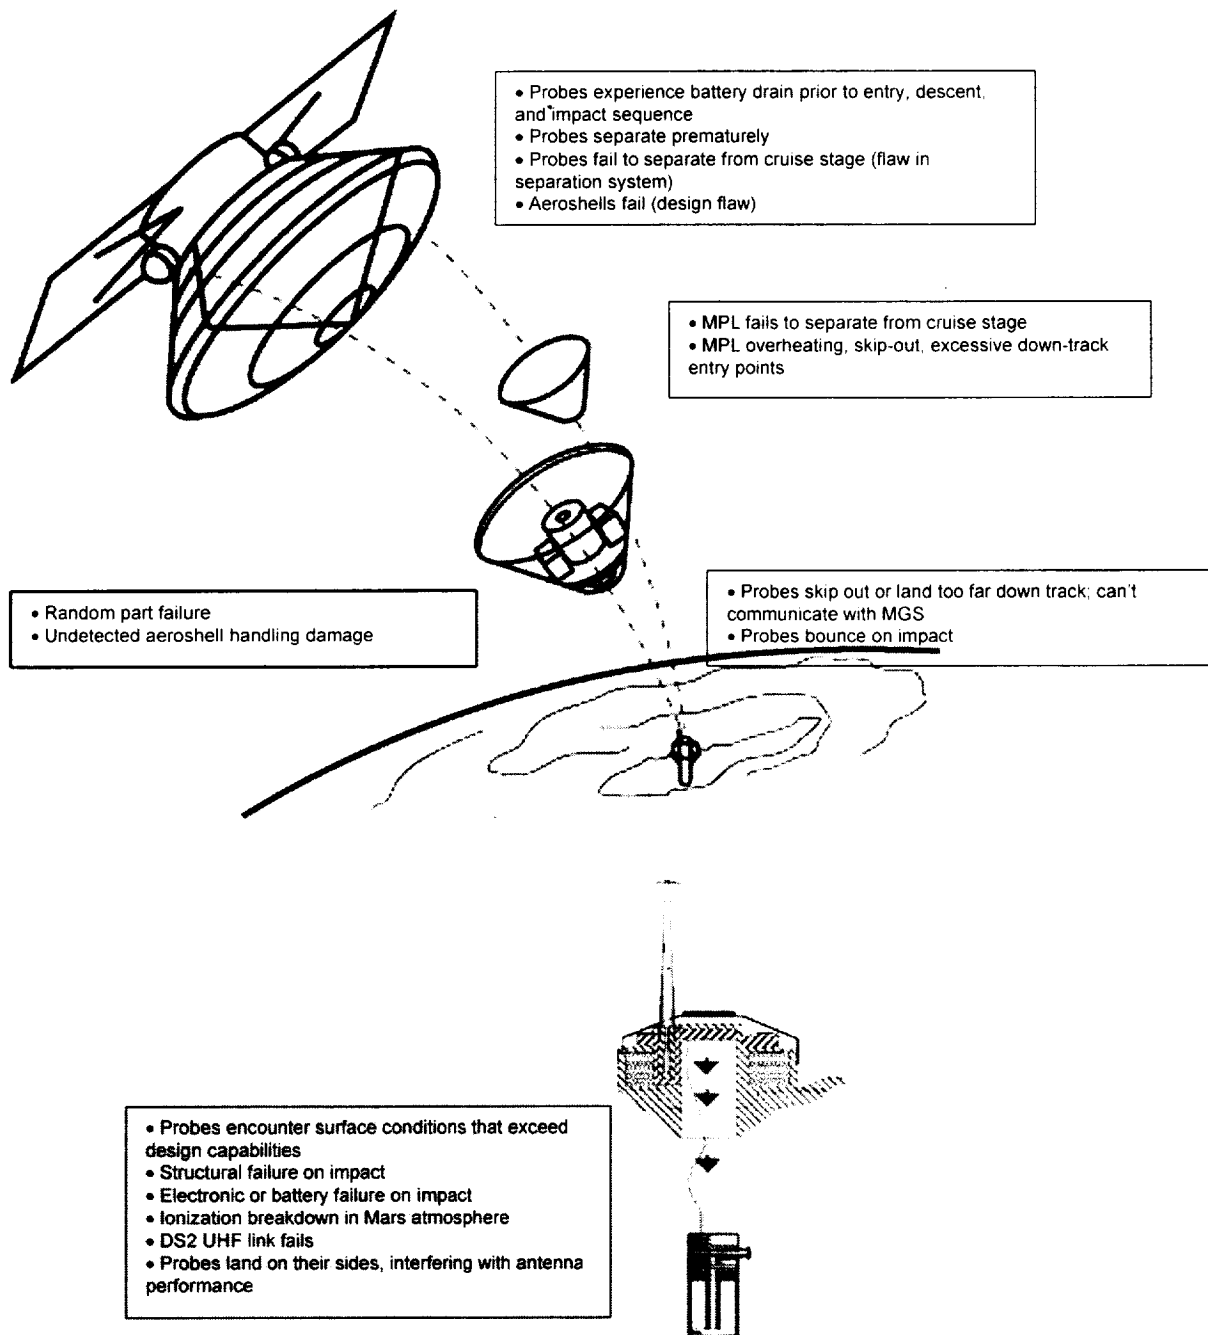
**Figure 8-1. DS2 Entry, Descent, and Impact Sequence with Potential Failure Modes**

The four DS2 potential failure modes identified by the Board as plausible are highlighted as *FLAG 1*, *FLAG 2*, *FLAG 3*, and *FLAG 4*.

Figure 8-1 illustrates the DS2 entry, descent, and impact (EDI) sequence and shows potential failure modes.
