RESTORATION OF THE DIII-D SOLENOID

GA PROJECT 3466
NOVEMBER 1997

Restoration of the DIII-D Solenoid*

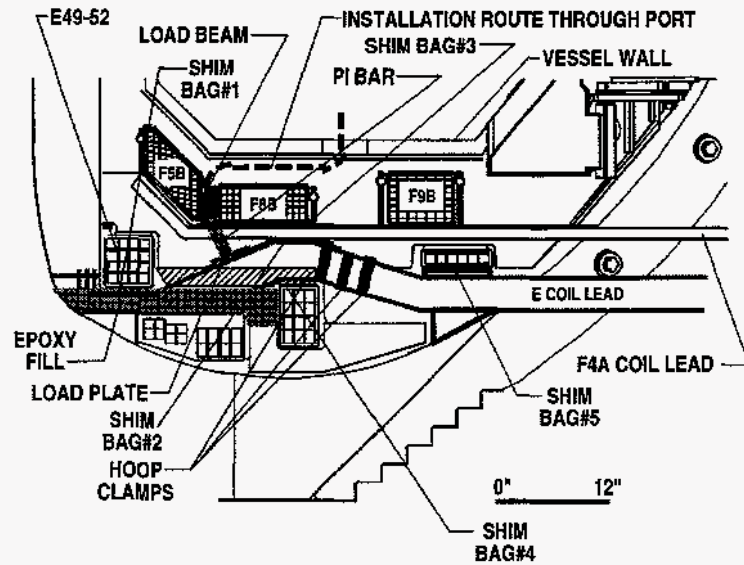
Fig. 1. DIII-D solenoid repair area.

Task 1 was considered to be the most demanding and would be completed successfully before attempting the other tasks. Access through the floor of the vacuum vessel greatly facilitated this task. Fig. 1 shows a vertical cross-section through the lower part of the DIII-D tokamak indicating the solenoid lead, mechanical clamp and bands required for repair.

The removal of failed shrink tube overwrap from the lead in month four indicated that the tear in the fiberglass structural overwrap extended farther outward than previously known. This extensive failure of the overwrap resulted in the requirement to install three metal strap bands, as shown in Fig. 1, to replace the hoop constraint function of the overwrap. These stainless band clamps were formed in a C shape with a stud and swing bolt on one end and a slotted captive barrel nut on the other end. Like all hardware installed through the vertical port, it was installed one handed with vision provided by two bore scopes with in-vessel and ex-vessel monitors. Designs were evolved to allow reasonable single handed attachment. These band clamps were tightened to develop 10700 Nt (2400 lbs) of hoop tension in each band.

1. Restrain the conductor pack in the lead area using a clamp to produce 23000 Nt (5200 lb) downward preload against the conductors in the lead. This loading will eliminate cyclic deflections in the conductors which would result in continued crack growth. Actively monitor the preload force to assure proper preload condition. Install three band clamps around the lead between the F5B and F8B coils to maintain the conductors in their proper position since the overwrap has failed in the area between the solenoid and the F9B coil.

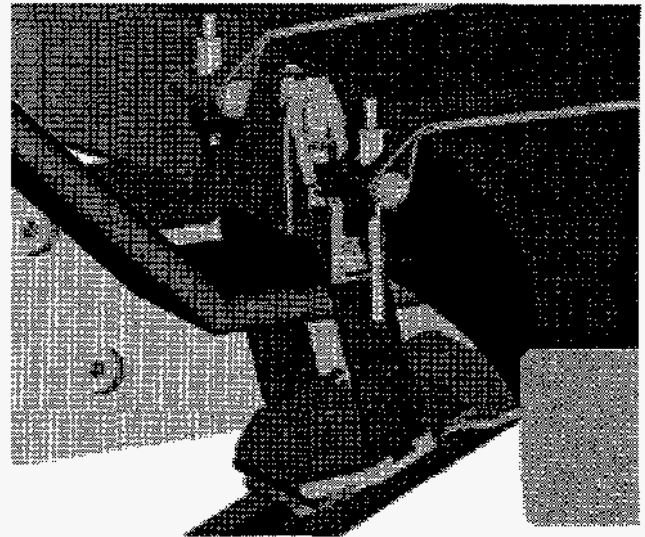
Fig. 2. Solenoid lead clamp system.

The basic mechanical clamp (Figs. 1&2) design was developed based on drawing dimensions. The component parts must be remotely positioned either by long handled tools, strings, or by the arm of a technician reaching through the hole in the vessel floor developed by removal of the vertical port. The clamp applies downward force to a load plate which in turn applies pressure to the inclined solenoid

lead through shim bag #2. Shimbags are positioned and then pressure filled with epoxy and function to distribute the load evenly to the irregular surface of the lead. The outer end of the shim bag is secured to the solenoid lead with one of three hoop clamps. Placement of the shim bag and clamp installation to constrain the shim bag is done first. Installation of the load plate is then done along a horizontal path parallel to the solenoid lead. A 5 m long concentric tubular handle is used to position the plate past its final insertion position at which time the plate is rotated 90° about two perpendicular axes and then tilted 25° about the third axis in order to align with the surface of the lead. The load plate is then moved outward on top of shim bag #2. The pi bar (a structural bridge that looks like π) is then brought into position through the vertical port opening, and rotated into place straddling the F4A coil lead and engaging mechanical keys into the load plate to prevent slippage between the pi bar and load plate. The load beam is then brought in through the vertical port with the load arms

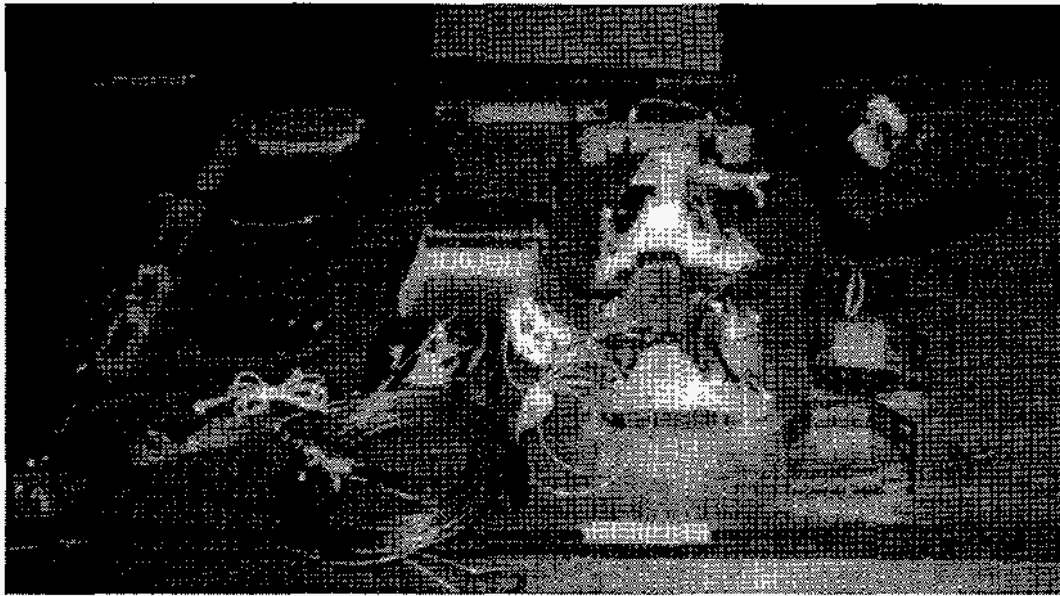
Fig. 4. Progression of mockups to production components.

Initial clamp models were made of wood for ease of fabrication and low electrical risk should they become stuck or trapped in place. Prototypes advanced to plastic (Delrin) with aluminum deployable arms constructed to as-built dimensions. Fig. 4 shows the progression of 4 or 5 generations starting at the top of the figure with wooden models and progressing down to production instrumented components of 7075 aluminum and Inconel 718. Inspection gages are on the left of the photo.

Difficulties occurred in fully deploying the arms on the plastic prototype. The clamp beam was being forced away from the F8B coil due to the equatorial bulge in the overwrap on the coil. This bulge was neither shown on the drawings nor directly measured. The successful trial fit was accomplished by thinning the arms on the prototype. This information was factored into the production design.
