## Rock slope stability problems in Gold Coast area, Australia

Shokouhi Ali, Gratchev Ivan, Charrismanagara Arry  
Griffith University – Gold Coast campus - Australia

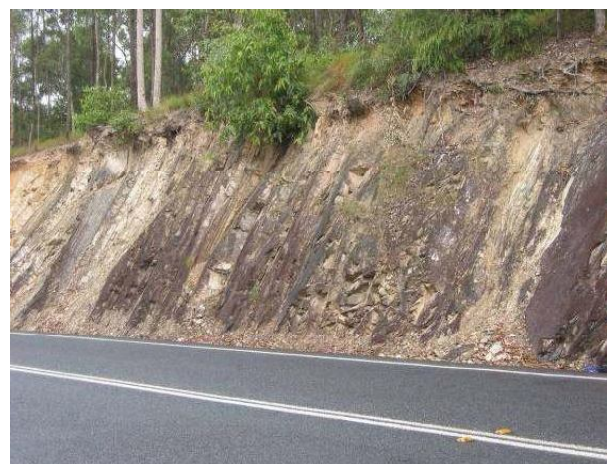
Figure 2 - One of investigated slopes

The investigation field was located along Beaudesert – Nerang Road, immediately south-east of the Beaudesert – Nerang Road / Arunta Drive intersection, on the Gold Coast (Fig.1). The approximate length of the existing cut slope is 200m and with the height of approximately 7m. (Fig.2)

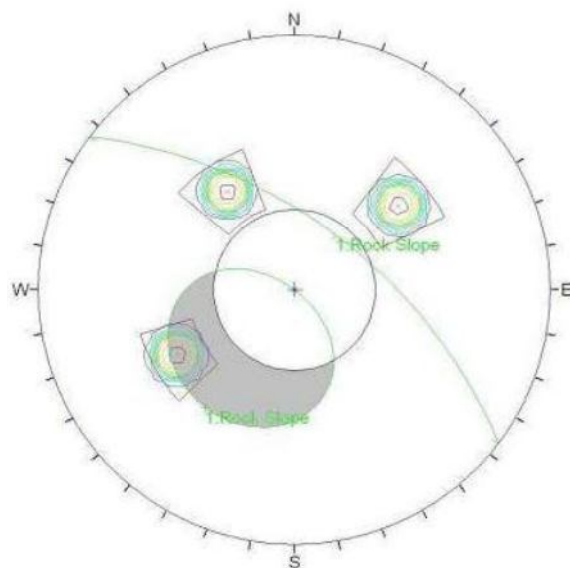
**Figure 3 - Planar sliding of location 1**

The collected data were analyzed by Dips computer software to identify the potential failure modes of the investigated slopes. The results from kinematic analysis indicate that at location 1, there is only one potential failure mode. Planar sliding is the most likely failure mode that may occur at this location (Fig.3). As can be seen in Fig3 some of the discontinuities are located in gray shade that shows the potential planar sliding area. Toppling and wedge failure analyses show, there are no toppling and wedge potential failure at location 1.

The results from SMR analyses consistently show that location 2 has the best rock mass condition out of the three locations, followed by location 1, and location 3 has the worst. These results reflect the evidence that there was a significant recent rock fall at location 3. At location 1, the rock fall was deemed to be minor, however, small fragments of rock blocks were found along the toe of the rock slope.

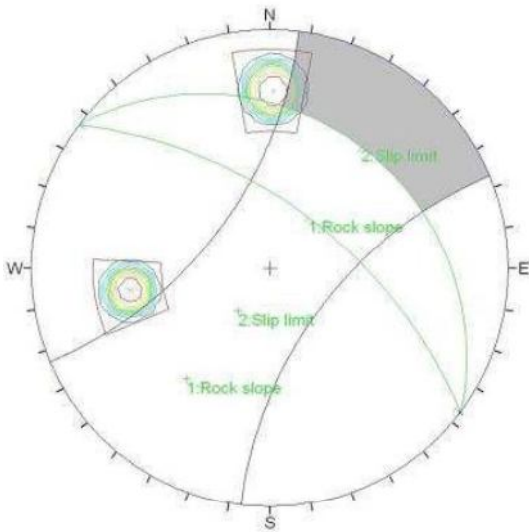
**Figure 4 – Toppling failure of location 2**

In location 2, the results produced by kinematic analysis suggest that there may be a potential toppling failure (Fig.4). In Fig.4, a part of the contour lines fall within the toppling failure zone that indicates the potential toppling failure.

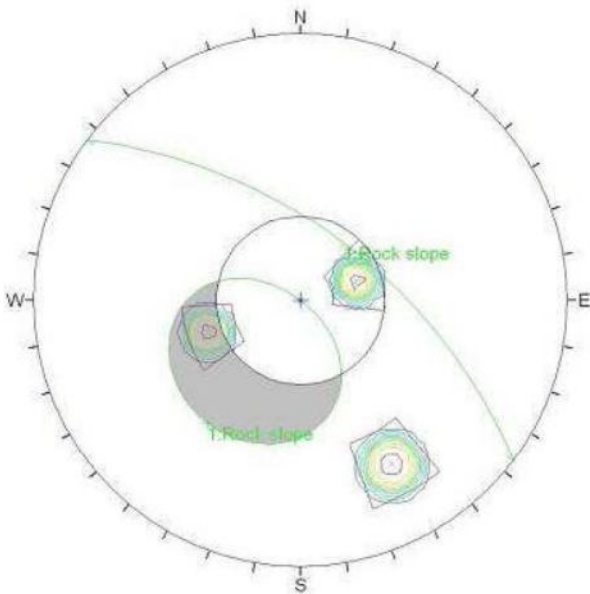
**Figure 5 – Toppling failure for location 3**

The results of kinematic analysis show that the rock slope at location 3 has two potential failure modes, planar sliding and wedge sliding. In Fig. 5, the discontinuity set #3 falls within the failure zone (grey shaded area) for planar sliding analysis. This means that planar sliding may occur along this failure plane.

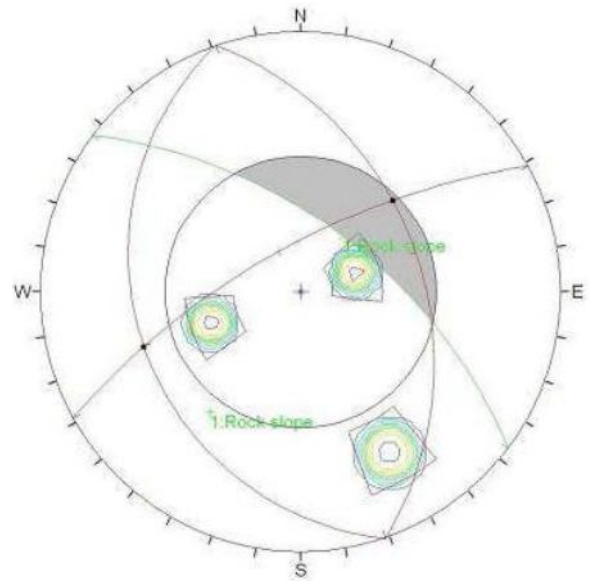
**Figure 6 - Wedge failure of location 3**

Fig.6 shows that there is a mean joint set orientation intersection (shown by black dots) that falls within the wedge failure zone (grey shaded area). This indicates that a wedge failure may potentially occur at location 3.

All the analysis done on the rock slope at location 3, point out that this section of the slope is the least stable out of the three.
