ROTOR-TO-STATOR RUB VIBRATION IN CENTRIFUGAL COMPRESSOR

Gao Jin Ji and Qi Qi Min
Liaoyang Petrochemical Fiber Company
Liaoning, The People's Republic of China

This paper discusses one example of excessive vibration encountered during loading of a centrifugal compressor train (H type compressor with HP casing).

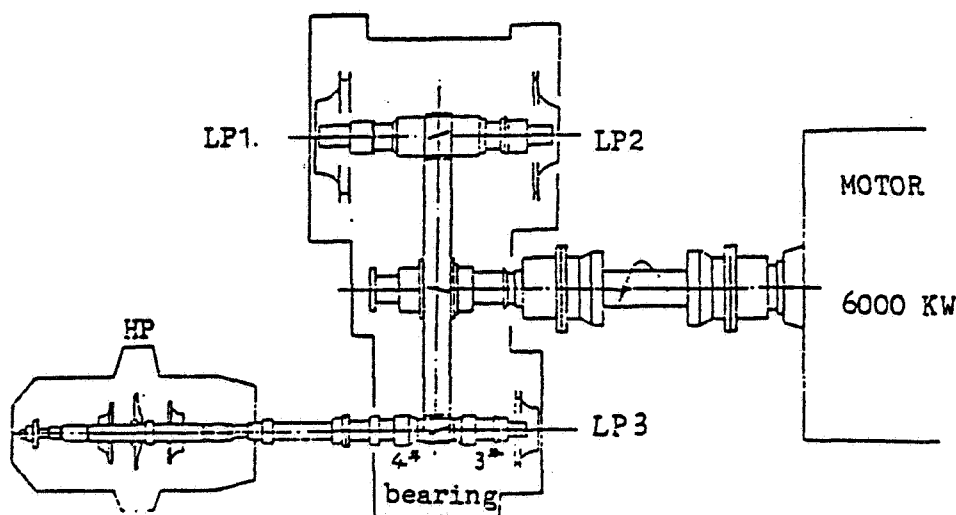
The subject machine is the H type compressor with one HP casing, one LP body including two shaft-lines mounted on a gear box with 3 compression stages, and one HP casing with 3 aligned impellers, mounted at shaft-line end of third LP stage (see Fig. 1).

Figure 1.- H type of centrifugal compressor with HP casing.

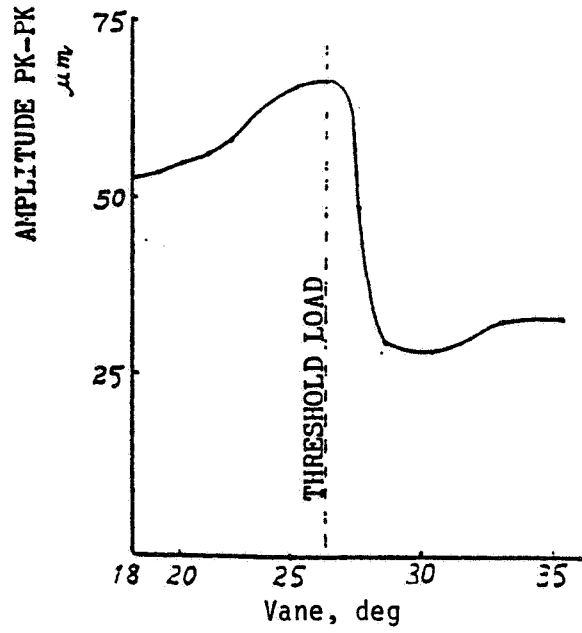
To detect the exact moment and cause of this high rotor vibration, the spectrum cascade during start-up and the curve of amplitude vs. degrees of the opened van had been recorded (see Figs. 3 and 4). Obviously, there is no amplitude peak in machine speed from 0 rpm to 13987 rpm. This means that the machine did not pass through a critical speed during start-up. But, with an increase in opening the vane, an amplitude peak occurred.

Figure 4.- Effect of dynamic load on vibration. February 10, 1982.

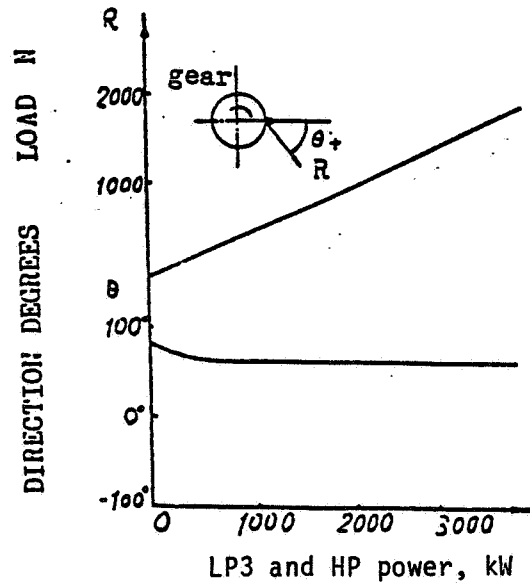
The results of calculation and analysis show that the high speed rotor and the #3, #4 bearings in the LP casing belong in the variable stiffness bearing system. It is different from most compressors. With an increase in dynamic load during opening the guide vane, both machine power and load of the #3, #4 bearings are increased. Fig. 5 shows radial load of the #3 bearing and direction angle vs. power of the machine. Because the bearing stiffness directly affects the critical speed of the rotor-bearing system (Fig. 6), at the moment when the dynamic load reaches a certain value, the critical speed can coincide with the operation speed, and the resonance will occur. This value of dynamic load is called "threshold load." In normal cases the machine runs smoothly as soon as it passes through the threshold load (Ref. 2).

Figure 5.- Radial load versus machine power.

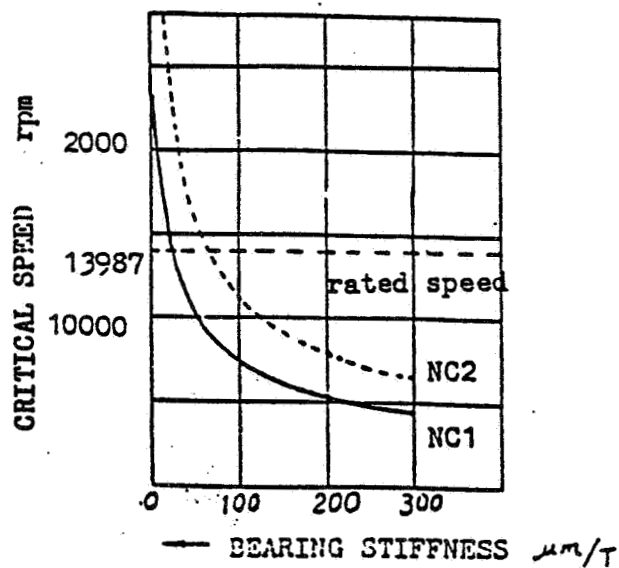
Figure 6.- Critical speed versus bearing stiffness.

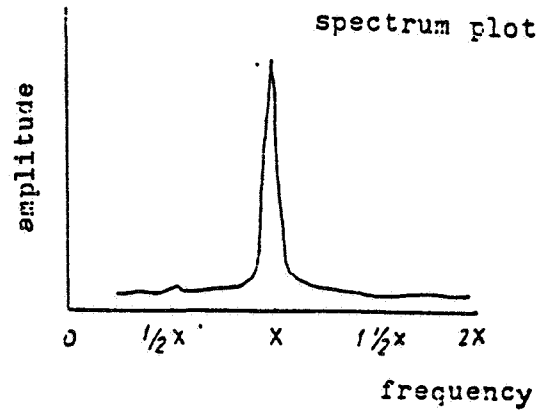
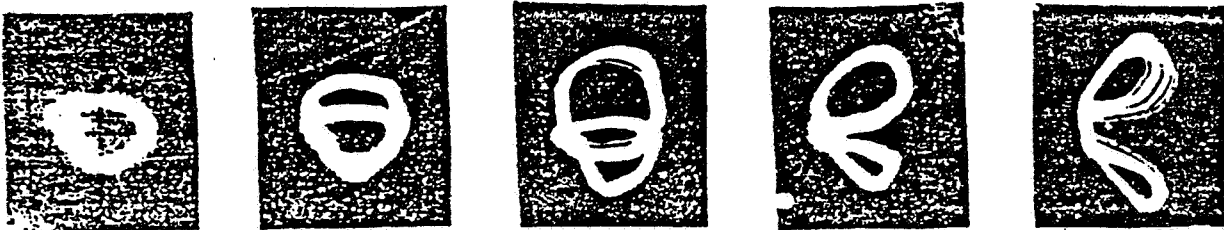
The change course of the orbit plots during loading the machine is shown in Fig. 7.

In the excessive vibration condition, there are two types of waves and orbit plots (A), (B) (see Fig. 7).

At the moment of passing through the critical speed on the threshold load, $1\times$ rpm high vibration occurred and soon dropped, but in the malfunction condition, excessive vibration did not drop even if passed through the threshold load. As shown in the Fig. 7 (A), the rotor motion orbit plot was elliptical with one fixed bright spot. During dismantling the machine, some wearing plots were discovered in the exact same direction on the #3 bearing. And at the moment when the excessive $1\times$ rpm vibration was dropping, the change of 720° in phase angle had been recorded by chance (see Fig. 8). It shows the excessive vibration was reverse precession due to full rub, because high friction forces may cause a dramatic change of the precession direction from forward to continuous backward whirl (Ref. 3). This is self-excited vibration. If harmful energy accumulates long enough, the orbit plots will diffuse (see Fig. 7 (A)). At this moment the machine must be shut down immediately.

(a) Full-rub, reverse-precession vibration.

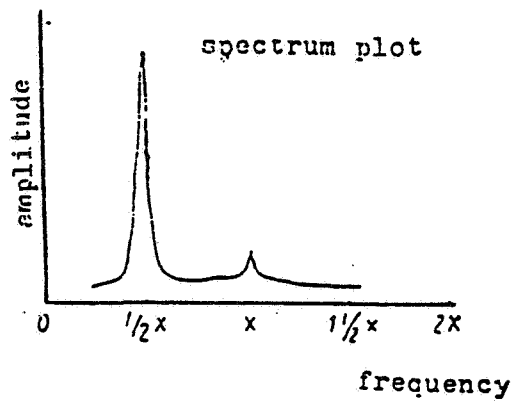
Oil whirl (hydrodynamic instability of bearings) is the most popular forced sub-rotative speed mechanism, but in this case according to the instability threshold curves of offset halves bearing (Ref. 4) and the results of the calculation of speed term and clearance term, the operation condition point on the #3 bearing was far from the region of instability. And it was exact $1/2\times$ rpm but not less than $1/2$ rpm vibration, which often occurs during oil whirl. In addition, the vibration wave was different from oil whirl and coinciding with subharmonic vibration (Ref. 5), so that the failure was not caused by oil whirl.

Exact $1/2$ subrotative vibration may be caused by partial rub or by a loose non-rotating part (Ref. 3 and 6). During dismantling the machine, no loose part was found on the bearing shell, bearing housing, or pedestal support. As observed in the performance of many machines, the partial rotor to stator rub, or rub in oversized or poorly lubricated bearings, often causes steady subharmonic vibration of the frequency equal to exactly half of the rotating speed (Ref. 3). In the subject machine, the top clearances of the #3 and #4 offset halves bearings was 0.48 mm.

The diameter of the bearings was 120 mm, the ratio of the diameter to the clearance was 0.4%; obviously it is too excessive. For this reason, the failure can be attributed mainly to the oversized bearings.

(b) Exact 1/2 subharmonic vibration.

(1) The top clearances of both #3, #4 bearings were reduced from 0.48 mm to 0.31 mm on November 2, 1984.

(2) To increase oil viscosity the PRESLIA 20 type lub oil was replaced by PRESLIA 30 and oil temperature was reduced from 42°C to 28-30°C on November 3, 1984.

(3) The gear coupling was replaced by a new one and exact alignment was taken in December 1984.
