**Seismic performance of precast industrial facilities following major earthquakes in the Italian
territory**

Abstract

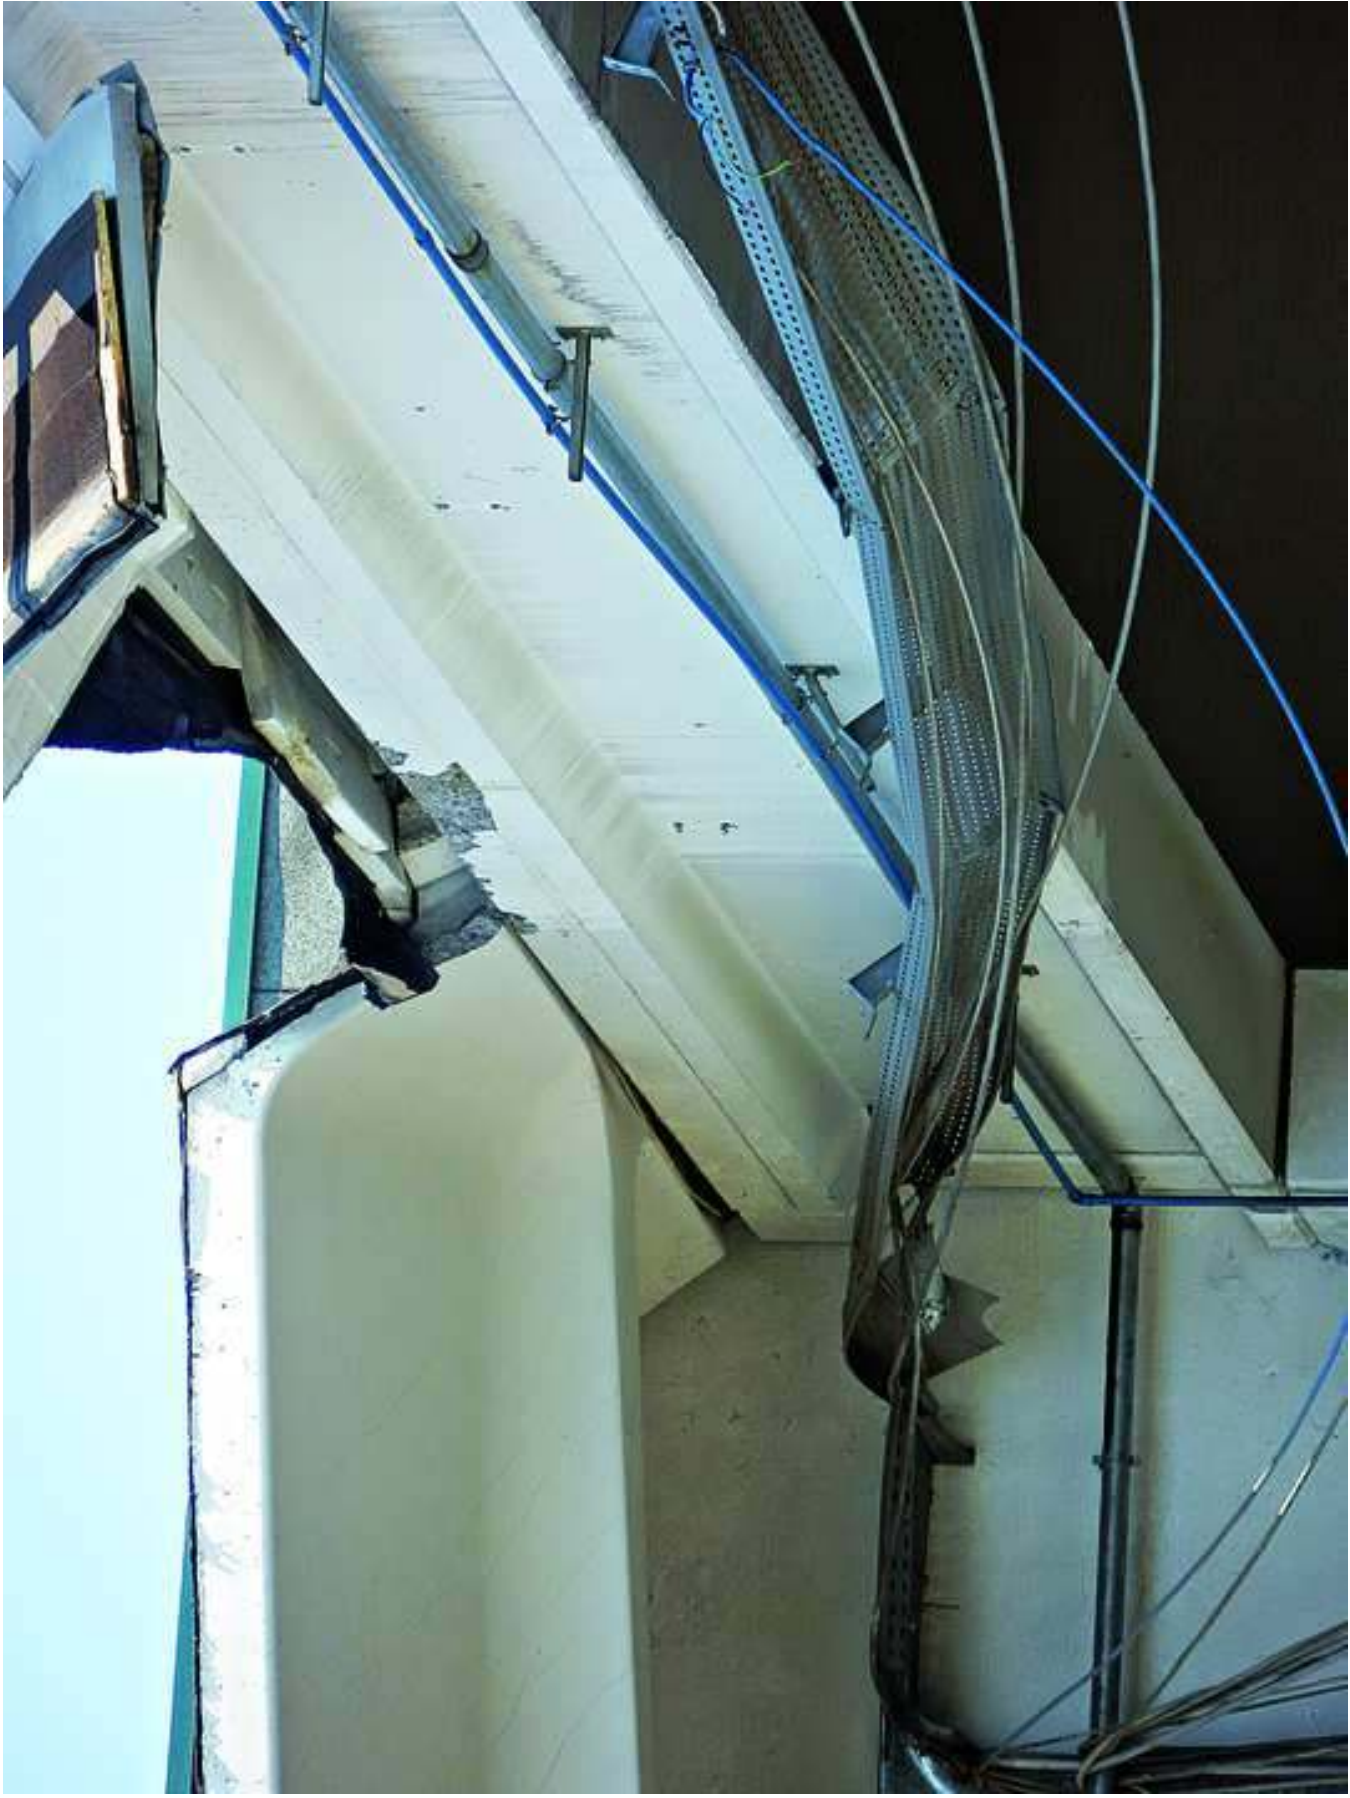
Figure 5
[Click here to download high resolution image](#)

As mentioned before, the most severe damage observed during the Emilia earthquakes is associated to the structural element loss of support and consequent falling, since the beam-to-column and roof-to-beam connections lacked mechanical devices as a seismic load transfer mechanism. Such type of collapse affected more significantly structures belonging to category A. Fig. 5 shows the loss of support of roof elements from the supporting beam, while Fig. 6 depicts the failure mode of a

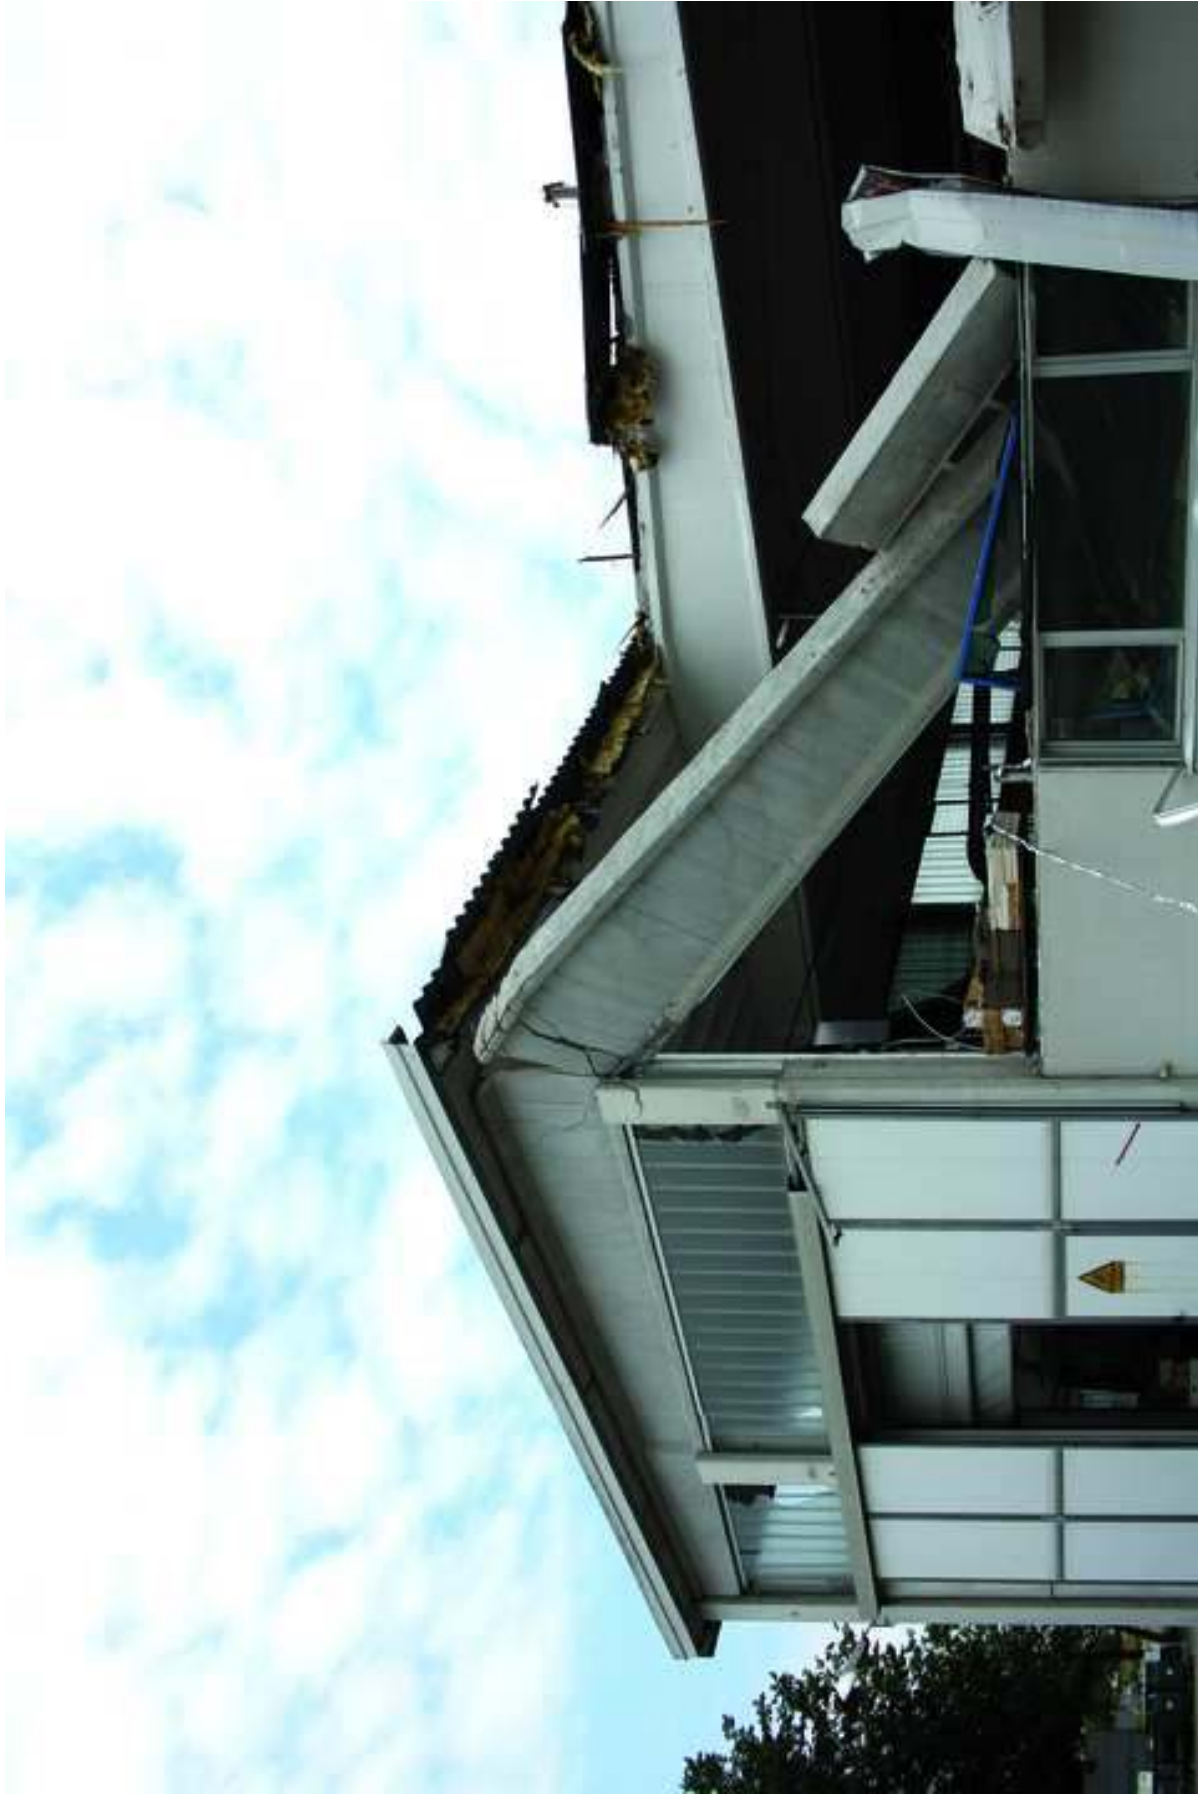
Figure 6

precast tapered I-beam due to its interaction with a column placed at the mid-span of the facade portal frame: designed as an element simply supported at its ends, the beam lost one of its supports during the earthquake and failed in flexure at mid-span, in accordance with a cantilevered static scheme not considered during design.

14 **Fig. 6. Precast tapered I-beam failure due to the loss of support**

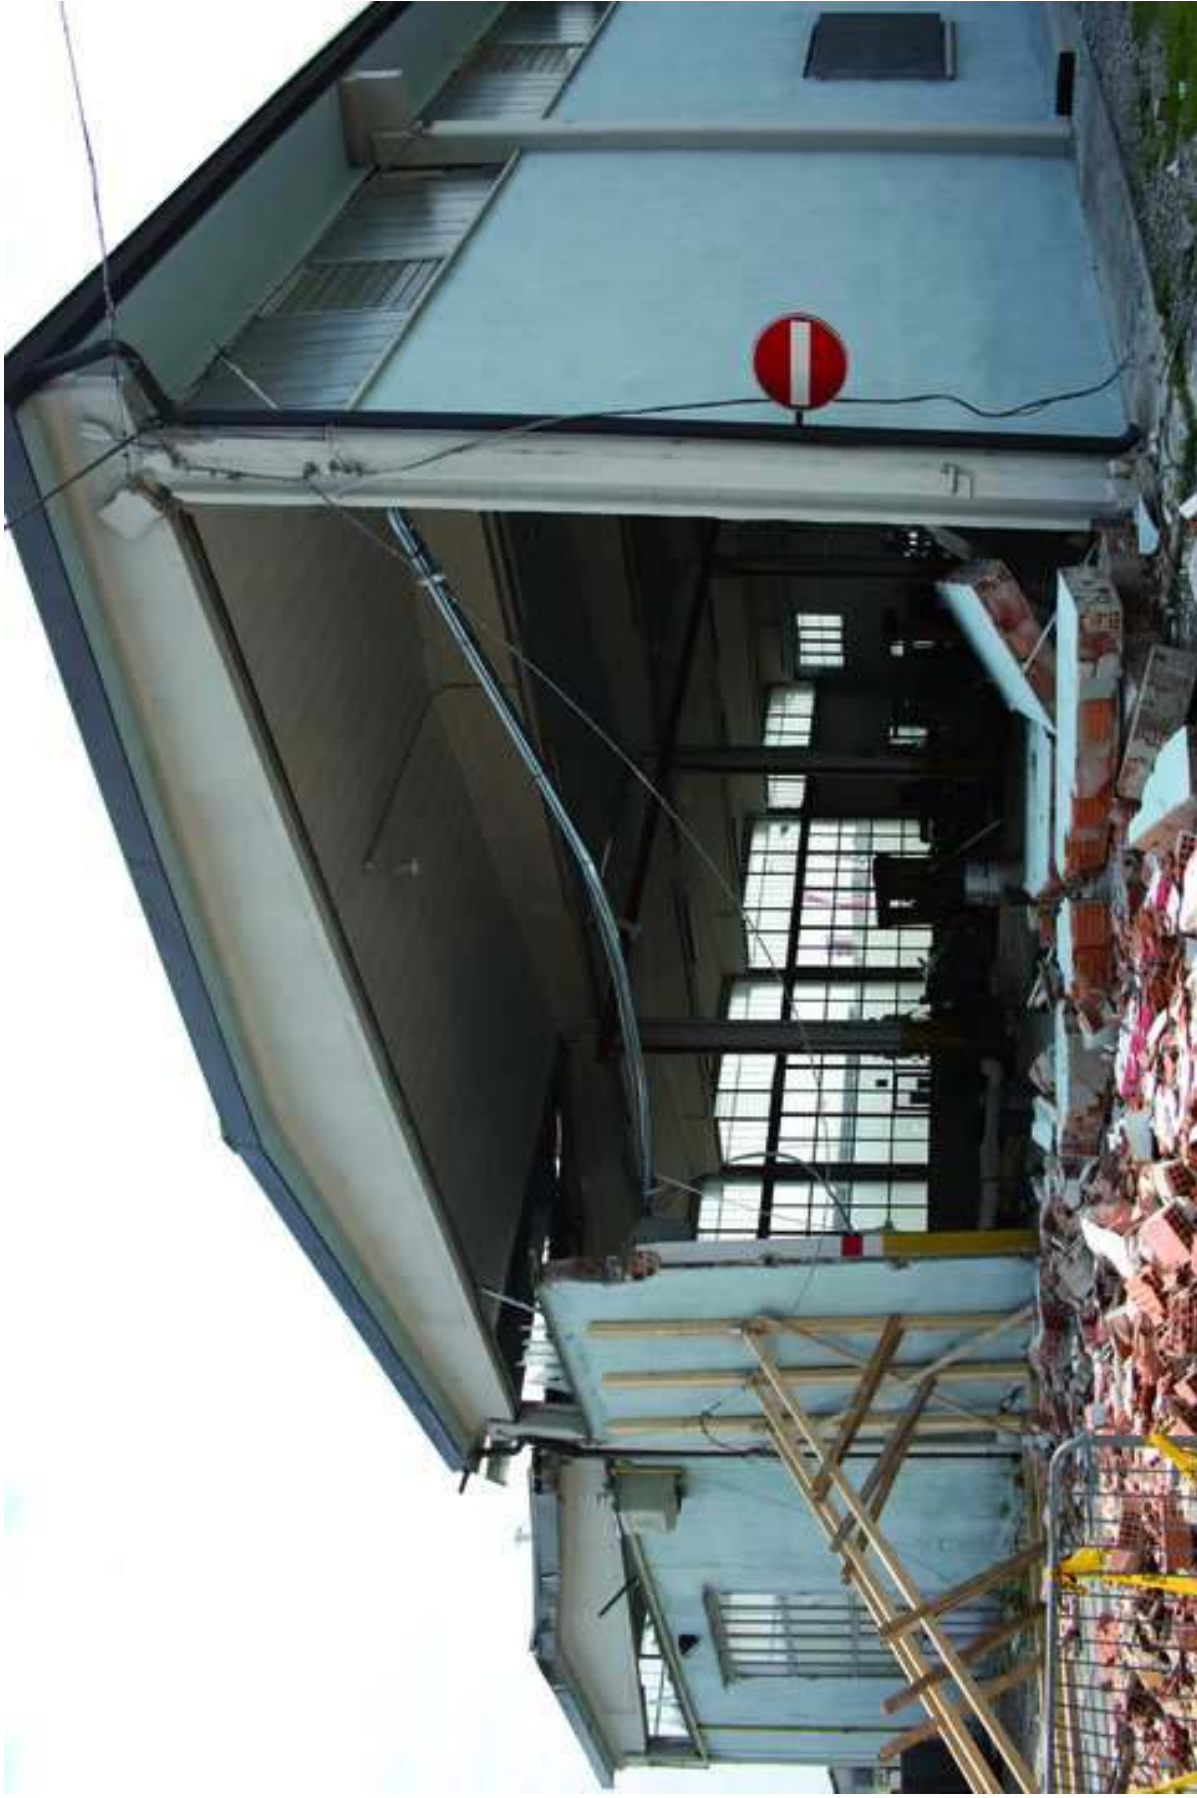
Figure 9

Another frequent failure typology observed is the collapse of the cladding panels, consisting both of brick masonry and precast RC elements. For what concerns the former, traditionally used in buildings of category A, the incipient collapse was observed to be associated with the high out-of-plane slenderness, as no lateral restraint was provided in correspondence to columns and RC spandrels (Fig. 9).

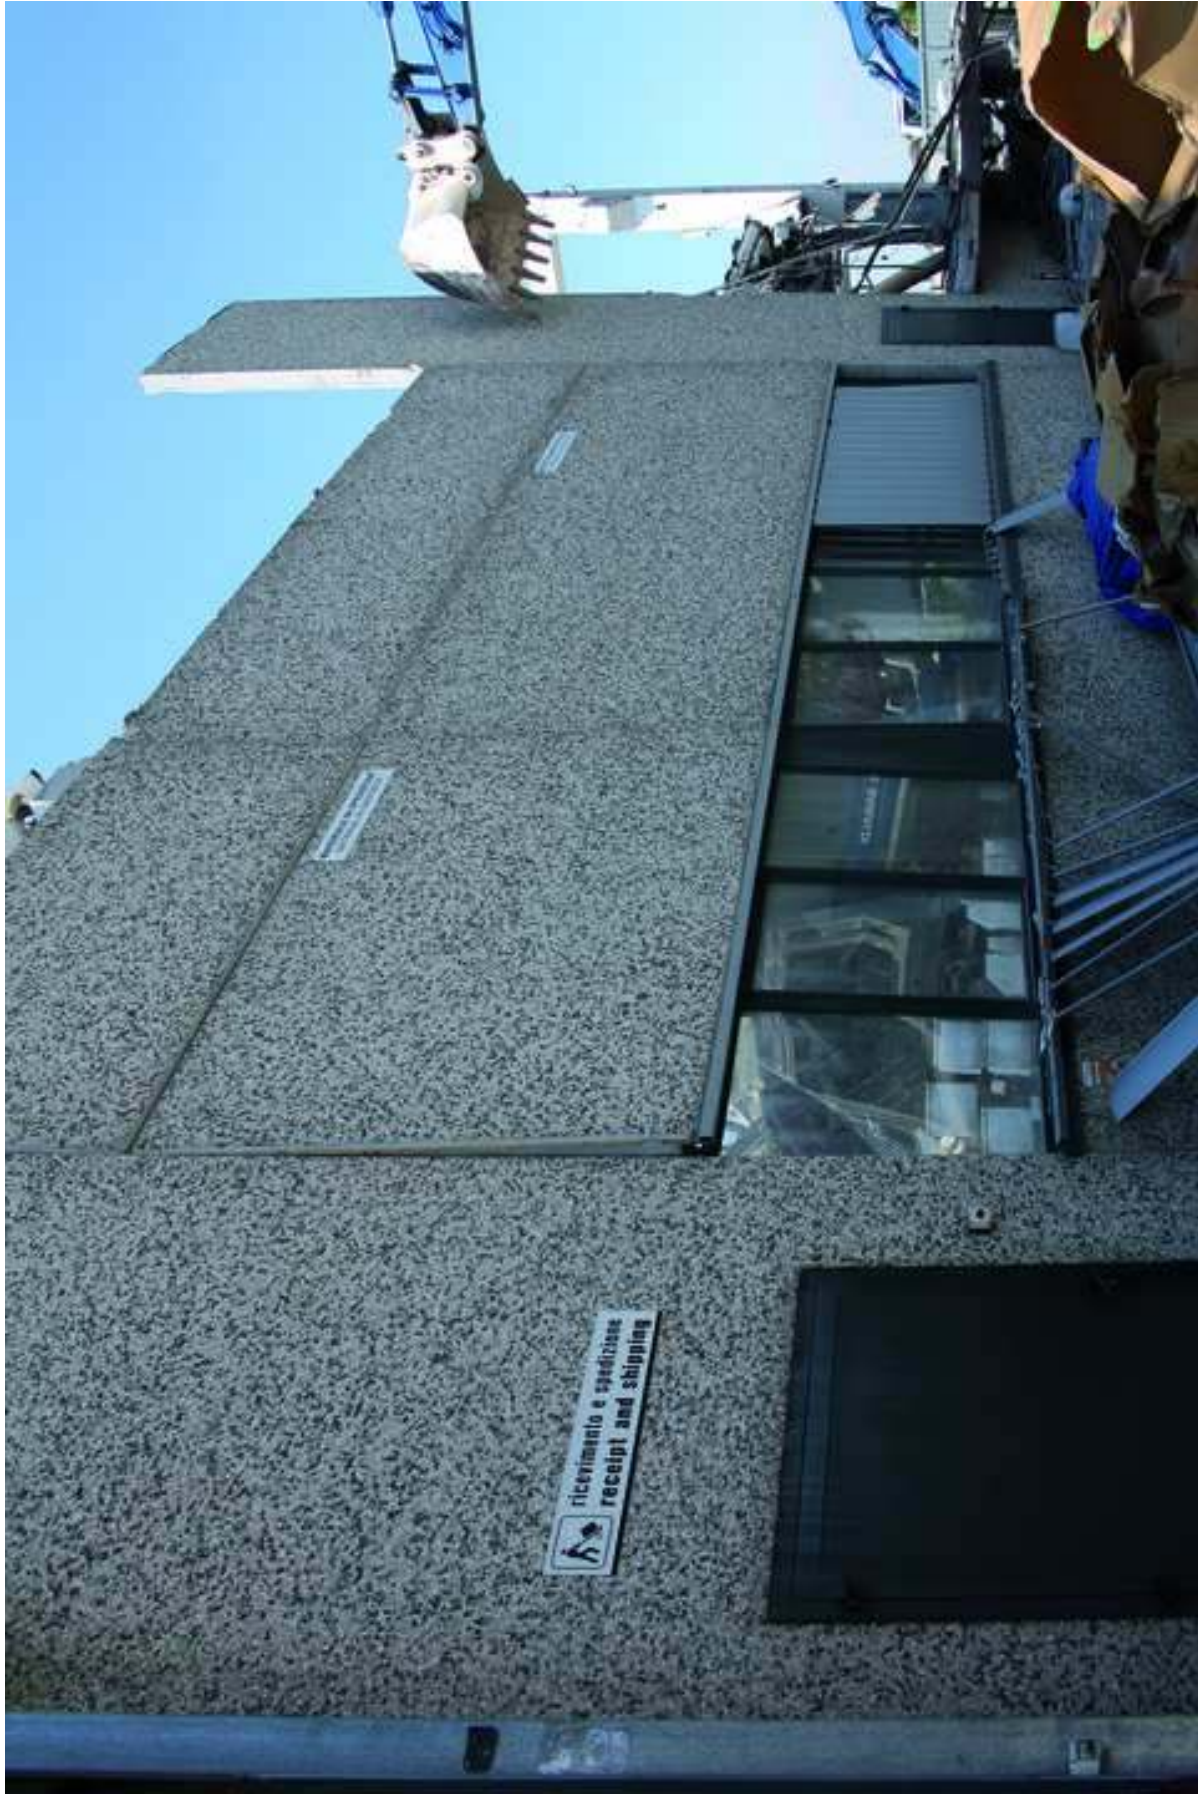
Figure 10
[Click here to download high resolution image](#)

Conversely, in structures of category B, the observed falling of horizontal (Fig. 10) and vertical (Fig. 11) RC precast cladding panels was clearly related to failure in the mechanical connections, typically anchor channels and C-shape or L-shape steel profiles, to the supporting columns and/or beams. In fact, these devices were designed to sustain mainly vertical gravity loads and to avoid the panel overturning as a consequence of low out of plane horizontal actions, such as wind loads. During an earthquake these connections need to accommodate high relative displacements and rotations, being the displacement and rotation demand concentrated at the connection level owing its lower stiffness compared to the connected precast elements.

The complex panel-structure interaction caused many collapses particularly in the case of irregularities along the height of the structure. Many horizontal panels dropped down, as anchor channels were absolutely not adequate to allow for large seismic displacement demands and, consequently, their plasticization induced the expulsion of the retaining bolts by prying action, particularly in the upper panels. On the contrary, vertical panels behaved slightly better; if properly fixed to their foundation beam or drowned into the industrial pavement, they stiffened and strengthened the building, however without inhibiting the previously observed vulnerabilities. By contrast, collapses were observed in the case of vertical sandwich panels, adopted for thermal insulation issues, characterized by lower stiffness and strength.

24 **Fig. 10. Horizontal precast cladding panels collapse due to connection failure**

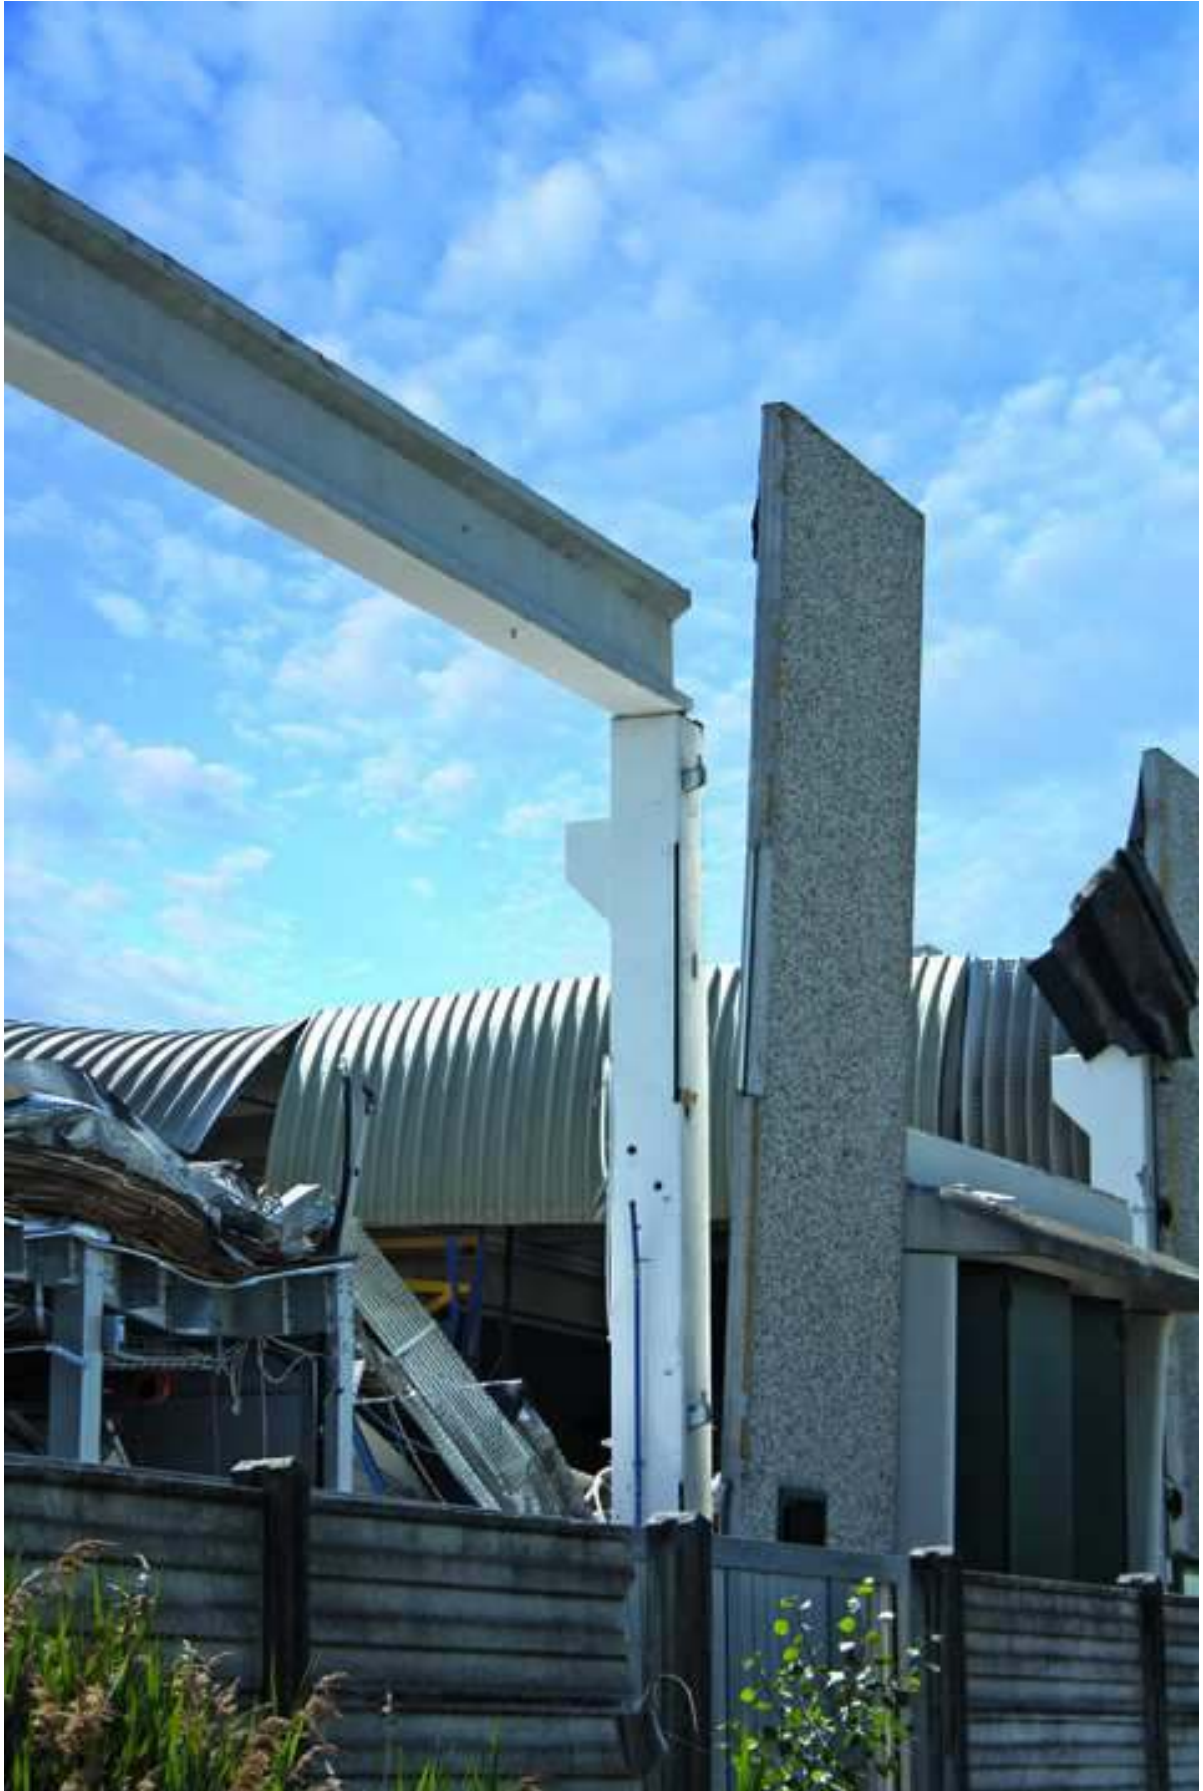
Figure 11
[Click here to download high resolution image](#)

26 **Fig. 11. Vertical precast cladding panels collapse due to connection failure**

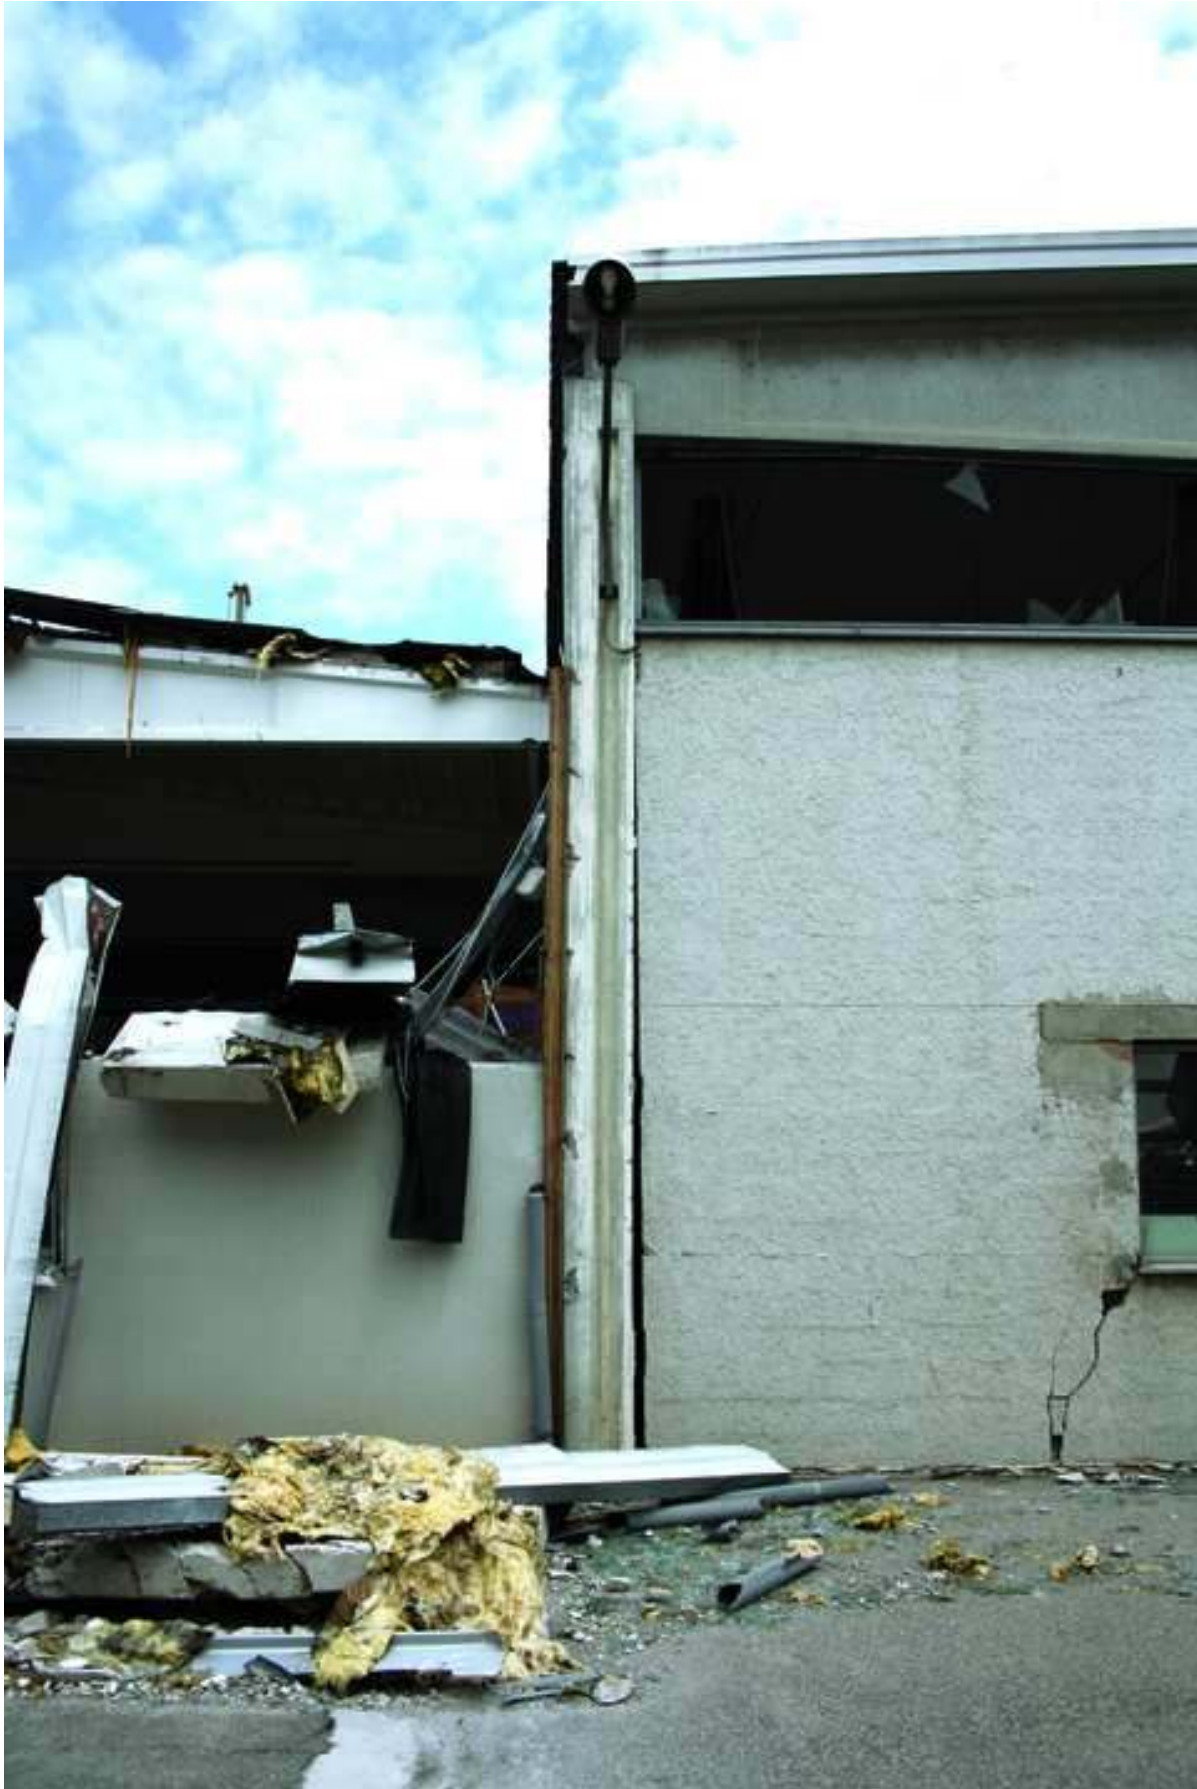
Figure 12
[Click here to download high resolution image](#)

Other damaged elements observed in Emilia are the columns. As depicted in Fig. 12 and 13, some columns lost their verticality due to permanent relative displacements and rotations experienced at

the foundation level, where socket foundations not designed for seismic loading were provided without additional interconnecting tie beams.

The presence of industrial RC floors and the loss of roof elements and beams could have contributed to this phenomenon: the former in providing only mono-lateral restraint to the columns relative movements, the latter in reducing the stabilizing gravity load. Such foundation typology was widely used since the nineties and it was commonly designed against the overturning induced by wind loads and industrial cranes only. Furthermore, being the foundations under-designed for seismic loads, they most likely experienced elastic uplift, considering the reduced foot print and the relatively high foundation vertical load safety factor. Proofs of uplift are provided by 45° cracks detected in the pavement in correspondence of the column edges.

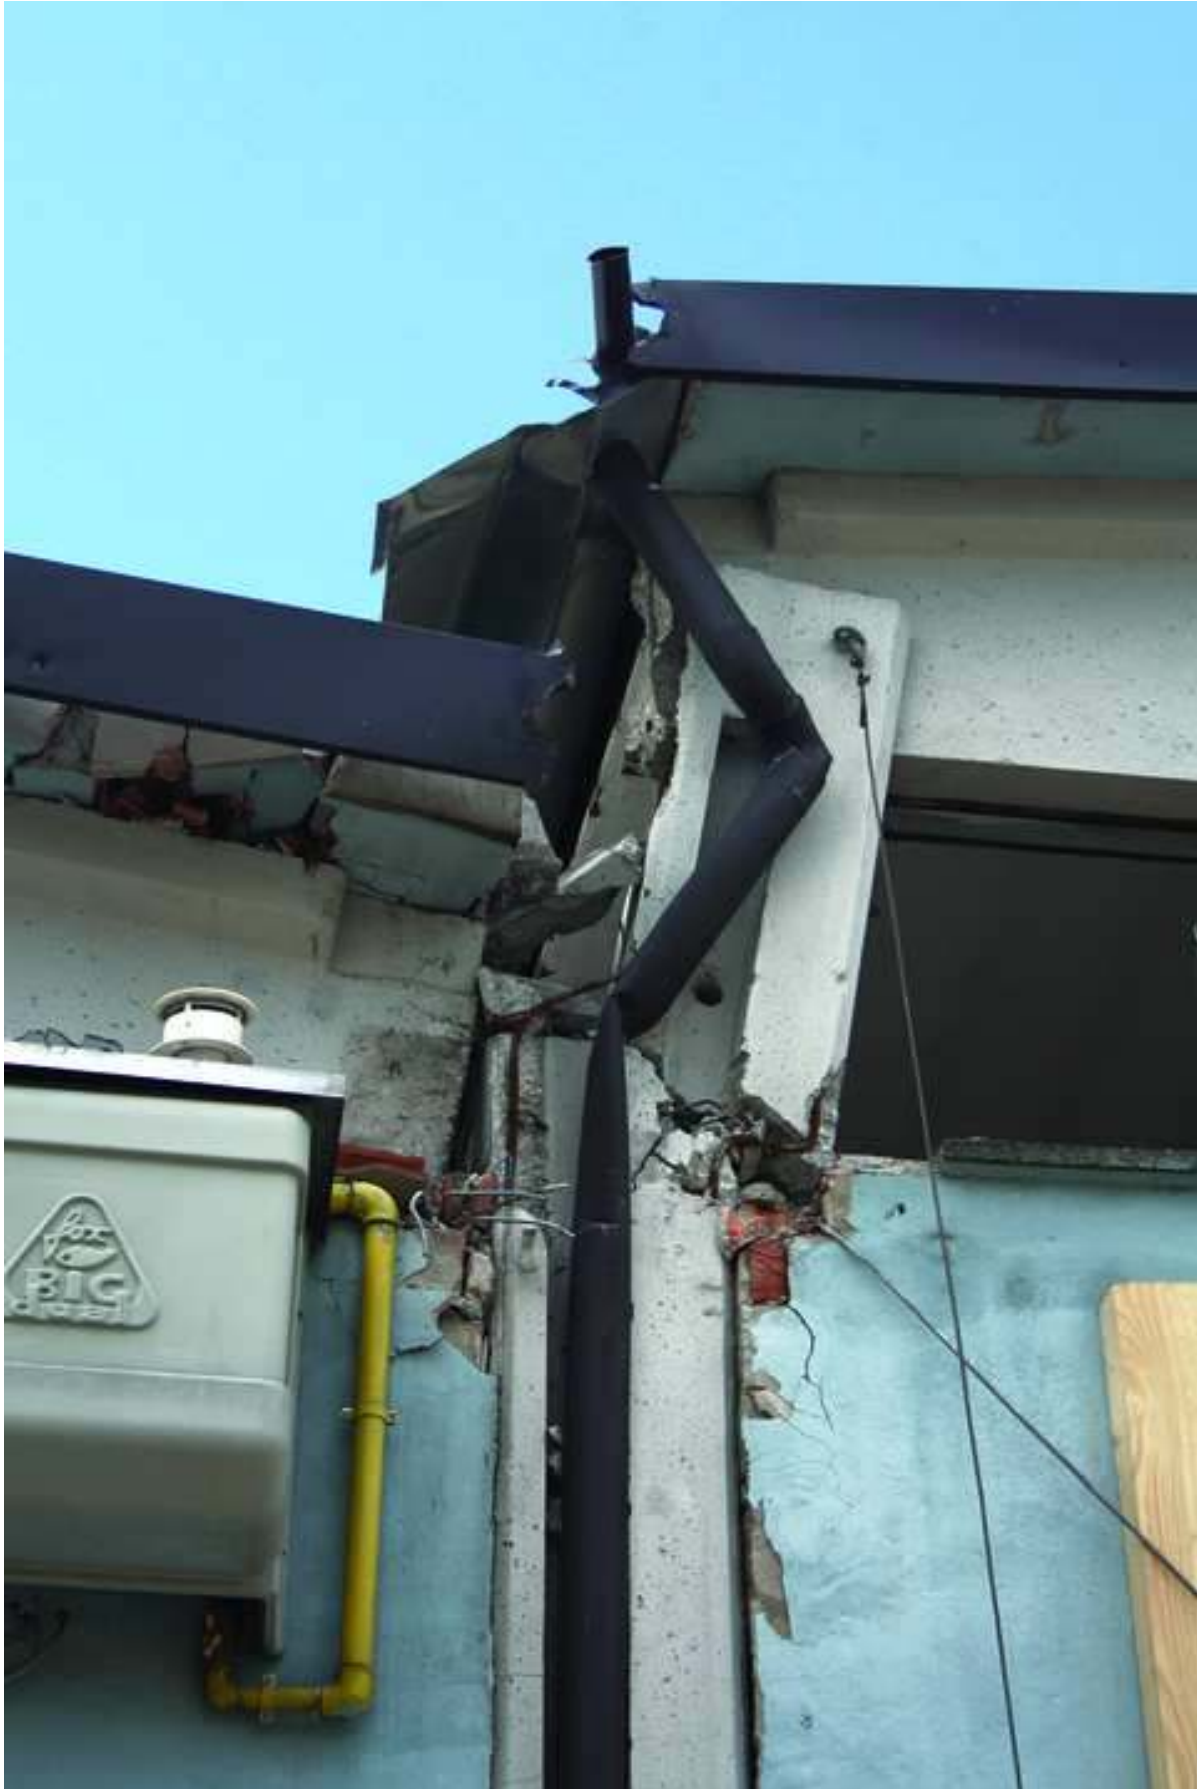
Figure 14
[Click here to download high resolution image](#)

Another column damage scenario is found in correspondence of ribbon glazing and cladding panels discontinuities where several stocky-column failures were noticed (Fig. 14). Furthermore, when RC forks were provided at the top of the columns, in more recent buildings, their flexural or shear capacities were clearly exceeded (Fig. 15), due to under-designed loads and poor detailing, therefore becoming ineffective in restraining the out-of-plane loss of the support.

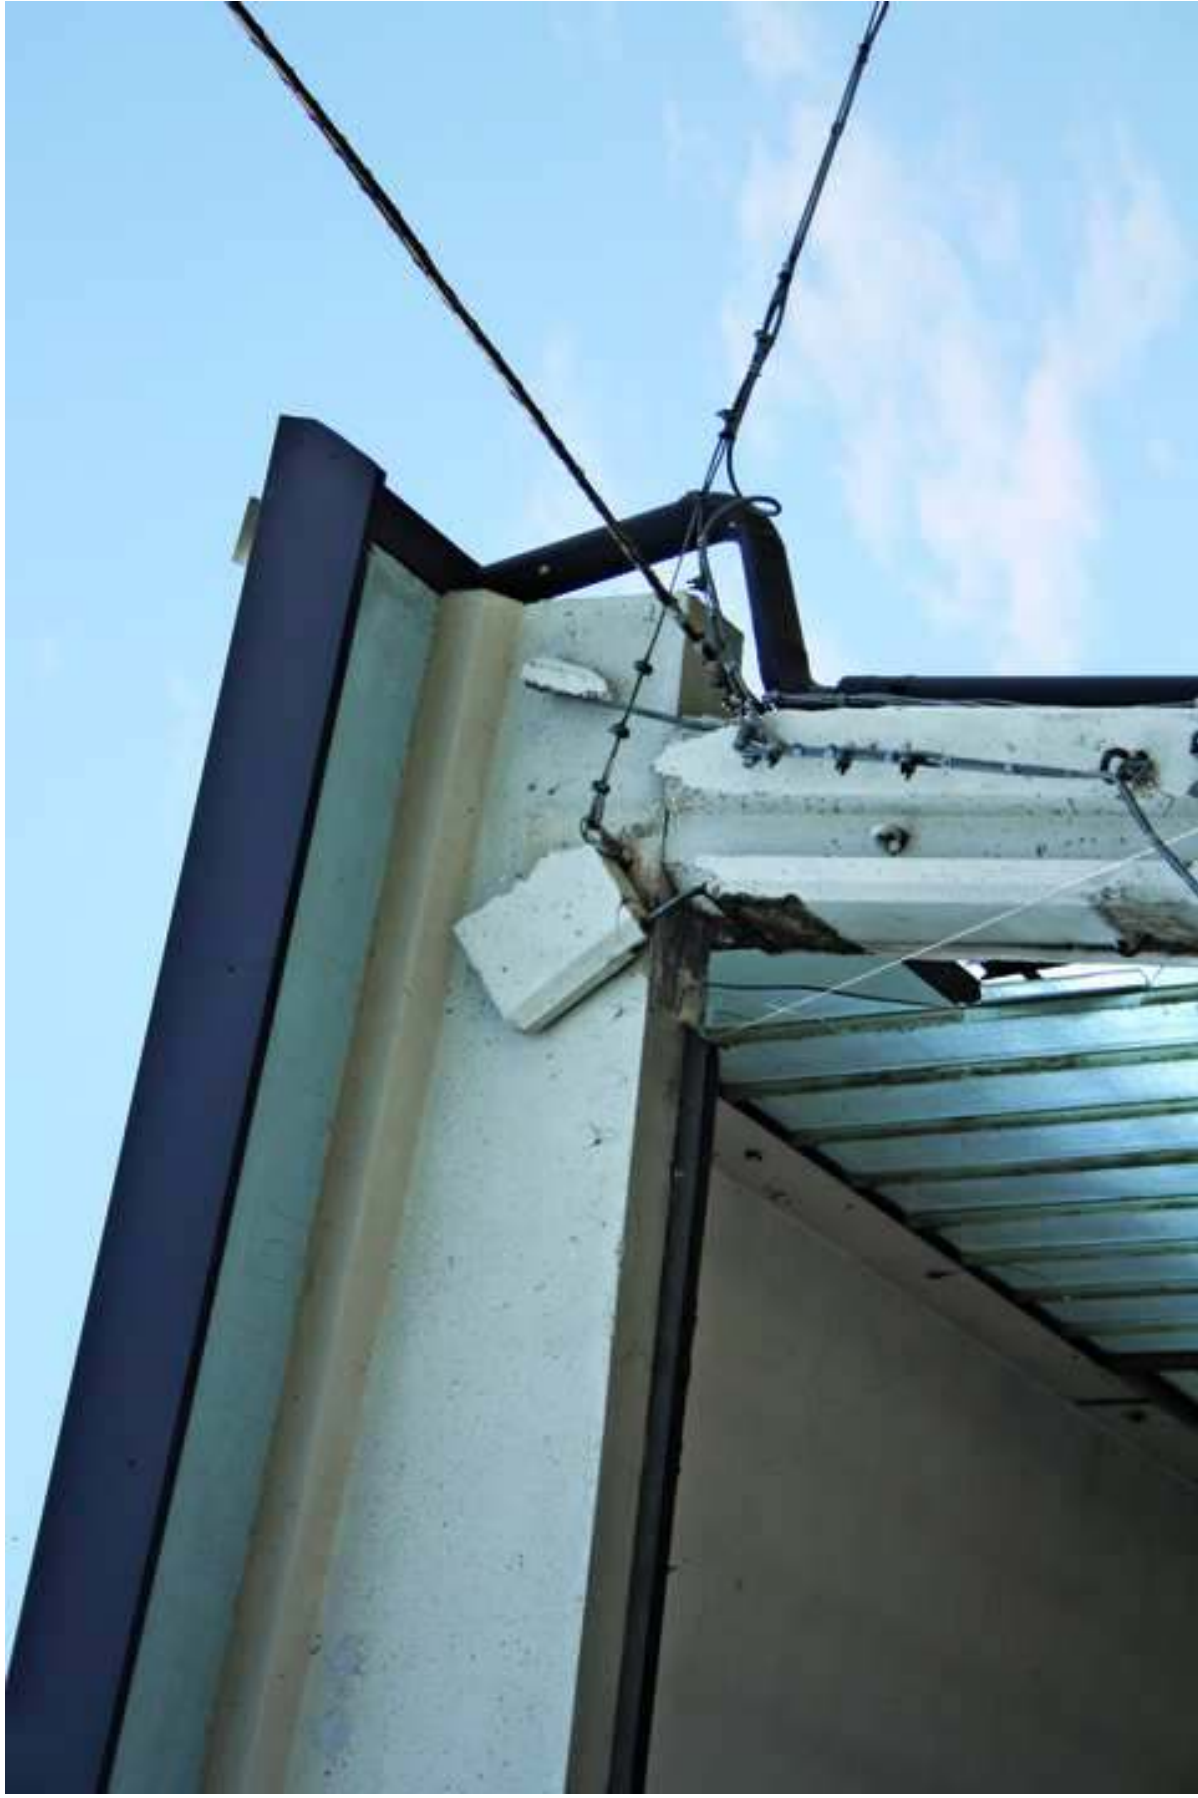
Figure 15
[Click here to download high resolution image](#)

The flexural and shear demand on existing RC forks at the top of the columns generally exceeded the capacity, leading to the inability of preventing the out-of-plane sliding and overturning of the framing beams. In addition, the columns were in some cases proven to rigidly rotate into the isolated socket foundations.
