MISCELLANEOUS PAPER CERC-87-20

# SIDE-SCAN SONAR INVESTIGATION OF BREAKWATERS AT CALUMET AND BURNS HARBORS ON SOUTHERN LAKE MICHIGAN

Andrew Morang

December 1987

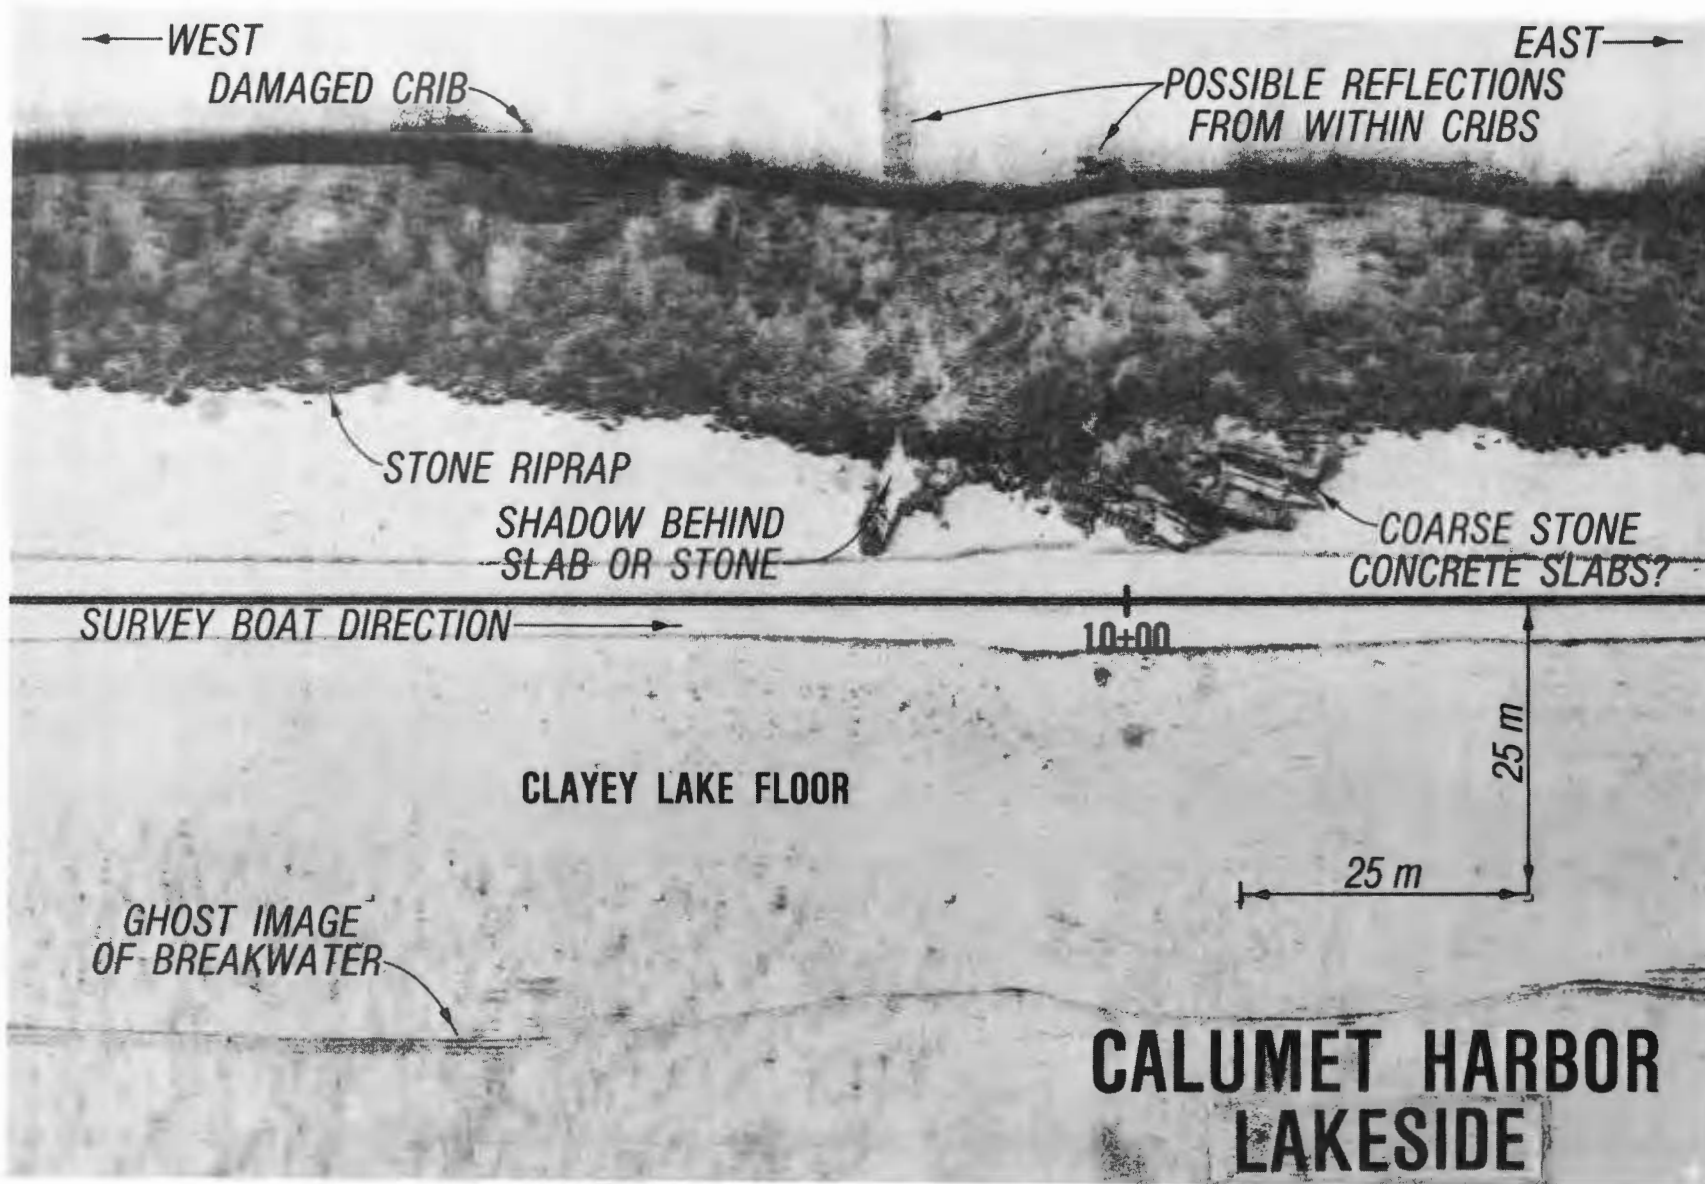
Figure 5. Lakeside, Section A, Calumet Harbor breakwater

10. The toe of Section A is protected by an armor stone berm which varies in width from 13 to 20 m. At sta 10+00, a lobe of the armor extends up to 30 m out from the toe of the cribs and may be coarse stone deposited recently for protective or repair purposes. The lake floor in this area is featureless and of low reflectivity, probably clay.

11. The lakeward face of the Section A breakwater is discontinuous and irregular, and numerous individual cribs project outward from the main body of the breakwater (Figure 5). Displaced units occur near sta 4+00, 8+00, 9+00, 12+00, and 15+00. The unit at sta 15+00 has been noted earlier in conjunction with a displacement evident on the harbor side. Numerous irregular reflections occur up to 3 m behind the face of the breakwater, and it is hypothesized that they occur at gaps in the damaged face of the cribs where the acoustic signal has entered a void and has reflected from the fill material within the cribs. These void reflections occur near sta 4+00 and 6+00 through 10+00, 12+00, and 13+00 (Figure 5). In support of this hypothesis, these reflections do not occur on the harbor side of Section A where the physical environment is less severe and where the faces of the cribs appear to be in better condition.

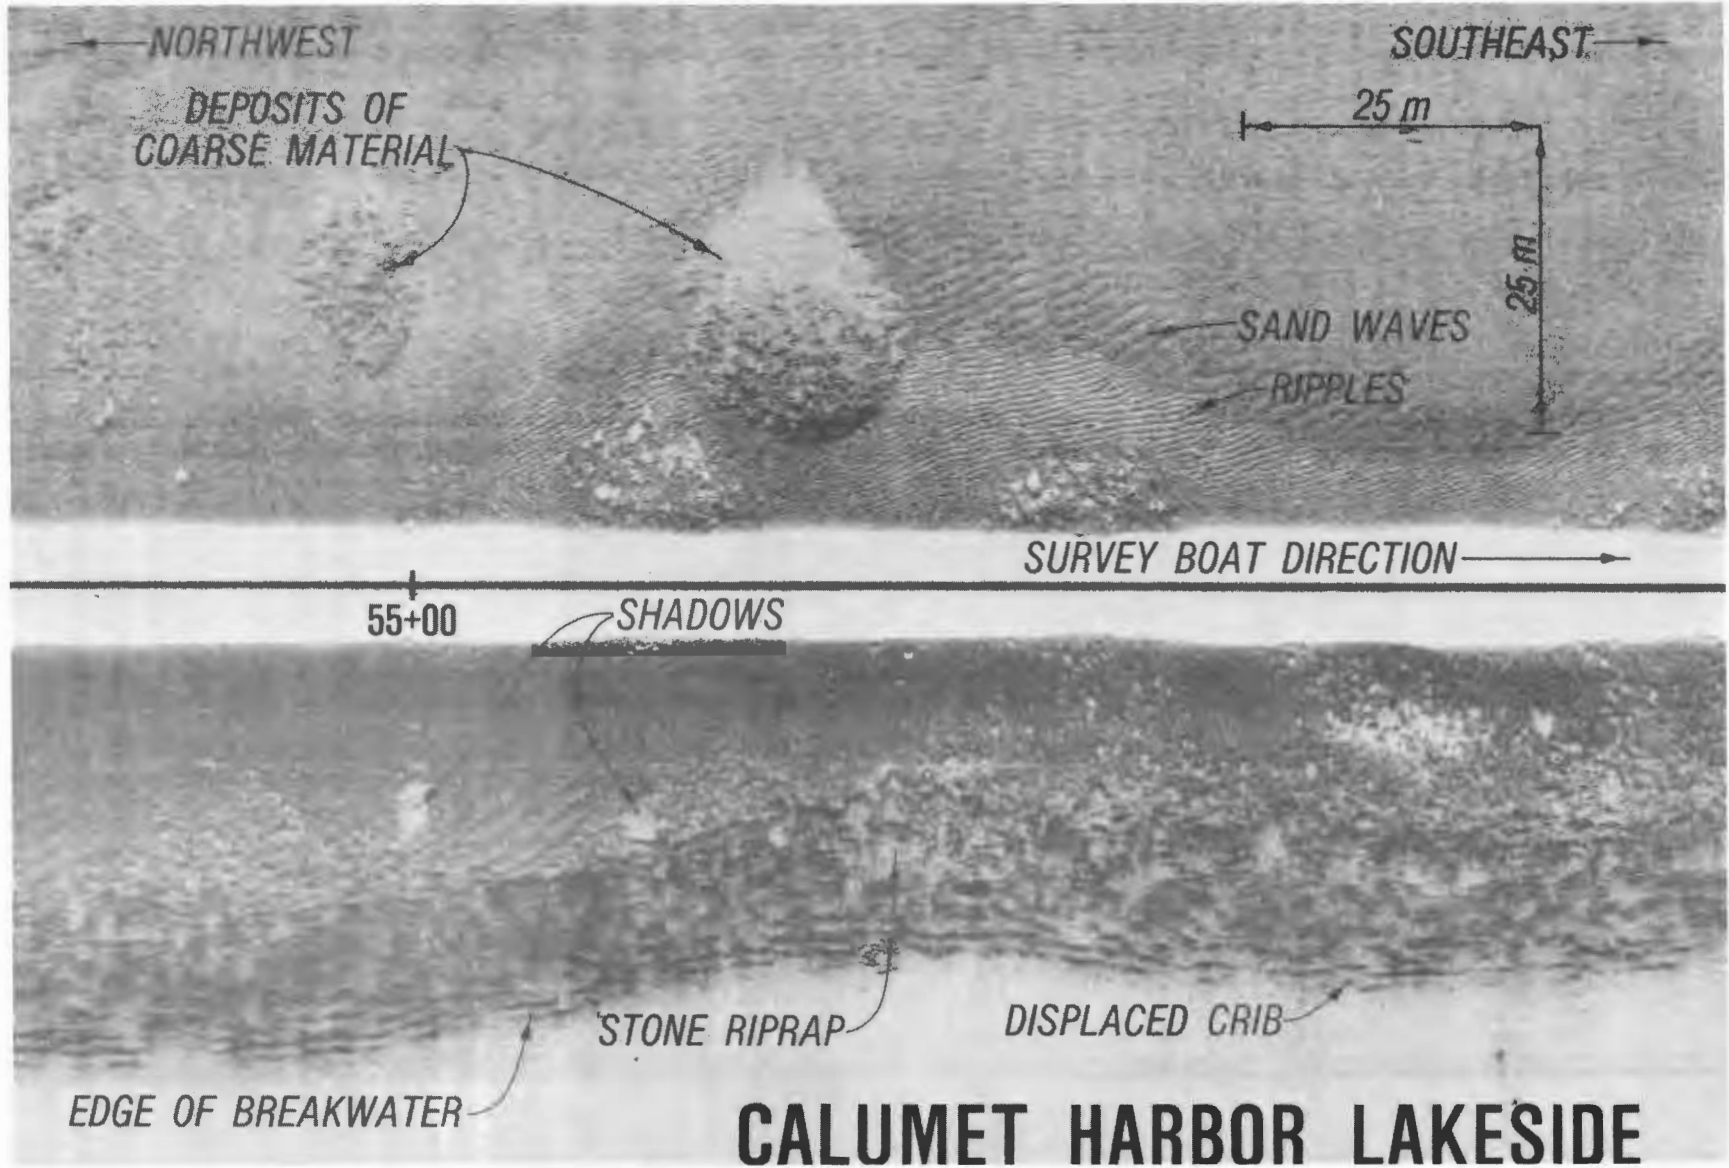
Figure 6. Lakeside, Section B, Calumet Harbor breakwater

16. The riprap which extends continuously along Section B is 12 to 15 m wide. Between sta 23+00 and 28+00, a deposit of finer stone extends out onto the lake floor up to 32 m from the edge of the breakwater. Although the size of this deposit appears to be too great to be the result of debris that has flowed out of damaged cribs, the Calumet Harbor Reconnaissance Report (NCC 1985) indicates that some of the units in this area are probably damaged since they have a steep lakeward slope. Alternatively, the report states that protective stone was placed along this area during 1961-62. Possibly some of this material was relatively fine and flowed out onto the lake floor under the influence of waves or was substandard in size and discarded by the contractor. A similar but smaller deposit of fine stone occurs near sta 31+00 to 32+00, and an oval patch 15 m in diameter occurs near sta 34+00, 30 m from the breakwater. More oval patches, consisting of somewhat coarser material, can be seen between sta 54+00 and 57+00 (Figure 6) as far as 35 m from the breakwater. Among these coarse oval patches is a prominent pile (near the center of Figure 6) with relief of 2 m (based on a geometrical reconstruction using the height of the towfish and the horizontal dimensions). Possibly, these are dredged material disposal mounds placed during maintenance operations. Particularly large armor blocks are at the base of the breakwater between sta 38+00 and the bend. An occasional individual block on the lake floor in this area probably represents more material dropped during construction. Numerous individual large stones are also on the lake floor off the southern tip of Section B. Coarse stone riprap prevents imaging the cribs directly, but the crest can be marked by parallel black lines in Figure 6.

17. The lake floor consists of clay close to shore and becomes sandy lakeward of sta 30+00. Sand waves and ripples with various orientations and wavelengths can be seen throughout the area. East of the breakwater between sta 43+00 and 50+00 the lake floor has a granular appearance and may be partially covered with gravel or fine stone. Mottled patches of clay are evident on the floor of the gap south of Section B, and it is likely that in this area there is a discontinuous veneer of sand over an essentially clay bottom. Most sediment movement probably occurs during winter storms when waves along the southern shoreline of Lake Michigan can exceed 4 m. Significant wave heights of 4 to 5 m were measured outside of Burns Harbor, Indiana, in February 1987 (Figure 7) using tripod-mounted, pressure-sensing wave gages located 30 m offshore from the breakwater on the lake floor. These data were collected and

18. Because the armor protection extends from the lake floor nearly to the water surface, the wood cribs could not be imaged during this part of the survey, and it has not been possible to directly assess their condition. From sta 15+00 to near 60+00, the breakwater is marked by two or three heavy black lines on the side-scan sonar records (Figure 6). The water lake surface was high during the survey, and the lines may represent the platform and the beveled edge of the concrete cap which lies on top of the cribs. The lines are not continuous, and numerous minor displacements suggest that many of the cribs may be tilting. If the walls of the cribs have spread apart, some of the timbers which should be flush with the edge of the cap might be exposed and could be causing the heavy black lines on the records.

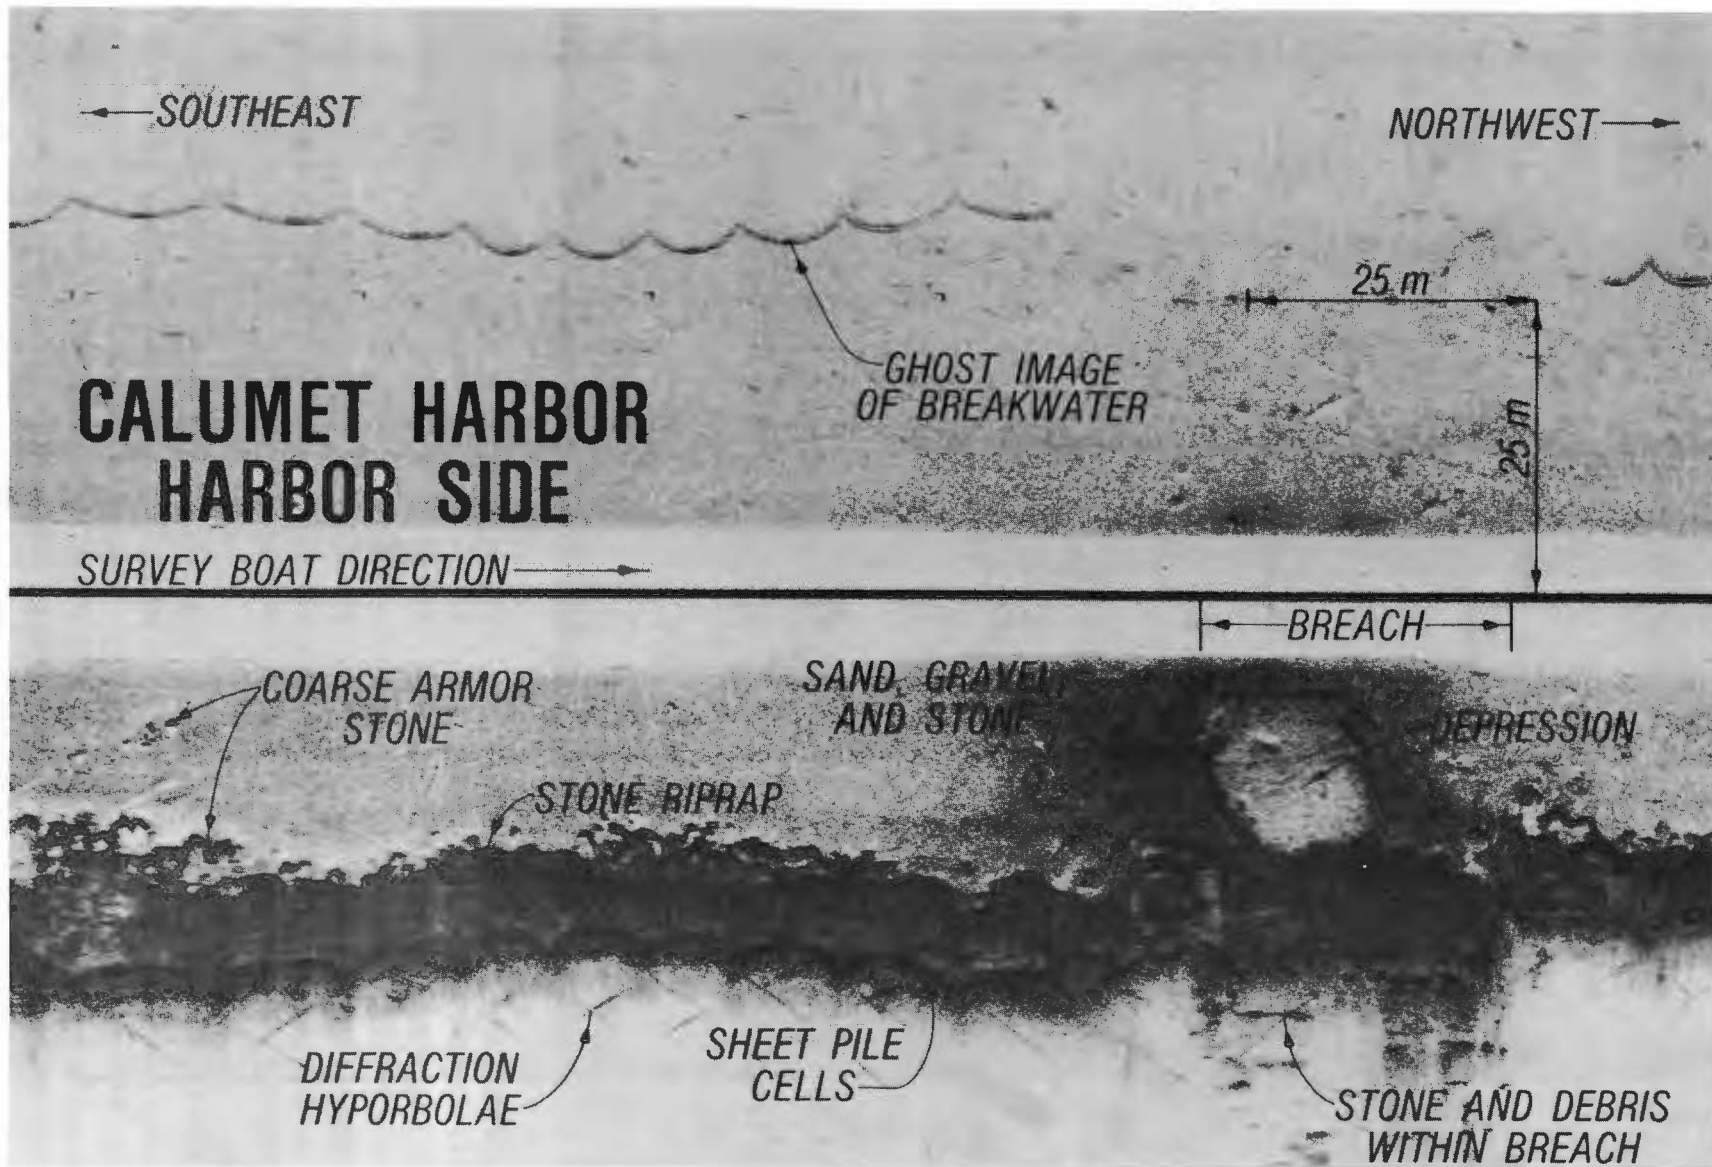
Figure 9. Harbor side, Section C, Calumet Harbor breakwater

20. The side-scan sonar survey shows that the harbor floor along most of Section C is predominantly featureless and of low-reflectivity, probably clay. There is no evidence of sand waves or ripples, even near the breach where storm waves in 1984 destroyed two cells and where the wave regime should be more than energetic enough to move noncohesive sediments. Only at the far south end of the breakwater does the lake floor become darker (i.e. demonstrating higher reflectivity), and large fields of ripples can be seen in the records. Here, too, wave action may be moving accumulations of sand which may be spreading over some of the clayey harbor floor.

21. Stone riprap toe extends along the entire breakwater. Between sta 79+00 and 96+00, occasional individual stones or small clusters of stone can be seen on the harbor floor near the toe. Some of these stones may have been displaced from the riprap by storm waves, or they may have been dropped during repair or construction of the breakwater. Table 2 summarizes the condition of the toe armor.

22. The rounded sheet-pile cells shown in the records (Figure 9) appear to be essentially in good condition. Because of the intensely strong signal return from the vertical steel walls, minor damage to the walls, such as gaps only a few centimeters wide, may be masked or not resolved. There is no signal penetration through the steel walls, and the faint lines and texture on the records are diffraction hyperbolae and noise. The breach where the cells failed in the 1984 storm is marked by an interruption in the sheet-pile cells and by debris on the harbor floor shown in Figure 9. The survey did not image within the actual breach itself because most of the signal reflected from the mounds of stone and debris.

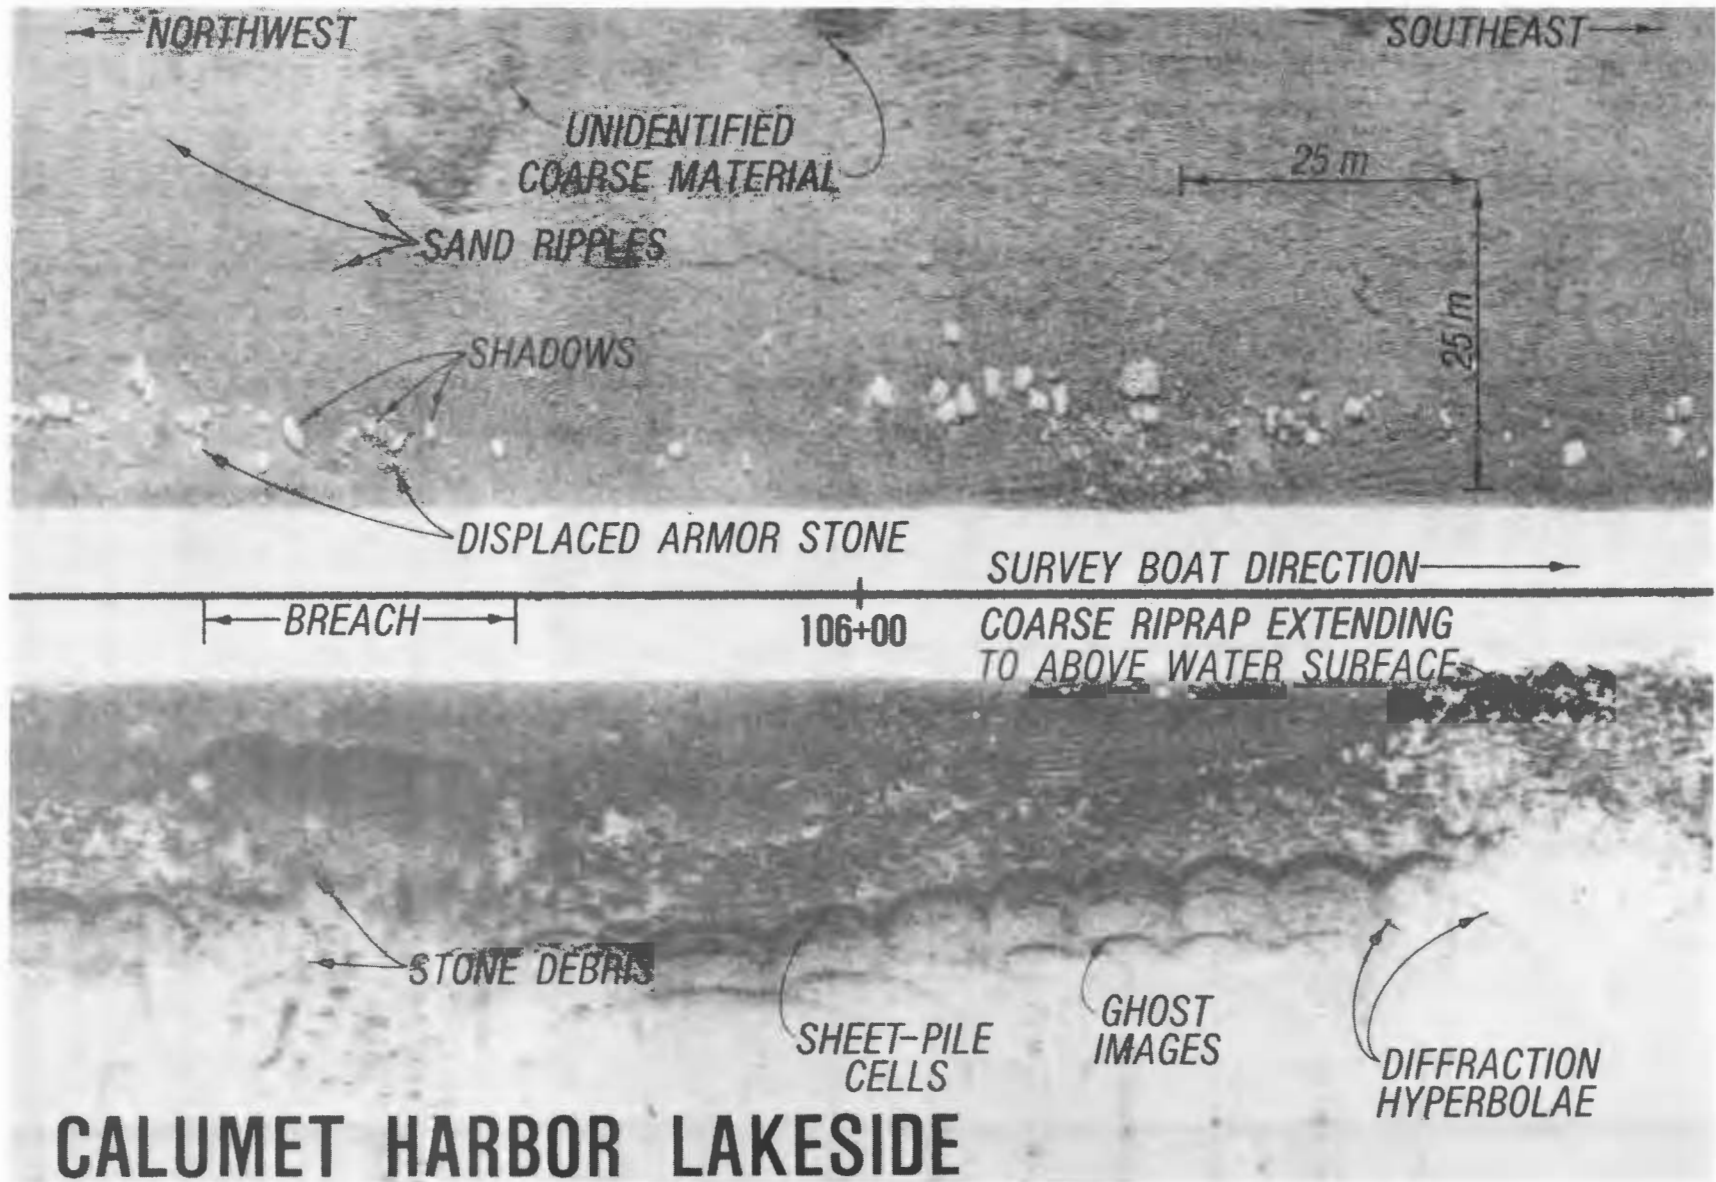
Figure 10. Lakeside, Section C, Calumet Harbor breakwater

23. The lakeside of the breakwater is exposed to a dynamic environment, as illustrated by the fields of ripples and sand waves in the sandy lake floor. Considerable coarse debris, similar to or larger than the riprap, is scattered about on the lake floor up to 35 m from the base of the breakwater. The high relief of individual blocks is indicated by long shadows. Since it seems unlikely that large armor stones had been moved up to 35 m by storm waves, most of these deposits are probably the result of construction and repair activities. Some of the stones may have been displaced by ice. During winter storms, the spray from breaking waves mantles the breakwater and can build up ice incrustations a meter or more high. Breaking waves can conceivably strike the ice mounds with enough force to dislodge them along with underlying stones. Nevertheless, in southern Lake Michigan it is unlikely that the ice incrustations would be voluminous enough to provide flotation to the blocks, which would allow them to be carried away from the structure.\* Between sta 92+00 and 100+00, irregular oval patches of unidentified coarse material occur on the lake floor to at least 60 m from the breakwater (Figure 10). Two hypotheses may account for these features: (a) stone and

rubble deposited during construction and (b) outcrops of hard limestone. These ovals are of much lower relief than the displaced stones described above and are volumetrically large; therefore, the second hypothesis seems reasonable. A definitive answer requires grab samples or diver inspection.

24. Side-scan sonar records show that most of the breakwater cells and the riprap toe along the lakeside of Section C are in good condition. From the north end of Section C to sta 62+00, coarse riprap extends to above the water surface and masks the underlying steel cells. Along the rest of the structure, the riprap is lower but is continuous and at least 2 to 3 m wide (Table 3). Since coarse debris prevents imaging within the breach (Figure 10), the condition of that section could not be determined.

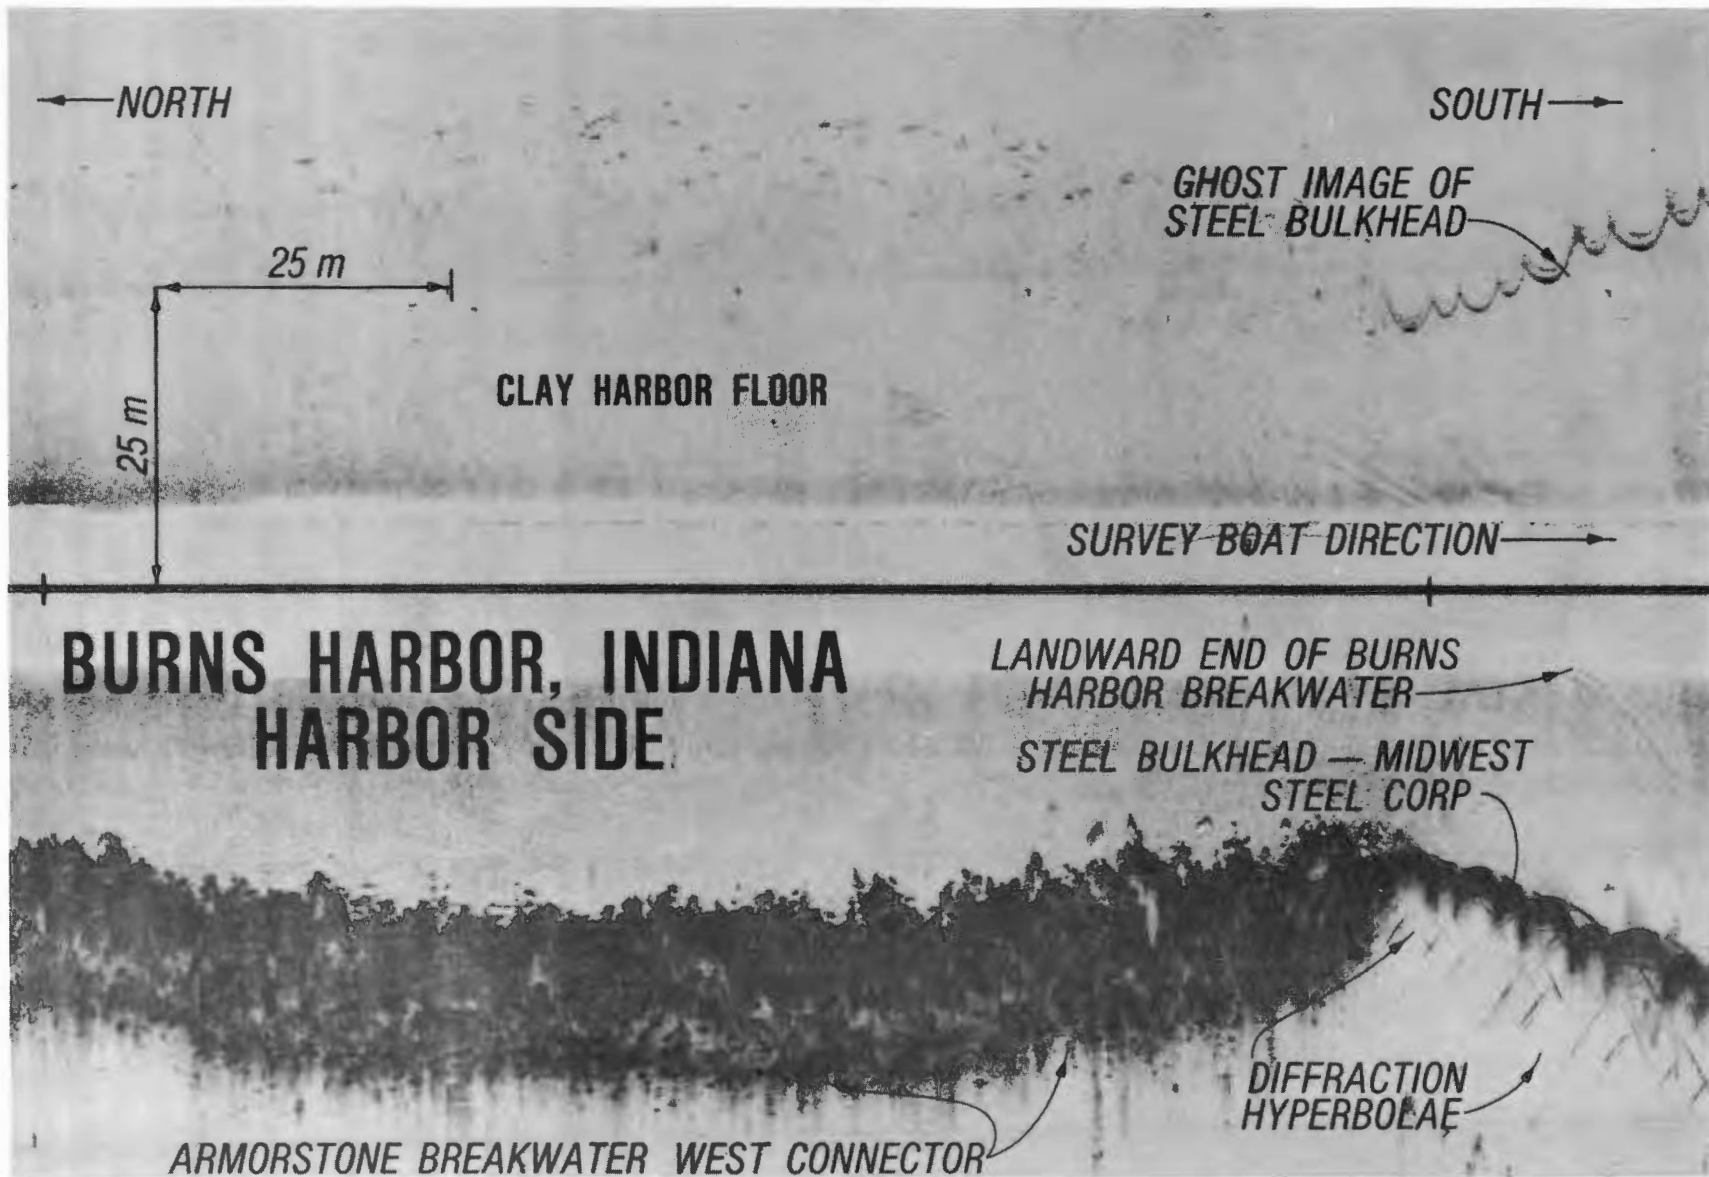
Figure 13. Harbor side, Burns Harbor, landward end

27. The most significant finding of the harbor-side sonar surveys is that the bottom consists of featureless, low-reflectivity clay, and that the clay extends to the very base of the breakwater. In recent years, extra armor stone has been added to the lakeside and harbor side of the structure to repair sections that have settled, but unless the sand mat extended only a slight distance beyond the toe of the original structure, it is unlikely that enough new stone has been added to obscure the clay-sand interface. Figure 13 shows the landward end of the breakwater where it joins Midwest Steel Corporation's steel bulkhead dock. Occasional isolated armor stones can be seen on the harbor floor a few meters from the toe of the breakwater. The breakwater itself, from harbor floor to water surface, is 15 to 20 m wide. Figure 14 depicts the end of the breakwater near the mouth of Burns Harbor. Dramatic scars on the harbor floor result from ships dragging anchor as they slow and turn into the harbor. Along the base of the structure, the harbor floor continues to be featureless and uniform with the exception of occasional isolated armor stones.

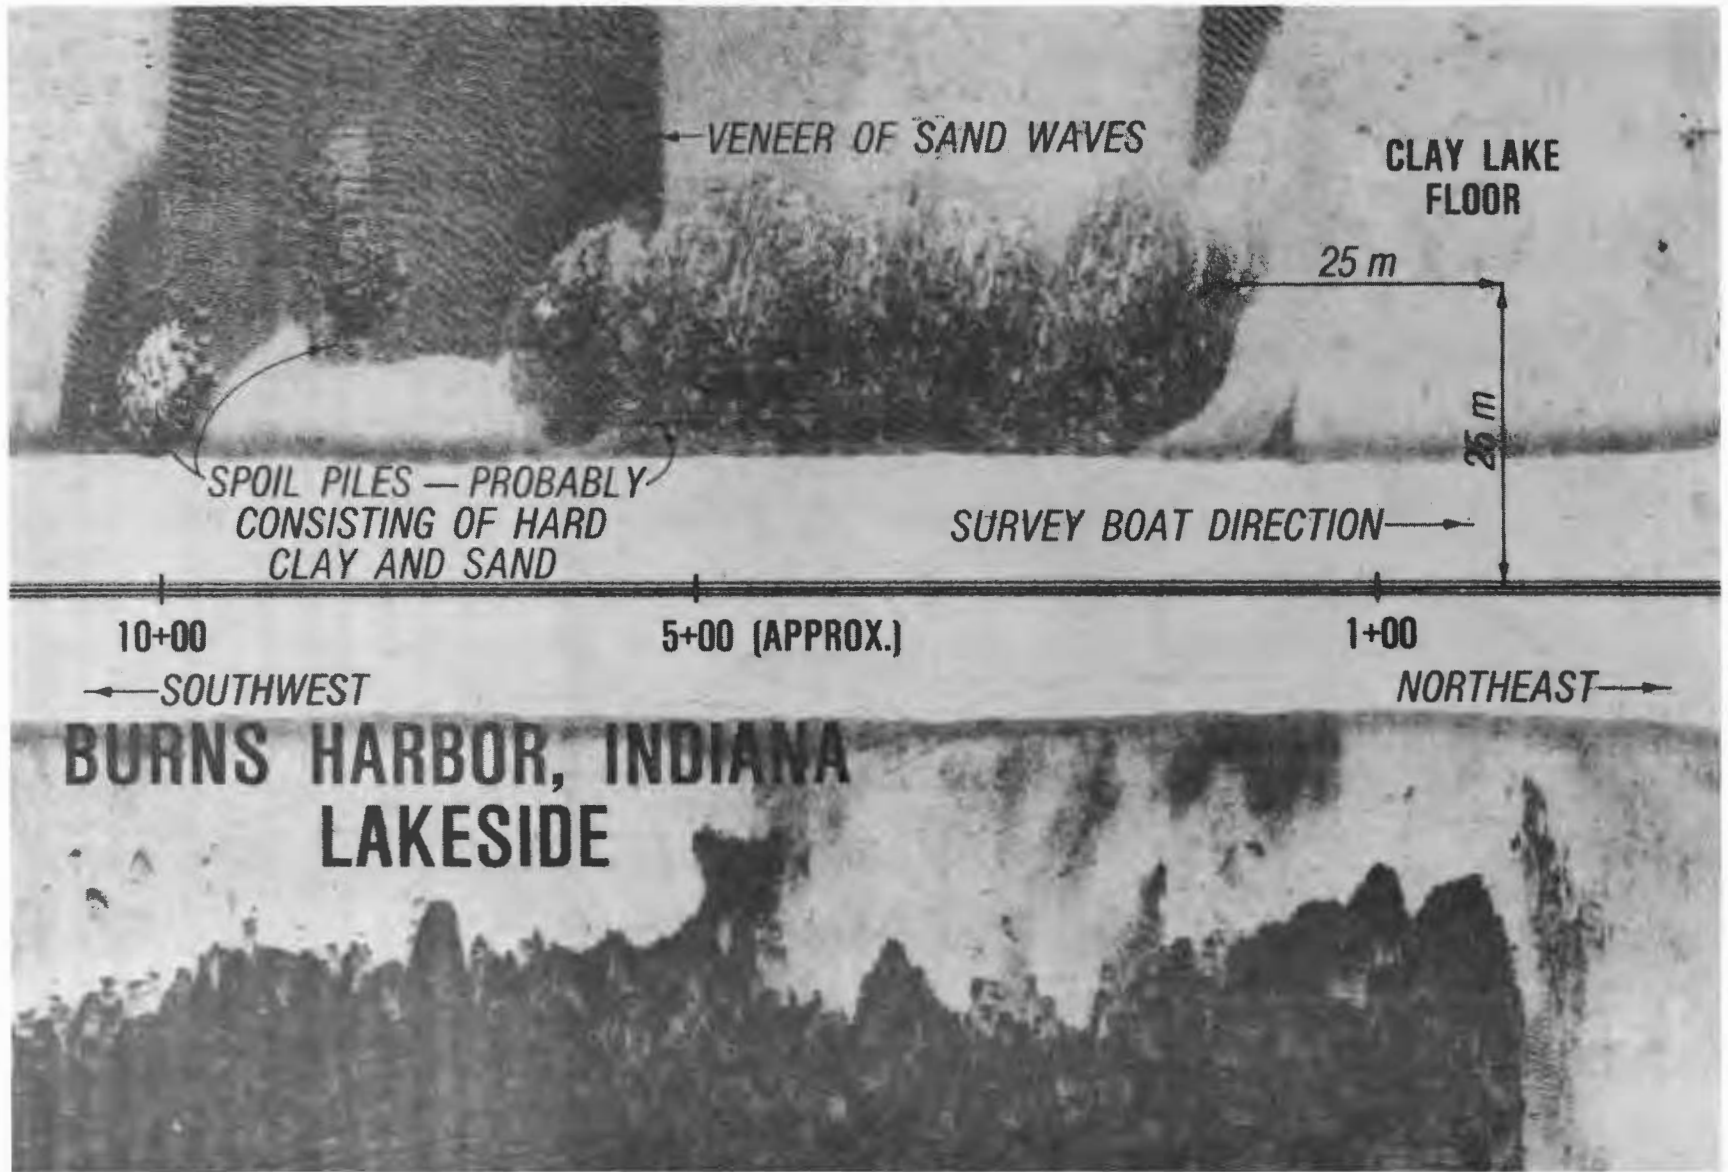
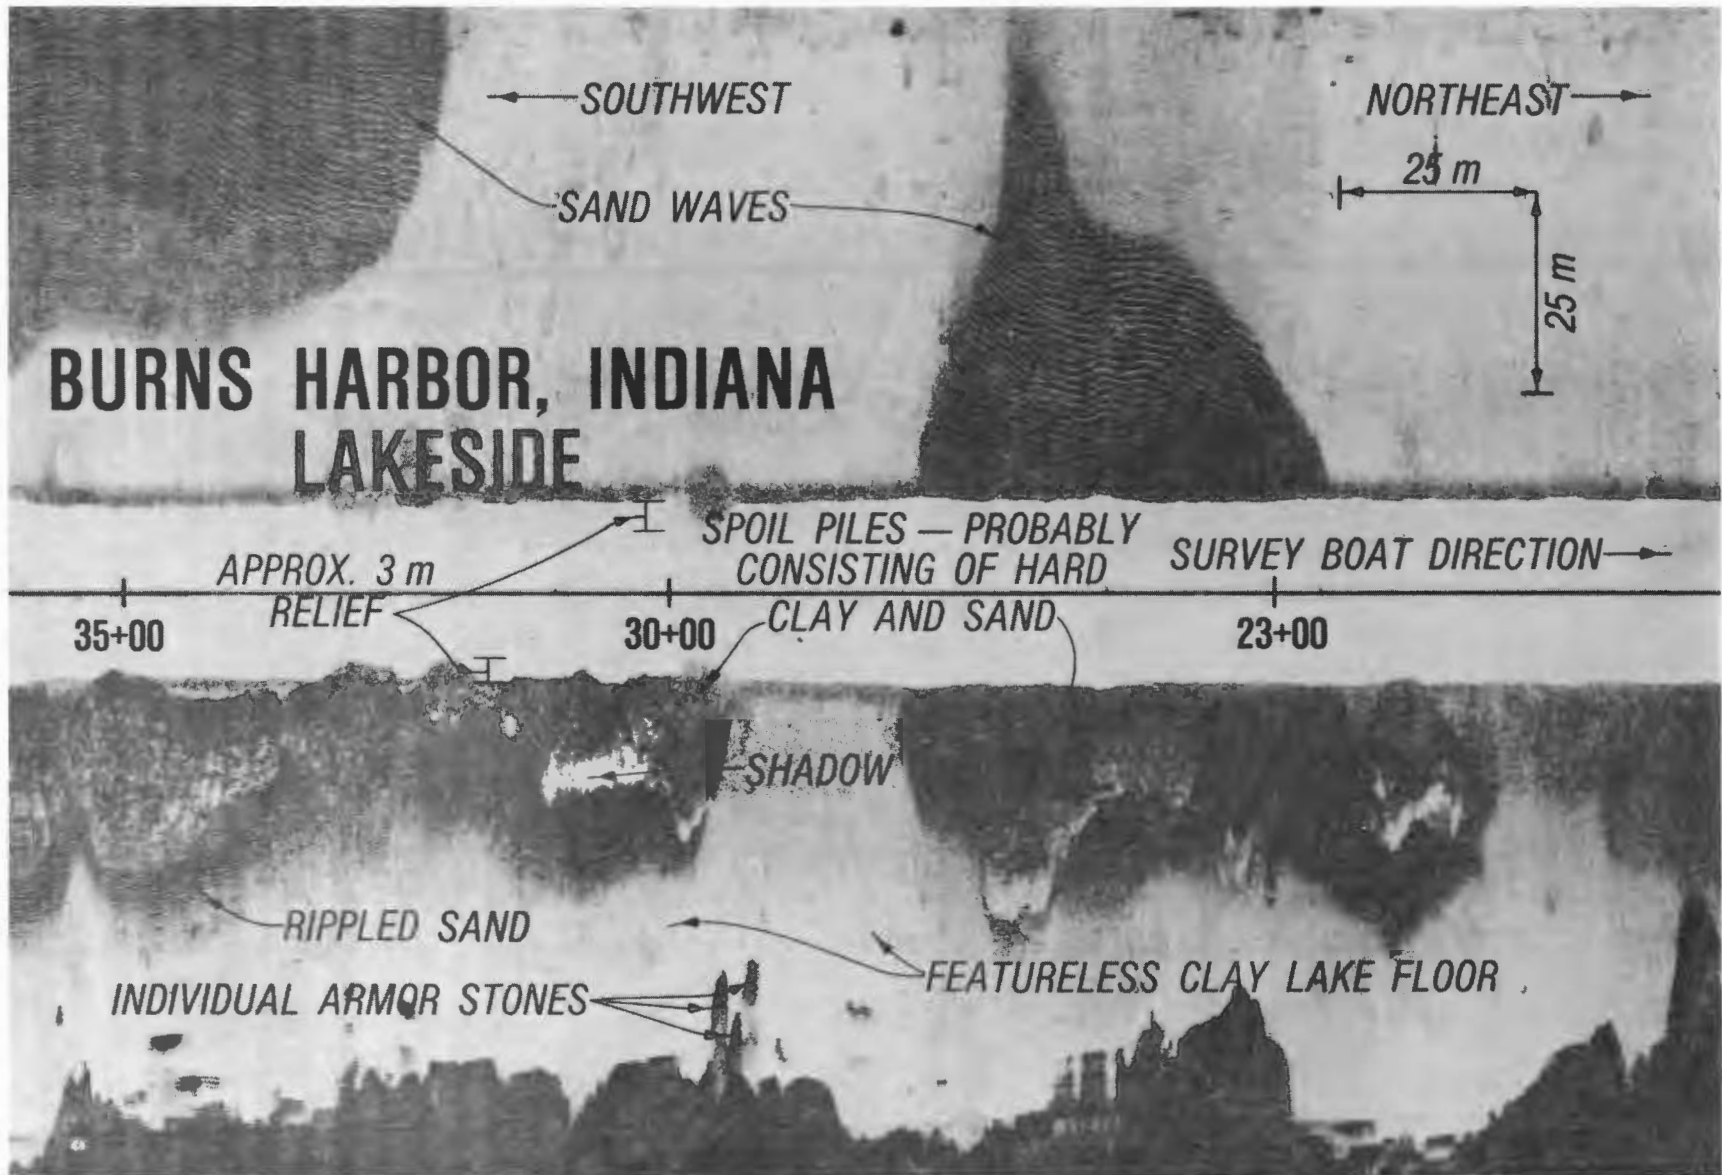
extending beyond the base of the breakwater (Figures 15 and 16). Patches of rippled sand ten or more metres from the base of the structure, as at Calumet Harbor, are believed to be veneers of sand moved by wave and current action over an essentially clayey lake floor. Many individual armor blocks litter the lake floor. Between sta 1+00 and 5+00, some of the stones along the toe appear to be partly buried. Toe instability may have caused settling or, as an alternative, soft sediments may have accumulated along the toe and covered some of the blocks along with any visible evidence of the sand mat. Although this latter hypothesis is reasonable for the lakeside of the breakwater, the harbor side experiences lower wave energy, and it is unlikely that enough sediment has been available to uniformly cover the sand mat along the entire length of the structure. Suspended sediment is not considered to be a significant factor in Burns Harbor.

29. Large, irregular, oval patches with blocky appearance, high reflectivity, and relief of up to 3 m probably represent dredged disposal material deposited during breakwater construction in the 1960's (Figures 15 and 16). Grab samples and diver inspections during the summer of 1986 revealed that the piles are composed of gravel and small stone held together with a clay binder. The volume of the dredged material is much less than the volume that presumably was excavated for the foundation of the breakwater, although soft clay and sand have undoubtedly been washed away over the last 20 years. Nevertheless, the areal extent of the remaining piles indicates that a large volume of hard soils must have originally been removed from the site of the breakwater, and this finding appears to conflict with reports that soft clay was excavated (Krampitz 1985).
