NASA Technical Memorandum 79112

SOME EFFECTS OF CYCLIC INDUCED
DEFORMATION IN ROCKET THRUST CHAMBERS

N. P. Hannum, R. J. Quentmeyer, and H. J. Kasper
Lewis Research Center
Cleveland, Ohio

TECHNICAL PAPER to be presented at the
Conference on Advanced Technology for Future Space Systems
sponsored by the American Institute of Aeronautics and Astronautics
Hampton, Virginia, May 8-11, 1979

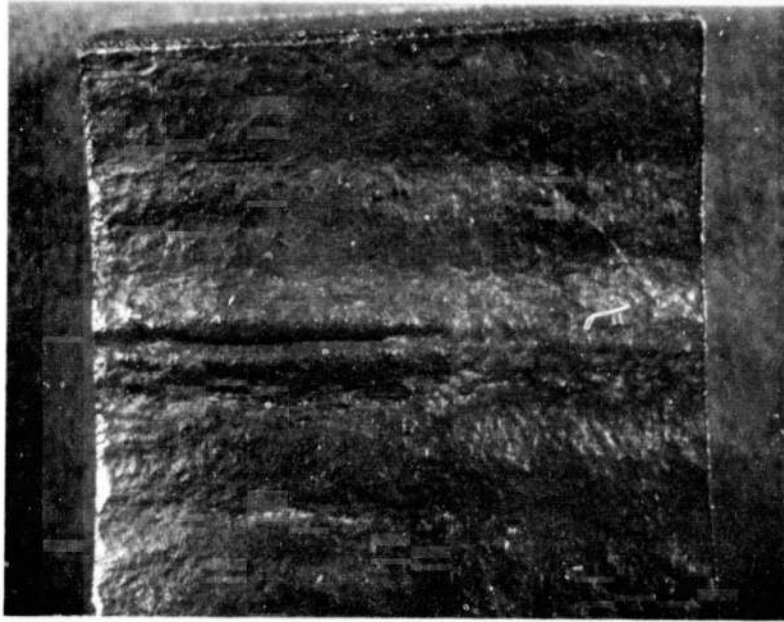
The failures are generally characterized by a thinning and bulging of the hot gas wall. Also, there was a roughening of the hot gas side wall, especially in the throat region of the thrust chamber. Figure 3(a) is a view of the hot gas side wall showing the general surface roughening for OFHC copper chamber S/N 74. A 3.5 cm (1.4 in.) long crack at the center line of a coolant channel can also be seen. The roughening was more severe with the OFHC copper than with the Narloy-Z and heat treated Amzirc. The roughening was more severe in the throat region where the temperature was higher than at other locations in the combustion chamber.

(a) VIEW OF THE HOT GAS WALL SHOWING A TYPICAL CRACK THROUGH THE WALL JUST UP STREAM OF THE THROAT.

Figure 3. - Photographs of OFHC copper thrust chamber S/N 74 typifying the failure site and deformation of the hot gas wall.

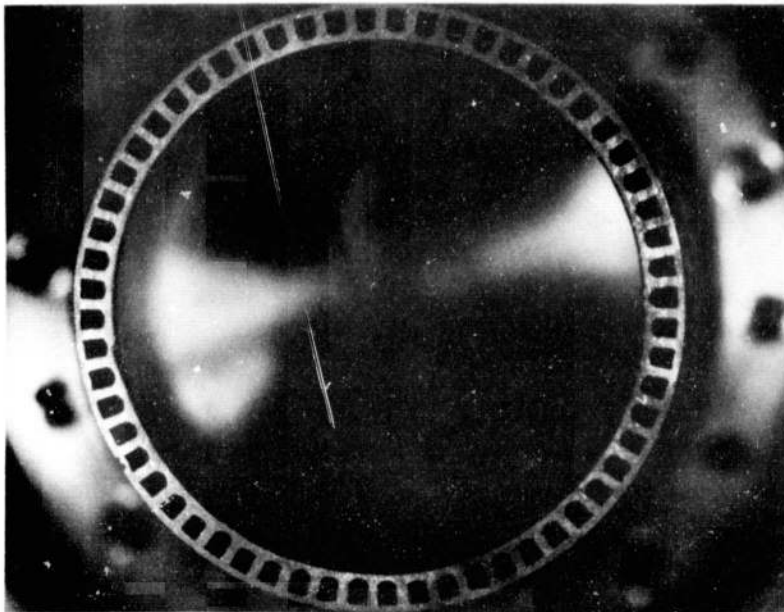
A cross section, at the throat, of an entire thrust chamber is shown in Fig. 3(b). This is the OFHC copper chamber S/N 74 which had the low stiffness closeout described in the Apparatus section. The fiberglass portion of the closeout has been removed. It can be seen in Fig. 3(b) that the deformation is not the same in each of the 60 coolant channels. The circumferential location of the most severe deformation seems to be random, that is, not related to injector patterns, cooling manifolds, or fabrication anomalies that are within the drawing specifications.

(b) CROSS SECTIONAL VIEW TAKEN IN THE THROAT PLANE SHOWING THE 60 COOLING CHANNELS AND THE ELECTROFORMED CLOSEOUT.

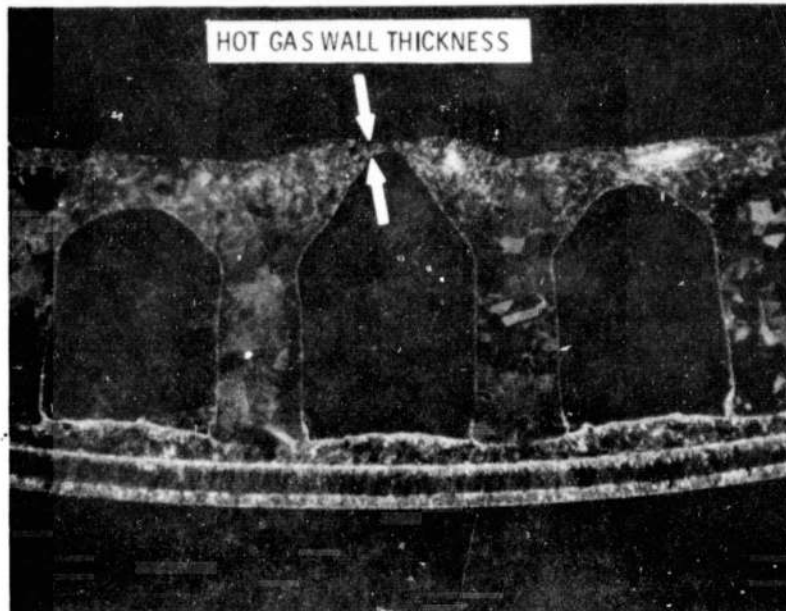
(a) OFHC COPPER THRUST CHAMBER S/N 75.

Cross section views of the failure sites for two different materials are shown in Fig. 4. The failed coolant channel is characterized by a "dog house" shape and a bulge of the hot gas wall toward the centerline of the thrust chamber. Conservation of the wall material was assumed since no hot gas surface melt or erosion was observed. The hot gas wall must thin, therefore, to accommodate the bulge. Because of the progressive thinning, the bulge on the hot gas wall tends to form two bumps per cooling channel. It can be seen in Fig. 4(a) that the bulging and thinning that occurred with the OFHC copper material was much greater than with the

Narloy-Z (Fig. 4(b)). The failure sites for the other thrust chambers not shown also had the "dog house" shape. Although all materials deformed similarly, an important difference is evident between the two failure sites shown in Fig. 4. In addition to the thinning of the hot gas wall, a necking of the material in a small region on each side of the failure site occurred with the OFHC copper. This is a typical appearance of a tensile failure with a ductile material. Tensile failures were observed in Ref. 4 for OFHC copper, heat treated Amzirc, and Narloy-Z. The failure mechanism was described as stress rupture. In the present work the failure site shown for Narloy-Z in Fig. 4(b) does not show necking of the material adjacent to the crack. Therefore, the visual evidence in the present work supports the Ref. 4 contention of a tensile stress failure mechanism only with OFHC copper. The failure sites for the Narloy-Z and heat treated Amzirc in the present work are different than observed in Ref. 4 because there is no evidence of necking adjacent to the crack with these materials.

Some metallographic observations were made for the material at the failure sites. It appears that some recrystallization has occurred in the hot gas wall of the OFHC copper chamber S/N 75 (Fig. 4(a)). No recrystallization was observed for the other materials. When hardness surveys were taken across sections similar to those shown in Fig. 4, it was found that hardness adjacent to the failure site was different from hardness away from the failure site (near the electroformed closeout). If it is assumed that the liner material away from the failure site remained in the pretest condition, then a change in hardness occurred at the failure site for all liner materials during cyclic testing. A tabulation at hardness measurements for each chamber are shown in Table I. The as fabricated hardness with OFHC copper was R_B 12-15. At the failure sites there was softening to R_B 0-9. In contrast the heat treated Amzirc and Narloy-Z hardened as cycles were accumulated. Heat treated Amzirc hardened from R_B 10 to R_B 15, Narloy-Z chamber S/N 140 hardened from R_B 33 to R_B 57. Narloy-Z chamber S/N 150 hardened from R_B 45 to R_B 60. An observation can be made that both Narloy-Z chambers failed at about the same hardness, but the one that hardened more (R_B 33 to 57) had longer life (301 compared to 154 cycles). The reasons for these differences in material behavior is not understood.

the cross section photograph (Fig. 4(a)) as local necking of the material adjacent to the crack. The rapid deformation and thinning may have occurred in the final cycle or progressively during the last nine cycles.

As noted in Ref. 4 and as can be seen in Fig. 4(a) of the present work the visual evidence supports the contention of tensile stress failure with OFHC copper. For a tensile stress failure to occur, the ultimate stress for the material must be exceeded at some point in the cycle. The exact point in the cycle when failure occurred is not known since both the stress in the wall and the ultimate stress of the material are changing with time. The stress is nominally the same for all three materials for the same wall thickness and would increase as the wall thickness decreases. Therefore, it is assumed that a wall thickness of approximately 0.475 mm (0.0187 in.) corresponds to a stress in the wall equal to the ultimate stress value of OFHC copper. The result is a tensile stress failure. However, since the published data for heat treated Amzirc and Narloy-Z indicate that the ultimate stress is greater than OFHC copper at similar temperature conditions, the level of stress in a wall 0.475 mm (0.0187 in.) would not produce a tensile stress failure in these stronger materials. Figure 7 shows that these stronger materials possibly failed at stress levels even less than the OFHC copper since the final wall thickness was greater than with OFHC copper. The implication is that the failure mechanism for the heat treated Amzirc and Narloy-Z thrust chambers in the present work is more complicated than simple tensile stress failure.

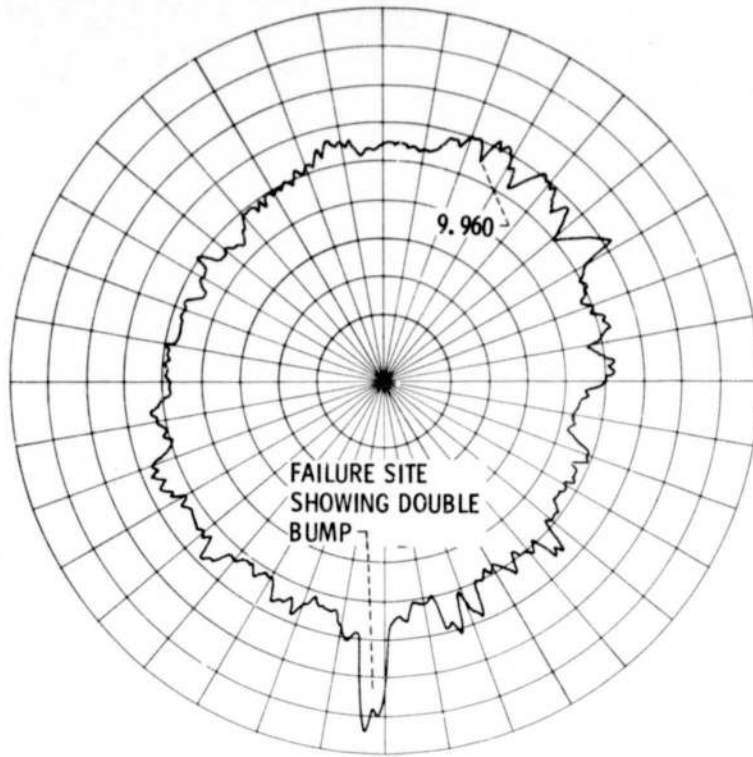
The hot gas side wall deformation was measured nondestructively. Polar plots were made for each of the thrust chambers to document the post test hot gas wall deformation. A typical plot is presented in Fig. 5(a). It can be seen in the figure that the failure site and one or two other channels exhibit the double bump characteristic (each cooling channel covers a 6° arc). The deformation at the failure site is much greater than at other locations in the thrust chamber. This was true for all materials. The deformation data from these polar plots are tabulated in Table I. Deformation at the failure site was defined as the distance from the valley (at approx. the rib center line) to the largest peak. The data tabulated was for the

(a) POST FAILURE DATA AFTER 193 CYCLES.

Figure 5. - Polar plots of OFHC copper chamber S/N 74 showing hot gas wall deformation.

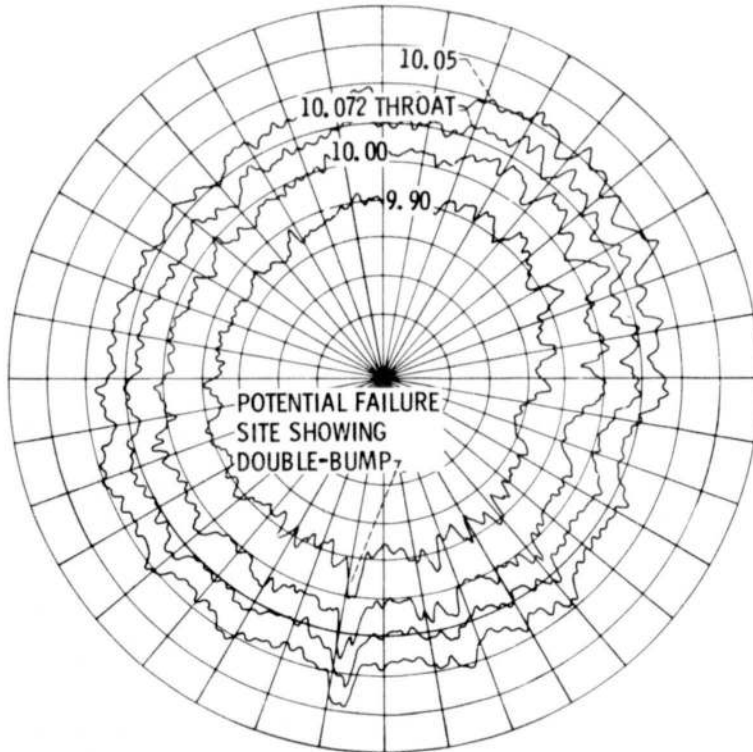
Since the method for measuring deformation was nondestructive, it was also employed to obtain deformation data of intermediate life points. Two variations of the nondestructive method were used. First, the 360° plots previously described could be made at various axial locations, but that required removing the chambers from the thrust stand. Second, it was found that after the most highly deformed area had been located, data could be taken from plaster casts of the area. These intermediate life data are also recorded in Table I. An example of intermediate life hot gas wall deformation data is shown in Fig. 5(b) for OFHC copper chamber S/N 74 after 124 cycles. The polar plots were made at various axial stations in the vicinity of the most highly deformed area. The potential failure site can readily be identified even though the failure did not occur for another 69 cycles. The double-bump characteristic is also evident. As can be seen from Table I there was good agreement between deformation data using the two methods for OFHC copper chamber S/N 74 at 124 cycles. The 360° plots indicated a deformation of 0.173 mm (0.0068 in.) and the plaster cast method indicated 0.155 mm (0.0061 in.).

(b) INTERMEDIATE LIFE DATA AFTER 124 CYCLES.

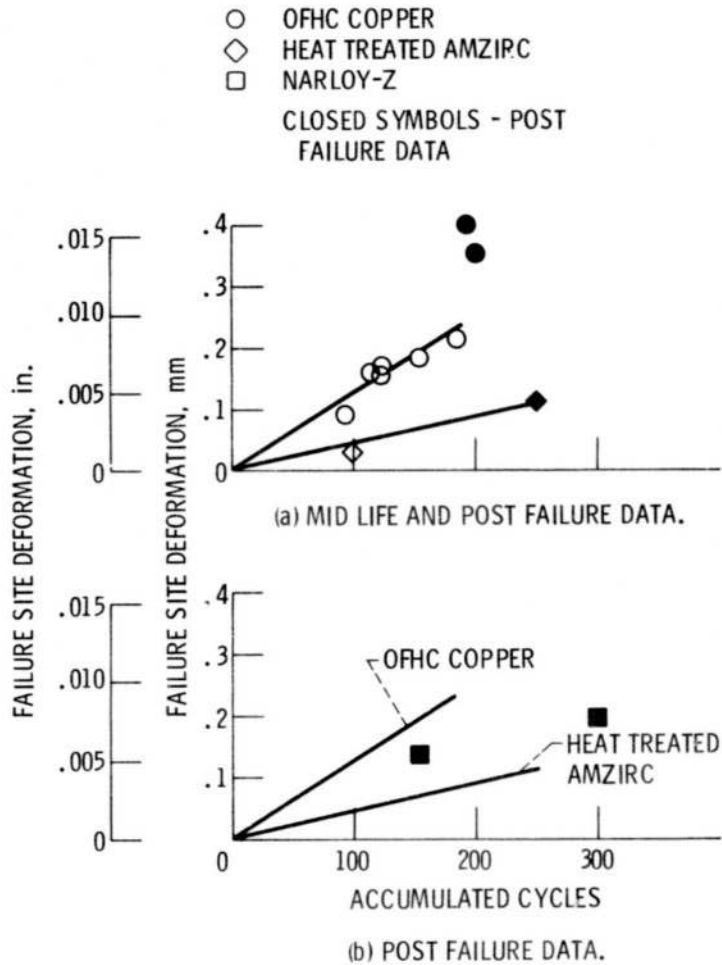
The failure site deformation data for the two OFHC copper chambers (S/N 74 and 75) and for the heat treated Amzirc chamber (S/N 82) are presented in Fig. 6(a) as functions of accumulated cycles. Where available, data using both nondestructive methods, that is, from plaster cast segments and full 360° plots are shown. The closed symbols are the post failure points and represent an average of the nondestructive and the post failure photographic data. Even as the deformation becomes large the failure site bulges out into the chamber in a nearly linear manner as cycles are accumulated. Reference 5 has characterized the failure mechanism as a ratcheting type process. The slope of the deformation histories presented in Fig. 6 could be considered a ratcheting rate. The ratcheting rate for the OFHC copper is nearly 3 times greater than the heat treated Amzirc. As noted in APPARATUS the stiffness of the structural jacket for the OFHC thrust chambers was less than the other chambers. It is reported in Ref. 6 that the low stiffness structure reduced the strain range approximately 10% compared to the thick nickel structure. Consequently, if the OFHC copper chambers had been fabricated with the same stiffness the trend would be toward increasing the ratcheting rate for the OFHC copper.

A rapid increase in the hot gas wall deformation can be seen in Fig. 6(a) just before failure with the OFHC copper. At the onset of failure the material no longer ratchets linearly but becomes unstable and rapidly deforms (thins) until a tensile stress failure occurs. This was seen visually in

Figure 6. - Failure site deformation as a function of accumulated cycles.

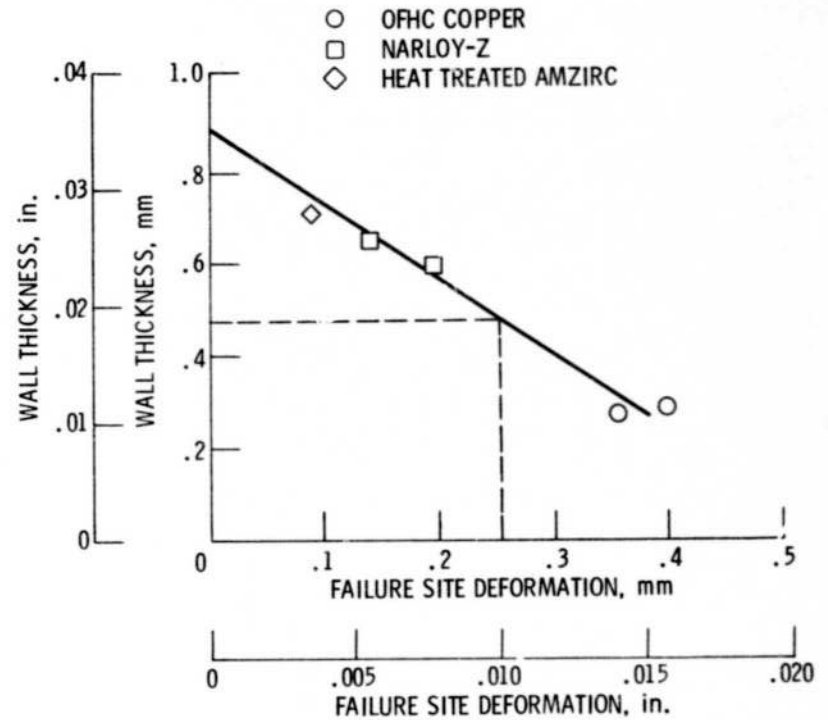
Figure 7 shows the final failure site deformation versus the final failure site hot gas wall thickness for three different thrust chamber materials. The data were obtained by measuring cross section photographs. The definition of deformation was the same as used with the polar plots (Fig. 5). The wall thickness was measured as indicated in Fig. 4. As shown in Fig. 7 the wall thickness versus deformation data are correlated by a straight line which extrapolates to the original wall thickness of 0.889 mm (0.035 in.) for zero deformation. Although this correlation was made from post failure data it is assumed that the correlation is also valid at intermediate life. Use of this correlation provides a means for determining wall thickness at intermediate life points from measurements of hot gas wall deformation.

For example, the use of the correlation between hot gas wall deformation and thinning made it possible to estimate the wall thickness for the OFHC copper at the onset of failure. By extrapolating the OFHC ratcheting rate curve (Fig. 6(a)) to 200 cycles it can be seen that at the onset of failure the deformation was approximately 0.25 mm (0.010 in.). From Fig. 7 it can be seen that 0.25 mm (0.010 in.) deformation corresponds to a wall thickness of 0.475 mm (0.0187 in.).

Figure 7. - Relationship of failure site deformation to coolant channel wall thickness for three different thrust chamber liner materials.
