## Some Experiences from Damages of Embankments During Strong Earthquakes in China

Shen Choggang

Adviser, Senior Engineer, Institute of Water Conservancy and Hydroelectric Research (IWHR), Beijing, China

**SYNOPSIS:** This paper gives a series of case histories of earth dams which have been damaged by strong earthquakes in the past 25 years in China. These damages include slides, cracks, settlements leakages and also some appurtenant structure failures. Experiences show it is necessary to stringently control the design and construction to resist earthquakes.

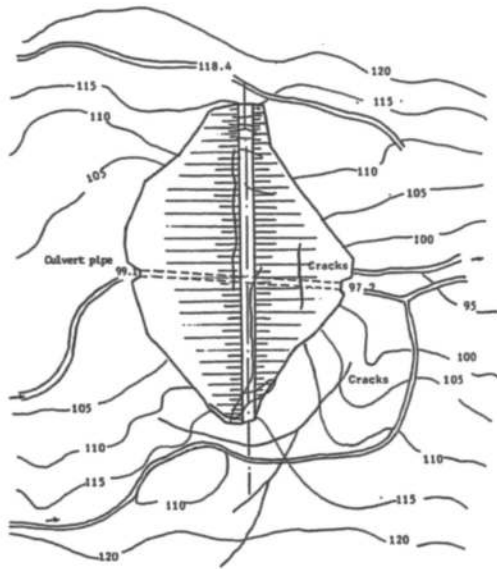
Fig. 1 Plan of Changmaidi earth dam

16 cracks were found on this dam after earthquake, mainly (12 cracks) along the abutments of dam (Fig. 1, 2 and 3). The width of cracks

was generally 1-3 cm, with maximum width of 18 cm. On the downstream slope the depth of cracks reached 2.5 m. 3 of 4 longitudinal cracks were on the crest, the longest one was 38 m. The fourth crack was on the downstream slope, the width of crack near the spillway channel was 10 cm, its depth was more than 1.2 m. Muddy water flowed through the culvert pipe about two hours after the earthquake.

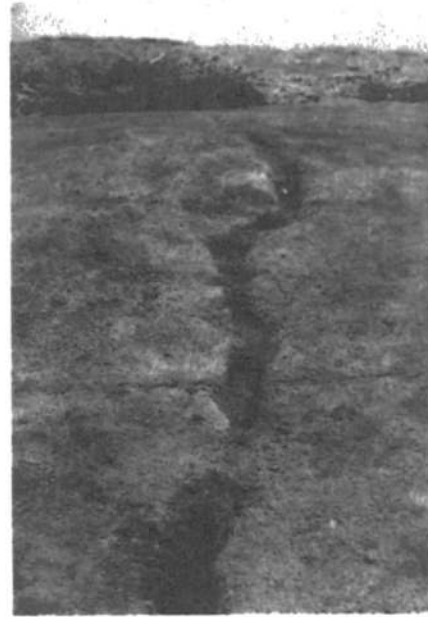
Fig. 2 Photograph of Changmaidi dam, transverse cracks on the dam.

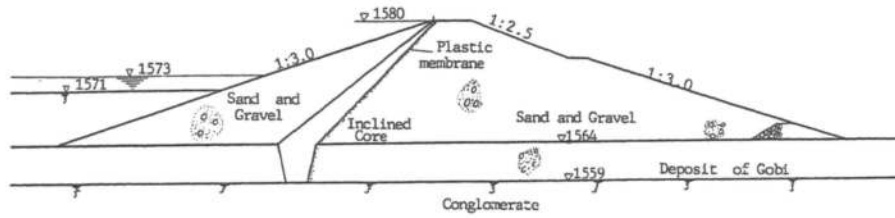
Fig. 6 Cross section of Kashi earth dam

For some small earth dams located in the counties, their design had obvious defects without proper control. For instance, the Kashi earth dam is of inclined core (silty clay loam) with sand gravel shells, the designers wanted to have an impermeable barrier and they put on two layers of plastic membrane with thickness 0.2 mm not on the surface but on the bed (Fig. 2). It made the whole core under water saturated and decreased the friction angle from  $34^\circ$  to  $23^\circ$ . It undoubtedly was the reason of the surface slide (Fig. 6). This is also an example of liquefaction of the core and shell.

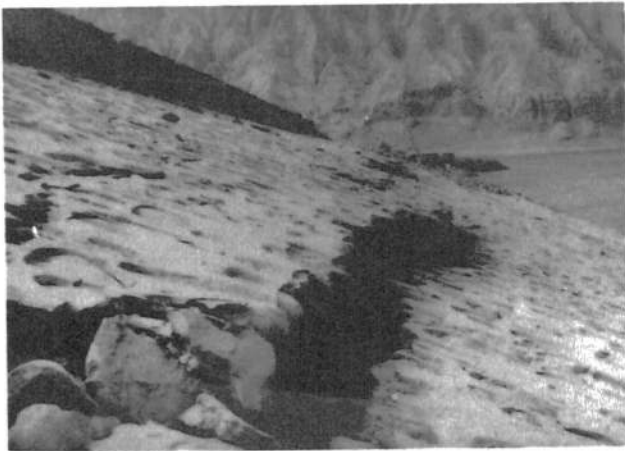
There were 6 longitudinal cracks, 2 of them were on the crest, 4 on the upstream slope (Fig. 8, 9). The horizontal displacements were 20-30 cm, the vertical displacements were 10-40 cm. 11 transverse cracks were discovered near abutments. The maximum width was 5 cm.

Fig. 8 Photograph of longitudinal cracks on the upstream slope of Kashi earth dam

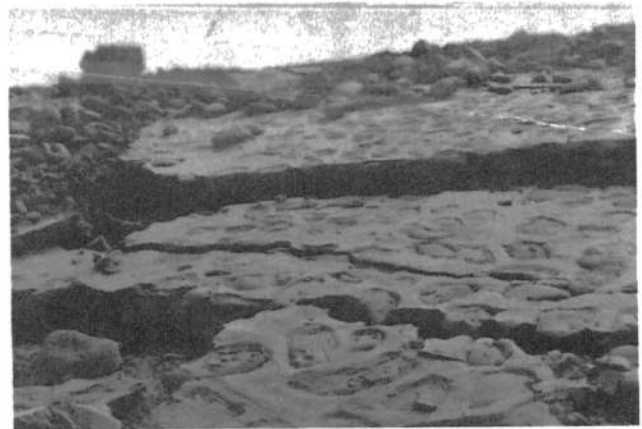
Fig. 9 Photograph of longitudinal cracks on the upstream slope of Kashi earth dam

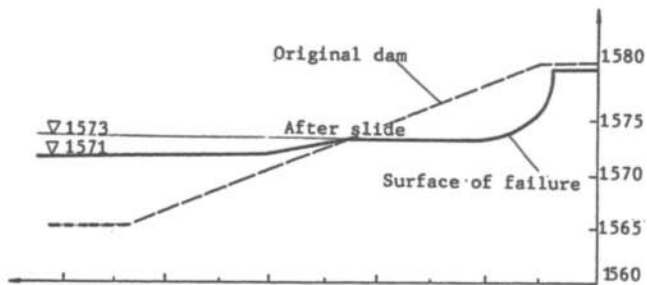
The slide of upstream slope 0+250 section show in Fig. 10, 11.

Fig. 10 Cross section of slide on the upstream slope of Kashi earth dam at 0+250 after earthquakes

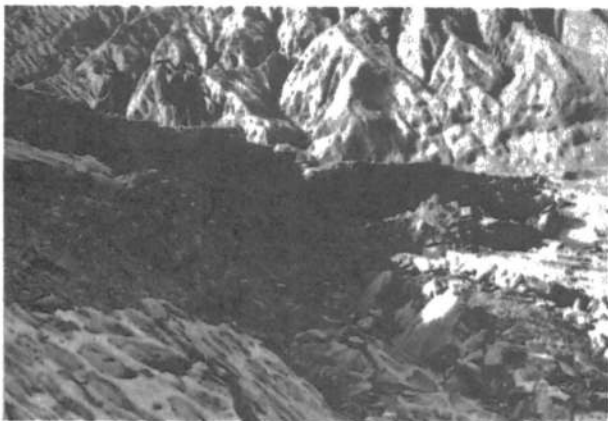
Fig. 11 Photograph of the slide on the upstream slope of Kashi earth dam at 0+250

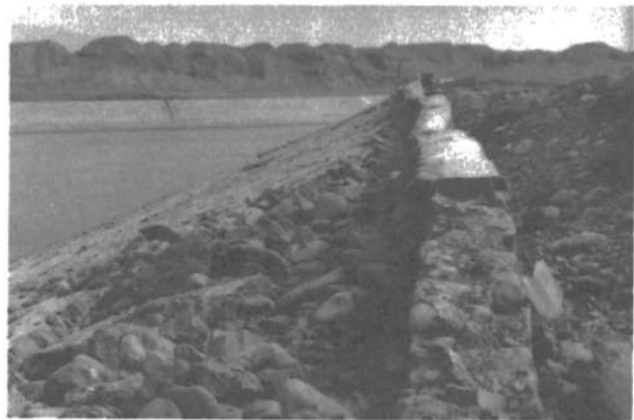
The masonry parapet on the crest of dam collapsed and fell onto the upstream slope mostly (Fig.12).

Fig. 12 Photograph of the failure of Parapet Wall on the crest of Kashi earth dam

7) Many parapet walls were destroyed during earthquake, because they stood on the crest of earth dams and there existed large horizontal acceleration force acting on them. Besides, the masonry structure had not enough tensile strength.

High structures are always weak points during strong earthquakes, experience proved that, the masonry parapet walls on the crest of dams were quite often damaged due to whipping effect.

4) High structures or wave walls on the crest of dams should be avoided in any case.
