Some Fractographic Features of Various Weld Cracking and Fracture Surfaces with Scanning Electron Microscope†

—Studies on Fractography of Welded Zone (I)—

Fukuhisa MATSUDA* and Hiroji NAKAGAWA**

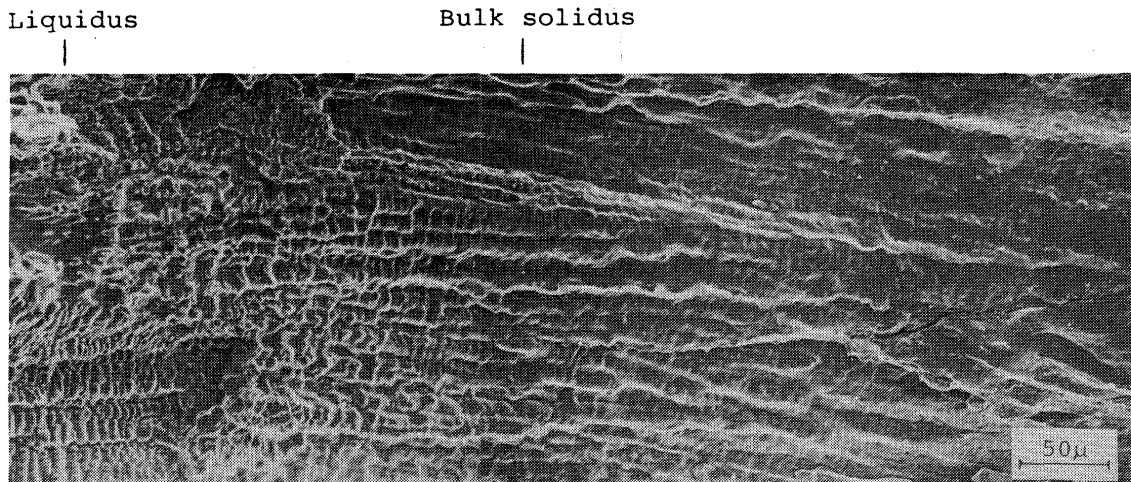
Photo. 2 Solidification cracked surface of SUS310S occurred with Trans-Varestraint test

Photograph 2 shows a solidification cracked surface of fully austenitic stainless steel of SUS310S* tested with Trans-Varestraint method. One of the merit of this testing method is to be able to determine the relation between the each location in the crack and its temperature during welding, since the crack occurs instantaneously. In **Photo. 2** the temperature is lowered from the left toward the right side. The cracked surface as a whole shows a feature of intergranular cracking which is elongated unidirectionally due to the columnar growth. The detail, however, changes from the higher temperature region to the lower temperature region. That is, in the region at the highest tem-

perature many and fine protuberances are remarkably observed, which correspond to the primary and secondary arms of cellular dendrites. In the region at the medium temperature the protuberances of secondary arms gradually become obscure. Further, in the region at the lowest temperature the protuberances of primary arms also become obscure, and a flat surface becomes dominant. The reason of such a change is mainly because of the decrease in the residual liquid together with the temperature drop, and partly because of the grain boundary migration among residual low melting liquids in the lowest temperature region¹⁾.

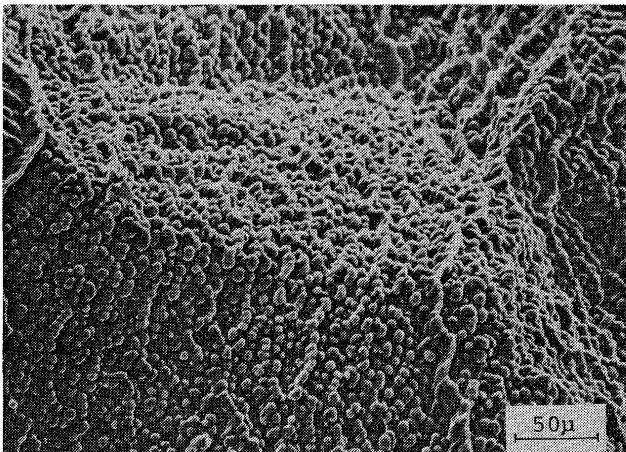
Photo. 3 Solidification cracked surface of 5083 aluminum alloy occurred with Houldcroft type test

cation cracked surface of aluminum alloy 5083 tested with Houldcroft type method. Though the cracked surface shows a non-directional intergranular cracking due to the equiaxed crystals, many protuberances are remarkably observed. Therefore it is considered that the crack occurred near the liquidus temperature. The authors confirmed this by photographing the tip of solidification cracking with 16 mm movie camera. Moreover the cracked surface near the arrested location of the cracking in this specimen was similar to that in the lowest temperature region in Photo. 2.

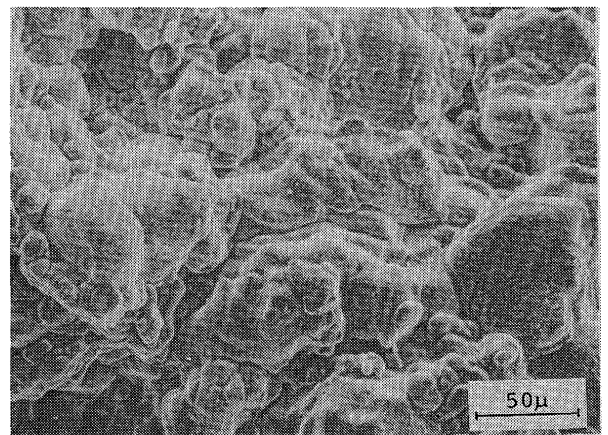
Photo. 4 Liquation cracked surface in HAZ of SUS310S

The cracked surface shows a feature of intergranular cracking, but gives an rounded appearance compared with that in cold cracking mentioned later. Besides, in Photo. 4 some protuberances which are somewhat similar to those of dendrites are observed. Since the location of Photo. 4 is an extreme vicinity of the

fusion boundary, it is considered that these protuberances mean the existence of much liquid among the grain boundaries during welding.

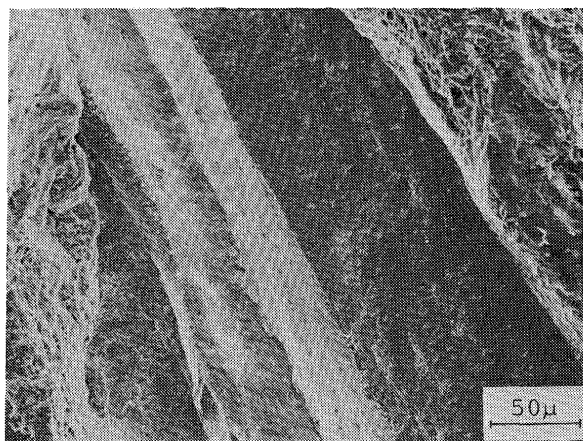
Photo. 5 Ductility-dip cracked surface in weld metal of SUS310S occurred with Trans-Varestraint test

In SUS310S tested with Trans-Varestraint method, ductility-dip cracks occur between about 1200°C–850°C. The cracked surface also shows a feature of intergranular cracking as shown in **Photo. 5***, but the

ridge of the grain boundary is seemed to be somewhat sharper than that in the lowest temperature region in Photo. 2. Besides the cracked surface looks slightly rough in higher magnification. Moreover the ductility-dip cracked surface differs from the solidification cracked surface in their element distributions. On the solidification cracked surface the elements such as sulphur forming low melting products are often observed. On the ductility-dip cracked surface, however, carbon which may form carbide of $M_{23}C_6$ type was detected.

* In Photo. 5 the left part and the upper right part are the artificially fractured region showing dimples.

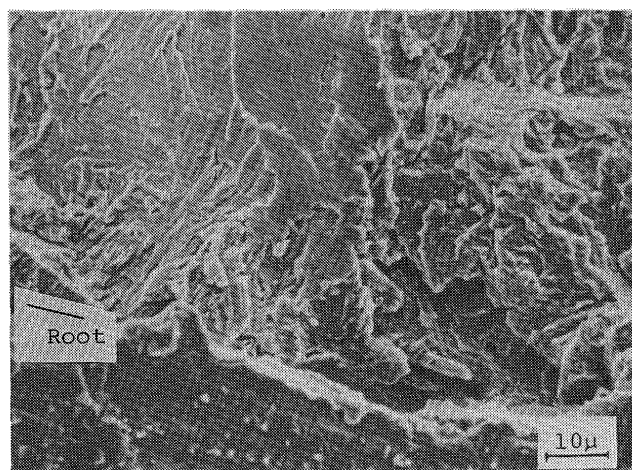
(a) vicinity of the root

It is shown⁹⁾ that the root crack in the y-groove cracking test generally originates in the heat-affected zone and propagates into the weld metal. The cracked surfaces in both the heat-affected zone and the weld metal are composed of either intergranular, quasi-cleavage, dimple, or their two or three mixed fracture mode. **Photograph 6(a)** shows an example of the quasi-cleavage fracture mode in heat-affected zone. Since in any welded zone the evaluation of the stress intensity factor and the hydrogen concentration at each crack tip is impossible at present, the systematic

Photo. 6 Root cracked surface in HAZ occurred with y-groove cracking test. material; HT50 (40 mm thickness), electrode; JIS D5016 (diffusible hydrogen; 4 cc/100 g), heat input; 22,000 J/cm, non-preheating

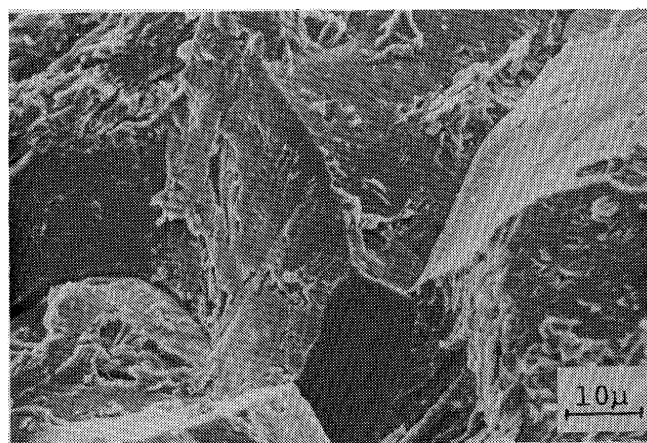
(b) coarse grained region near fusion boundary

description of the distribution of fracture mode in the cold cracked surface is difficult. Despite this circumstance, intergranular fracture mode is often observed in the coarse grained region of the heat-affected zone as shown in **Photo. 6(b)**.

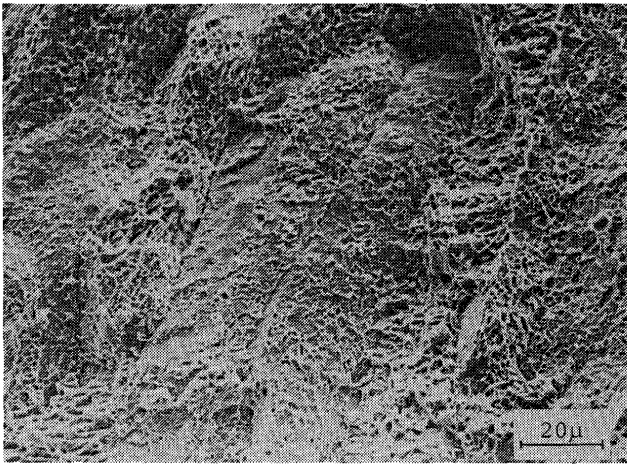
Photo. 7 Root cracked surface in weld metal occurred with Controlled restraint fillet weld cracking test⁴⁾. material; HT80 (25 mm thickness), electrode; E11016 (hydrogen; 20 cc/100 g), heat input; 17,000 J/cm, non-preheating

Besides, in most weld metal not only the intergranular mode but also the quasi-cleavage and dimple modes have often a directional appearance due to an elongated prior austenite grain. An example of this is shown in **Photo. 7**.

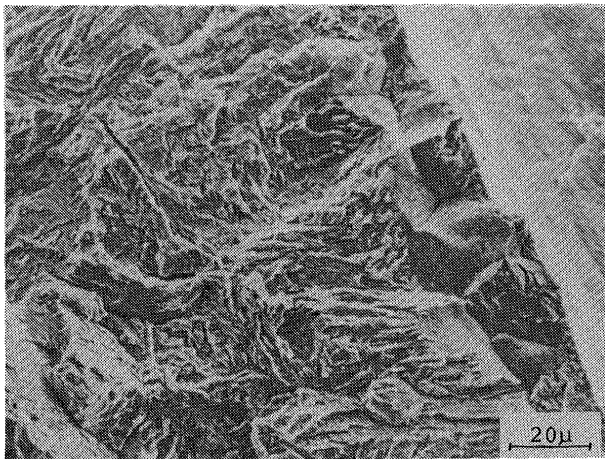
Photo. 8 Root cracked surface near the notch occurred with Implant cracking test. material; HT80, electrode; E11016 (hydrogen; 2 cc/100 g), applied stress; 70 kg/mm² heat-input; 17,000 J/cm, non-preheating

Photograph 8 shows a fractured surface near the notch of an Implant tested specimen, in which the intergranular and the quasi-cleavage fracture modes are clearly observed.

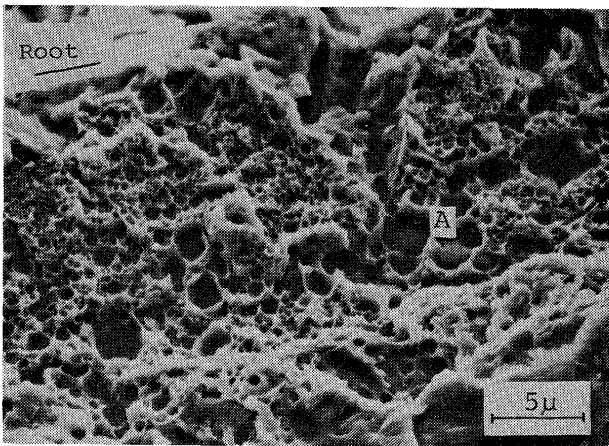
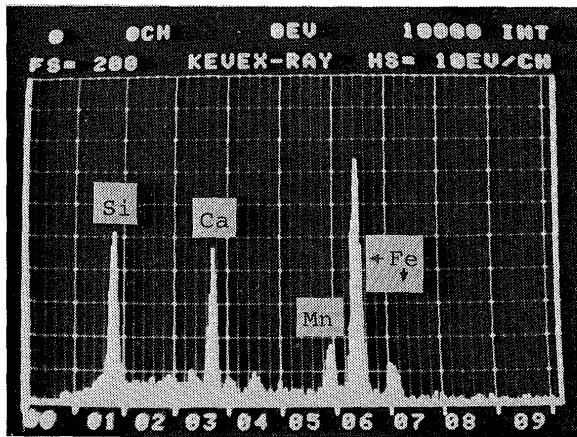
(a) vicinity of the root

A heel cracked surface at an extreme vicinity of the root in HT50 (high tensile steel more than 50 kg/mm² in ultimate strength) with Non-restraint T type cracking test⁵⁾ shows a quasi-cleavage or fine dimple fracture mode, both of which are affected by hydrogen. An example of the fine dimple fracture mode is shown in **Photo. 9(a)**. **Photograph 9(b)**, whose abscissa is X-ray energy and the ordinate is the intensity, is the EDX result of an inclusion A in a dimple in **Photo. 9(a)**, and this shows the existence of Si, Ca, Mn and Fe. Since the large quantity of Fe is considered to be due to an effect of the matrix judging from the resolving

power of EDX, the inclusion must be an oxide composed of Si, Ca and Mn. Moreover the existence of Si and Ca which are the slag constituents may suggest that the heel crack at the extreme vicinity of the root is passing through the weld metal.

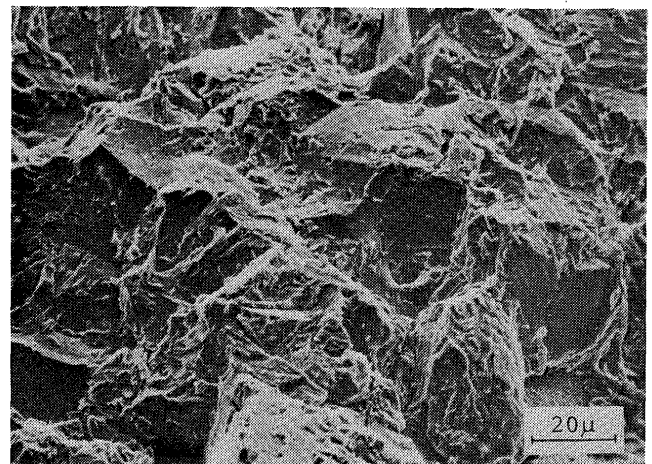
(c) general feature

Except the extreme vicinity of the root, the cracked surface is composed of a mixture of intergranular and quasi-cleavage fracture mode, as shown in **Photo. 9(c)**. By the way, the sulphur content of this HT50 is 0.009% and thus the inclusions which were mainly composed of manganese sulphides elongated along the rolling direction were sometimes observed as shown in **Photo. 9(d)**.

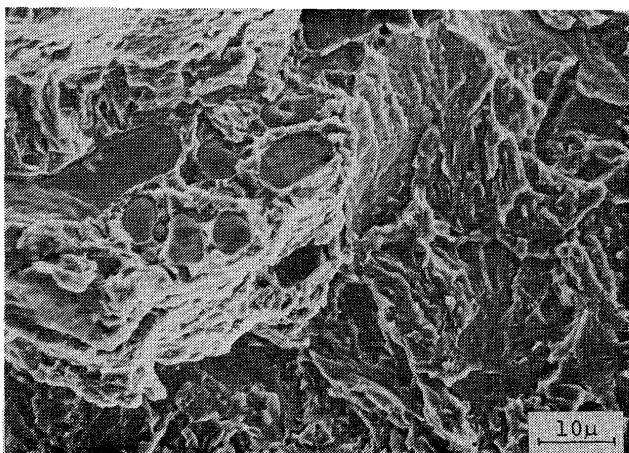
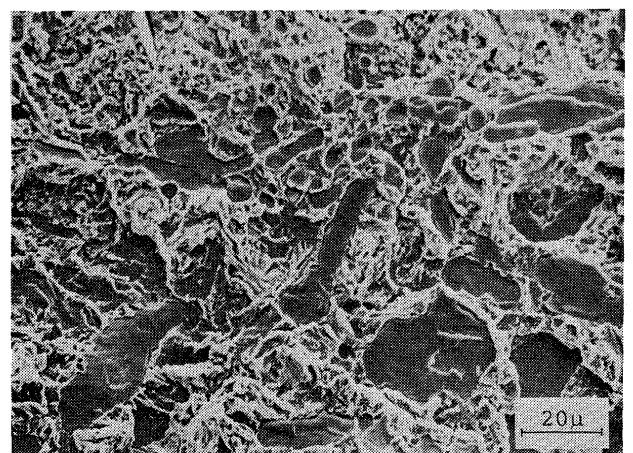
Photo. 10 Another example of heel cracked surface. material; HT50 (40 mm thickness), other conditions are the same as in Photo 9.

On the other hand, in a heel crack of another HT50 containing 0.018% sulphur, a cracked surface as shown in **Photo. 10(a)** was sometimes observed, which is similar to the terrace and wall type in a lamellar tear. Moreover, a cracked surface where many and flat manganese sulphides were clustered together as shown in **Photo. 10(b)** was often observed, although the major cracked surface was the same as in **Photo. 9(c)**.
2.2.2 Lamellar tearing

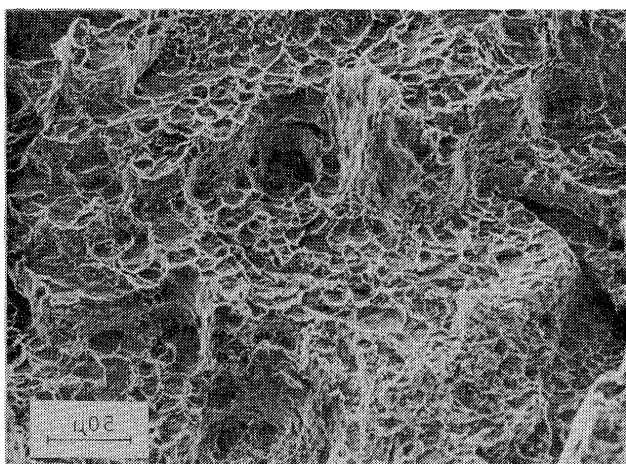
(a) typical terrace and wall type

Photograph 11(a) shows a lamellar tearing occurred from a root in a corner joint of HT50 (40 mm thickness, 0.018% sulphur), and this is the typical example of the terrace and wall type reported by Elliot et al⁶⁾. That is, the terrace part shows an equiaxed dimple fracture mode in which manganese sulphides along the rolling plane are mainly observed, and the wall part shows a shear dimple mode. Near the root, however, the wall part and the intermediate zone between the adjacent manganese sulphides on the terrace part occasionally show a quasi-cleavage fracture affected by hydrogen, which is similar to **Photo. 10(a)**.

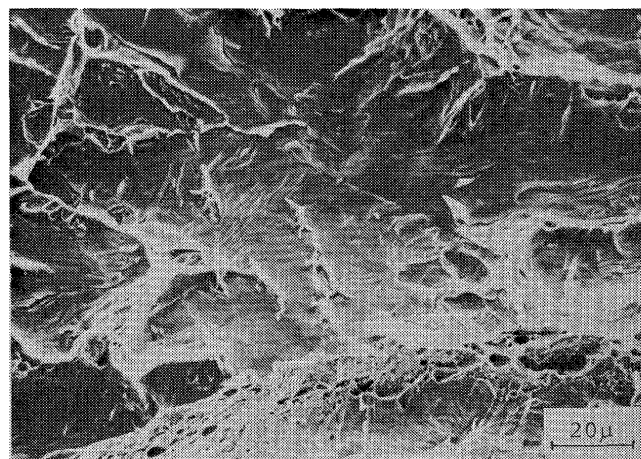
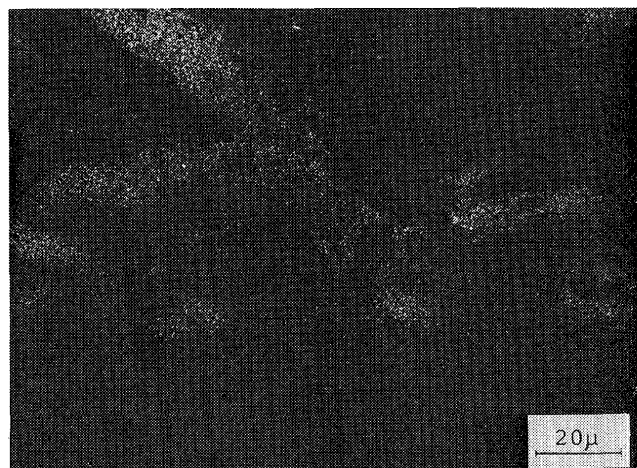
Photo. 12 Lamellar teared surface occurred with Implant cracking test of thickness direction without notch. material; HT50 (same as in Photo 11), electrode; D5016 (hydrogen; 4 cc/100 g), applied stress; 40 kg/mm², heat input; 17,000 J/cm, non-preheating

By an application of the Implant cracking test of the thickness direction without notch to the above mentioned HT50, a lamellar tearing easily occurred at a distance of about 12 mm from the fusion boundary. The fractured surface is shown in **Photo. 12(a)**, which is similar to **Photo. 11(b)**. The lower portion of **Photo. 12(a)** is the wall part composed of shear

dimples, and the other portion is the terrace part. The bright lines in the terrace part are the tear ridges between matrices, and the other part shows a flat separation between the matrix and the inclusion. **Photo. 12(b)** is the sulphur characteristic X-ray image of Photo. 12(a), from which the distribution of manganese sulphides is distinctly observed.

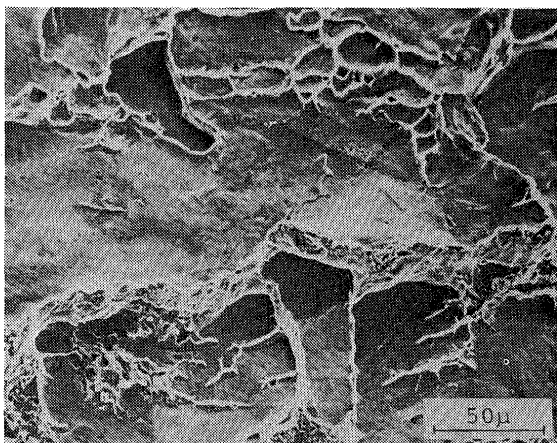
(b) another feature of terrace and wall type

Photograph 11(b) shows another example of the lamellar tearing which occurred at a distance of about 15 mm from the fusion boundary in the same joint as in **Photo. 11(a)**. This is somewhat similar to the terrace and wall type, but the terrace part shows a feature of flat separation between the matrix and the manganese sulphide. The reason may be that there are lots of large manganese sulphides in the nearer position to the thickness center. Though obscure in **Photo. 11(b)**, the large and flat manganese sulphides are often observed on the terrace parts.

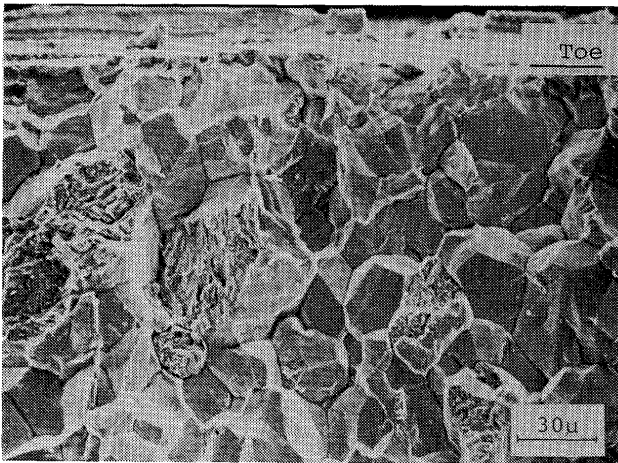
Photo. 13 Toe cracked surface occurred in SAE4340 steel welds. thickness; 25 mm, electrode; D5016 (hydrogen; 4 cc/100 g), heat input; 25,000 J/cm, non-preheating, water quenched just after welding

It was reported by Kobayashi et al.⁷⁾ that another type of cold cracking, that is, a kind of quenching crack during martensitic transformation occurs in hardenable steels. **Photograph 13** shows a toe crack in a SAE4340 steel occurred by the same method as Kobayashi et al.⁷⁾. **Photograph 14** shows a similar crack occurred in an electron beam weld metal of a high

carbon bearing steel (JIS SUJ2). In both cracked surface, intergranular fractures are mainly observed, though transgranular fractures are partly observed.

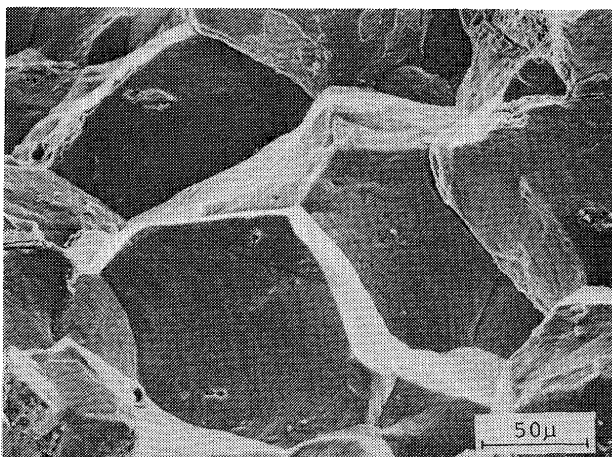
Photo. 15 Stress-relief cracked surface occurred in HT80. electrode; E11016, heat input; 17,000 J/cm, annealing temperature; 600°C

When HT80 specimen of y-groove cracking test which was conducted in the environmental and welding conditions free from hydrogen-induced crack was annealed at 600°C as the stress-relief, a stress-relief crack readily occurred. **Photograph 15** shows the surface which is a typical intergranular fracture. The cracked surface of the specimen annealed for long duration was severely oxidized, and the feature of the intergranular fracture became obscure.

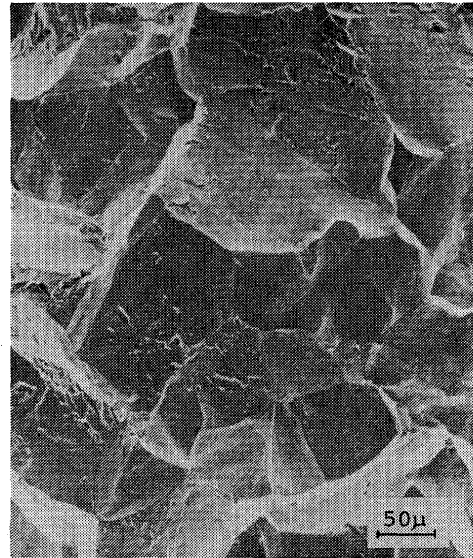
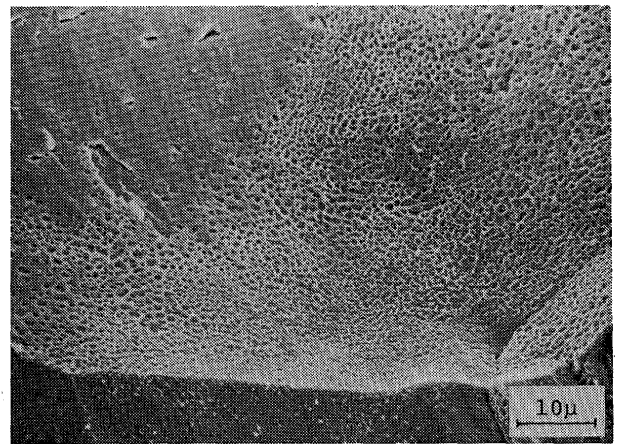
Photo. 16 Under-clad cracked surface occurred in Ni-Cr-Mo low alloy steel overlaid with stainless steel electrode, annealing temperature; 620°C

Photograph 16 shows an example of the cracked surface of a Ni-Cr-Mo low alloy steel which was overlaid with a stainless steel electrode and then annealed at 620°C as the stress-relief. This crack is called as under-clad crack in Japan. The cracked surface also shows the intergranular fracture, and the observation of a higher magnification often revealed many and small voids as seen in Photo. 16(b).

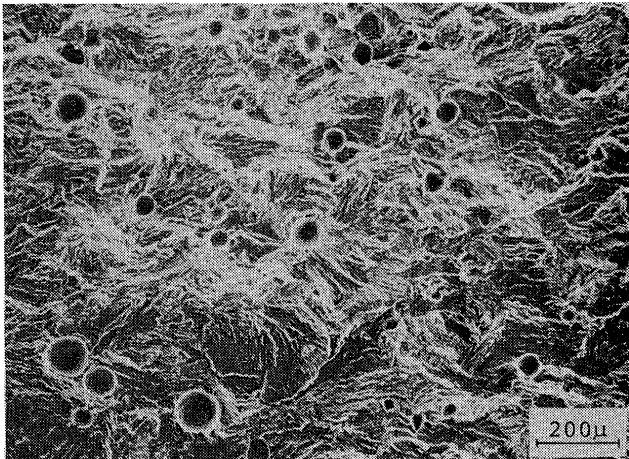
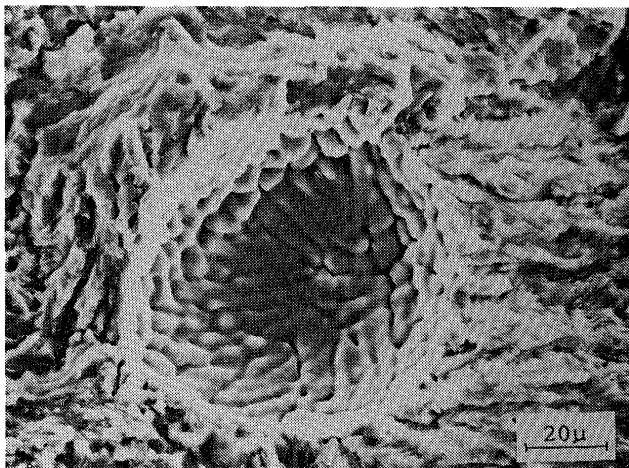
Photo. 17 Blowhole observed on a fatigue fractured surface of 5083 aluminum alloy welds.

Many and small blowholes were sometimes observed on a fatigue fracture surface of MIG weld metal of aluminum alloy, as shown in **Photo. 17(a)**. The observation of a higher magnification revealed a feature of dendritic protuberances inside the blowhole, as shown in **Photo. 17(b)**. The feature of blowholes of another materials was the same.

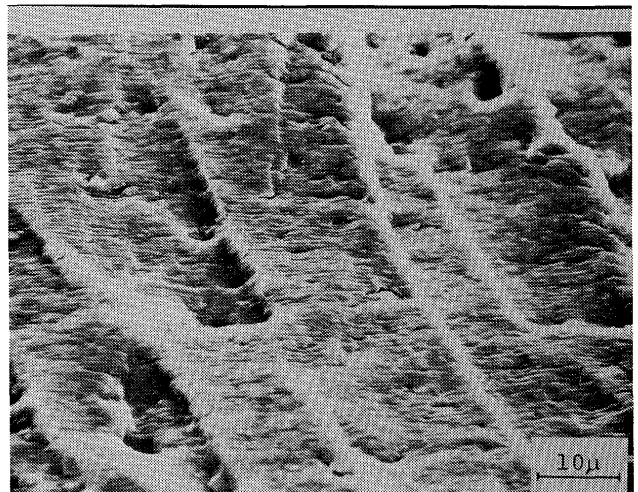
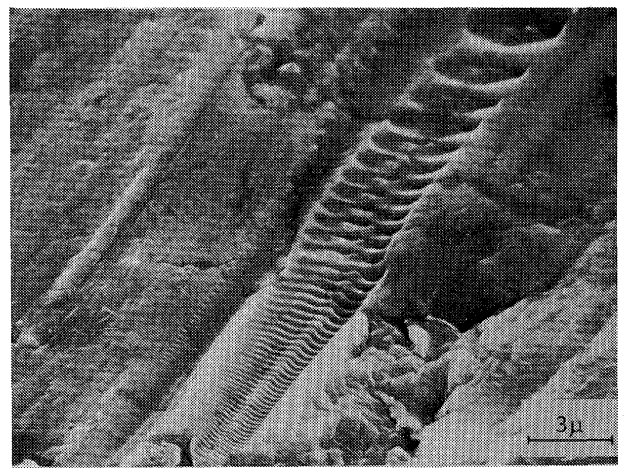
Photo. 18 Fatigue fractured surface of 5083 aluminum alloy weld metal. testing method; Schenck bending type, electrode; 5183, stress; 10 kg/mm², N ; 2.6×10^5

An example of a fatigue fracture of MIG weld metal of aluminum alloy 5083 is shown in **Photo. 18**. Photograph 18(a) shows typical striations on plateaus, and Photo. 18(b) shows a tire track and rub mark which are another evidence of a fatigue fracture.

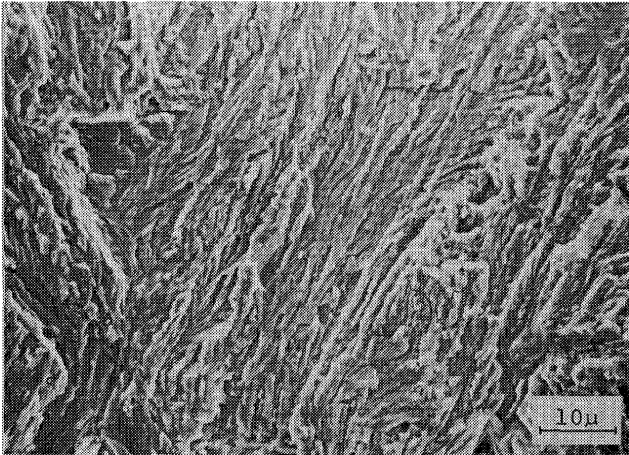
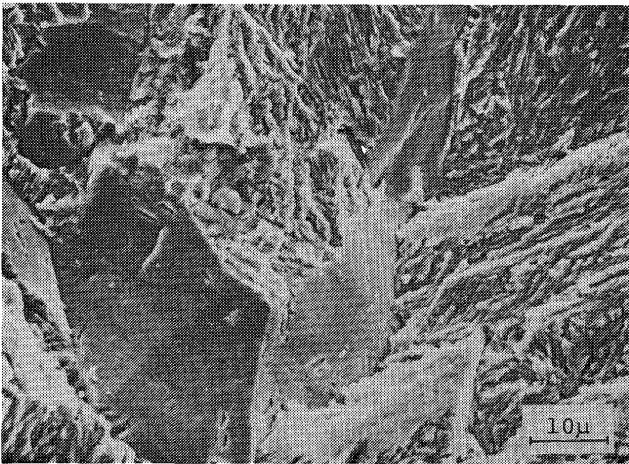
Photo. 19 Fatigue fractured surface near toe part of HT50 electron beam welds. testing method; Schenck bending type, stress; 18 kg/mm^2 , N ; 7.5×10^5

Photograph 19 shows a fatigue fracture near a toe of electron beam welds of HT50 which occurred from the toe of welds. Major fracture surface was perhaps a kind of cleavage fracture as seen in Photo. 19(a), and an intergranular fracture was sometimes observed as seen in Photo. 19(b).

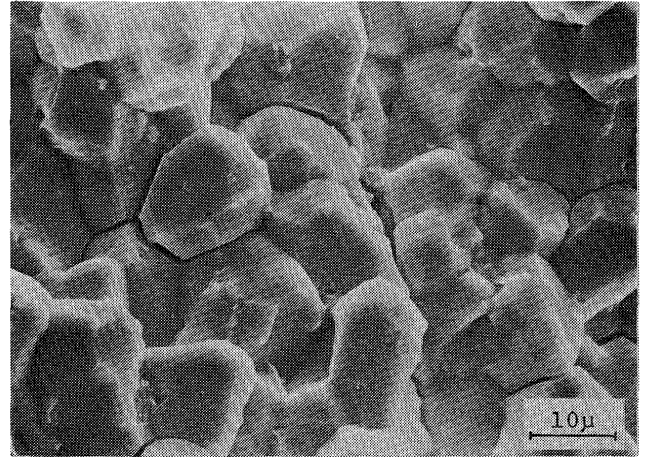
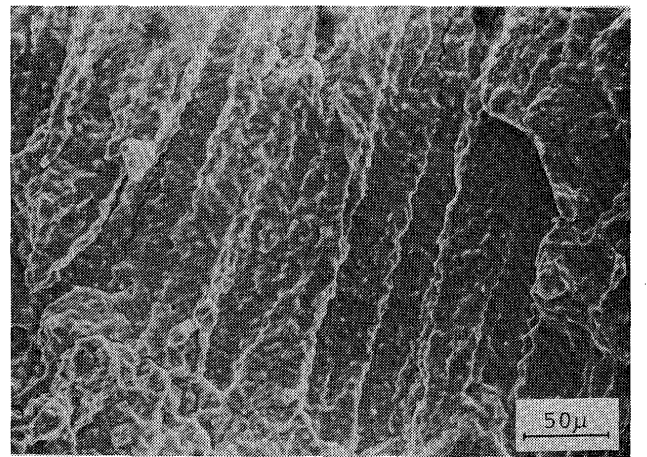
Photo. 20 Stress corrosion cracked surface of 7N01 aluminum alloy welds. electrode; 5556, corrosive agent; chromate saline solution, stress; 75% of the proof stress

Photograph 20(a) and **(b)** respectively show the examples of stress corrosion cracking in heat-affected

zone and weld metal of aluminum alloy (JIS 7N01), and both show intergranular features.
