O'Kelly B.C., Ward P.N. and Raybould M.J. 2008. Stabilisation of a progressive railway embankment slip, *Journal of Geomechanics and Geoengineering*, Vol. 3, No. 4, 231–244.

Stabilisation of a progressive railway embankment slip

Abstract: A walkover survey of a side embankment on the West Coast Mainline railway (UK) revealed significant movement of the twin-track; a waterlogged trackbed and general deterioration of the slope. Ground monitoring and investigations indicated that in addition to shallow washout failures and formation pumping problems at trackbed level, the embankment was at limiting equilibrium with progressive downslope movement occurring along a deep-seated shear zone ($\bar{\varphi}'_{postpeak} = 22^\circ$) within underlying strata of glacial till and laminated clay (weathered mudstone/siltstone). Phreatic level increases during rainstorm events, in combination with winter groundwater maxima, induced artesian pressures on the underside of the steeply-sloping shear zone triggering step increases in shear displacements. Other factors included the gradual post-peak decline in shear strength due to creep; internal weathering; cyclic, transitory stress increases by pas

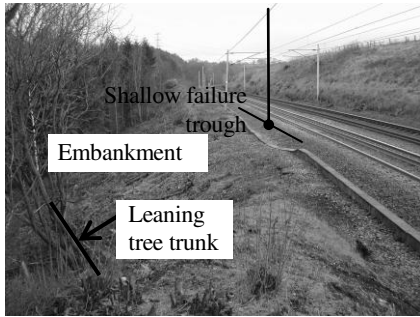
(a) Up-line slope.

Site walkover surveys in December 2000 revealed that the embankment was between 7.0 and 8.0 m in height and sloped towards the river at an overall angle of about 30° to the horizontal (Figure 3(a)). The top section of the embankment slope was covered with shale, cinders, over-spilled ballast and ash material and although mostly bare included some areas of poor vegetation growth (margin maintained clear of rough vegetation/trees to manage leaf fall and tree fall hazards to the tracks). Sparse rough vegetation and tress (many exhibiting distorted trunk growth) lower down the slope had been recently cleared as far as the Network Rail fence-

Significant distortion and movement of the track and trackside services and a general deterioration of the embankment slope had occurred. A shallow failure trough was also present along the Up-cess between 44 miles 577 yards and 44 miles 596 yards, which had caused significant snaking of the signalling and telecommunications cable trough (Figure 3(a)). The ground movement in this area had also caused the stanchion that supported the overhead line equipment in the Up-cess to lean by about three degrees to the vertical towards the track (Figure 3(b)). Passing high-speed trains were observed to cause significant vibration of the whole embankment.

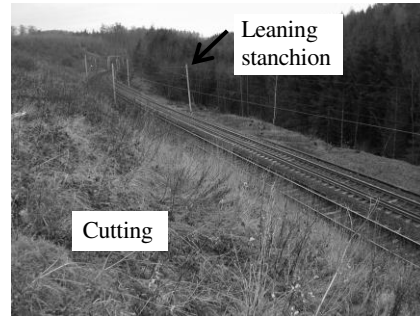
(b) Down-line slope.

On the Down-line (west side), there was a 6.0 to 7.0 m deep cutting (Figure 3(b)) with open pastureland present behind the crest. The cutting had also been excavated at an overall gradient of about 30° to the horizontal and was well vegetated with ground cover further up the cutting. Blocky, limestone outcrops were evident over the lower section of the cutting and a moderate seepage occurred from the exposed rockhead, close to the trackbed level.

The existing surface drainage comprised a diversion ditch near the crest of the cutting and two rubble drains that connected the crest ditch to the Down-cess. The ditch had become blocked, the rubble drains were ineffective and the Down-cess was waterlogged. There was no evidence of any drainage beyond the Down-cess and there were no engineered drainage channels over the embankment slope.

However, the Six-foot trace indicated that the strip of trackbed between the Up and Down-lines was in a poorer condition and a shallow interface between 44 miles 462 yards and 44 miles 616 yards was indicative of a dirty ballast. The Down-cess trace indicated a very variable interface depth (indicative of a well established formation pumping problem) between 44m 528 yards and 44m 570 yards and was consistent with the waterlogged Down-cess observed during the walkover surveys.

A shallow filter-drain (French drain) was constructed along the line of the existing ditch, set a distance of 2.0 m back from the crest (Figure 11(f)) to intercept runoff from the pastureland that sloped onto the cutting. Counterfort drains, which replaced the existing rubble drains on the cutting slope, connected the crest drain to a newly constructed Down-cess drain, which intercepted and discharged groundwater and seepages away from the embankment foundation. A subsurface filter-drain, installed behind the gabion wall (Figure 11(c)), intercepted the runoff from the upper embankment slope. The new outfall-headwall was located along the existing line of the riverbank, with the construction works taking place behind a bund, at low stage, during the summer months.

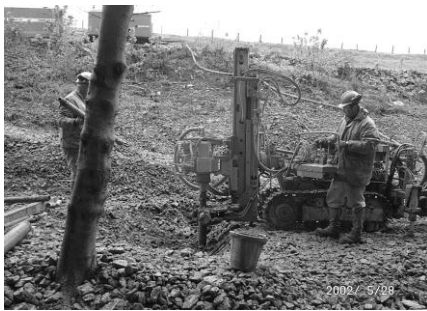
Figure 4. Mini track-mounted drilling rig operating on embankment slope. Note distorted tree trunk in foreground leaning down slope.

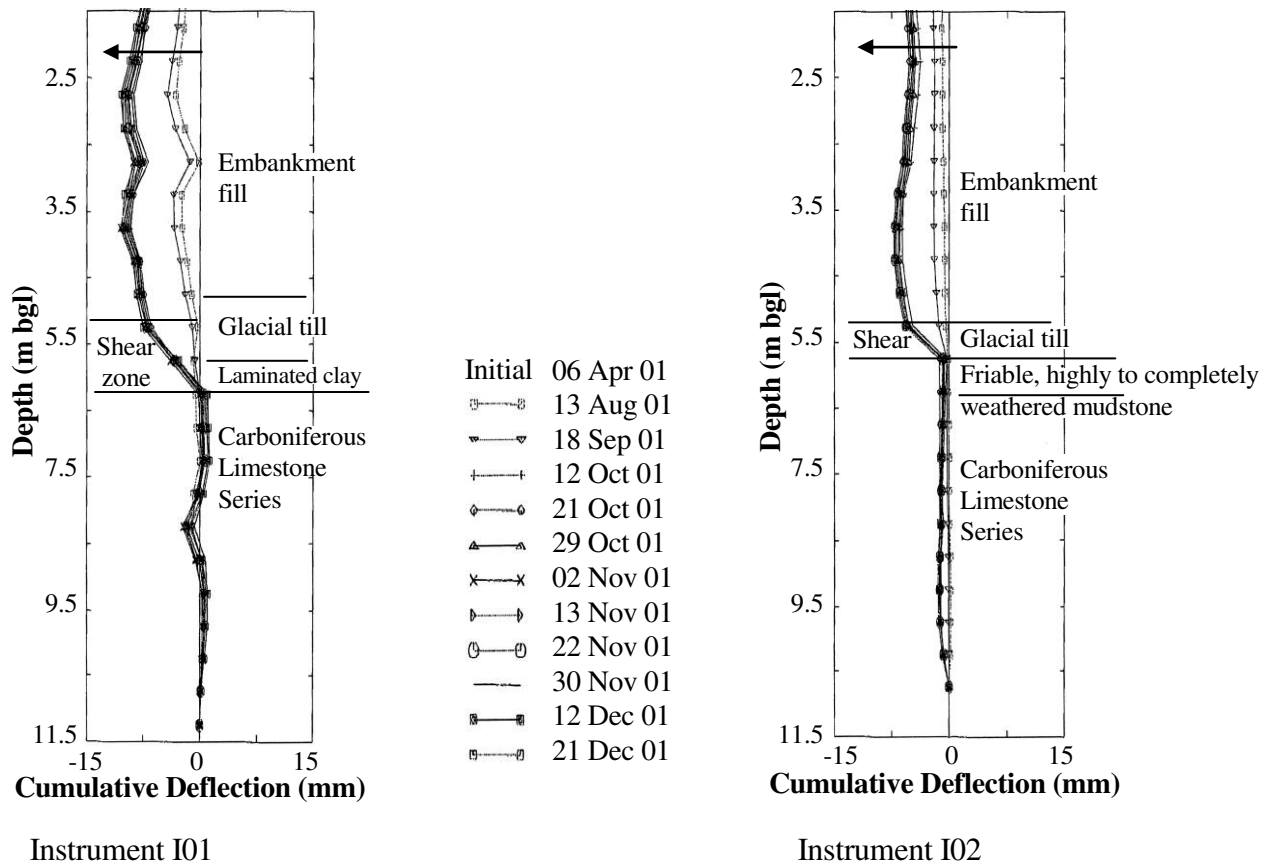
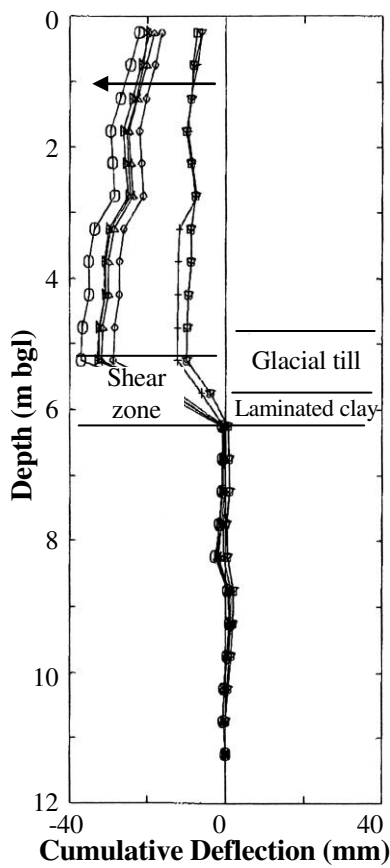
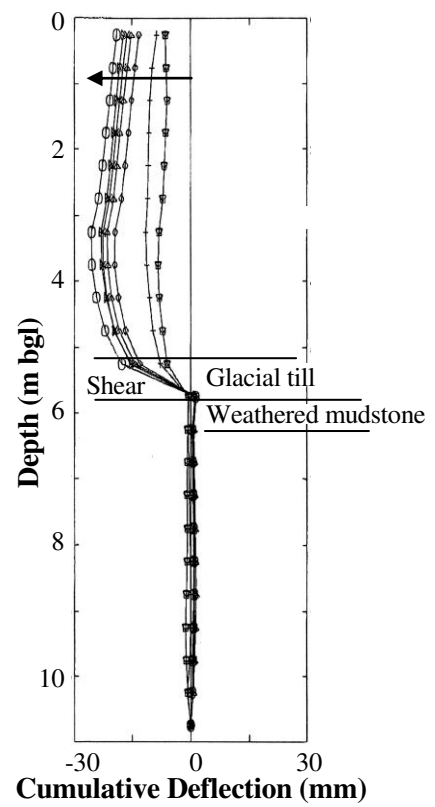
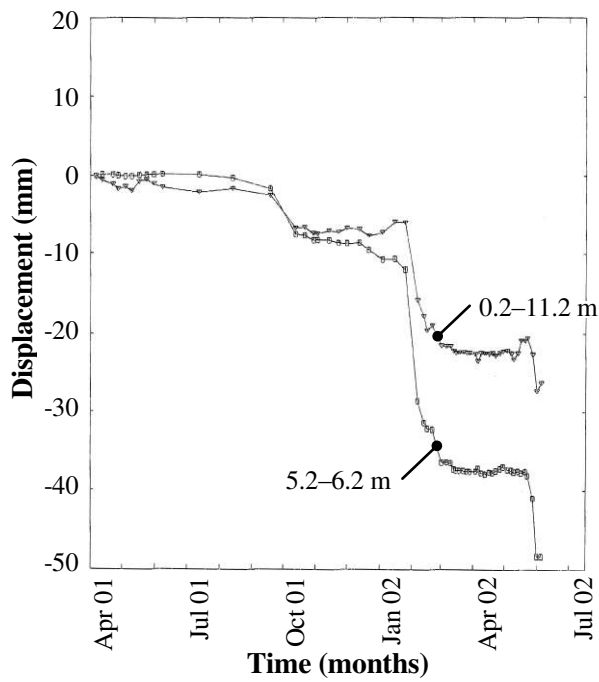
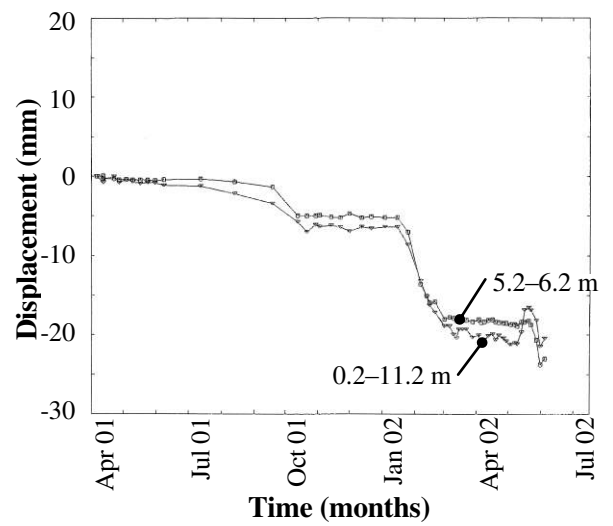
Figure 6. Inclinometer data for I01 and I02 located 4.2 and 6.4 m, respectively, down embankment slope from near rail on Up-line.

Two number inclinometers, namely I01 and I02, were installed in the upper embankment-slope (about 4.2 and 6.4 m, respectively, from the near rail on the Up-line). The inclinometer boreholes were cored to 11.0 mbgl, which provided an embedment of about 5.0 m in the stable bedrock. Monitoring twice-weekly began in April 2001 and the data are presented as cumulative deflection and displacement versus time plots in Figure 6. Note that a negative deflection reading indicates movement away from the track (down the slope).

Slow and progressive downslope movement had occurred (no reversals in ground movements due to seasonal effects) with sharp inclinometer distortions occurring between 5.2 and 6.2 mbgl. Maximum inclinometer deflections of between 36 and 52 mm were recorded roughly perpendicular to the track between April 2001 and July 2002. Instrument I02 indicated a more clearly defined shear surface whereas instrument I01 indicated a shear zone of up to 1.0 m in thickness within the glacial till (very soft, very silty, sandy gravely clay) and thinly laminated clay (completely weathered mudstone/siltstone). The maximum deflection recorded by instrument I02 occurred about 1.5 to 2.0 m above the shear surface (Figure 6(a, b)) suggesting sympathetic shear displacements in the overlying embankment fill, which was not surprising given its loose state. Both inclinometers indicated negligible movements below rockhead, at about 6.2 mbgl.

The rate of downslope movement (shown in Figure 6(c)) responds to seasonal rainfall patterns and individual rainstorm events. By specifying depth limits for the displacement versus time plots, shear zones affecting the installation can be isolated and movement measured separately. For example, the 5.2–6.2 m plot in Figure 6(c) shows the relative movements of the inclinometer tubes across the shear zone (between 5.2 and 6.2 mbgl). Similarly, the 0.2–11.2 m plot shows the movement of the top of the tube relative to the bottom of the tube (secured in stable bedrock). The rates of movement measured along the shear zone accelerated from typically 0.03–0.04 mm/day (averaged over 284 days) up to 0.85 mm/day (averaged over 31 days) due the wet season of November to March. Step increases of about 8 and 27 mm in the displacement measured along the shear zone occurred during prolonged periods of inclement weather between mid September and mid October (2001) and mid January to the end of February (2002), respectively.

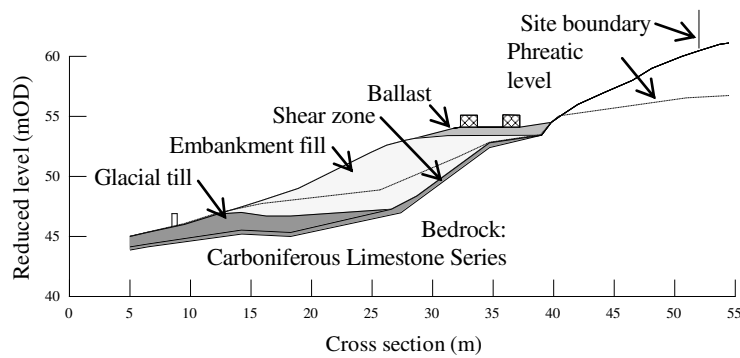
Figure 7. Critical embankment section.

The available strength data for the shear zone were limited to the driller's description and inspections of the rock cores (poor recovery). Hence, an effective stress back-analysis of the critical embankment section (Figure 7) was carried out to determine representative shear strength parameter values for design. The critical section was analysed in plane strain using Geosolve SLOPE\W and the method of slice equilibrium after Morgenstern and Price (1965), assuming the limiting equilibrium condition (factor of safety, FOS = 1.0). The input values for the embankment fill and glacial till strata were based on the *insitu* and geotechnical laboratory test data. A sensitivity check was also carried out for lower phreatic levels since high phreatic levels are unconservative for the purpose of back analysing the shear strength parameter values.

A design $\bar{\varphi}'_{postpeak} = 22^\circ$ was determined for the shear zone. Note that this is an intermediate value between the peak (CU triaxial compression value of 33°) and the residual condition. Back analysis of other structures suggests that large ground movements can occur, and are sufficient to lead to a serviceability failure (as at the

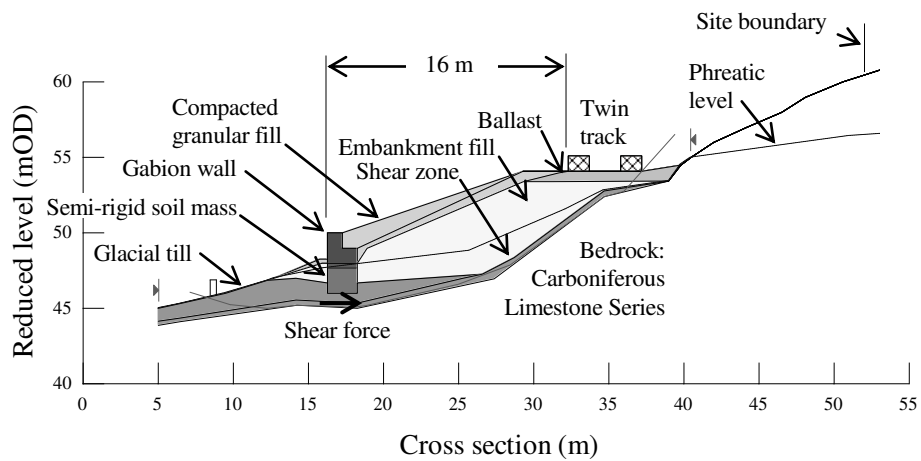
Figure 9. SLOPE\W analysis of upgrade works.

A sensitivity study was carried out in which two scenarios were considered, namely: a most probable embedment of 4.0 m from the underside of the gabion wall to rockhead (Figure 9) and a pile embedment of 5.0 m, which corresponded to the most unfavourable ground conditions expected. The ground model for the 5.0 m embedment was the same as that shown in Figure 9 except that the rockhead depth was located a distance of 1.0 m lower.

The analysis indicated that the pile wall must be capable of supplying horizontal forces of 85 and 100 kN/m-run for the most probable and most unfavourable ground conditions, respectively, to increase the FOS value along the existing shear zone from unity to 1.2. Other potential rotational slides, including compound slips incorporating part of the shear zone, and shallow slips day-lighting just upslope of the gabion wall had FOS > 1.3. Further SLOPE\W analysis indicated that the FOS value for the temporary works condition (piling rig operating on a working platform near the mid slope) was satisfactory.

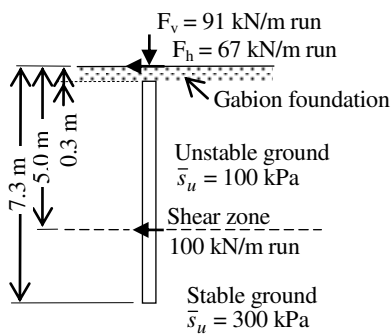
Figure 10. Analysis of single stabilising pile for most unfavourable ground conditions.

The simplified ground model and the system of forces that a single pile must be capable of resisting are shown in Figure 10(a). Unstable ground (4.0 and 5.0 m in thickness for the most probable and most unfavourable conditions, respectively) overlies the stable ground of the Carboniferous Limestone Series bedrock. Representative undrained shear strength (\bar{s}_u) values of 100 and 300 kPa were determined from unconsolidated undrained triaxial compression and *insitu* test data for the upper and lower layers, respectively. The SLOPE\W analysis had indicated that

Figure 10(b) shows the critical failure mechanism, namely Viggiani (1981) mode B, with the ground simultaneously failing above and below the shear zone. The pile undergoes a rigid rotation since the maximum bending moment acting on the pile section is significantly lower than its yield moment of 285 kN.m. The ultimate horizontal forces that the stabilising pile can exert along the shear zone are 288 and 276 kN/m-run for the most probable and most unfavourable ground conditions, respectively. Hence, the most probable FOS values on the ultimate lateral load capacity of the stabilising piles were 3.4 and 1.9 for the short and longer-term conditions, respectively. The corresponding FOS values for the most unfavourable ground conditions were slightly lower at 2.8 and 1.7.

The pile section was designed in accordance with BS5400 (1988) to resist the system of working loads and bending moments, and for a design life of 120 years. The maximum bending moment acting on the piles was 79 kN.m in the underlying stable ground. The minimum FOS value of 1.7 (longer term and most unfavourable ground conditions) for the geotechnical design was slightly greater than the load factors (FOS = 1.65) applied for the structural design of the pile.

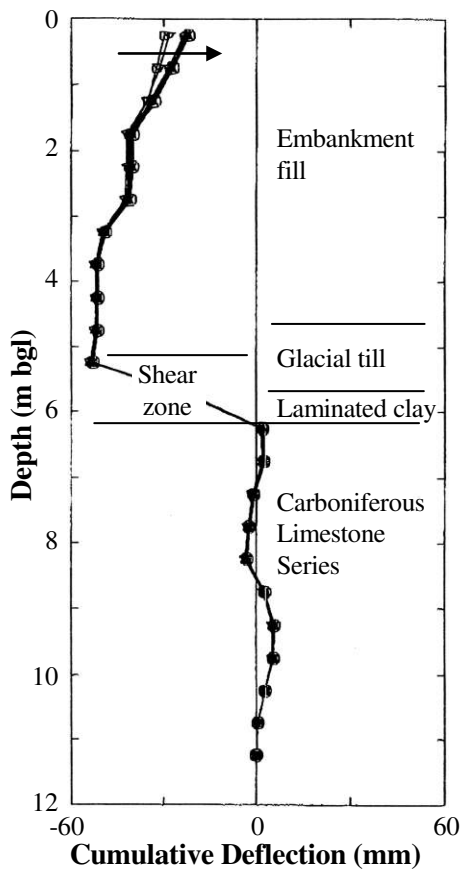
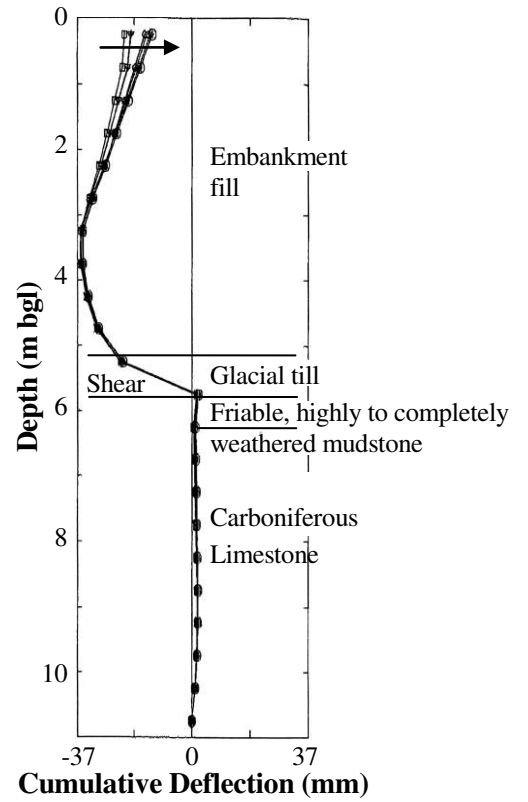
Figure 12. Inclinometer data for upper embankment slope.

Drops in the track levels occurred over the full length of the site between August and mid September (2002) and resulted in significant increases in cant between 44 miles 577 yards and 44 miles 596 yards. It is postulated that the recorded track settlements, particularly in the case of the Up-line cess rail, mainly occurred due to the densification of the loose embankment fill by vibrations caused by machine plant operating on the slope. In particular, the drops in both track levels (Up 8.0 mm max and Down 5.0 mm max) between mid July and the end of August coincided with the piling works. A further drop in the Up-line (10.0 mm max) between early and mid September coincided with the construction of the gabion wall and slope regrading. Although the cant and cant gradient values were still acceptable, remedial works (lift, pack and tamp ballast) were undertaken during mid September (2002) in order to limit future settlement of the tracks.
