# Study on the Causes of Secondary Cracks of the Eave Wall Mural of Daxiong Hall at Fengguo Temple in Yixian, Liaoning, China

**Abstract:** Built in Kaitai nine years of Liao Dynasty (1020 A.D.), the Daxiong Hall of Fengguo Temple in Yixian County, Liaoning Province, is one of the largest existing ancient single-eave wooden structure in China. There are nearly 470m<sup>2</sup> murals of Yuan Dynasty on the four walls of the hall. Since the in-situ reinforcement and protection of the mural were carried out in the 1980s in cooperation with the maintenance and restoration project of the main hall, the seriously developed cracks have become the primary factor affecting the structural stability of the mural. In order to find out the macroscopic causes of secondary cracks, endoscope, infrared thermal imager, three-dimensional laser scanner and other equipment were applied to study the relations between cracks' attitude and structural defects of the eave wall, as well as the pathway that external environment act on the mural noumenon through comprehensive investigation, and the idea of restoring the stability of the mural by blocking the air channel and offsetting the environmental stres

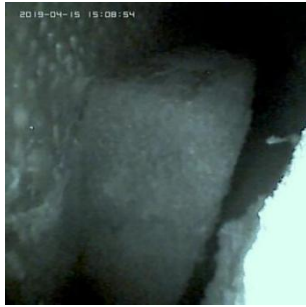
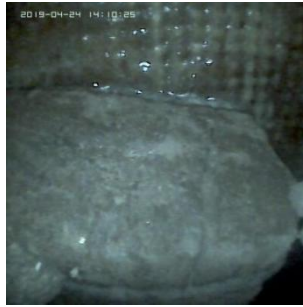
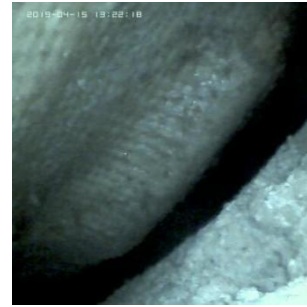
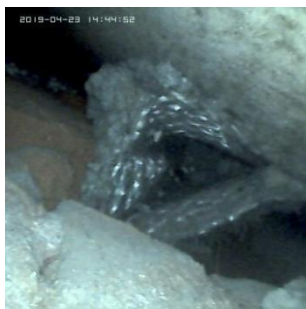
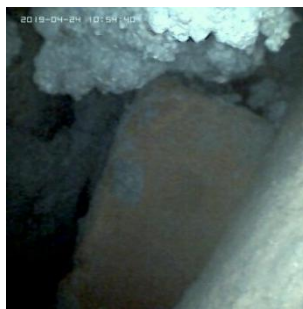
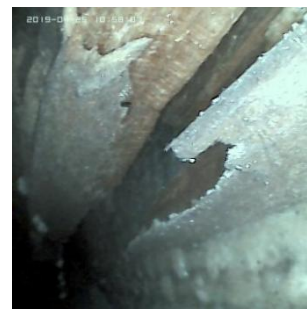
Figure 2. Endoscopic photographs of internal structure details of the eave wall

The filed investigation results(As shown in Figure 2 and Figure 3) show that there is a cavity with a thickness of 2 ~ 10cm between the GFRP backing and the red brick wall in addition to the structure mentioned in the engineering report. The red brick wall was built roughly and the brick joints are relatively large. Furthermore, there are 5~6 rows of horizontal wood keels adhered to the GFRP backing, which are parallel to each other. Their thickness is about 3cm, height is about 10cm, and length is basically equal to the width of a unit. However, there is no physical connection between the wood keels and the red brick wall, and some of the wood keels split near the bonding surface due to the deformation of the material. The wood keels of the two adjacent units are discontinuous and their upper and lower positions are staggered to a certain extent. The ends of some wood keels are covered by the upturned fiberglass cloth of the adjacent units, which is consistent with the description in the engineering report that the reinforcement was carried out unit by unit. The combination of "wood keels + GFRP backing" was commonly used as the support for the detached mural in China in the

(a) The end of the wood keel

(b) The wood keel bonded to the GFRP backing

(c) The wood keel covered by the GFRP backing

(d) The GFRP fixture

(e) Rough red brick wall

(f) Splitting of the wood keel

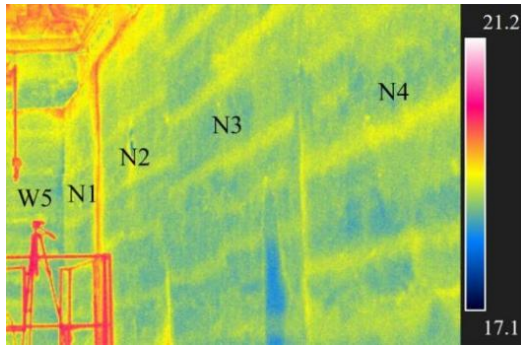
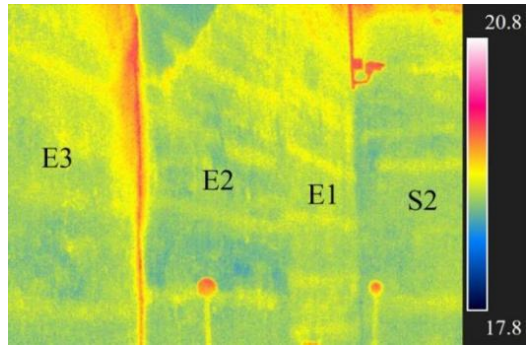
Figure 3. Infrared thermal images of the arrangement of wood keels behind the mural backing

1970s and 1980s<sup>[15]</sup>. The wood keels were generally arranged into a horizontal and vertical grid frame to improve the strength of the support and enhance the integrity of the mural. But it is difficult to apply the grid frame of wood keels in the in-situ reinforcement project in Fengguo Temple due to the mural's large size. Therefore, only the horizontal wood keels were applied in the order of top-down reinforcement, instead of the vertical wood keels.

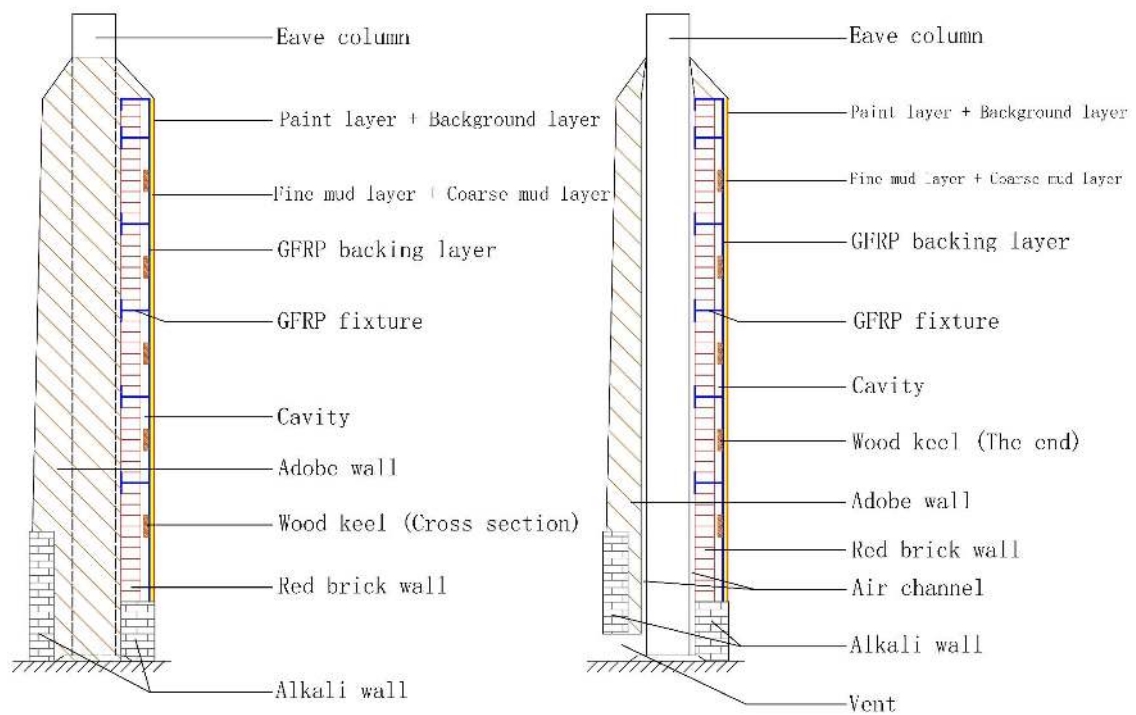
Figure 4. Cross-section of the eave wall mural's existing structure

The structure of the wall at the junction of the two adjacent units, where is the joint part of wood keels and GFRP backing with a weak strength, is somewhat different from the wall in the unit due to the existence of inner columns. In order to protect against corrosion and buffer the expansion stress, two layers of reeds and flat tiles are wrapped around the wooden column, and a vent is arranged at the position of the column root on the external wall. The loose reeds form a ring of air channel about 5cm thick around the wooden column, which is connected to the cavity through the red brick wall joints. The existing basic structure of the eave wall mural is shown in Figure 4.

The position of the eave column, as the junction of two adjacent units of the mural, lacks the overall reinforcing effect of transverse wood keels, and is relatively weak in structure. As the murals of adjacent units are respectively strengthened, the different installation conditions of fixtures and wood keels such as their position and tightness will cause the difference of restriction strength, thus generating the overall stress at the eave column, that is, at the junction of two adjacent units. The concentration and superposition of stress and the weakness of structure constitute the two potential internal causes for the formation of longitudinal cracks. The existence of transverse cracks in the unit shows that the horizontal wood keel only plays a unidirectional reinforcing role, and the stress is confined to the horizontal direction and released in a concentrated way. Since there is no physical connection between the wood keels and the red brick wall behind them, when the GFRP backing is overall deformed or displaced, the wood keels will move along with it, thus offsetting part of the overall stress and making the local stress at the edge of the reinforced parts by wood keels play a decisive role. Therefore, the transverse cracks in the unit are generally less serious than the longitudinal cracks at the eave column.

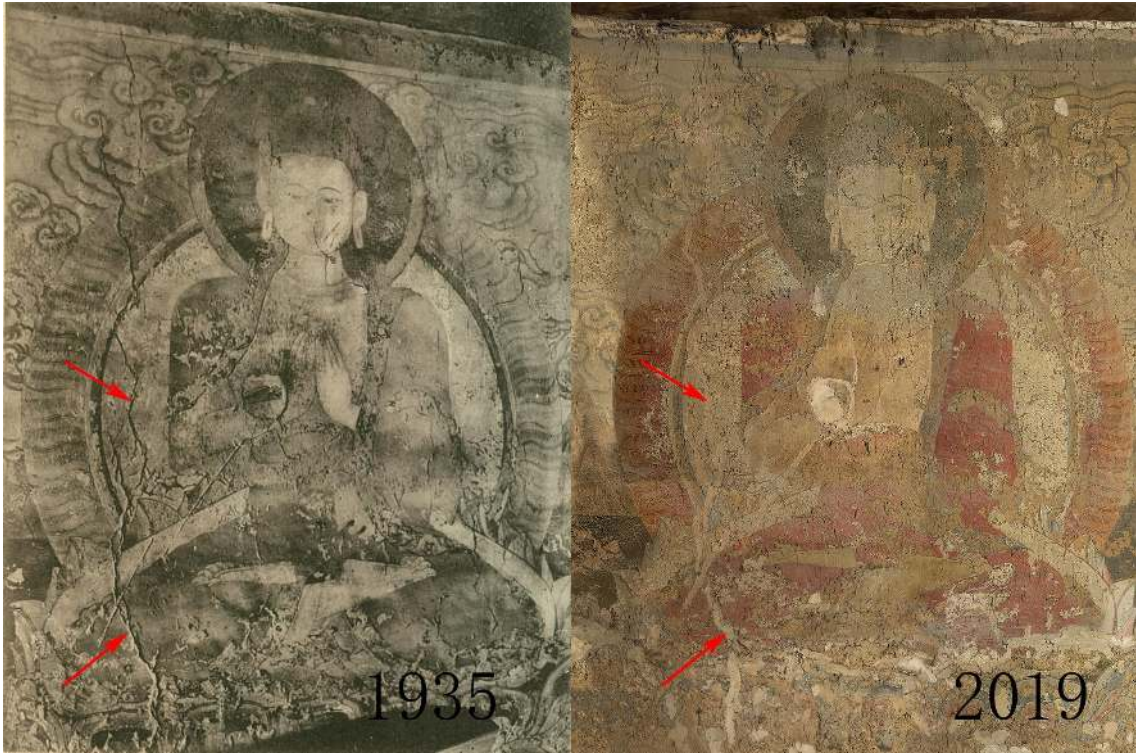
Figure 5. Comparison of the eave wall mural in Daxiong Hall between the present and the past (East wall E4)

In the 1930s, the Japanese scholar Sekino Tadashi took a group of black-and-white photos of the eave wall mural of Daxiong Hall during his investigation in Fengguo Temple<sup>[16]</sup>. After comparing them with the existing murals, it is found that most of the initial cracks at that time have been filled with the same material (Figure 5), and it is one of the coordination measures of the reinforcement and protection project in the 1980s. Then the secondary cracks can be basically distinguished after eliminating very few initial cracks which have not been filled. In addition, some cracks obviously penetrate through the FRP backing layer, and can be directly judged as secondary cracks by the intrusion relation.

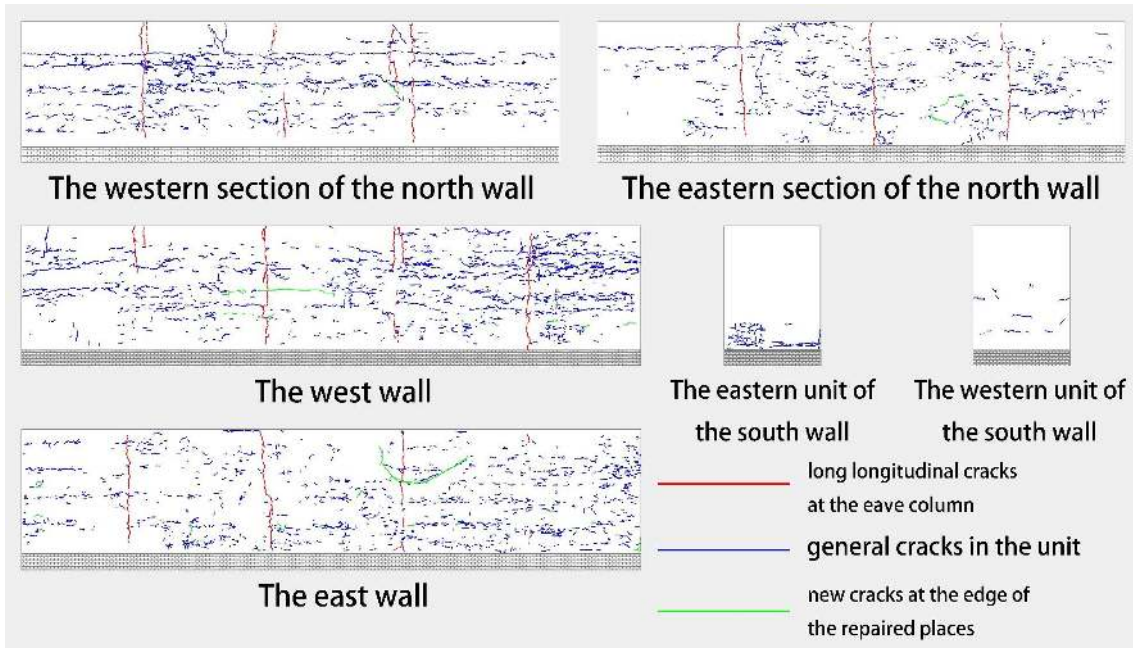
Figure 6. The vector diagram of the distribution of secondary cracks of the eave wall mural

Figure 6 shows the planar distribution of secondary cracks on the surface of eave walls, which can be divided into three categories according to their attitude. The first category are the long longitudinal cracks at the eave column position, which are developed vertically and generally run through the whole wall from top to bottom, dividing the mural into units. Some of them are developed into upper and lower sections but have not yet been connected with each other. Most of these cracks have caused the tear of the GFRP backing, and the wall on both sides of them often has the phenomenon of dislocation due to shear failure. In terms of the orientation, the cracks in the north wall are obviously more serious than those in the east and west wall, especially the crack at the junction of N1 and N2, whose widest point can even reach 5cm. And the ends of horizontal wood keels are arranged on both sides of this kind of cracks. The second category are the general cracks in the unit. In addition to the long transverse cracks that intersect with the longitudinal ones at some locations, others mostly form transverse development trends in the form of short cracks groups. Several rows of parallel distribution are formed among different short cracks groups in the same unit, and their development locations are mostly near the edge of the horizontal wood keels. The third category are the new cracks at the edge of the repaired places, which are mainly the results of the release of internal stress along the weak part of the repaired edge.

which should be avoided in the subsequent protection treatment. On the one hand, the air channel should be blocked or changed, and the insulation layer should be added to reduce the impact of the external environment on the mural noumenon. On the other hand, the backing and supporting materials should be replaced with ones who have smaller expansion and contraction, and the connection between layers should be strengthened to offset the stress caused by the difference of restriction conditions.

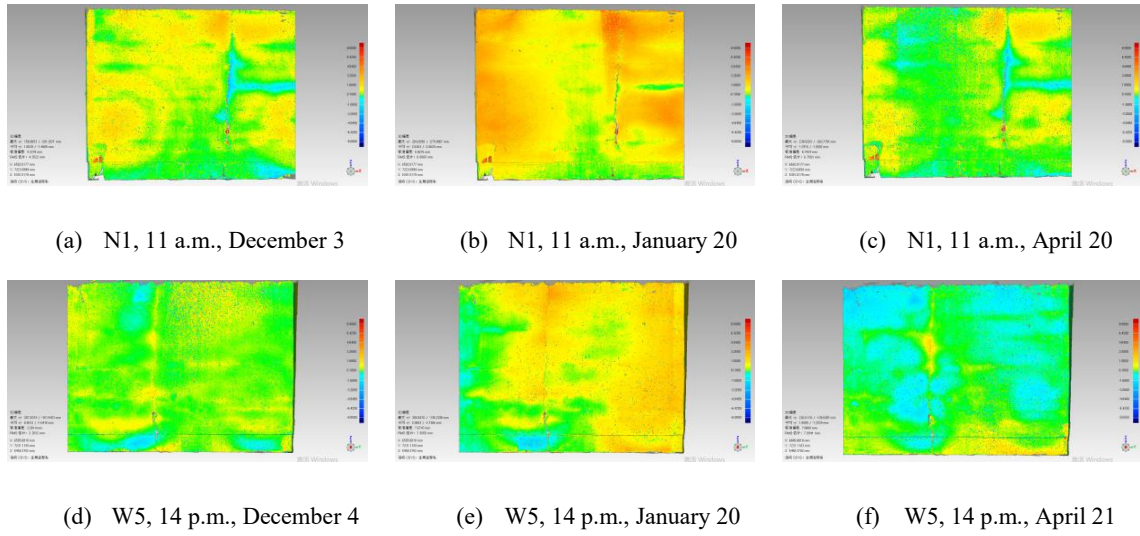
Figure 7. Deviation chromatogram of surface deformation of the eave wall mural in the northwest corner of Daxiong Hall

The 3D scanning point cloud data of the north wall (N1) at 11:00 on December 2, 2018 and the west wall (W5) at 14:00 on December 2, 2018 were respectively packed into a grid model as a reference, and the other three 3D scanning point cloud data of the corresponding wall from December 2018 to April 2019 were compared with it, and the deviation chromatogram was made as shown in Figure 7. It can be seen that the surface

deformation of the eave wall mural has the characteristics of both integrity and locality. Among them, the deformation of the area near the longitudinal and transverse long cracks is different from that of the next adjacent area, while the deformation of the transverse short cracks groups in the unit are not obvious. There are stripe areas parallel to each other in the unit, which are basically consistent with the position of the horizontal wood keels. The deformation degree in the stripe areas is obviously smaller than that in other areas, which should be caused by the restriction of the horizontal wood keels and the GFRP fixture. In the figure, the deformation phenomenon of some block areas is different from that of other parts, which can be interpreted as the non-uniform deformation restriction conditions inside the eave wall. On the whole, the surface deformation of the mural in the two stages before and after January 2019 has a reverse trend, which corresponds to the temperature change trend, reflecting that the deformation may be a cyclical process of reciprocating fluctuation with the temperature change.

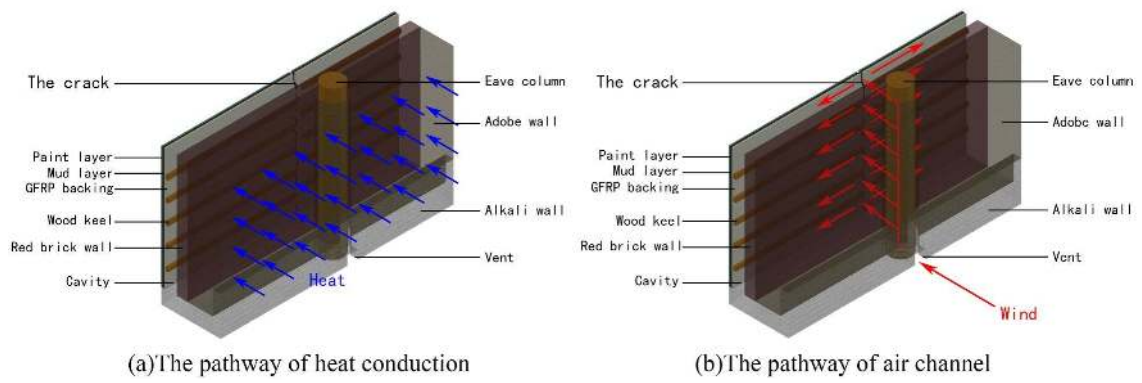
Figure 11. The pathway of external environment acting on the mural noumenon

Based on the above discussion, two major models of the pathway that external environment promote the formation of secondary cracks of the eave wall mural through its structural defects can be summarized:

- (1) The effects of atmospheric temperature and humidity levels as well as fluctuations can reach to the GFRP backing layer through the air channel at the eave column with the help of good air fluidity, resulting in aging and deformation of the GFRP backing, making the stress release along the end and edge of the wood keel in a directional way under the restriction of it so that the transverse and longitudinal long cracks near the eave column are finally generated.
- (2) The external environment takes the eave wall as the medium to exchange heat with the mural noumenon, generating overall temperature stress inside the unit as well as local temperature stress on the edge of the wood keel. The former further promotes the shear failure near the eave column, while the latter induces the formation of the parallel short cracks group between the horizontal wood keel.

It can be seen that the deep influence of external environment and the non-uniformity of material reinforcement are the two major causes of secondary cracks,

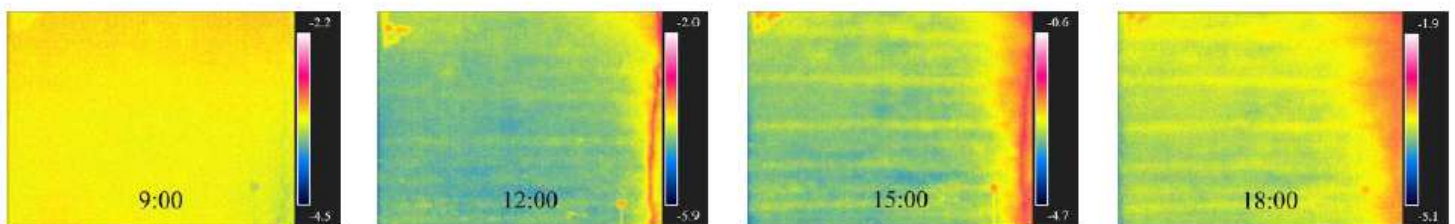
Figure 10 shows the infrared thermal images of the N1 surface of the north wall at different time in a sunny day, which visually reflects the influence process that the external environment act on the mural from the perspective of heat transfer theory.

The changes of infrared thermal images of the mural surface show that the temperature changes at the longitudinal cracks are more responsive to the diurnal changes of air temperature compared with other areas, which proves that the longitudinal crack has good connectivity with the outside atmosphere, and the heated or cooled outside air can reach the crack site through the air channel, causing a lasting impact on the mural there. The thermal image of the transverse wood keels gradually appeared synchronously after noon, which reflects that the influence of the external environment on the mural is not only realized through the air channel at the eave column, but also the heat conduction of the wall (As shown in Figure 11). Just because of the good buffering effect of the 1.2m thick eave wall, the influence of this heat conduction pathway is mild and slow. In addition, the thermal image of the longitudinal

crack tends to become coarser and diffuse over time, which means that the mural noumenon and wood keels near the crack are significantly heated up due to the continuous conduction of the external air, which proves that the external air entering through the channel at the eave column can also cause a certain degree of influence on the mural inside the unit.
