# 1           **Subsidence damage assessment of a gothic church using** 2                           **Differential Interferometry and field data**

## 11 12    **Abstract**

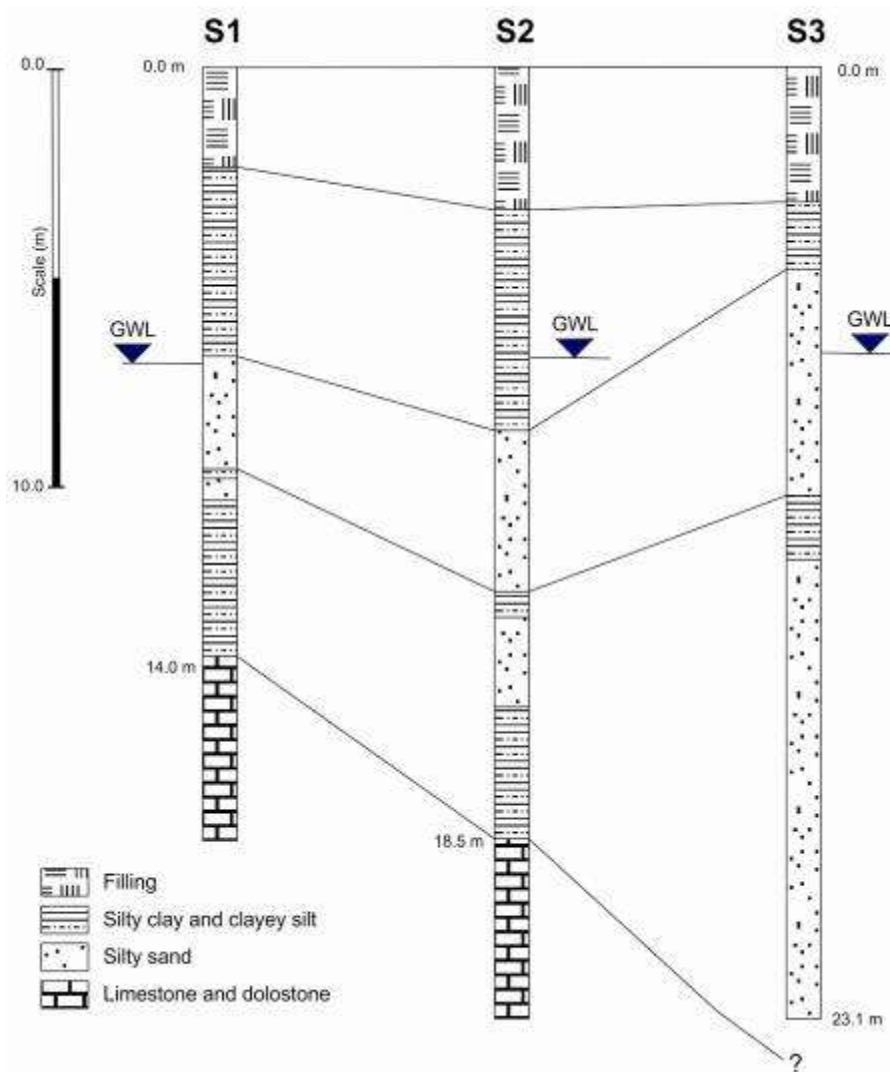
153 Figure 4. Geotechnical boreholes performed in the Santas Justa and Rufina gothic church.

156 Three geotechnical boreholes have been drilled in the proximities of the church (Figure 4) in  
157 order to better know the substrate properties and the geometry under the church. Four different  
158 lithologies have been recognized (from top to bottom): a) Fillings; b) Silty clays and clayey silts;  
159 c) Silty sand; and d) Limestones and dolostones.

160 The fillings have up to 2 m depth and present a low relative density with standard penetration  
161 test results lower than 5 blow counts. Next layer is composed by silty clays and clayey silts that  
162 present a slight improvement of the properties (standard penetration test up to 6 blow counts).  
163 The penetration values of this lithology increase notably with depth, reaching maximum values  
164 up to 15 blow counts on standard penetration test. Silty sands are intercalated among  
165 previously described layer. These sands have a higher penetration resistance than fillings and  
166 more surficial silty clays layer (11 blow counts). The geotechnical substrate is constituted by  
167 carbonatic rocks (Figure 4), limestones and dolostones with refusal values on standard  
168 penetration test and uniaxial compressive strength higher than 30 MPa. This layer appears at a  
169 depth higher than 16.0 m and is usually used for founding deep foundations due to the

170 considerable improvement of its geotechnical properties. Notice that the depth of this layer  
171 changes in a few meters with slopes higher than 0.19 m per meter ( $>11^\circ$ ) in the church area.

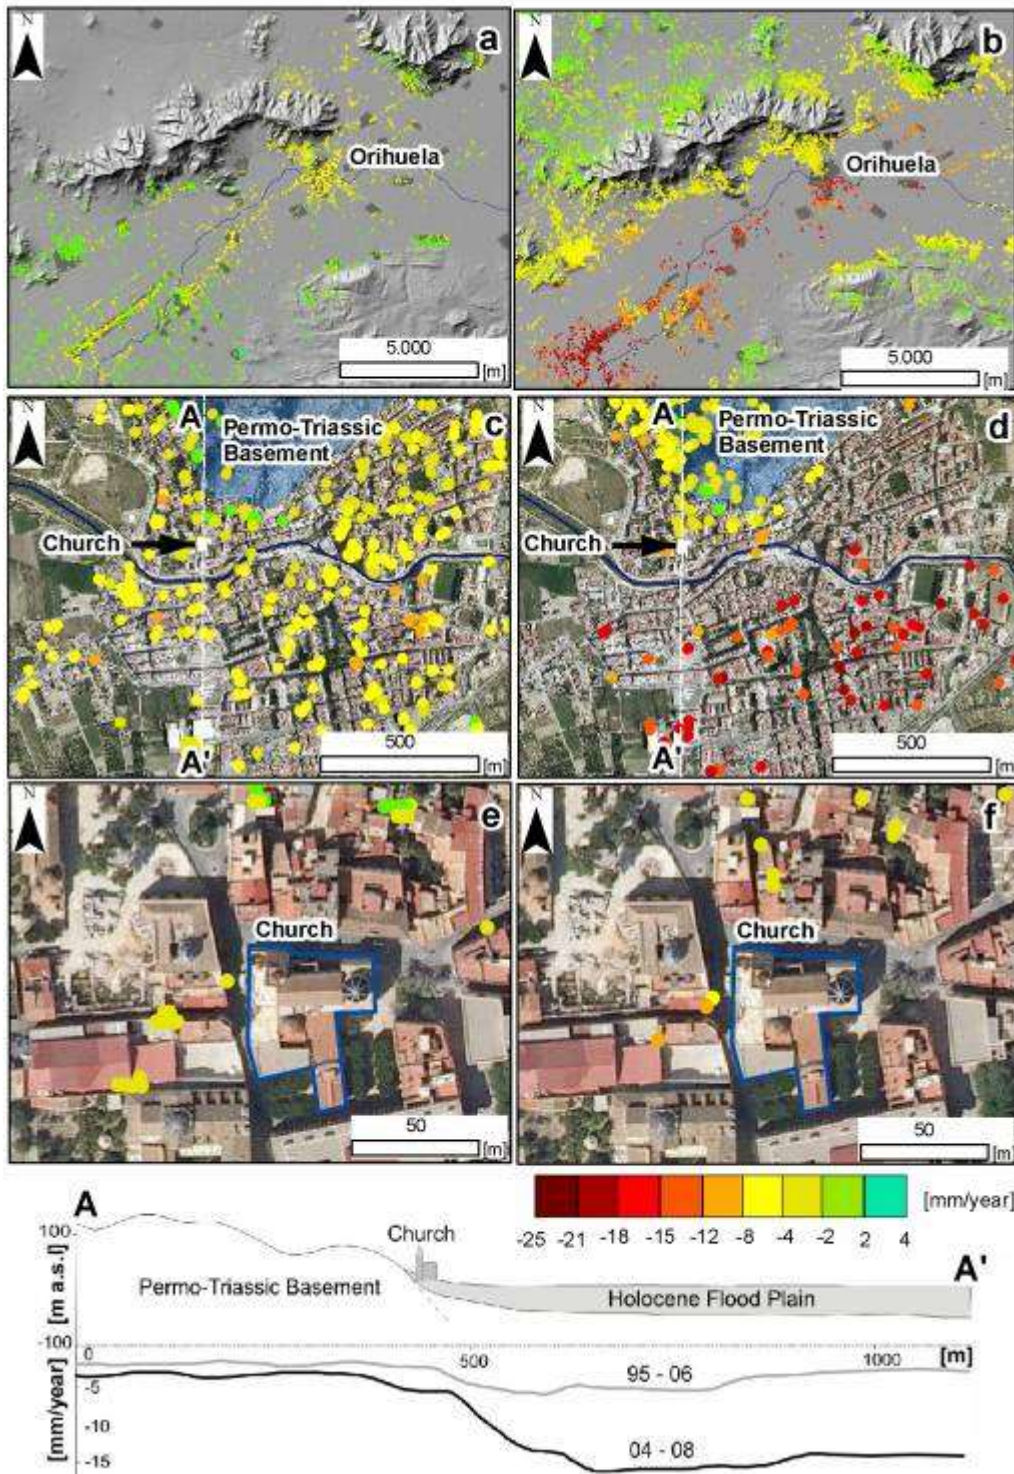
265 Results of subsidence in the city of Orihuela for both periods (1995-2005 and 2004-2008) are  
266 shown in Figure 8. As it can be seen in figure 8a and b, the higher density of PSs corresponds  
267 to the urban area of Orihuela. In the Santas Justa y Rufina church neighborhood deformation  
268 rates up to -2.1 and -9.5 mm/year for 1995-2005 and 2004-2008 periods respectively have been  
269 measured by means of DInSAR (Figure 8a to 8d). Notice that subsidence measured for 2004-  
270 2008 period in the vicinity of the church is higher than the measured deformation for the

277 Figure 8g represents N-S cross section of the study area. As it can be noticed, Holocene  
278 sediments from the flood plain of the Segura River increase their thickness from the north  
279 towards south (from the Sierra de Orihuela relief towards the center of the basin). Subsidence  
280 follows a similar trend. The Santas Justa and Rufina church is just located near the Sierra de  
281 Orihuela that is composed of carbonatic rocks (dolostones and limestones). This relief deepens  
282 under Holocene sediments with high slopes causing important changes in substratum depth as  
283 it has been observed in the available boreholes performed in the church perimeter (Figure 4).  
284 These substratum changes favor differential settlements occurrence. Differential settlements  
285 affecting the church have been computed interpolating the available data for both study periods  
286 (Figure 9). The maximum differential settlements have been calculated considering the highest

287 and the lowest subsidence values contained in an area composed by the church and a buffer  
288 ring of 14 m providing 12.5 and 24.46 mm for 95-06 and 04-08 periods respectively. The  
289 angular distortion has been obtained dividing differential settlement by the distance between the  
290 two points that provides the maximum and minimum subsidence value. Computed distortion  
291 values for both periods are  $1.5 \times 10^{-4}$  m/m and  $3.4 \times 10^{-4}$  m/m.

294 Figure 8. Subsidence measured by means of DInSAR for 1995–2005 and 2004–2008 periods:

295 a) and b) for the whole study area; c) and d) in Orihuela city; e) and f) in the vicinity of the

296 church; g) Geological simplified and subsidence N-S cross section along Orihuela city.
