Survey on PV Modules' Common Faults After an O&M Flight Extensive Campaign Over Different Plants in Italy

Index Terms—PV module faults, PV monitoring and control, unmanned aerial vehicle (UAV).

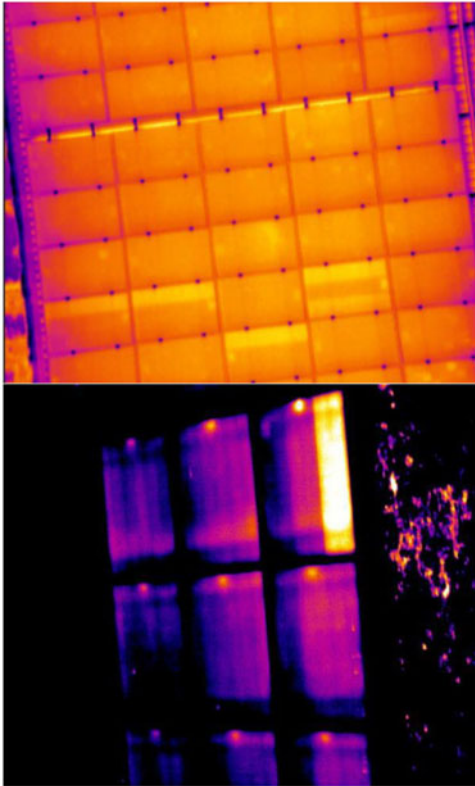
A very common occurrence is when 1/3 or 2/3 of a module is hotter than the other parts (see Fig. 3). Since all the modules here analyzed are Si-crystalline with three by-pass diodes, this problem can be due to by-pass diode failure or to soldering defects in the junction box. In any case, we always classify this failure as *by-pass failure*. Even modules or string disconnections (see Fig. 4) are quite popular and they cause loss in efficiency of PV plant. They represent one of the three most common defects among the observed plant in Italy and they can be easily recognized just using IR sensors mounted onboard.

Fig. 3. Multiple (up) and single (down) by-pass failures observed with IR sensor in plant B and plant D.

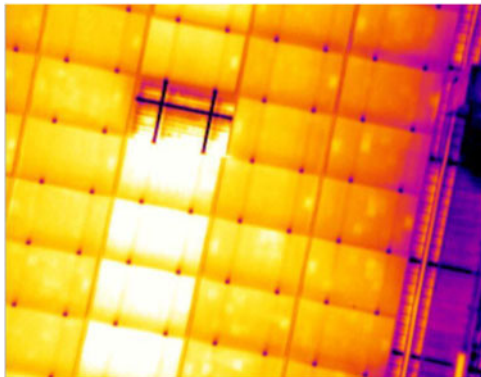
Fig. 4. Complete disconnected string with an empty module observed by the IR sensor in plant B.

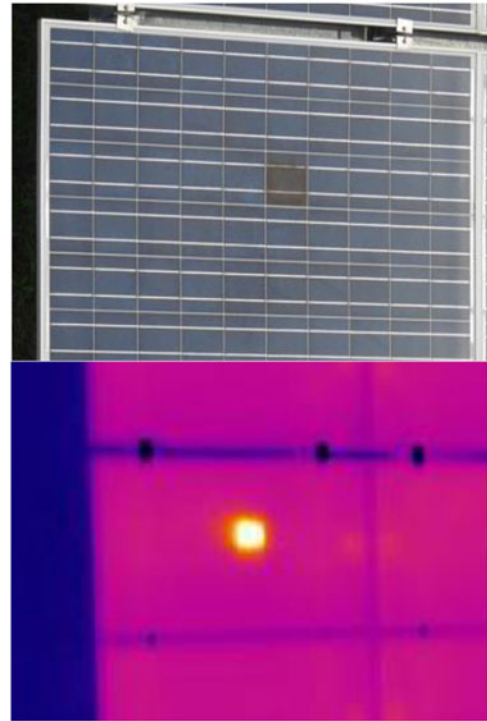
Fig. 5. Cell corrosion detected both in visible and IR in plant C.

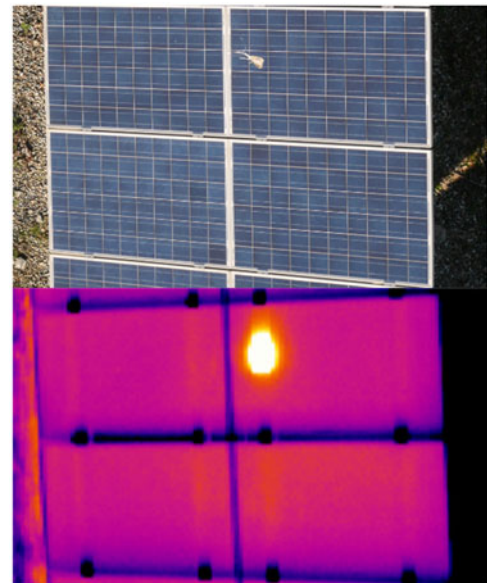
Fig. 6. Dirty module detection both in visible and IR in plant A.

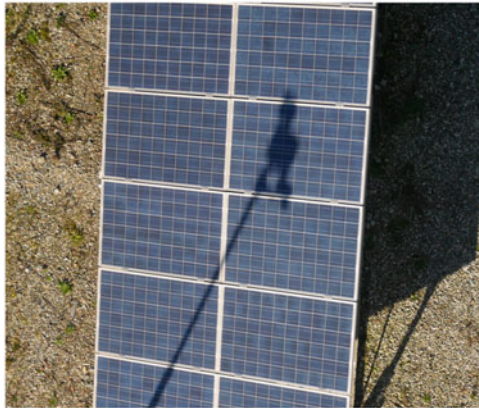
Fig. 7. Shading detection by a visual sensor in plant A.

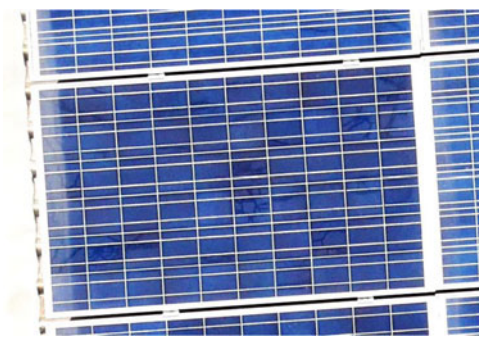
Snail trail phenomenon, due to production causes linked to a particular manufacturer, appears as dark and irregular small lines (see Fig. 8). It is not so common according to our inspections, even if plant B was dramatically affected by this failure (92.2% over only the found defected modules) while in plant E (12.5% over only the found defected modules). It is important to notice that once again the correlation with visual pictures has made possible to classify as *severe* the snail trail in plant B while as *incipient* (with no thermal effect) in the case of plant E. Snail trail can be detected by visual inspection: in this case we

Fig. 8. Snail trail detection by a visual sensor in plant B.

need high-resolution sensors or to flight as close as possible to the module [17]. In some cases, snail trails are associated with cracks and then to hot spots [18].

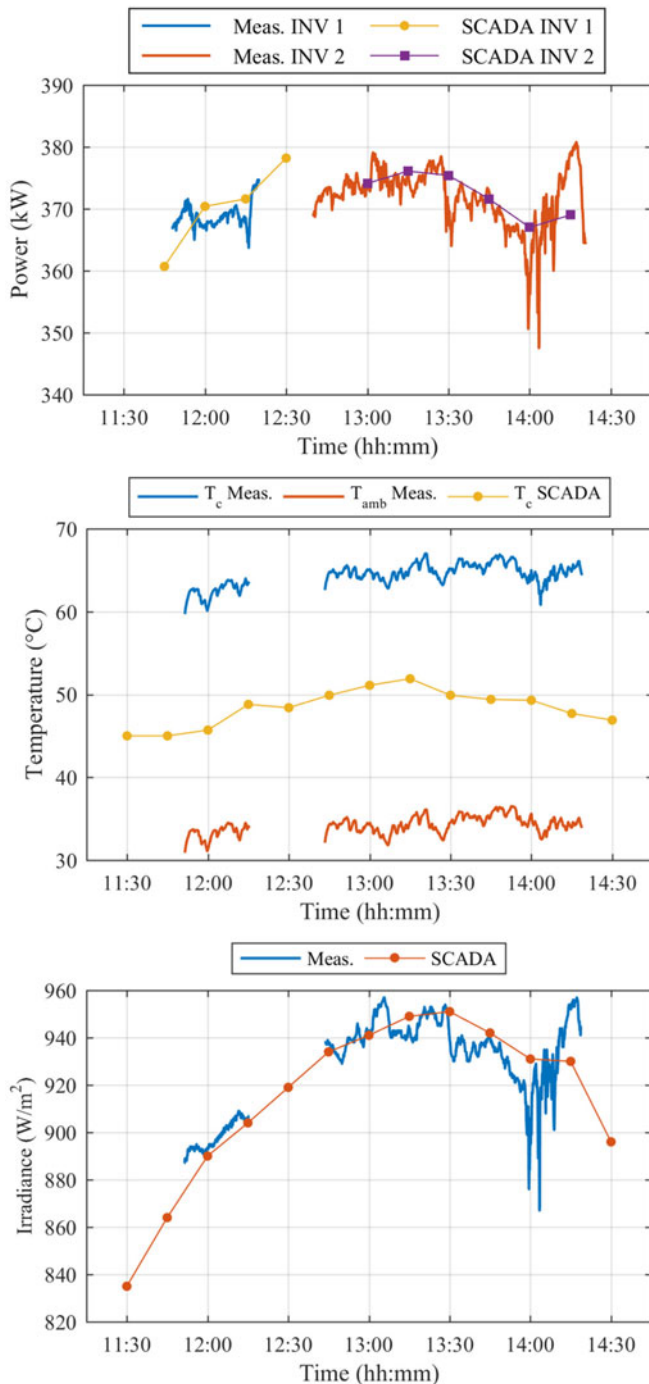
By the analysis of Fig. 9, it is possible to notice the incorrect calibration of the temperature plant sensor (T_c SCADA). Instead there is a good match between irradiance and power data recorded by SCADA and that measured in field (*Meas.*). Furthermore, a very strong correlation has been found between the final modules' defect map and the performance measured in each of the two separate parts of the plant with relative computed

Fig. 9. Temperature, irradiance, and power comparison between data recorded by SCADA and measurement (Meas.) in plant D.

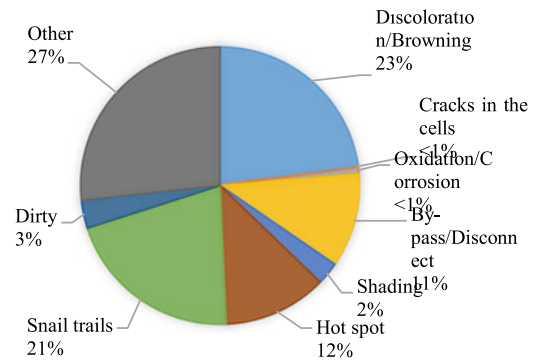
Fig. 10. Circle chart related to the module defects in the 5 plants (over the total number of failures).

With respect to the percentage of failures at module level found in this flight campaign (see Fig. 10), it is quite valuable comparing our findings with the recent literature even if not trivial and made on heterogeneous samples. In [19], both failure rates due to customer complaints in the first two years after delivery and based on a field study of many manufacturers in the midlife are reported. The rates are given relative to the total number of failures such as in our study, and show a wide range of occurrences, often with different classification criteria: for example, defect cell interconnects are around 10%, j-box and cables around 10–20%, glass failures 10–30% depending on the plant age and means of detection. In [20], a physical model for degradation and reliability is validated on a large statistical data set, confirming that some studies do not distinguish for example corrosion damage from fatigue damage; however, more than 60% of returns is attributed in this case to cell-interconnection issues, considering modules that are aged less than 10 years. Kurtz *et al.* [21] discuss the degradation mechanisms depending on both technology and climate zones, as well as how they generally affect differently current and voltage giving average rates in terms of %/year with no distinction based on the nature of defects. Finally, [22] reports a project report on PV plant risk assessment, finding that among the overall common failures, glass breakage, ethylene-vinyl acetate discoloration, and defective backsheets bear a higher level of economic impact on O&M.
