VIII. T-111 ALLOY CRACKING PROBLEMS  
DURING PROCESSING AND FABRICATION\*

R. A. Ekvall,<sup>†</sup> R. G. Frank,<sup>†</sup> and W. R. Young<sup>†</sup>

SUMMARY

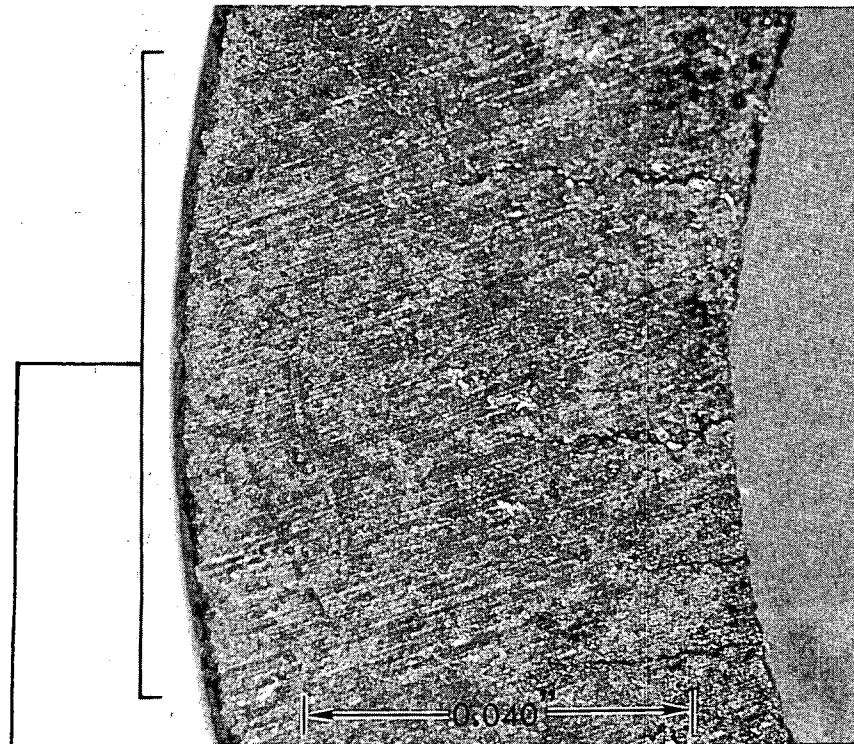
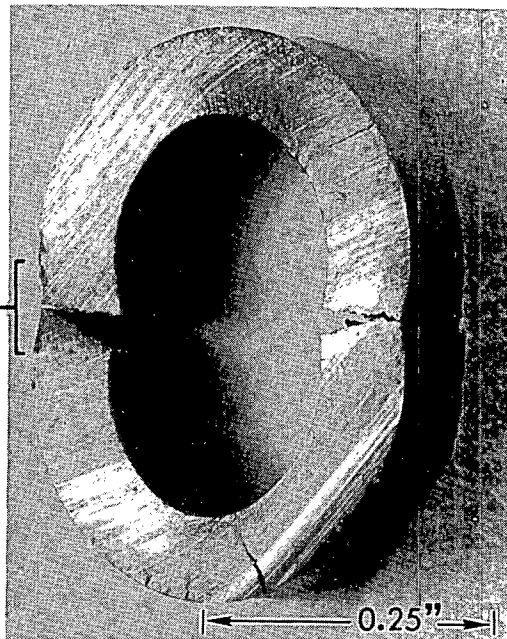
Cutting of T-111 alloy mill products with an alumina abrasive (Allison VA 1202 MRA) cutoff wheel frequently produced cracks in the cut surfaces. The cracks induced by abrasive cutting always propagated in a brittle manner upon subsequent bending (fig. VIII-1). Although water cooling of the T-111 alloy and wheel was used in all cases, the cooling did not prevent cracking. Generally, slow feeding of the T-111 alloy mill products into the wheel resulted in more severe cracking than occurred with fast feeding. The effect of cutting T-111 alloy with an alumina abrasive wheel at varying speeds is illustrated in figure VIII-2, which shows transverse sections of a 0.375-inch-outside-diameter tube that were partially flattened after cutting. Removing 0.060 to 0.080 inch from the cut tube surfaces by grinding was sufficient to remove the cracks generated during cutting, and the tubing could then be bent without cracking (fig. VIII-3). Further evidence of the damage that can be caused by the use of an improper cutoff wheel is exhibited in figure VIII-4. Cracks were observed in T-111 alloy tube hollows during initial attempts to tube reduce the hollows. The deep cracks shown apparently propagated from shallow cracks resulting from cutting with an abrasive cutoff wheel. The sound portions of the tube hollows were used to successfully fabricate tubular bellows blanks (0.625-in. o.d. by 0.0085-in. wall). Alumina abrasive cutoff wheel induced cracking was not limited to tubing mill forms. Cracking also was observed in solid rods, as shown in figure VIII-5.

(a) Before bending.

(b) After bending.

Figure VIII-1. - T-111 alloy tubing (0.375-in. by 0.062-in. wall) after cutting with water-cooled alumina abrasive cutoff wheel.

In limited testing to find a way to avoid crack initiation during cutting operations, it was found that cracking could be eliminated by the use of SiC cutoff wheels (Allison C120-K-RA), tube cutters, or band saws. Because of the limited testing and possible inadvertent use of the wrong wheels, GE-NSP has adopted the policy of using tube cutters and band saws for cutting operations.

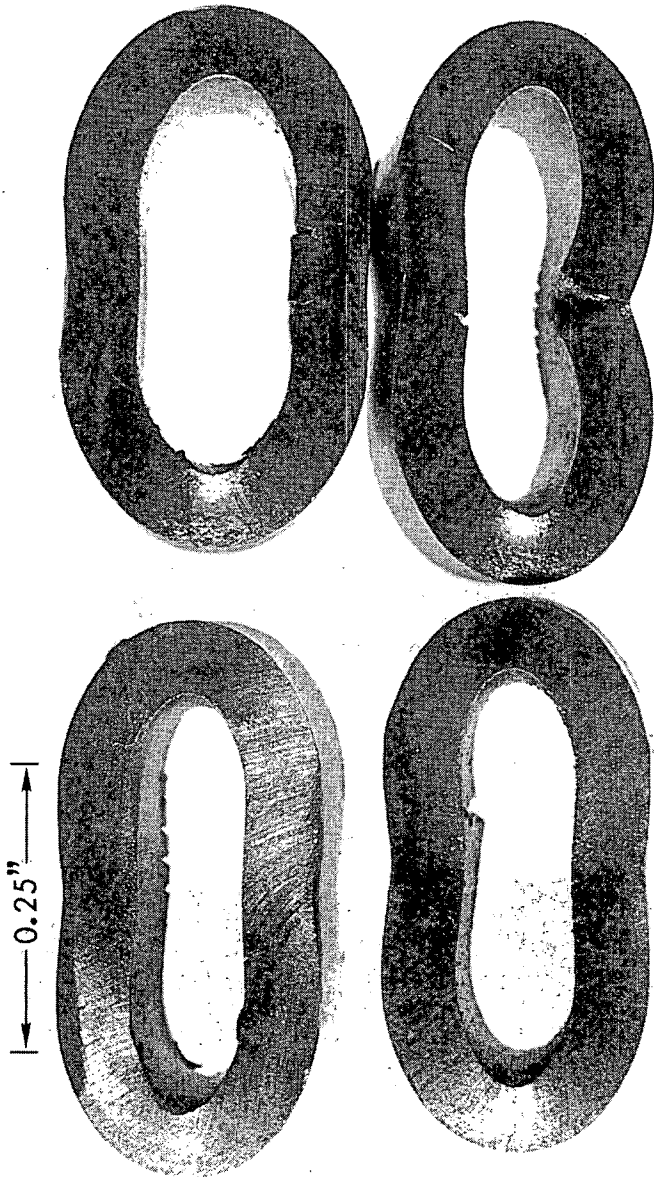
(a) Bent following "slow" cutting.

(b) Bent following "fast" cutting.

Figure VIII-2. - T-111 alloy tubing (0.375-in. by 0.062-in. wall) showing effect of cutting speed on cracking. Tubing was cut using alumina abrasive cutoff wheel.

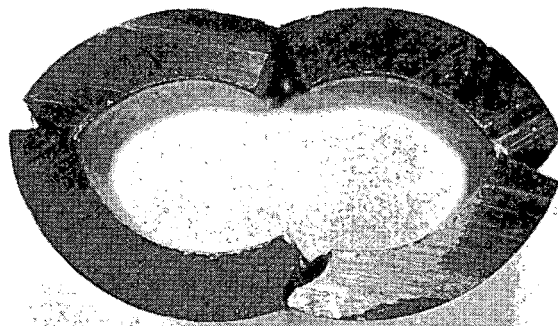
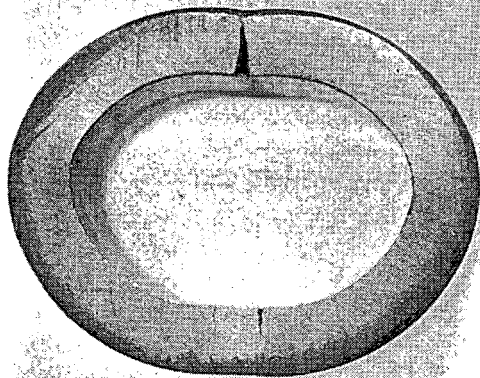
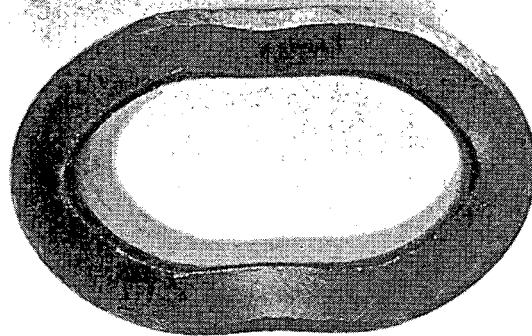
(a) Bent as cut.

(b) 0.040 Inch ground off cut surfaces prior to bending.

(c) 0.10 Inch ground off cut surfaces prior to bending.

Figure VIII-3. - Effect of removing cracked surface prior to bending of T-111 alloy tubing (0.375-in.) cut with alumina cutoff wheel. Tubing was supplied by ORNL from tubing described in Westinghouse Report WANL-PR(N)-004.

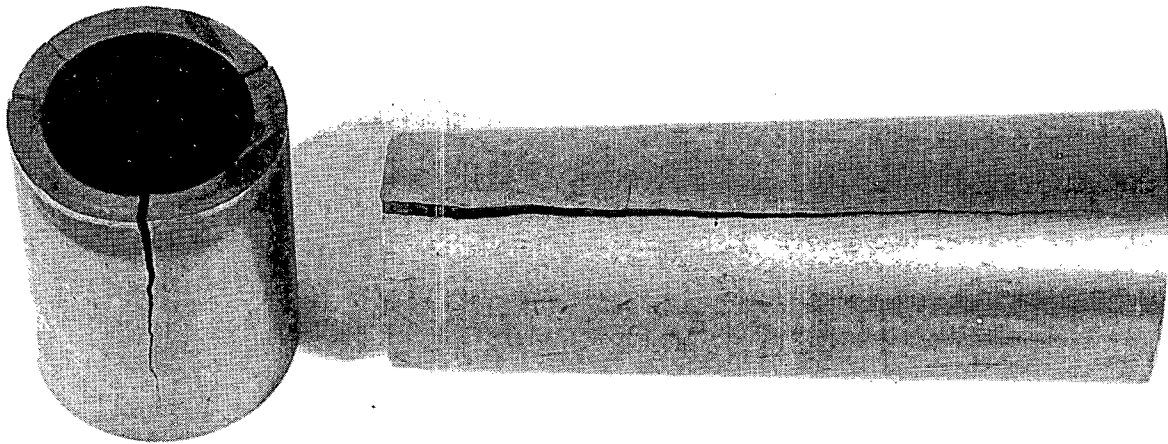
Figure VIII-4. - Cracks in T-111 alloy tube hollows (2-in. by 0.25-in. wall) observed during initial tube reducing. The cracks apparently propagated from shallow cracks introduced when hollows were cut with abrasive cutoff wheel.

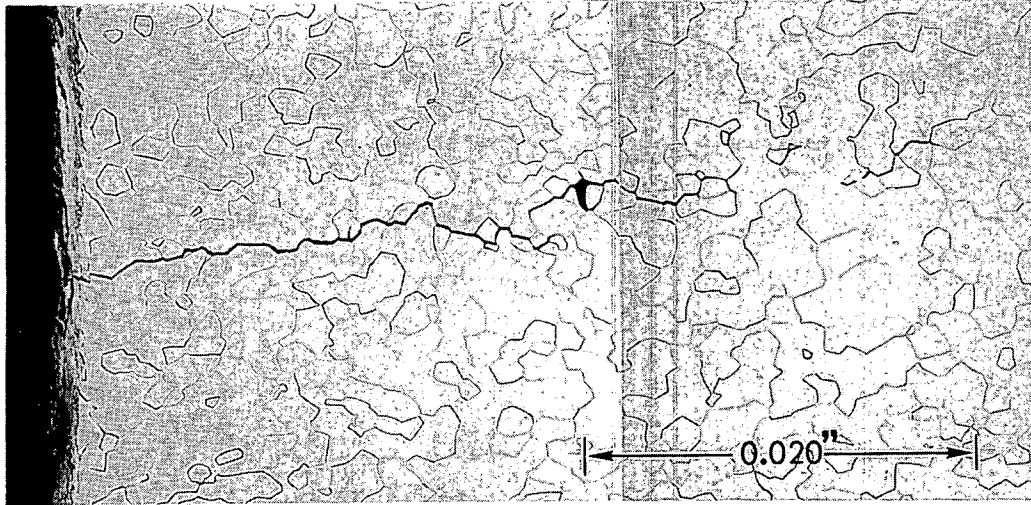
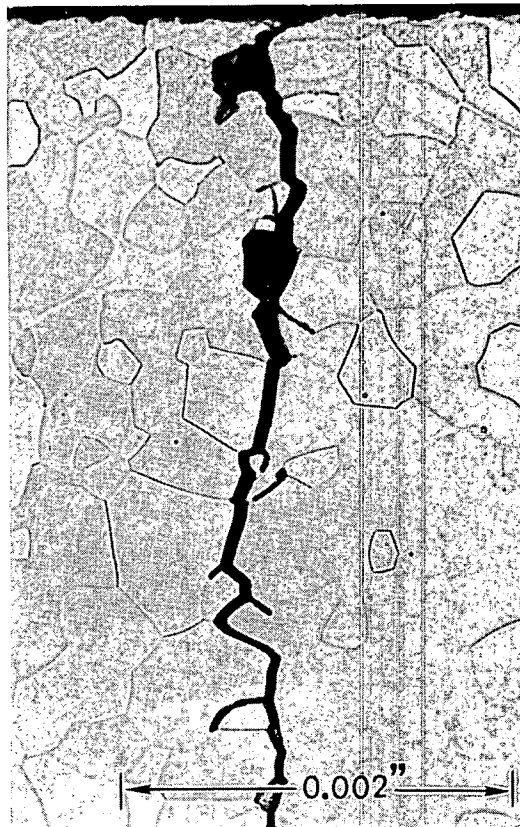
The cracking that occurs in both solid rod and tubing is intergranular in nature. However, the mechanism of the crack formation in T-111 alloy and, of even greater interest, the mechanism which causes the cracks to propagate in a brittle manner are not understood. However, embrittlement with nascent hydrogen from breakdown of coolant or abrasive binder is a possibility.

(a) 1.5-Inch-diameter rod.

(b) 0.5-Inch-diameter rod.

Figure VIII-5. - Intergranular cracks in T-111 alloy rod cut with water-cooled alumina abrasive cutoff wheel. Etchant: 30 grams  $\text{NH}_4\text{F}$ , 50 milliliters  $\text{HNO}_3$ , 20 milliliters  $\text{H}_2\text{O}$ .

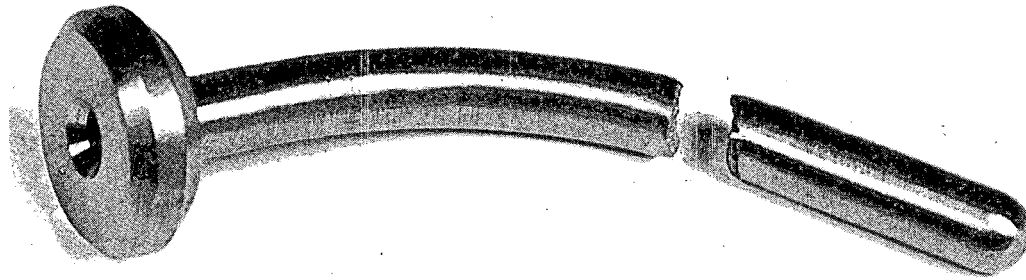
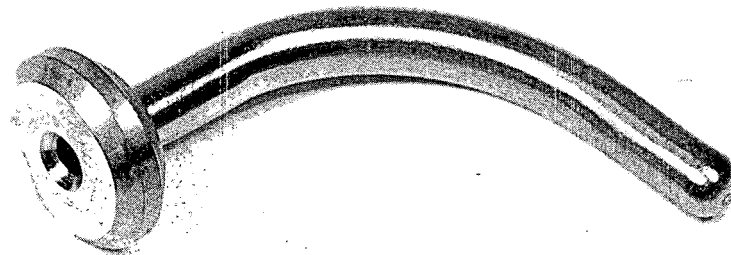
striking example of failure of machined parts during forming is the brittle fracture of machined parts during forming is the brittle fracture of machined thermocouple wells during bending (fig. VIII-6(a)). Five wells were machined from 1.0-inch-diameter rod. The wells were jig bore drilled with a 0.156-inch-diameter hole to a depth of ~2.75 inches using Tap Magic as the cutting fluid. Then the part was turned on a lathe to final dimensions of 2.45- to 0.255-inch diameter to a 63 rms finish. After machining, the straight thermocouple well was placed between matched concave and convex aluminum blocks machined to a 1.01- to 0.99-inch radius with a 0.125-inch-radius groove in each block, and an attempt was made to form the machined T-111 alloy thermocouple well to an angle of 86° to 84°. Cracking began almost immediately and resulted in brittle fracture. The same type of failure occurred during initial attempts to bend a second machined thermocouple well. It was suspected that residual surface stresses present at the completion of the machining operations were responsible for the cracking during bending. In an attempt to alleviate this problem, subsequent thermocouple wells were given a stress relief heat treatment of 2400° F for 1 hour in a vacuum of  $\sim 10^{-5}$  torr after machining and prior to bending. The remaining three thermocouple wells were bent successfully without cracking, as determined by fluorescent penetrant inspection (fig. VIII-6(b)).

Metallographic and X-ray diffraction evaluations of the cracked thermocouple wells were performed. The metallographic results showed the major fracture to be intergranular and also revealed several areas of incipient intergranular cracking near the outside diameter of the tube on the tension side of the bend (fig. VIII-7). No cracking was observed in the inside diameter of the thermocouple wells. A comparison of the microstructure of an as-machined and a machined and stress relieved thermocouple well indicated the overall structures to be similar with the exception that recrystallization had occurred in a thin worked surface layer of the stress relieved thermocouple well. X-ray diffraction analyses qualitatively indicated that a reduction in residual stresses from machining and bending had occurred as a result of the 2400° F, 1-hour heat treatment.

(a) No stress relief before bending.

(b) 2400<sup>o</sup> F, 1-hour stress relief before bending.

Figure VIII-6. - Machined T-111 alloy thermocouple wells after bending.

specification (GE-NSP 03-0071-00-A) requiring that all machined parts of T-111 alloy be given a postmachining stress relief treatment at 2400<sup>o</sup> F for 1 hour was prepared and issued.

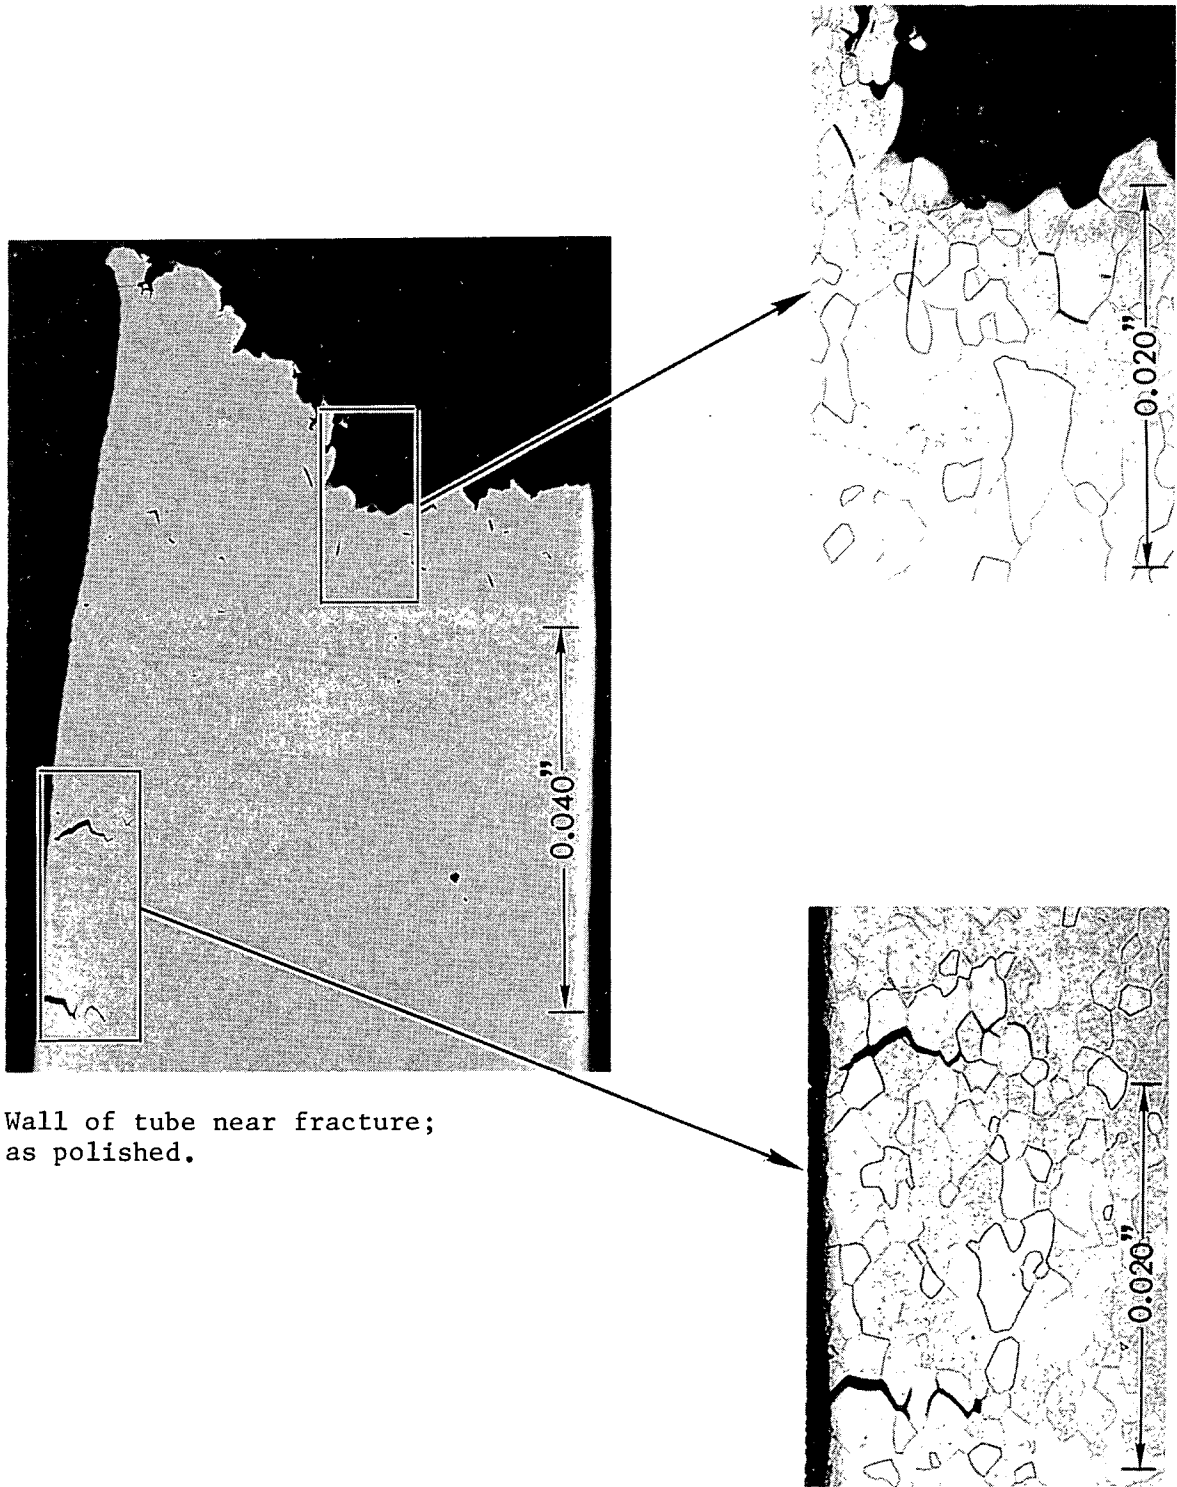
Wall of tube near fracture;  
as polished.

Figure VIII-7. - Longitudinal sections of fractured T-111 alloy thermocouple well after bending showing intergranular cracking in the wall on tension side of bend. Etchant: 30 grams  $\text{NH}_4\text{F}$ , 50 milliliters  $\text{HNO}_3$ , 20 milliliters  $\text{H}_2\text{O}$ .

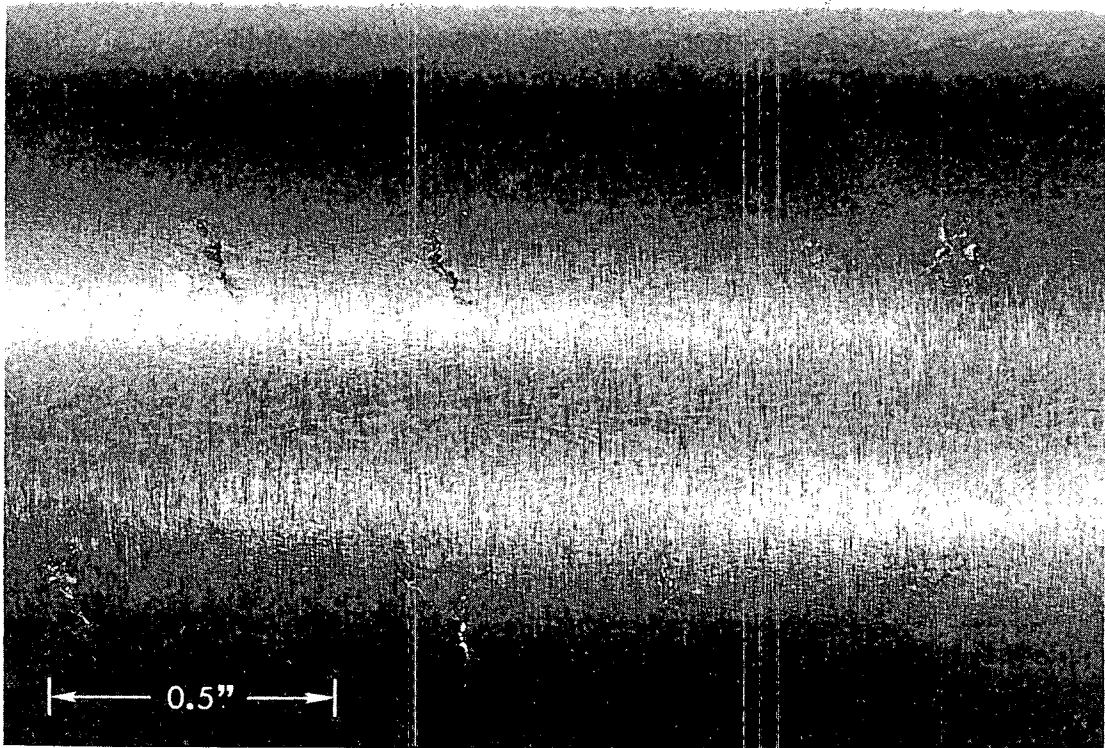
Welded and reworked tube. - To compare the biaxial creep properties of EB welded and seamless tubing, two 2.0-inch-outside-diameter by 0.25-inch-wall tube hollows (one welded and one seamless) made from the same heat of material were tube reduced and drawn to 1.5-inch-outside-diameter by 0.100-inch-wall tubing. The weld in the "welded" hollow was a simulated full penetration EB weld running the length of the hollow parallel to its longitudinal axis. The weld was formed by making two consecutive EB welding passes on a seamless hollow. The second pass was made to smooth the rough weld surface produced by the first pass. No defects were found in the "welded" tube hollow during ultrasonic and fluorescent penetrant inspections to NSP specifications 03-0001-00-C and 03-0027-00-A, respectively. After a 37-percent tube reduction, intermittent transverse cracks were observed in the heat-affected zones on either side of the weld for the entire length of the tube. Grinding the tube within allowable tolerances did not completely remove the cracks. Without further conditioning, the tube was annealed, processed to final size, and final annealed at 3000<sup>o</sup> F for 1 hour. The appearance of the finished tube is shown in figures VIII-8 and VIII-9. Because the quantity of the "welded" material required for the program was critical, no metallography was performed on the tubing after cracking was first observed. It is difficult to determine with certainty from the recrystallized structure of the finished tube whether or not the cracking was intergranular.

It is believed that residual stresses in the tube surface, promoted primarily by the second weld pass, were a major contributing factor to the observed cracking. Although a postweld stress relief treatment might have avoided the problem, it would seem wise to avoid multipass welds whenever possible. Details of the tube history, processing, and ultimate utilization have been reported (ref. 3).

Figure VIII-8. - Transverse cracks in the heat-affected zone adjacent to weld on outside diameter of 1.5-inch-outside-diameter by 0.100-inch-wall EB welded and reworked T-111 alloy tube.

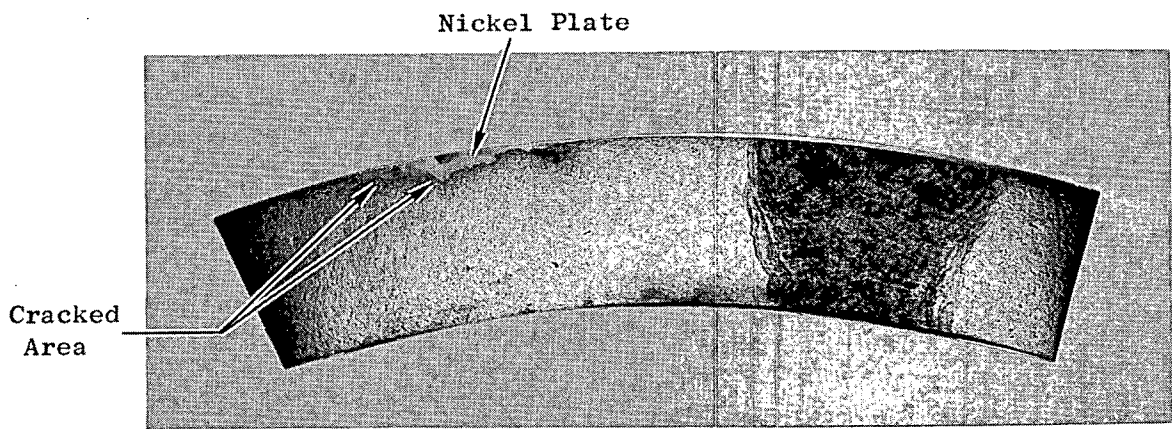
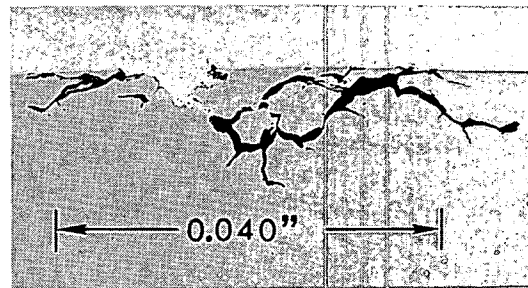
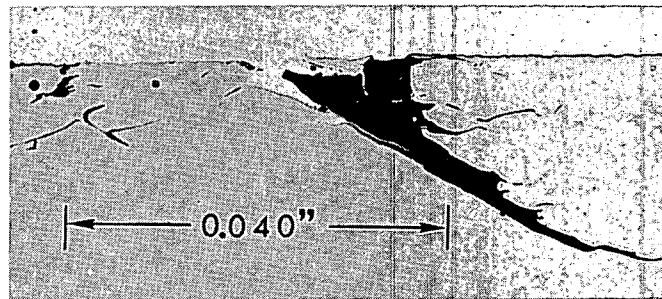
(a) Transverse section; etched.

(b) Transverse section; as polished.

(c) Longitudinal section; as polished.

Figure VIII-9. - Sections through cracks in 1.5-inch-outside-diameter by 0.100-inch-wall EB welded and reworked T-111 alloy tube after final anneal at 3000<sup>o</sup> F for 1 hour. Etchant: 30 grams NH<sub>4</sub>F, 50 milliliters HNO<sub>3</sub>, 20 milliliters H<sub>2</sub>O.

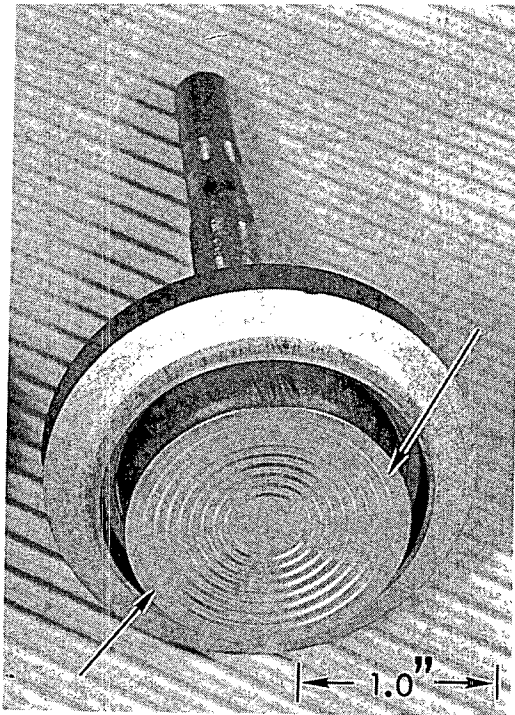
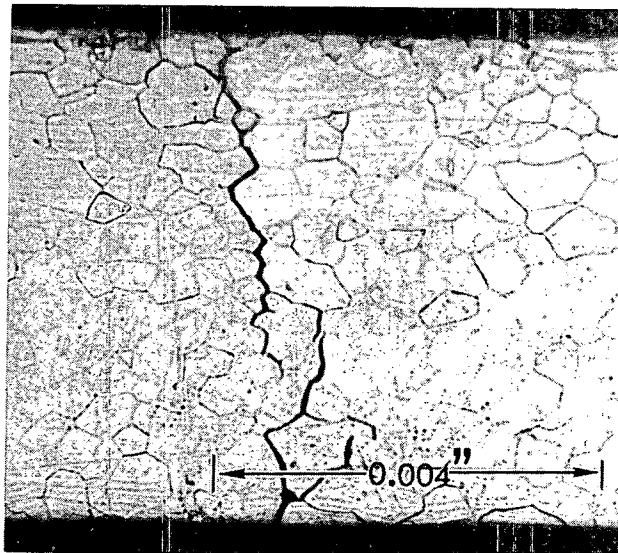
Pressure transducer diaphragm. - Helium mass spectrometer leak checking and visual examination of the 0.005-inch-thick T-111 alloy diaphragm of a pressure transducer shown in figure VIII-10 revealed two diametrically opposed cracks. The cracks were approximately 0.040 inch from the fusion zone joining the diaphragm to the transducer housing. The transducer had been postweld annealed (2400° F for 1 hr) prior to the discovery of the leaks. Metallography indicated the cracks were intergranular. The microstructure appeared normal, and no significant variations in microhardness were found in the cracked sample. Bend tests of foil similar to that used to fabricate the diaphragms and heat treated similarly (2400° F for 1 hr) showed the material to be ductile. The cause of the cracking is not known, as numerous pressure transducers have been fabricated using the same procedure without cracking of the weld.

(a) Cracks (arrows).

(b) Transverse section through one cracked area of T-111 alloy diaphragm; etched.

Figure VIII-10. - Intergranular cracks in T-111 alloy pressure transducer diaphragm. Etchant: 30 grams  $\text{NH}_4\text{F}$ , 50 milliliters  $\text{HNO}_3$ , 20 milliliters  $\text{H}_2\text{O}$ .

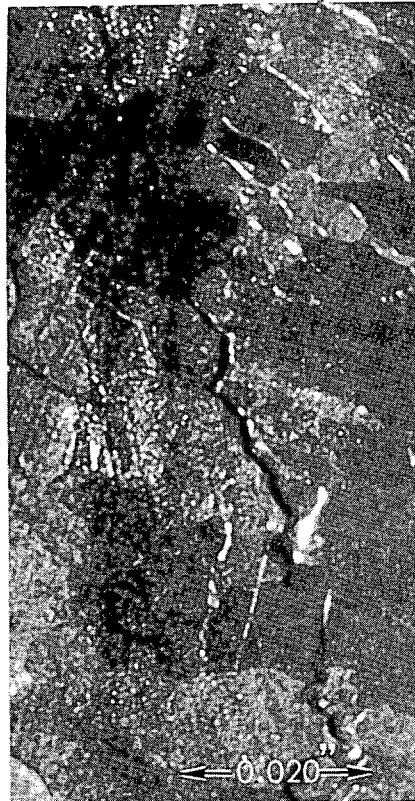
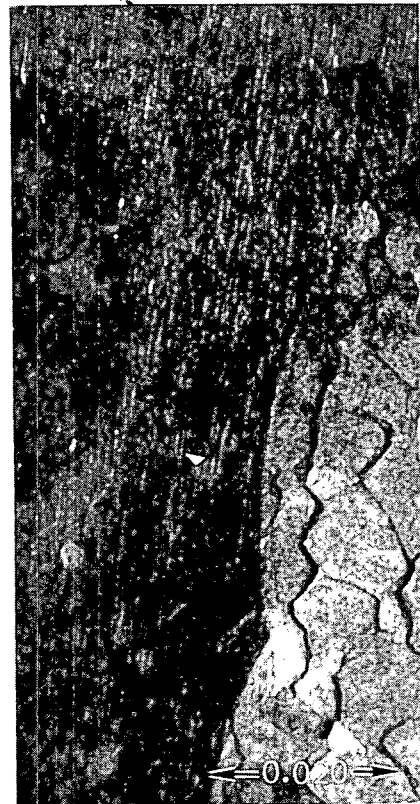
Butt weld joint. - During welding of a tube (0.375-in. o.d. by 0.065-in. wall) butt weld joint, one of the tubes was unsupported and sagged. In order to straighten the tube sections, the welded assembly was clamped between Mo plates and heated on one side of the weld nugget with a TIG torch. Intergranular cracking appeared on the side (tension side) of the weld nugget opposite the TIG torch. The cracks and grain boundary sliding observed in the weld nugget are exhibited in figure VIII-11. Similar grain boundary separation has been noted in welds inadvertently deformed at Oak Ridge National Laboratory (data obtained from B. Fleisher of ORNL).

(c) Intergranular cracking.

(d) Grain boundary sliding.

Figure VIII-11. - Cracking in T-111 alloy tube-to-tube (0.375-in. by 0.065-in. wall) butt weld joint. Cracking occurred during attempts to straighten tube after it had sagged during welding.

Prevention, by providing adequate support for parts being welded, was the obvious solution to this problem.

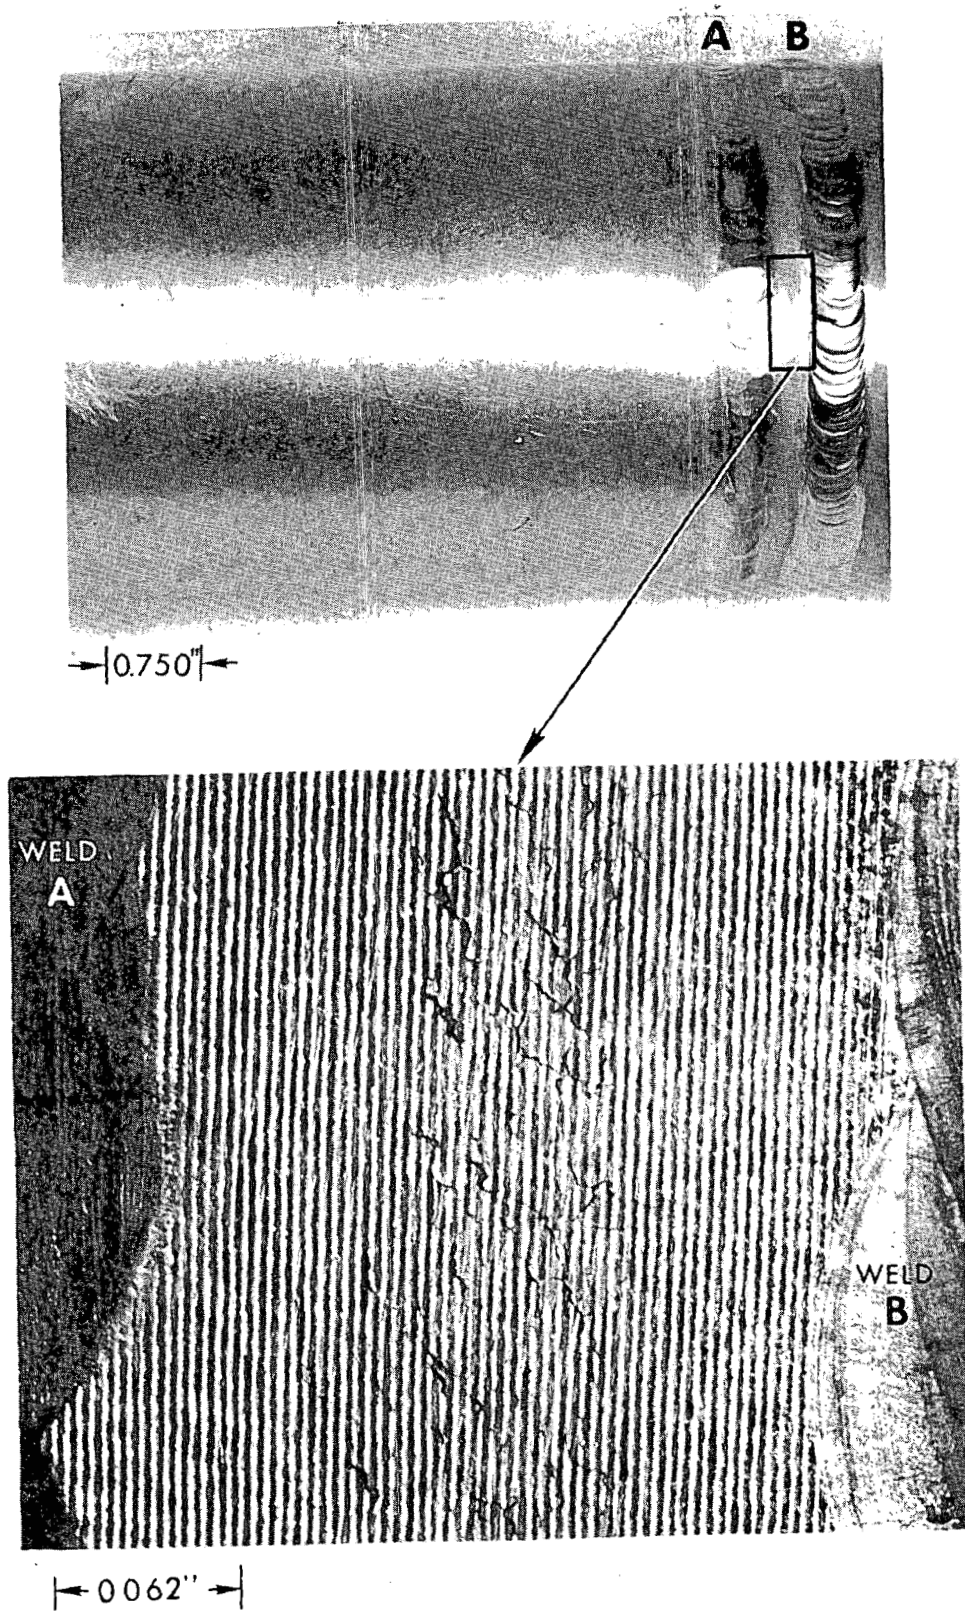
Electromagnetic pump duct. - In repairing an electromagnetic (EM) pump duct, it was necessary to run a circumferential TIG weld approximately 0.8 inch (weld centerline distance) from a preexisting circumferential weld as illustrated in figure VIII-12. Cracking and grain boundary relief were noted in the machined duct surface between the welds after completion of the second weld. The location of the

cracking implies a critical temperature at which grain boundary sliding and separation occurs.

Figure VIII-12. - Typical area of cracking between GTA welds of T-111 alloy EM pump duct.

The cracks and grain boundary relief were removed by machining, benching, and hand polishing. Final visual, helium leak check, and X-ray inspection indicated the part was sound.

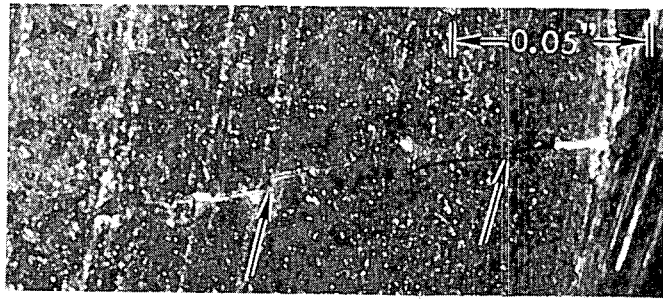
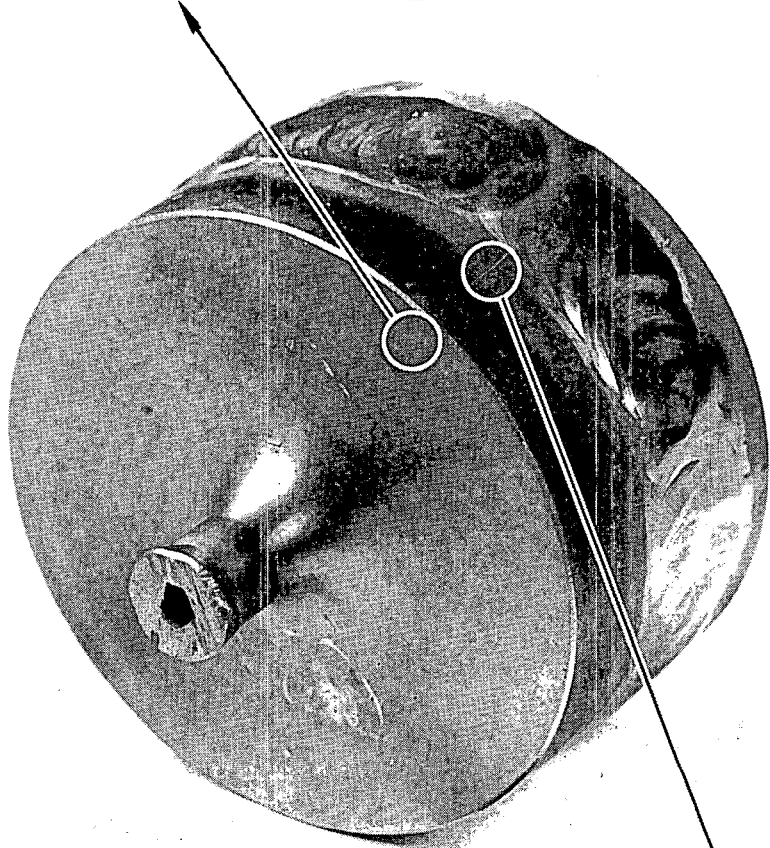
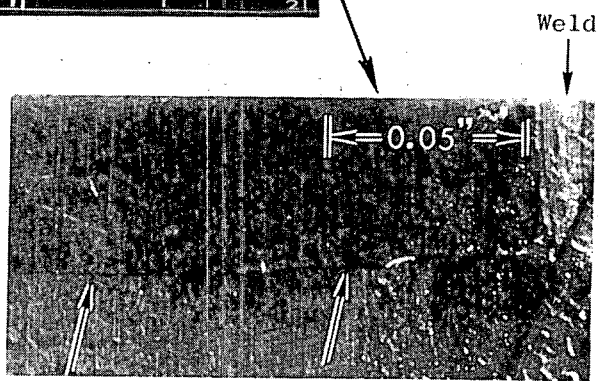
Absolute pressure transducers. - Cracks were discovered in three of six Taylor absolute pressure transducers after welding. Immediate leak testing with a helium mass spectrometer leak detector, according to NSP specification 03-0013-00-B, revealed that none of the transducers leaked. (A full section view drawing of a typical Taylor absolute transducer showing its functional relation to a test loop is given in fig. VIII-13.) The cracks were found near the circumferential TIG welds joining the top and bottom flanges. Photographs of the most severely cracked transducer (no. 14) are presented in figure VIII-14. The crack on the outer surfaces of the bottom flange of the transducer was approximately 0.5 inch deep, as can be seen in figure VIII-15, which shows the flange after removal of the weld nugget. Photomicrographs of end A of the crack are exhibited in figure VIII-16. The crack was quite wide where it intersected the outer circumferential surface of the flange, and it was not possible to definitely determine the mode of fracture. In figure VIII-16, however, cracking appears to be intergranular at end A.

Figure VIII-14. - Taylor absolute pressure transducer 14 showing large crack (see arrows in enlargements of cracked areas) extending from edge of weld nugget to flat surface of bottom flange.

Cracks in all transducers (except the bottom flange of no. 14, which was metallographically sectioned) were removed by benching the material to a depth of approximately 0.030 inch. The shallowness of the cracks (except on transducer no. 14) indicates that the cracks may have been related to the surface condition of the machined transducers. The flanges were stress relieved at 2400° F for 1 hour following machining; however, X-ray diffraction studies have shown that this treatment does not completely relieve residual stresses. A longer time at 2400° F or a higher stress relief treatment might be necessary if residual stress from machining is the cause or contributes to the cause of the cracking.

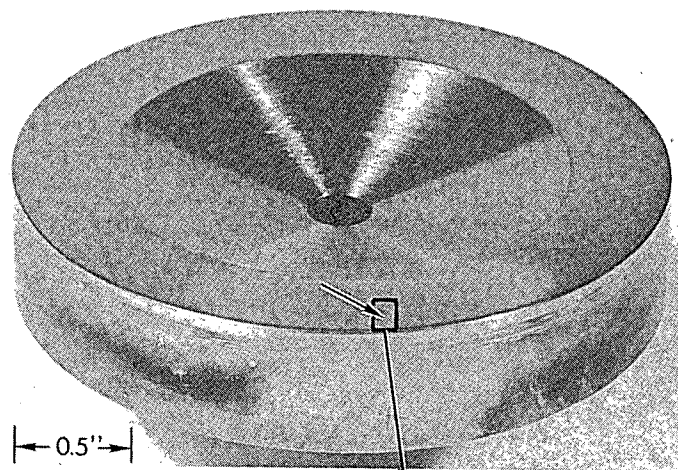
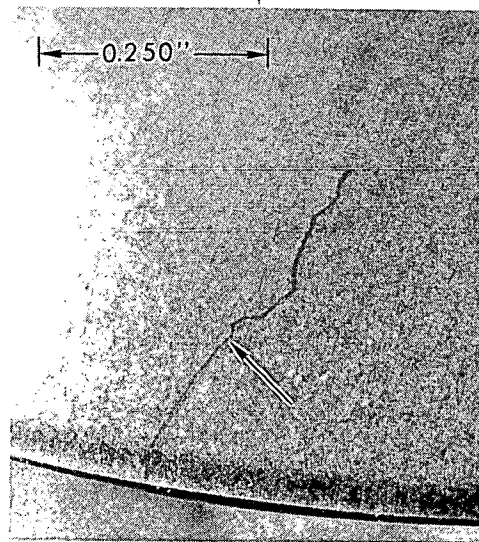
Figure VIII-15. - Bottom flange of pressure transducer 14 after removal of weld nugget. Enlargement of inside facing flange shows depth of crack propagation.

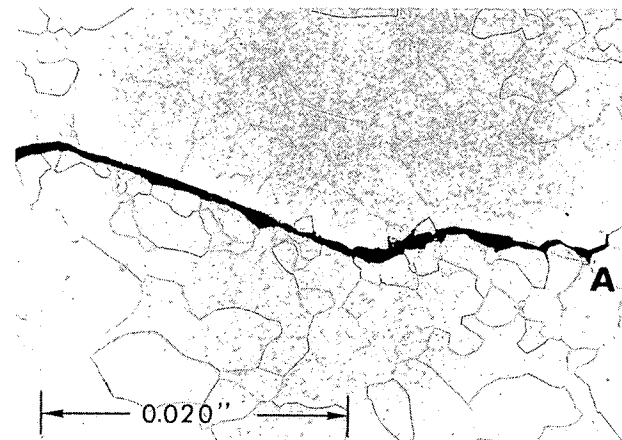
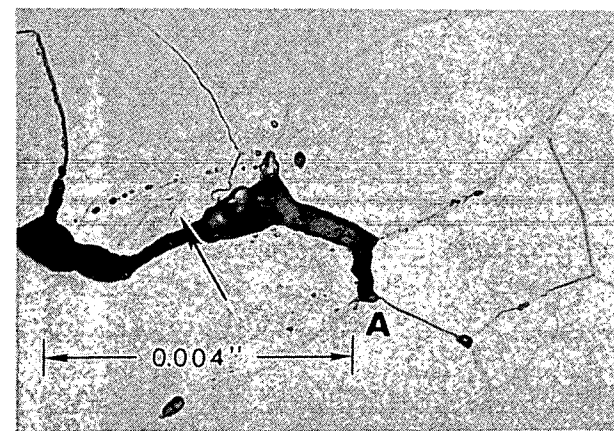
It is interesting to note the amount of distortion in the grain shown by the arrow in figure VIII-16(b). It is possible that this distortion was not sufficient to relieve local stresses which resulted in grain boundary separation and subsequent propagation toward the surface. The fact that the crack width is larger at the surface than the center would tend to discount this theory by indicating the crack started at the surface. However, if residual stresses were induced at the surface during welding, there would be a considerable amount of spring back as the crack broke through the surface from the inside. This would cause a larger crack width at the surface, which would decrease as the spring back effects decreased from the edge to the center.

Figure VIII-16. - Photomicrographs of end A of crack shown in Figure VIII-15 at two magnifications. The arrow in photomicrograph (b) shows presence of highly distorted grain near end of crack. Etchant: 30 grams  $\text{NH}_4\text{F}$ , 50 milliliters  $\text{HNO}_3$ , 20 milliliters  $\text{H}_2\text{O}$ .

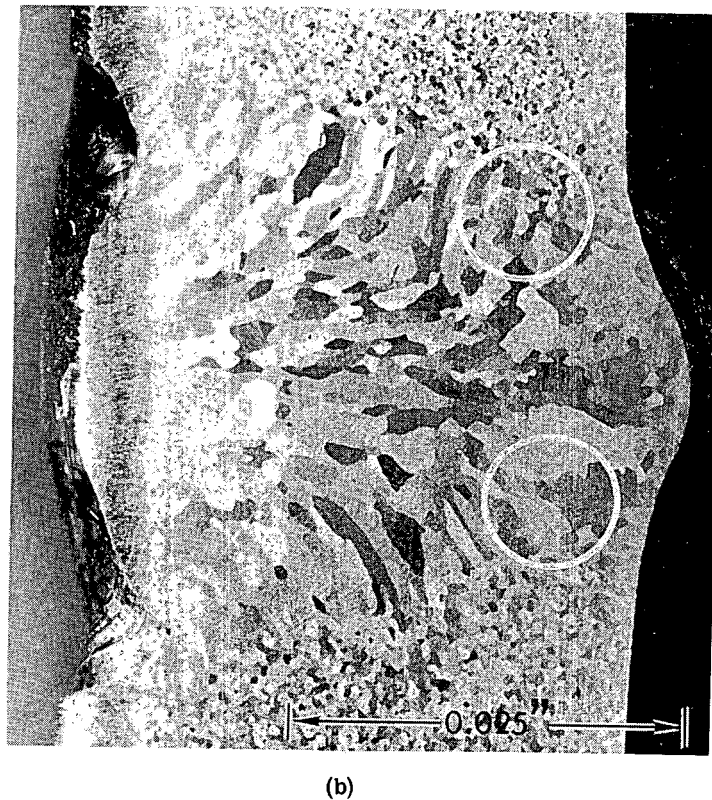
Multipass tube welds. - One of the most reproducible incidents of cracking found in T-111 alloy is that which occurs in multipass welds (T-111 alloy filler material) of the type needed to join heavy sections (ref. 5). Grain boundary separation is first visible in the root pass after the second weld pass has been made. The grain boundary separation becomes more pronounced after the third pass and was found to extend into the second pass material after the fourth pass was complete. (Similar observations with multipass TIG welding of T-111 alloy have been made by R. Begley and W. Buckman of Westinghouse Electric Co.) Cracking and grain boundary separation were found predominantly in the periphery of the fusion zone (circled areas of fig. VIII-17(b)). Photomicrographs of a portion of one of these areas are presented in figure VIII-18. Although grain boundary separation was found primarily near the periphery of the fusion zone, some grain boundary separation was noted in the center of the fusion zone also. Occasionally grain boundary separation was found in the heat-affected zone near the edge of the fusion zone.

To determine the effect of filler wire composition on the cracking behavior of multipass welds, two 2.5-inch-outside-diameter by 0.375-inch-wall T-111 alloy tubes with solid ends were machined from 2.5-inch-diameter rod and subsequently butt welded using the TIG process with T-111, Ta-10W, and Cb-1Zr alloy filler wires. A J-shaped weld preparation was machined in each part prior to welding. The first weld pass, or root pass, was a T-111 alloy fusion pass except for a short region of the joint which was not welded to allow for the venting of the tube interior. Three additional passes were made using T-111 alloy filler for one 120° segment around the tube, Ta-10W alloy filler for another 120° segment, and finally Cb-1Zr alloy filler for the last 120° segment. A photograph of a section through the welded parts is shown in figure VIII-17(a). The welded tube was metallographically sectioned through each of the three segments representing the three filler materials. Photomicrographs of transverse sections through these welds are shown in figures VIII-19, VIII-20, and VIII-21. The major observations of this study are (1) grain boundary separation occurs in the T-111 alloy root pass for all three filler alloys, and (2) grain boundary separation is not observed in the Cb-1Zr or Ta-10W alloy portions of the corresponding weld segments. These observations indicate that hafnium, present only in T-111 alloy, is a significant factor contributing to the grain boundary separations in the T-111 alloy weldments.

Figure VIII-17. - Multipass GTA weld sample formed by joining two 2.5-inch-outside-diameter by 0.375-inch-wall T-111 alloy closed end tubes with three different filler wires, T-111 alloy, Cb-1Zr, and Ta-10W. The circled areas in (b) indicate approximate locations of most cracking observed.

Of the possible solutions to the multipass weld cracking in T-111 alloy, the most obvious solution is to design to avoid the use of heavy sections requiring multipass welds wherever possible; no weld cracking has been observed on TIG welds of parts having thin sections (~0.100 in.). Other suggested solutions include designing for single-pass EB instead of TIG welding, intermediate stress relieving, alloy modification, and alloy overlay.

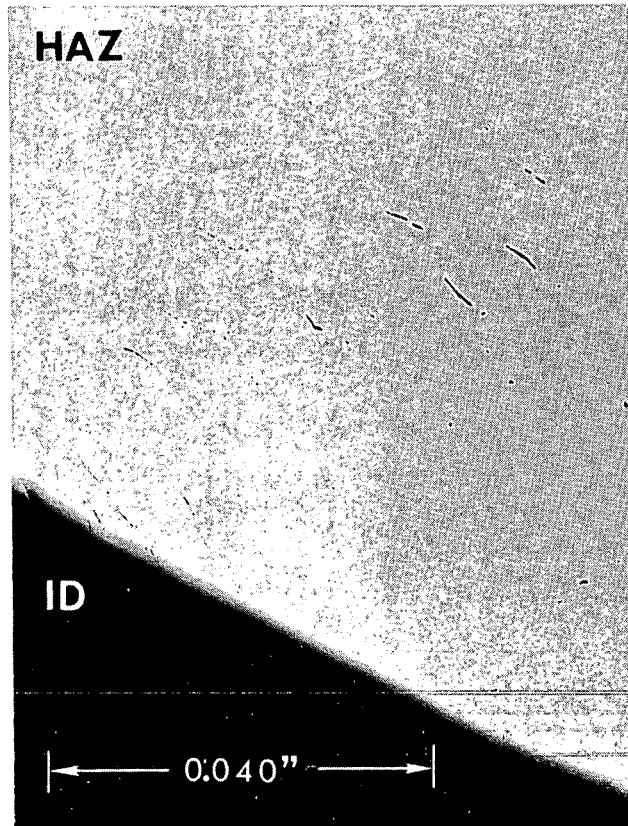
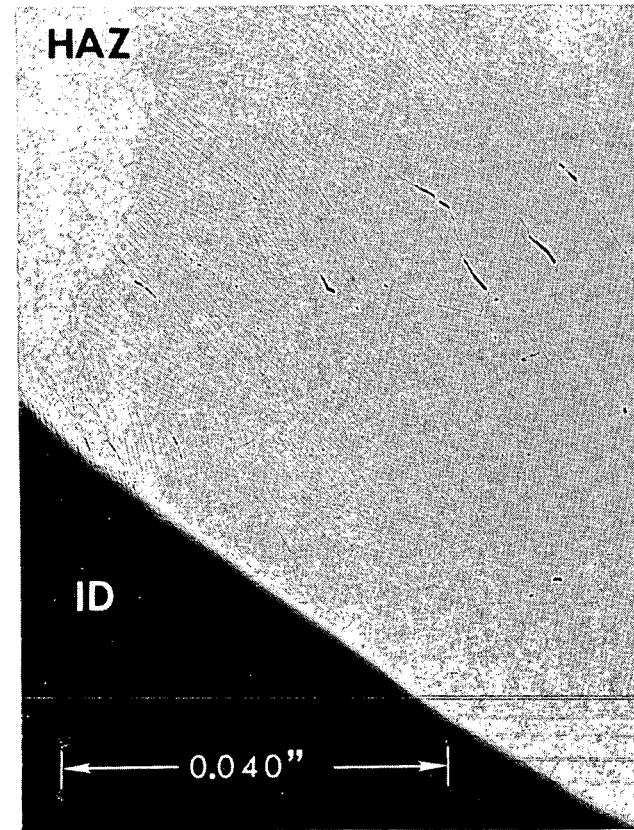
Figure VIII-18. - Transverse microstructure near edge of weld nugget in three-pass T-111 alloy weld showing cracking typical of this area. Etchant: 30 grams  $\text{NH}_4\text{F}$ , 50 milliliters  $\text{HNO}_3$ , 20 milliliters  $\text{H}_2\text{O}$ .

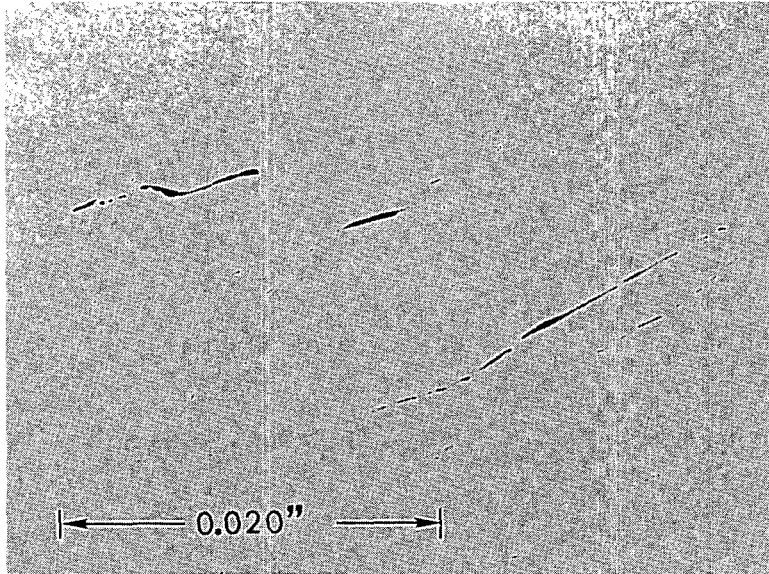
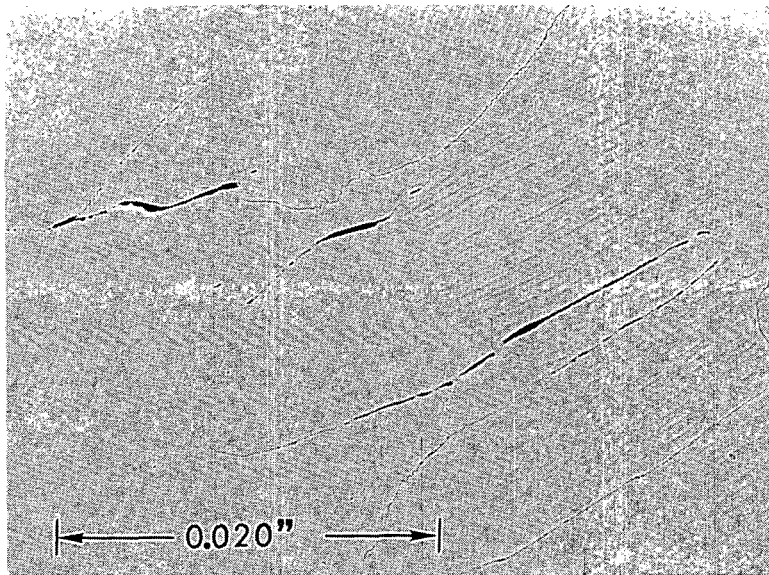
Figure VIII-19. - Transverse microstructure of T-111 alloy fusion pass of multipass T-111 alloy tube weld using T-111 alloy filler showing grain boundary separation. Etchant: 30 grams  $\text{NH}_4\text{F}$ , 50 milliliters  $\text{HNO}_3$ , 20 milliliters  $\text{H}_2\text{O}$ .

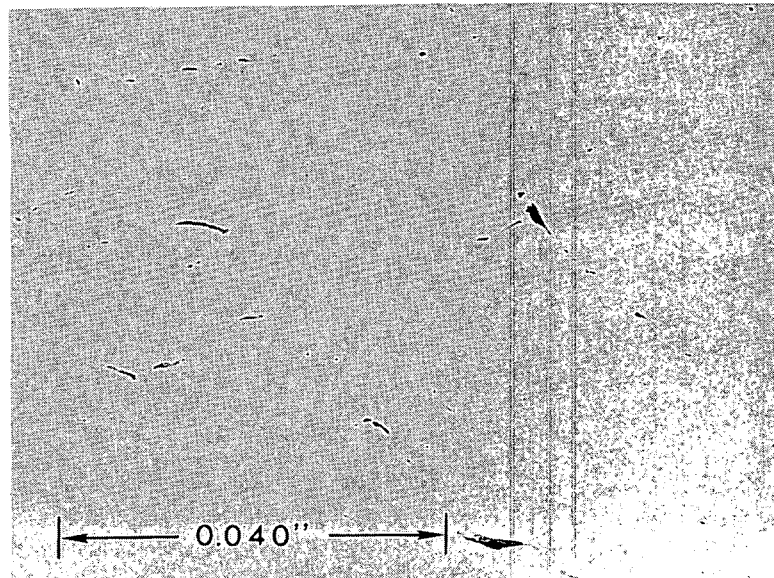
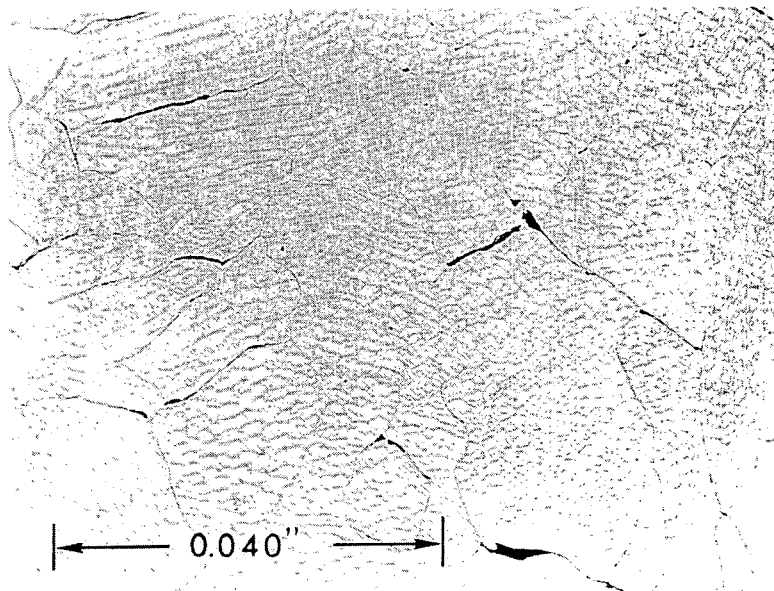
Figure VIII-20. - Transverse microstructure of T-111 alloy fusion pass of multipass T-111 alloy tube weld using Cb-1Zr alloy filler showing grain boundary separation. Etchant: 30 grams  $\text{HN}_4\text{F}$ , 50 milliliters  $\text{HNO}_3$ , 20 milliliters  $\text{H}_2\text{O}$ . X100.

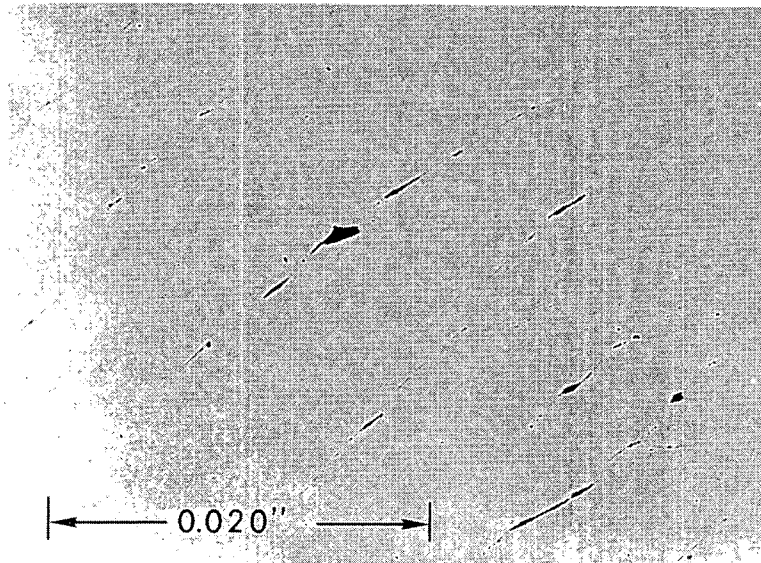
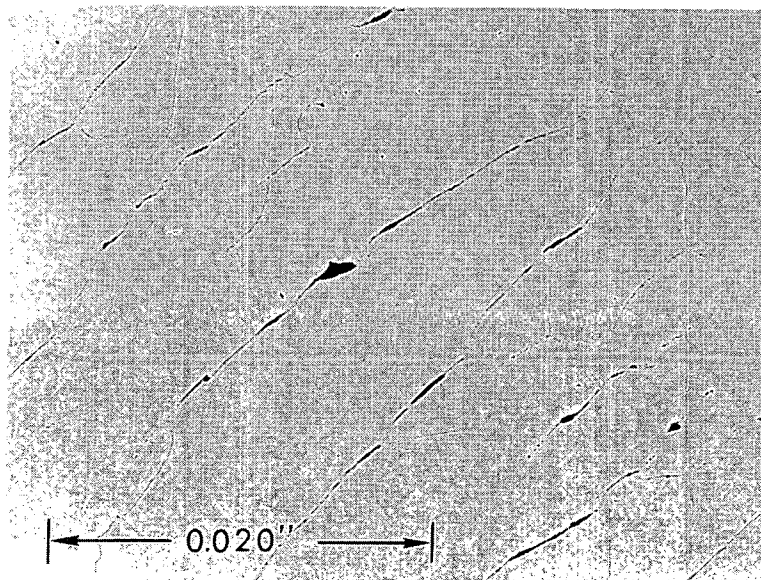
**Figure VIII-21. - Transverse microstructure of T-111 alloy fusion pass of multipass T-111 alloy tube weld using Ta-10W alloy filler showing grain boundary separation. Etchant: 30 grams  $\text{HN}_4\text{F}$ , 50 milliliters  $\text{HNO}_3$ , 20 milliliters  $\text{H}_2\text{O}$ .**
