VIII. T-111 ALLOY CRACKING PROBLEMS  
DURING PROCESSING AND FABRICATION\*

R. A. Ekvall,<sup>†</sup> R. G. Frank,<sup>†</sup> and W. R. Young<sup>†</sup>

SUMMARY

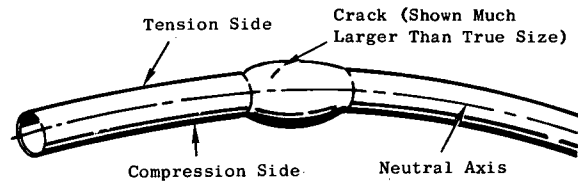
Boiler weld failure. - During the initial startup of a T-111 alloy corrosion test loop, a leak developed between the lithium primary circuit and the potassium secondary circuit (refs. 6 and 7). The leak in the coaxial T-111 alloy tube boiler was traced to a crack in the weld nugget of the 0.375-inch-outside-diameter by 0.062-inch-wall inner tube, as shown in figure VIII-22. During operation of the boiler ( $\sim 2100^{\circ}$  F), lithium flowed in one direction in the annulus between the two tubes, and potassium flowed in the opposite direction within the inner tube. After the cracked segment of tube was cut from the boiler, stepwise removal of material from the surface of a longitudinal section through the crack, to a depth of 0.006 inch, clearly showed the crack to be intergranular (fig. VIII-23) with entire grains delineated as the result of grain boundary separation (fig. VIII-24). The appearance of grain boundary separation suggests some action of lithium which has penetrated into the crack. Although the intermittent voids in the grain boundaries are similar in appearance to those observed as a result of attack by lithium, the crack is not believed to have been initiated by a corrosion mechanism, since corrosion by lithium would not be expected in T-111 having an oxygen concentration as low as that (40 ppm) of the as-received boiler tube.

Figure VIII-22. - Sketch showing location of crack in weld nugget of T-111 alloy tube removed from corrosion test loop boiler.

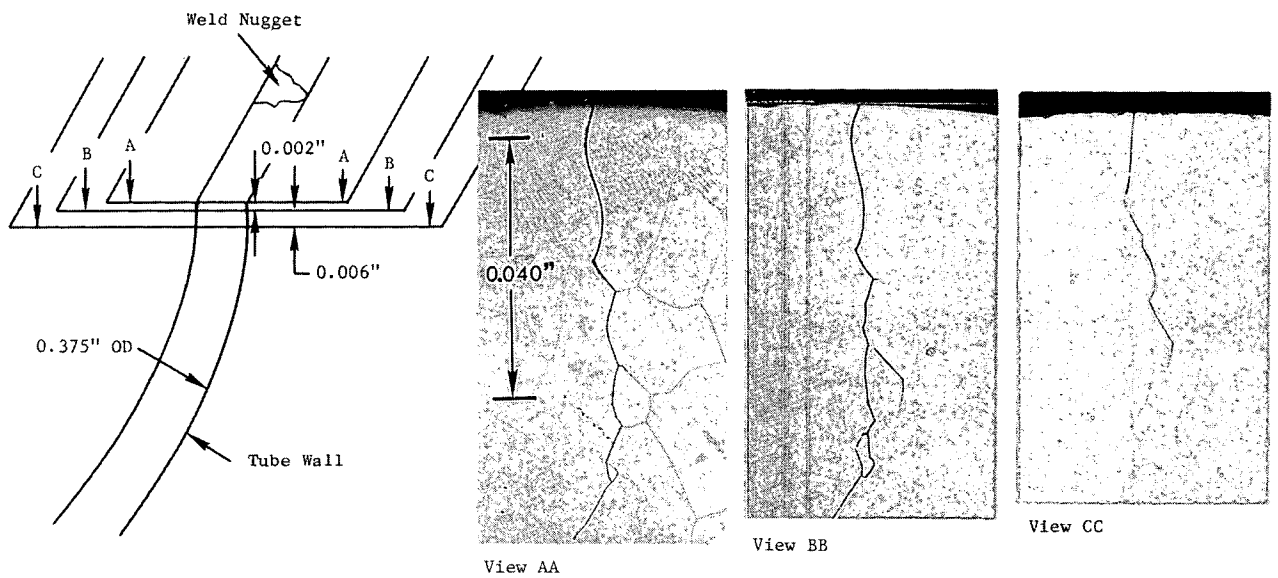
Although the cause of the crack is not evident, it is believed that the most likely explanation would be that straining of the weld nugget while it was hot might have caused grain boundary separation similar to that which occurred during butt welding of tubes (described in the section Butt weld joint). Propagation of such a crack could have occurred during subsequent bending to form the helically shaped boiler.

Figure VIII-23. - Intergranular crack in weld nugget of 0.375-inch-diameter T-111 boiler tube removed from T-111 Rankine system corrosion test loop.

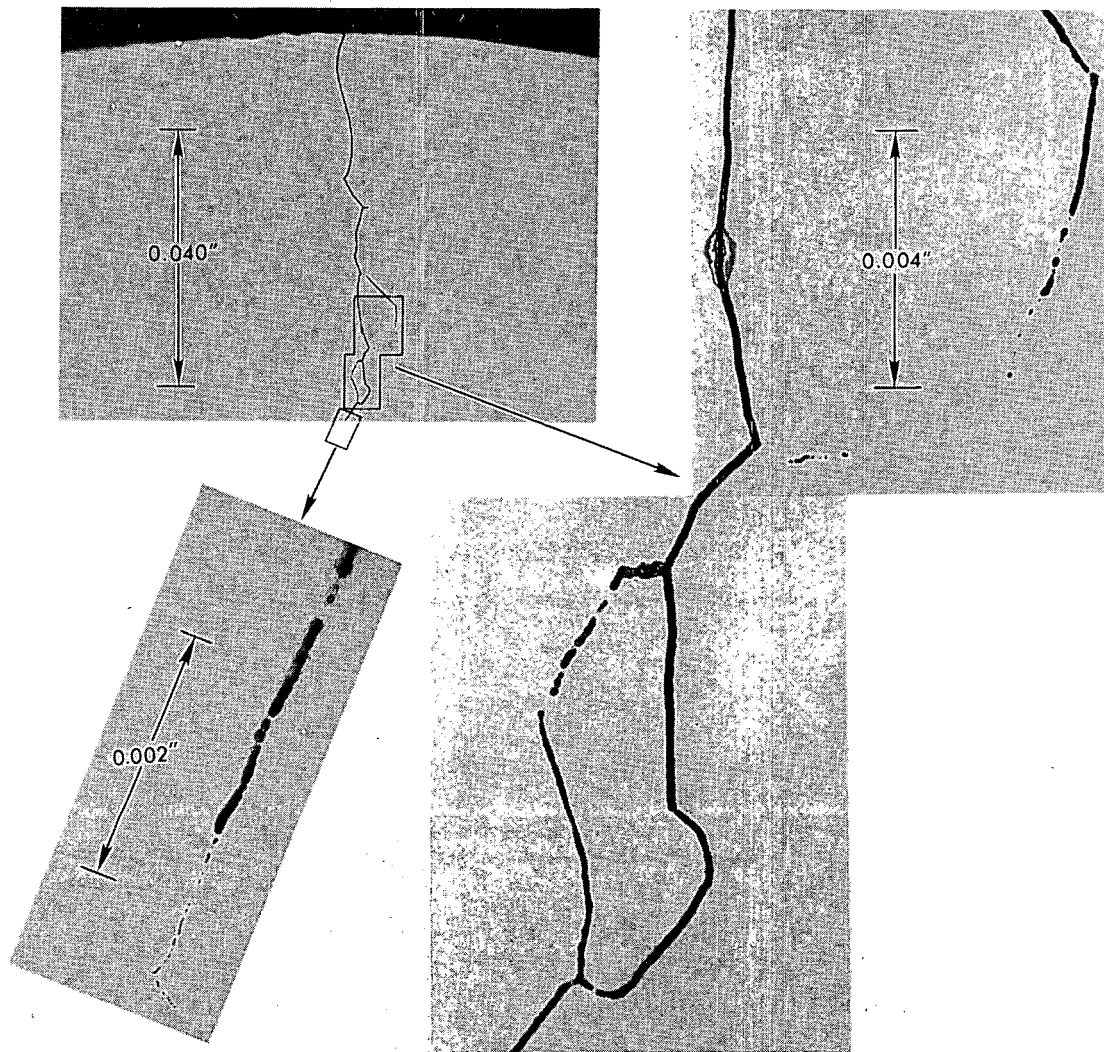
Figure VIII-24. - Intergranular crack in weld nugget of 0.375-inch-diameter T-111 boiler tube removed from T-111 Rankine system corrosion-test loop.

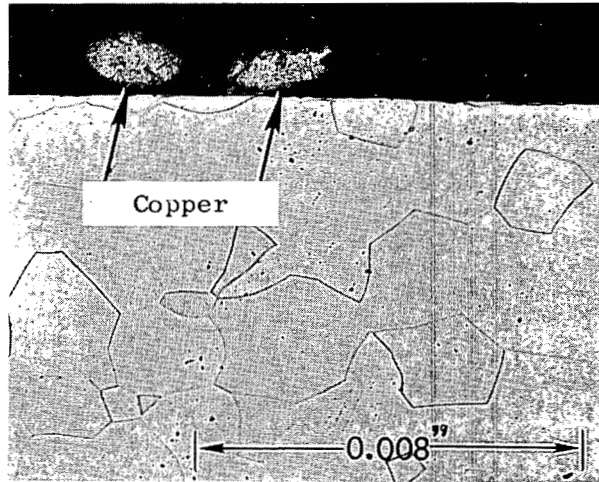
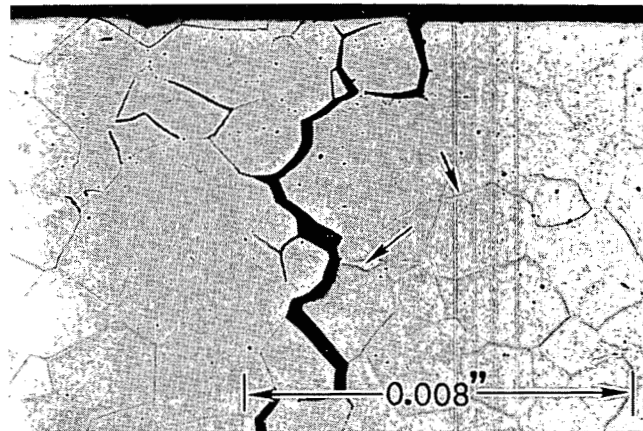
fastened in place by spot tack welding. After heat treatment, cracking was observed in the T-111 alloy in the vicinity of the tack welds. No cracking had been observed previously in spot tack welding of Cb-1Zr foil to T-111 alloy using a molybdenum (Mo) tipped welding electrode. The subassemblies exhibiting cracks, however, had been spot welded using a copper (Cu) electrode. The utilization of the Cu electrode was believed to be responsible for the observed failures. The highlights of an investigation to identify and eliminate the cause of cracking are summarized in the next paragraph (ref. 8).

(a) As tack welded.

(b) Tack welded followed by 2400° F, 1-hour heat treatment.

Figure VIII-25. - T-111 alloy tubing (1.5-in. by 0.100-in. wall) tack welded with copper electrode. Residual copper shown by arrows in (a). Etchant: equal volumes of  $H_2O$ ,  $H_2O_2$ ,  $H_2SO_4$ , HF.

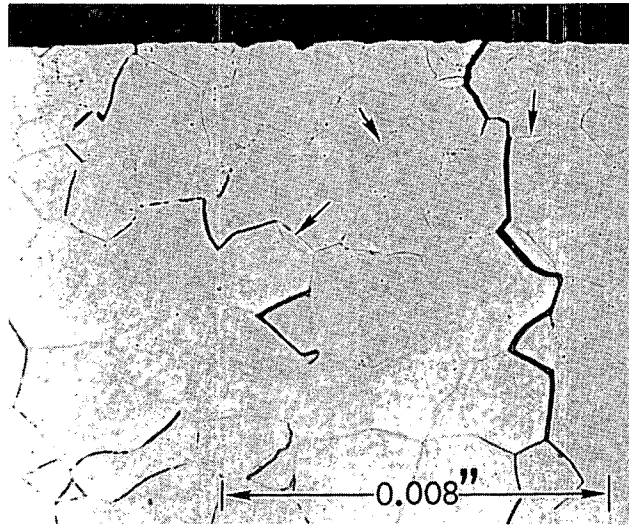
Figure VIII-26. - Intergranular cracking of T-111 alloy tubing (0.375-in. by 0.065-in. wall) tack welded using copper electrode and heated to 2400° F for 1 hour. Etchant: equal volumes of H<sub>2</sub>O, H<sub>2</sub>O<sub>2</sub>, H<sub>2</sub>SO<sub>4</sub>, HF.

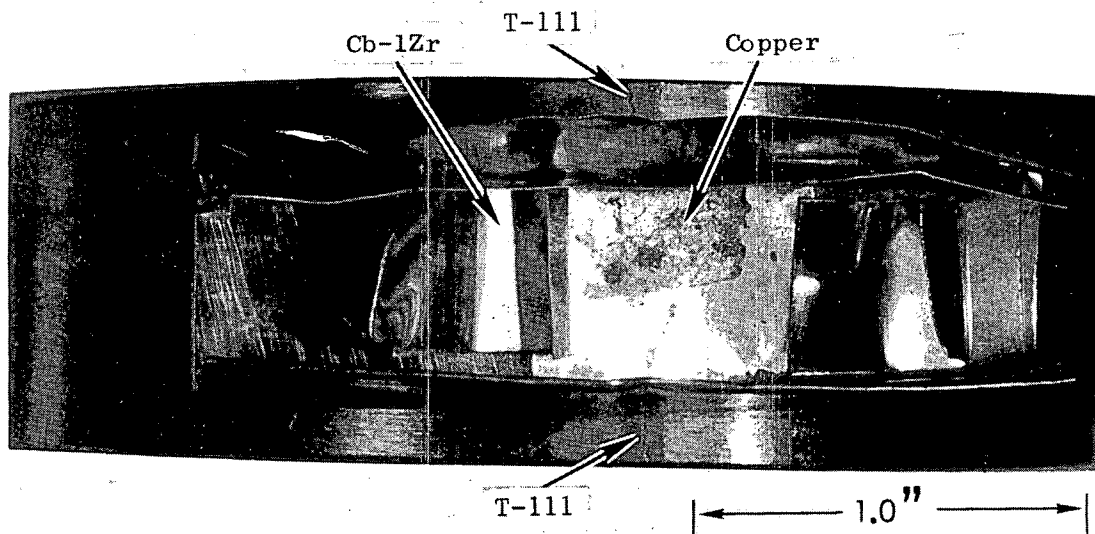
Figure VIII-27. - Crack (see arrows) in T-111 alloy tube (1.5-in. by 0.100-in. wall) produced by copper diffusion into tube through multilayers of 0.002-inch-thick Cb-1Zr foil during heat treatment at 2400° F for 1 hour.

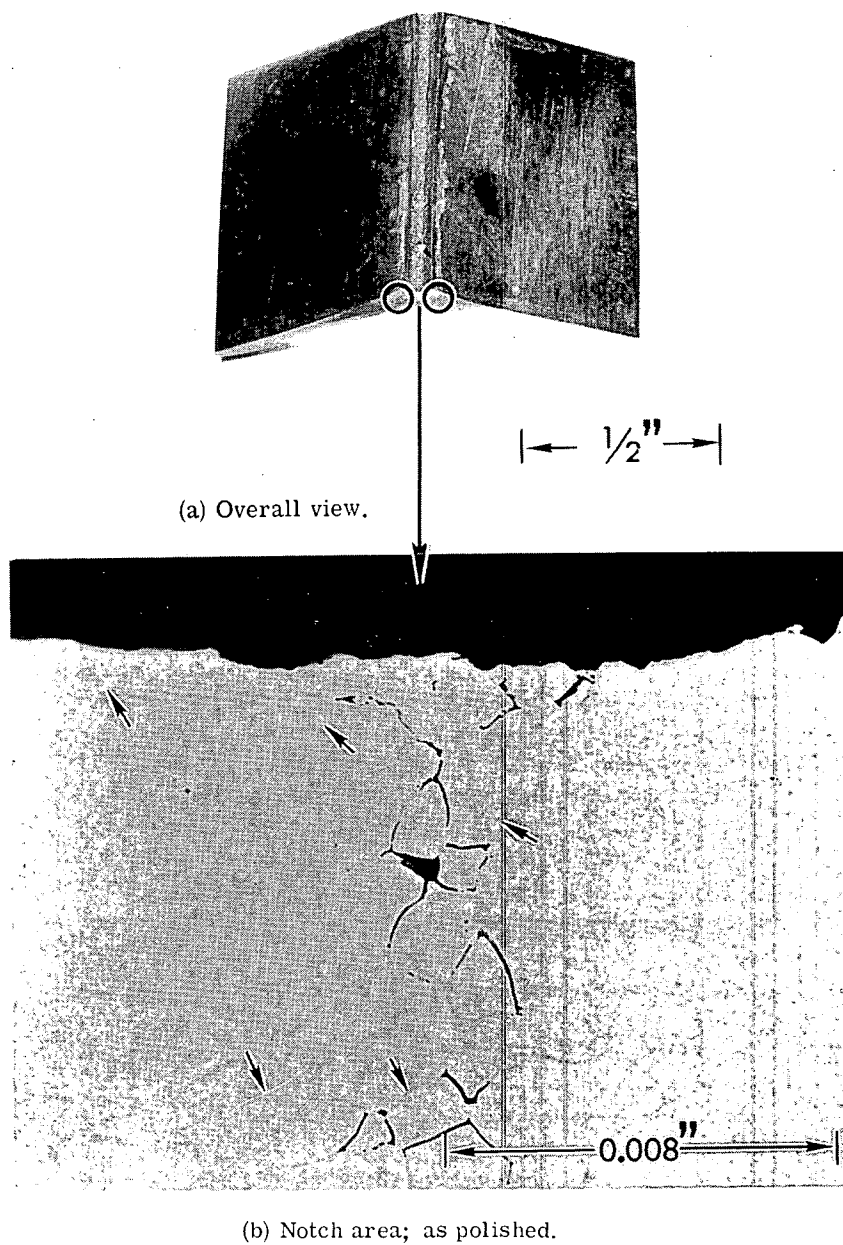
for 1 hour. Microcracking was found at symmetrical locations on each side of the notch, as illustrated in figure VIII-28(b). An identical notched, bent, and heat treated sheet specimen without Cu did not exhibit microcracking. The notched sheet sample, heated to 2400<sup>0</sup> F, with Cu in the notch was examined with a microprobe at the failure location and at random positions throughout the specimen. The phase present at sample grain boundaries next to the failure contained Hf concentrations significantly higher than the matrix; Cu was also found in these grain boundaries. Cu was not present within the grains of the sample nor in grain boundaries remote from the failure. These results indicated that a Cu/Hf reaction, at grain boundaries originally high in Hf content, was the probable major factor causing Cu penetrations and the resultant failures.

Figure VIII-28. - Copper filled notch in T-111 alloy bend sample (0.063 in. thick) after heat treatment at 2400° F for 1 hour. Light colored grain boundary phase in (b) is rich in Cu and Hf.
