**The 11 March 2011 East Japan Earthquake and Tsunami:
Tsunami Effects on Coastal Infrastructure and Buildings**

Abstract: The 11 March 2011 East Japan Earthquake and Tsunami caused unprecedented damage to well-engineered buildings and coastal structures. This report presents some notable field observations of structural damage based on our surveys conducted along the Sanriku coast in April and June 2011. Engineered reinforced concrete buildings failed by rotation due to the high-velocity and deep tsunami inundation: entrapped air in the buildings and soil liquefaction by ground shaking could have contributed to the failure. The spatial distribution pattern of destroyed and survived buildings indicates that the strength of tsunami was affected significantly by the locations of well-engineered sturdy buildings: weaker buildings in the shadow zone tended to survive while jet and wake formations behind the sturdy buildings enhanced the tsunami forces. We also found that buildings with breakaway walls or breakaway windows/doors remained standing even if the surrounding buildings were washed away or destroyed. Several failure patterns of coastal structures (seawalls) were observed. Flo

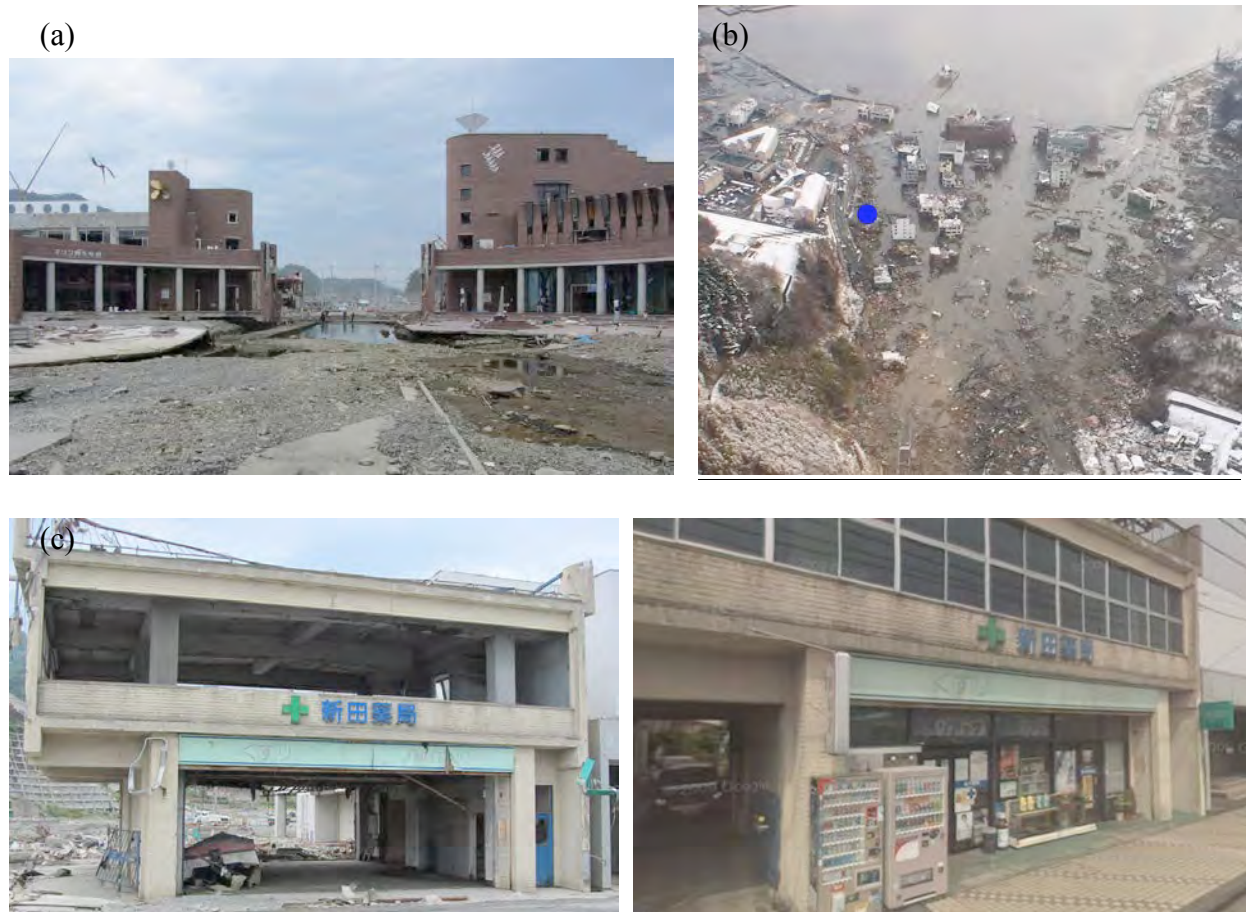
In spite of such extraordinary failure of several RC buildings in Onagawa, two large RC buildings at the waterfront and the smaller buildings directly behind them were found standing (Fig. 3a). The damage pattern shown in the figure suggests that the waterfront buildings must have acted as a barrier for the smaller buildings behind them. Video footage (Video, 2011) shows a strong jet formation in the gap between the two large forward buildings, which wiped out everything in its path. Clearly, the presence of the sturdy RC buildings altered the tsunami flows, which in turn affected the surroundings. This type of observation is not new, however. Abe et al. (1993) reported reduction and enhancement of tsunami effects on the surroundings of sturdy buildings in the town of El Transito affected by the 1992 Nicaragua Tsunami. This indicates that tsunami resilient structures should be designed with consideration of the effects from the surroundings, which resembles the design practices for high-rise buildings and long-span bridges for wind forces. Recently Reese et al. (2011) incorporated the shielding effects in their building fragility analysis for the 2009 Samoa Tsunami.

We found that some of the structurally survived buildings were those in which ground-level walls were blown off by tsunami forces; in other words, the walls acted as so-called breakaway walls. Note that the similar observations have been made from the previous tsunami events: e.g. the 1992 Nicaragua Tsunami (Yeh, 1995) and the 2004 Indian Ocean Tsunami (Dalrymple and Kriebel, 2005). Figure 3c shows a typical example in Onagawa: the right panel of the figure shows the condition prior to the tsunami attack that we obtained from Google Maps/Street View. This building formed openings piercing from the front to the back aligned with the tsunami flow direction. Those openings were not designed for tsunami protection, but the tsunami forces punched through the windows and doors.

The water pond between the two waterfront buildings shown in Fig. 3a is a very deep scoured hole (more than 3.5 m deep), where a road was located prior to tsunami inundation. Judging from the video footage (VIDEO, 2011), high-velocity and debris-laden return flow between the sturdy

Figure 3. Tsunami destruction pattern in Onagawa ($38^{\circ}26.5'N$ $141^{\circ}26.5'E$). (a) A pair of sturdy large buildings at the waterfront acted like barriers for some of the weaker buildings behind. (b) An areal view (the photo was enhanced from the original taken by Satake). The waterfront buildings can be identified in the photo. The gap between the buildings created a jet flow that completely destroyed the narrow strip of the jet trajectory, and caused a deep scour hole in-between. The blue circle shows the location of the toppled building shown in Fig. 2d, approximately 200 m from the waterfront. (c) The RC building severely damaged but standing. The walls on the ground floor were punched away by tsunami. The right panel shows the conditions prior to the 2011 tsunami, taken from the GoogleMaps/StreetView.

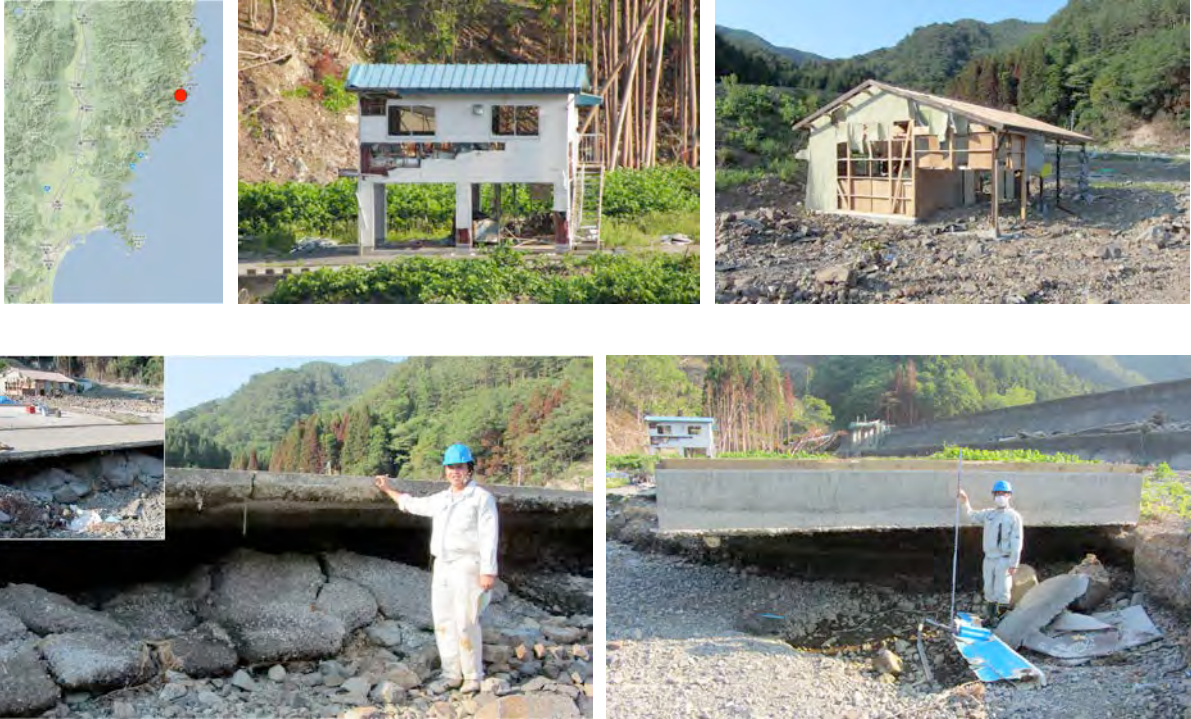
Figure 6 shows the damaged area on the seaward side of the seawall in the town of Tohni. The seawall is seen in the background of Fig. 6d, and its crown elevation is at 11.8 m TP. Tsunami overtopped the seawall: the average tsunami height was 15.5 m (Max. 17.4m; Min. 11.8 m). In spite of the significant inundation depth, we found two buildings still standing in front of the seawall. One of them is a 2-story steel-frame building, and the other is a small wood-frame shack (Fig. 6b). The tsunami flow power must have been weak enough for those buildings to survive. Nonetheless, we observed severe undermining damage in the road and scour under the building foundation (Fig. 6c and d). Considering the survived buildings, it is unlikely that shear forces or hydrodynamic lift forces that require high-velocity flows caused the substantial scour damage.

Figure 6. Undermined road and building foundations on the sea side of the seawall in Tohni. (a)

The location of Tohni: the average runup height was 15.5m ($39^{\circ}12.5'N$ $141^{\circ}53.2'E$). (b) A

couple of buildings survived from the tsunami inundation. (c) The size of the undermined

road shown is 1.5m deep and 1.5 m high. (d) The size of the undermined foundation is 1.2 m

high and 2.0 m deep.
