**THE BUMP AT THE END OF THE BRIDGE**

**KYHPR-64-17; HPR-1-(4), Part II**

**June 1969**

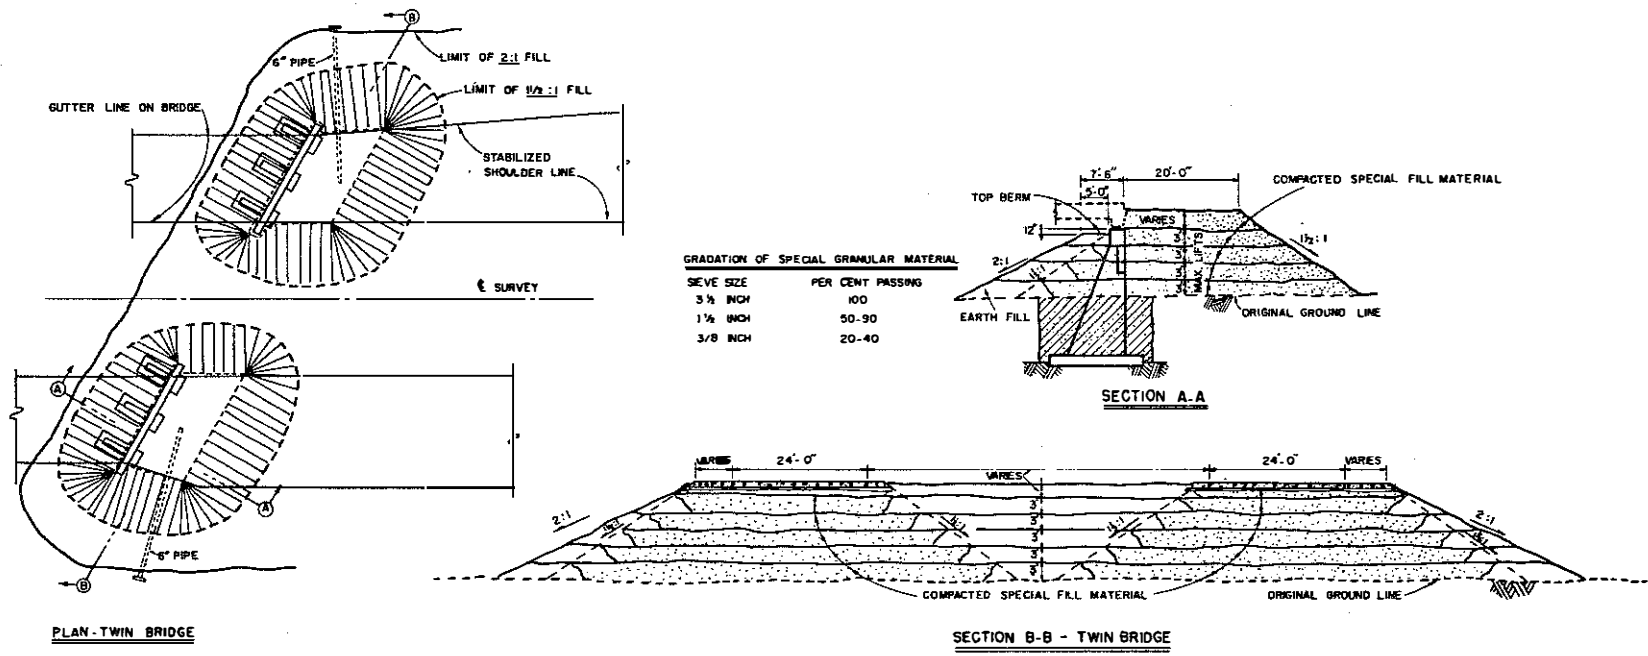
Figure 19 Kentucky Standard Drawing SF-1 showing the Requirements for Backfilling around Abutments with a Granular Material

At 54 bridge approaches located on I 64 between Frankfort and Louisville, the approach embankments were constructed of a special granular fill material extending approximately 20 to 60 feet behind the abutments. The special fill was formed and placed around the abutments, primarily open-column, in accordance with Kentucky Standard Drawing SF-1 (see Figure 19), which is no longer in use. Below original groundline, the special fill consisted of either sand, crushed or uncrushed gravel, crushed limestone, crushed sandstone, crushed slag, broken stone from solid rock excavation, or a combination thereof and was required to meet the gradation shown in Figure 19. Above groundline, the special backfill was of a type listed above; however, gradation requirements were waived. Whenever crushed stone or slag was used, the backfill was formed and compacted by spreading with a dozer or grader blade in such a manner that voids, pockets and bridging were minimized; the maximum layer thickness did not exceed three feet. Whenever sand was used, the backfill was compacted by saturation with water. In this case, the layer thickness did not exceed one foot. No stone or fragment of the special fill material was placed within one foot of the finished subgrade elevation.

The performance of bridge approaches associated with the special granular backfill is shown in Figure 20 and compared with bridge approaches not associated with the special backfill on the same route. The data show that backfilling behind abutments in a manner specified by Kentucky Standard SF-1 did not check the development of faulted approaches. Moreover, for cases involving the special backfill when compared to cases without the special fill, there was an increase in frequency of faulted approaches.
