The Effect of Humidity on the Reliability of a Surface Micromachined Microengine

Danelle M. Tanner, Jeremy A. Walraven, Lloyd W. Irwin, Michael T. Dugger, Norman F. Smith, William P. Eaton, William M. Miller, and Samuel L. Miller

Sandia National Laboratories, P.O. Box 5800, MS 1081, Albuquerque, NM 87185-1081
<http://www.mdl.sandia.gov/Micromachine>
 email: tannerdm@sandia.gov

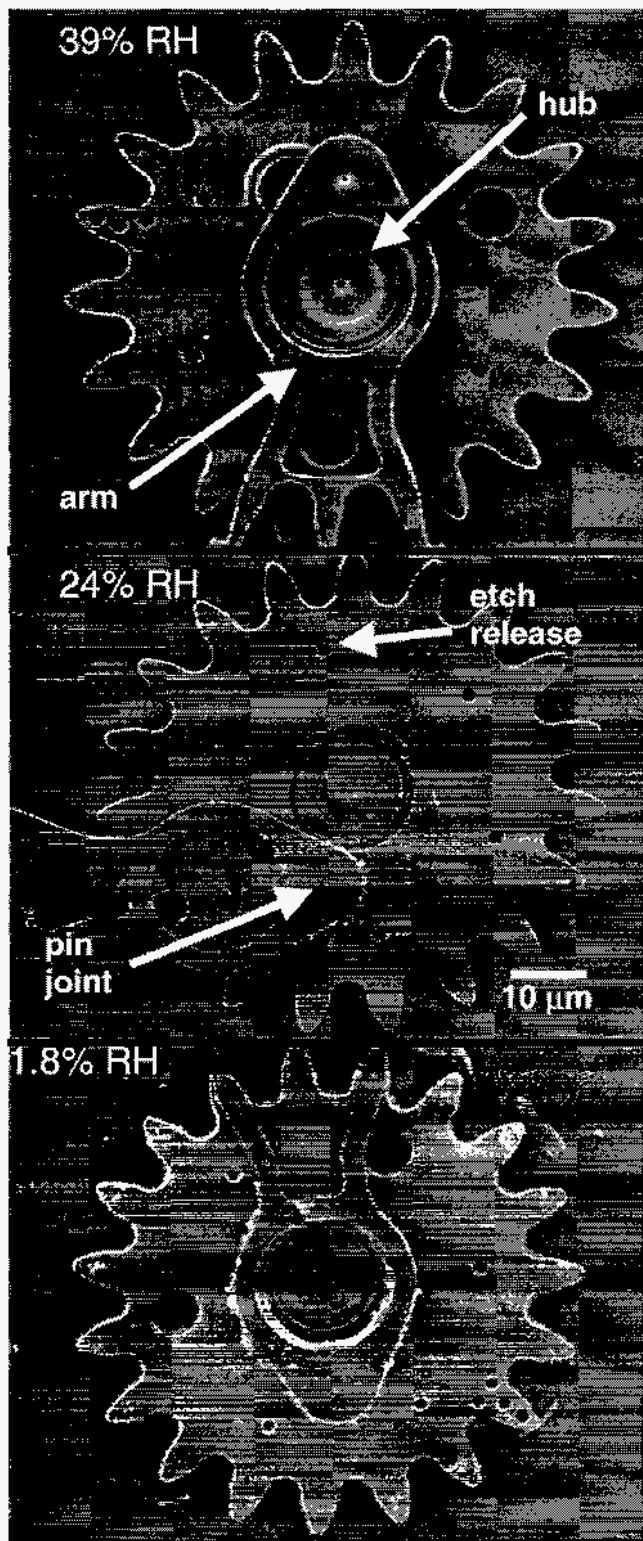
FTS Treatment: The dominant failure mechanism for these microengines has been identified as wear. The major effects of the wear process were either pin joint wear-out causing the linkage arm to break away from the gear or accumulation of wear debris causing the microengine to seize. The overwhelming effect of the humidity was demonstrated by the amount of wear debris observed. The volume of debris increased dramatically as we lowered the humidity. In Figure 5, we show a comparison of the gears of microengines stressed in air environments of 39%, 24%, and 1.8% RH at 25°C. These microengines were stressed to failure at 862,000, 746,000, and 742,000 accumulated cycles, respectively, yet the microengine with the most accumulated cycles has the least amount of wear debris. In the 39% RH case, there is a small amount of debris located around the hub. The 24% RH case shows more noticeable wear debris around the hub and on the linkage arm. The debris in the 1.8% case includes large slivers near the gear teeth. Debris has been thrown out and collected on the hub face, at the tips of the gears, on the linkage arm, in the etch-release holes, and onto the substrate area outside of the gear face. These images are characteristic of observations at different humidity levels.

Figure 5. SEM images of various microengine gears stressed under different humidity conditions 39%, 24%, and 1.8% RH at 25° C. The microengines were stressed for roughly the same number of cycles, but the amount of wear debris for each humidity was dramatically different. (FTS)

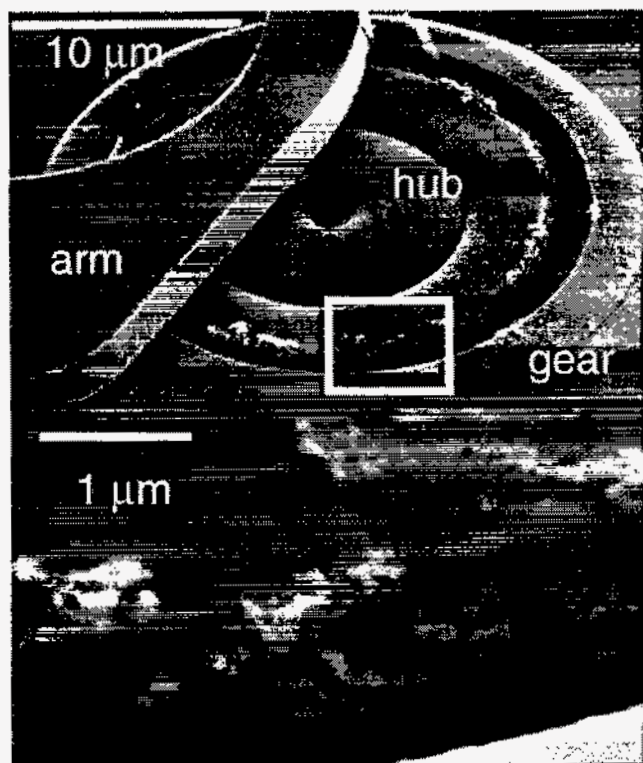
Using a field emission SEM to further magnify and characterize the wear debris, we again noticed a difference between the 39% and the 1.8% RH case. Figure 6 shows a magnified view of the hub of a microengine that failed at 510,000 cycles at 39% RH. The box region has been magnified further to illustrate the debris morphology. The wear debris appears to be 200 to 500 nm agglomerates which string together with other agglomerates to form chains of 1 μm or longer.

Figure 6. SEM magnified view of the hub region on a microengine that failed at 510,000 accumulated cycles during the 39% humidity test shows the morphology of the wear debris. (FTS)

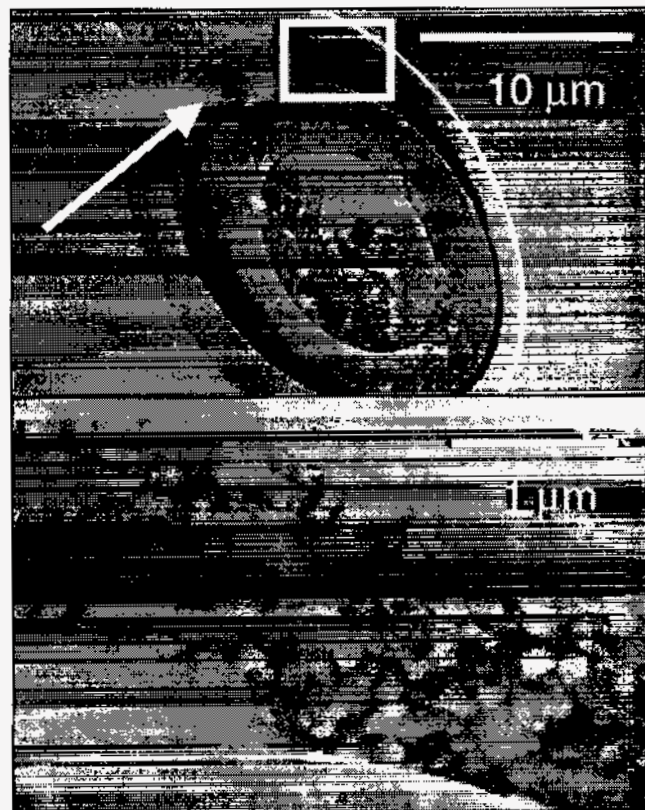
For comparison, we investigated the hub of a microengine stressed to failure after 642,000 cycles in 1.8% RH at 25°C. This hub is shown in Figure 7. The first item to note (indicated by an arrow) is the radial offset in the gear and hub due to the large amount of wear between the hub and the mating gear. The offset caused a wobble in the motion of the gear at the inspection frequency of 1 Hz. Note also that the entire hub is covered with particulate wear debris. This is shown more fully in the lower image of Figure 7, which is a higher magnification of the box region. There are no stringy agglomerates in the 1.8% RH case.

Figure 7. SEM magnified view of the inner gear region on a microengine stressed to failure after 642,000 cycles at 1.8% RH. The wear debris formed particulate matter, each smaller than 100 nm. (FTS)

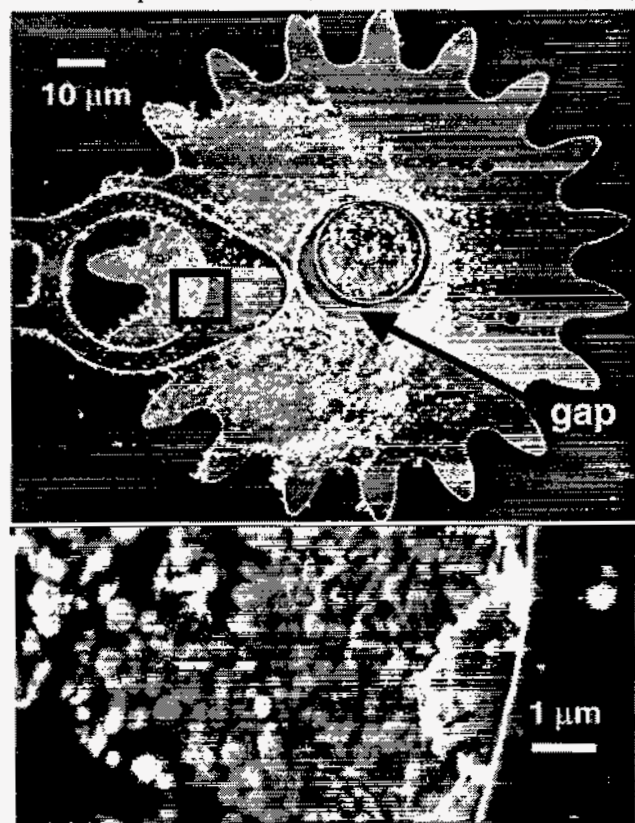
SCCO₂ Treatment: Just as in the FTS treatment, the dominant failure mechanism was associated with wear. As shown in Figure 8, the amount of wear debris on the face of the gear far exceeded that observed in the FTS case at the humidity level of 1.8% RH. This engine failed at 600,000 cycles. The gap around the hub was an indication of severe wear.

Figure 8. SEM image of a microengine that failed at 600,000 cycles at 1.8% RH illustrates the wear debris produced. The gap near the hub is an indication of severe wear. Note the morphology of the wear debris in the lower magnified image. (SCCO₂)

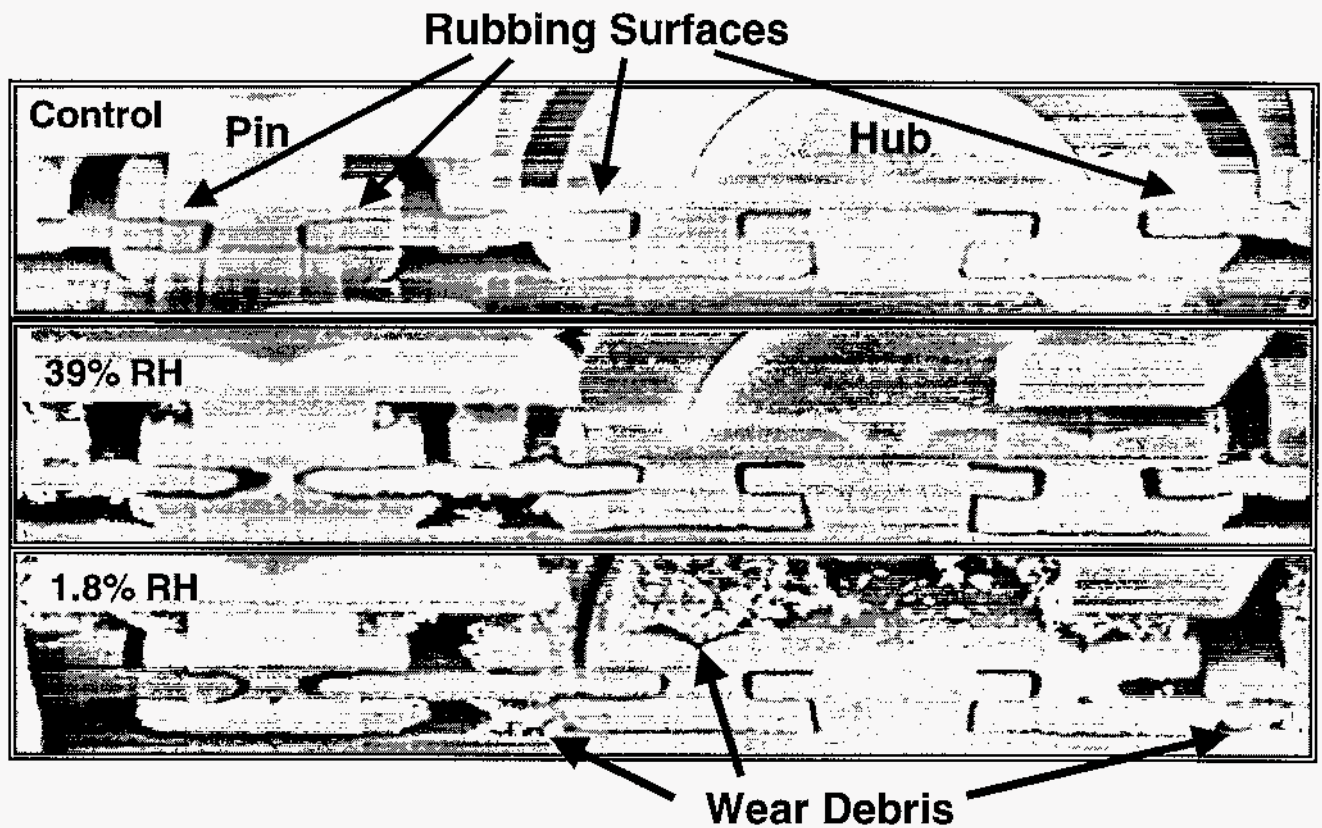
FTS Treatment: To investigate the effect of wear, FIB cross sections were performed on a sample from each humidity level. Shown in Figure 9 are cross sections taken from a control (top), 39% RH (middle), and 1.8% RH (bottom) samples. The control sample was tested for functionality, but was not stressed. Because debris is not shown in the control sample we believe the debris was caused by wear, not the FIB cut. The 39% RH microengine was stressed to failure at 606,000 cycles and the 1.8% RH microengine was stressed to failure at 542,000 cycles. In the 39% RH case, we observed mostly pin joint wear as shown with the notched diameter. The wear of the pin joint was accompanied by a reduction in the pin joint opening, probably due to a buildup of debris. For the 1.8% RH experiment the wear was observed in both the pin joint and the hub. The pin joint diameter eventually broke in the majority of samples tested (32 times out of 50 samples) for the 1.8% case.

Figure 9. SEM images of the control, the 39% RH sample and the 1.8% RH sample illustrate the amount of wear debris created in each experiment. Arrows indicate the rubbing surfaces. In both stressed samples, the pin joint has been worn down from its fabricated 3 μm diameter. (FTS)

To estimate the wear volume of material one can either measure the volume of the wear debris or measure the missing volume in the worn device. We chose the latter and used the FIB cross sections (Figure 9) from FTS-coated devices to estimate the volume worn for the humidity levels of 1.8%, 10%, 24%, and 39% RH at 25°C.

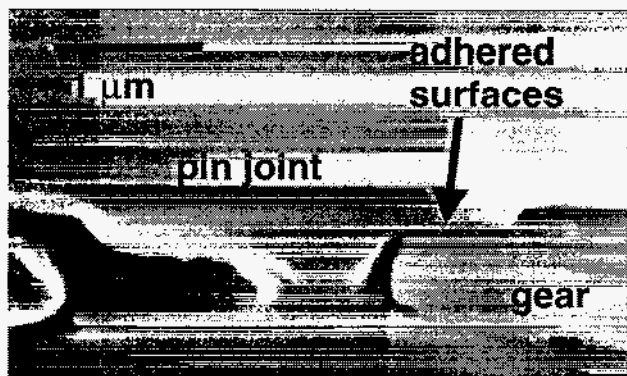
Figure 10. SEM magnified view of the pin joint region in a FIB cross section shows the area where the two surfaces adhered causing the microengine to seize. This microengine was tested at 10% RH at 25°C. (FTS)

veals adhesion of the wearing surfaces (Figure 10). This was our first observation of adhered surfaces, which yielded clear evidence of the cause of failure. As indicated on the right hand side of Figure 10, the adhered region is approximately 0.7 μm long.

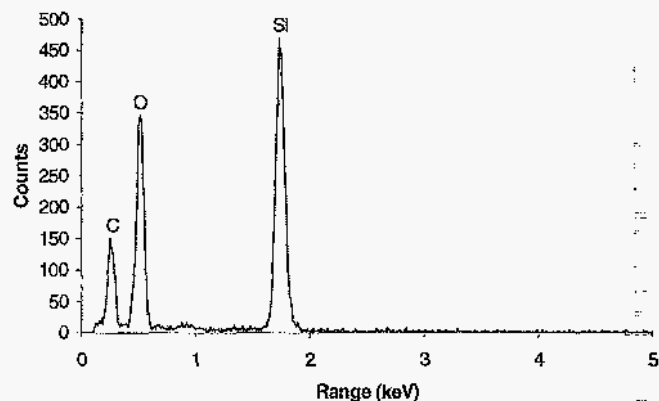
Using TEM in conjunction with EDS, the wear debris has been identified as amorphous oxidized silicon with either spherical or rod-like morphologies. EDS spectrums taken from wear debris found outside the gear, adhering to the gear teeth, and inside etch release holes revealed high concentrations of carbon, oxygen and silicon. Diffraction patterns (not shown) taken from these locations showed broad ring-like patterns typical of amorphous materials. The lack of diffraction spots or speckled rings from these areas indicate no polysilicon was worn directly away from the hub or pin joint regions during testing. Figure 12 illustrates an EDS spectrum typical of debris analyzed from all three regions. High concentrations of carbon result from the thin carbon film used for sample preparation.

Figure 12. EDS spectra of wear debris found outside the gear. Note the strong presence of oxygen and silicon.
