## THE EXAMINATION OF AIRCRAFT TIMBER BY X-RAYS

BY CAPT. R. KNOX, M.D., R.A.M.C., AND MAJOR G. W. C. KAYE,  
M.A., D.Sc., R.A.F.

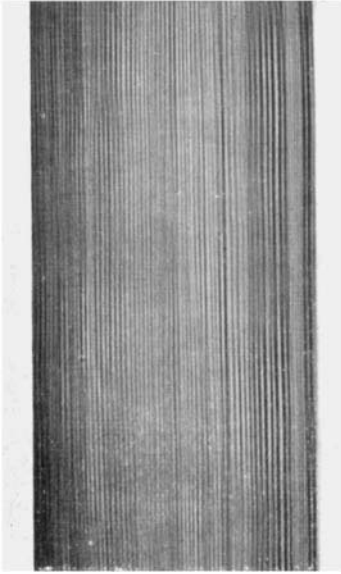
FIG. 1.  
CANADIAN WHITE PINE.

*Figure 1. Canadian White Pine, radiographed tangentially to annual rings.*

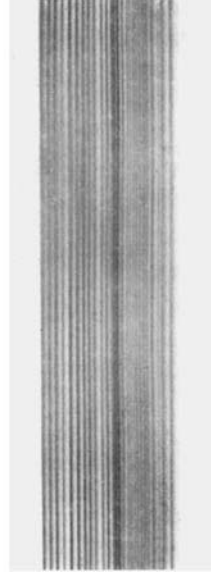
FIG. 2.  
WEST VIRGINIA SPRUCE

*Figure 2. West Virginian Spruce, radiographed tangentially to annual rings. The ribbed effect is marked. The dark band running down the centre is due to the closer growth over this region which was also deeper in colour.*

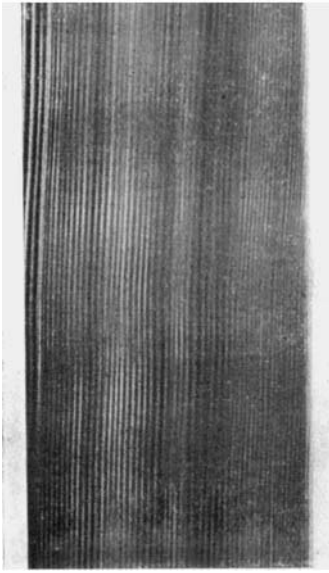
FIG. 3.  
OREGON PINE.

*Figure 3. Oregon Pine. Cross-grained material radiographed tangentially to annual rings. The dark bands coincide with the redder colour of the regions in question.*

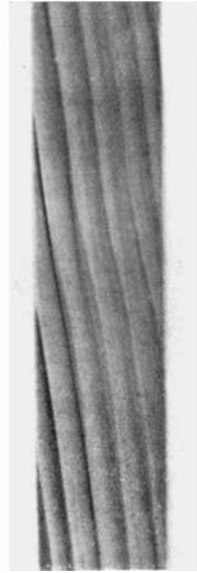
FIG. 4.  
SILVER SPRUCE.

*Figure 4. Silver Spruce, radiographed tangentially to annual rings. Note the rope-like effect.*

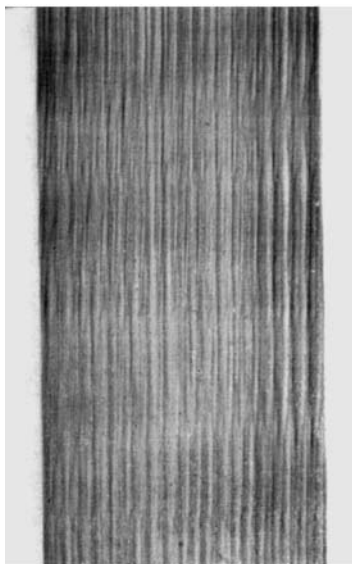
FIG. 5.  
SILVER SPRUCE.

*Figure 5. Silver Spruce. A highly figured specimen radiographed tangentially to the annual rings. The curious criss-cross effect is doubtless due to the presence of the "figure," which is caused by elongated depressions in the annual rings repeated from year to year.*

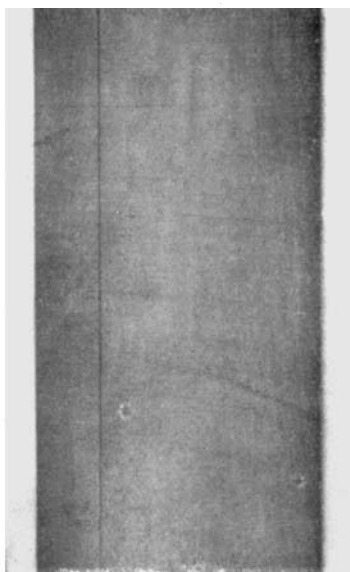
FIG. 6.  
SILVER SPRUCE.

*Figure 6. Silver Spruce showing glued joint, radiographed "radially" to annual rings. The slant of the fibre is faintly shown ascending towards the left, but interest chiefly attaches to the clearness with which a well-made glued joint is shown. The X-rays will infallibly detect either excess or deficiency of glue between glued surfaces.*

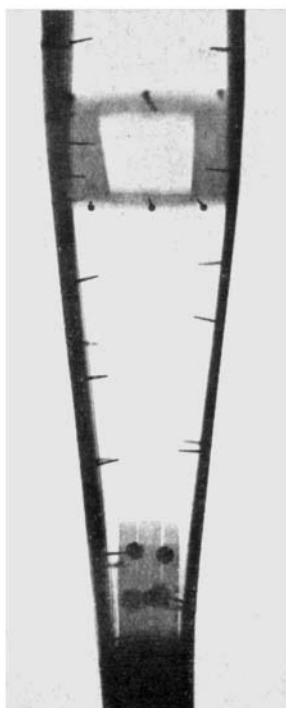
*Figure 7* shows the front and side view of the end of a hollow box strut. The internal strengthening block is seen to be badly fitted and each of the screws has split the wood, making altogether insecure and poor work.

FIG. 7.  
X-RAY PHOTOGRAPH SHOWING  
THE INTERIOR OF THE END OF A  
HOLLOW "BOX" AEROPLANE  
STRUT. THE INTERNAL STRENGTH-  
ENING BLOCK AT THE END IS SEEN  
TO BE BADLY FITTED AND EACH OF  
THE SCREWS HAS SPLIT THE BLOCK.

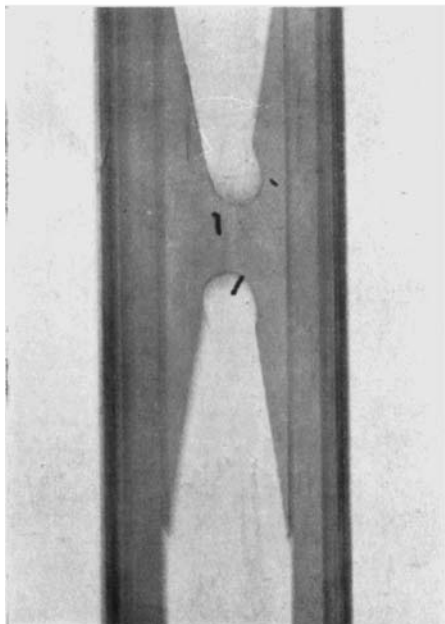
FIG. 8.

*Figure 8* is the front and side view of a hollow main-wing spar. In this, poor workmanship is shown in the cutting to shape of the internal block. The block is also split across the centre, facilitating the breaking of the spar under shear stresses.

X-RAY PHOTOGRAPH OF HOLLOW MAIN-WING SPAR. POOR WORKMANSHIP IN INTERNAL STRENGTHENING BLOCK.

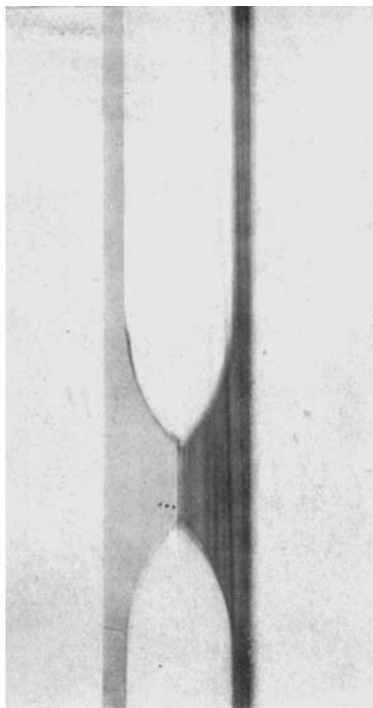
FIG. 9.

*Figure 9.* This shows the side view of a hollow aileron spar. The spar consists of two halves fitted together by glued joints down centre. It is important that both sides of the outer skin should be of the same thickness; but in reducing the glued-up spar to correct finished dimensions, workmen are apt to plane away more wood from one side than from the other, occasionally reducing the strength to a critical degree. The use of X-rays affords an immediate indication if this is the case. Sometimes the internal block is misplaced or omitted from one of the halves and its absence cannot be determined by external examination. In the present case, the block is correctly placed.

X-RAY PHOTOGRAPH SHOWING SIDE VIEW OF HOLLOW AILERON SPAR CONSISTING OF TWO HALVES GLUED TOGETHER AFTER SIDES HAVE BEEN SPINDLED OUT. THE TWO HALVES OF THE CENTRAL BLOCK SHOULD REGISTER ACCURATELY, AND THE SIDES SHOULD BE EQUALLY THICK.

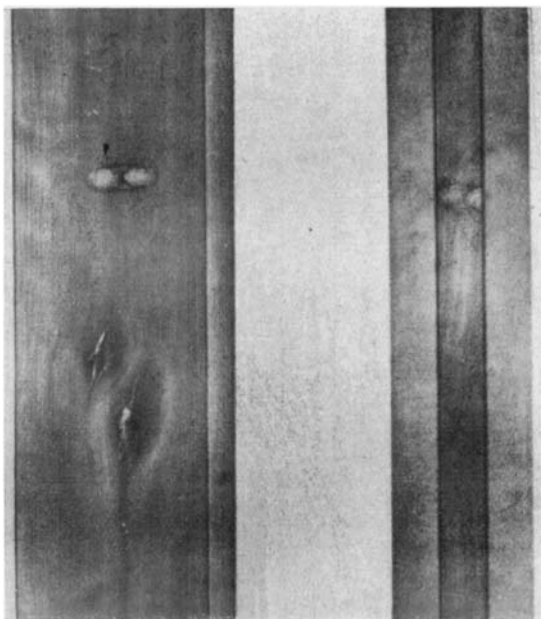
FIG. 10.

*Figure 10.* Front and side view of portion of laminated spar consisting of three layers of wood glued together. The outside surfaces are perfect all round, but the X-rays disclosed a large knot and grub-holes in the middle layer, which would have had the effect of dangerously weakening the spar.

X-RAY PHOTOGRAPH SHOWING FRONT AND SIDE VIEWS OF A LAMINATED WOODEN SPAR OF AN AEROPLANE. THE SPAR IS MADE UP OF THREE LAMINAE GLUED TOGETHER. THE EXTERNAL APPEARANCE DID NOT INDICATE THAT THE MIDDLE LAYER CONTAINED TWO KNOTS AND A GRUB-HOLE AND SHOULD NOT HAVE BEEN USED.

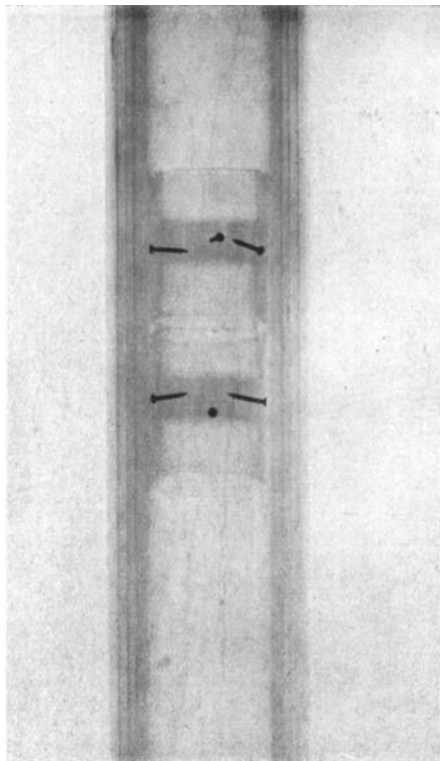
FIG. 11.

*Figure 11* is a portion of a hollow tail boom which was presumed to be fitted with a solid block. The radiograph shows the shoddy arrangement actually fitted.

X-RAY PHOTOGRAPH SHOWING HOLLOW TAIL BOOM WHICH WAS PRESUMED TO BE FITTED WITH A SOLID INTERNAL BLOCK.

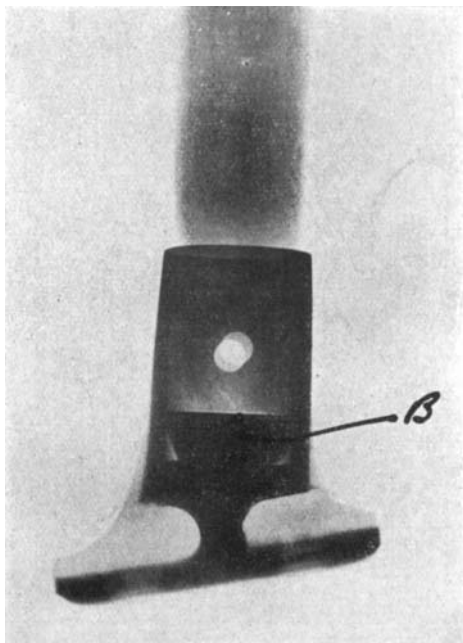
FIG. 12.

*Figure 12.* A skid was cut off too short to fit properly into its socket, and, to make up the necessary length, a piece of packing was introduced into the space below. (Shown dark at "B"). [The skid socket was of aluminium about 1/8th inch thick. The alternative spark gap was 8 inches between points, and the current through the tube 10 milliamperes.] In a wing skid like the example shown, this would not be a vital matter, but the same practice has been found in connection with the ends of interplane struts, where serious consequences might result in the event of their escaping detection.

X-RAY PHOTOGRAPH OF AN AEROPLANE WING-SKID WHICH DID NOT BED PROPERLY INTO ITS ALUMINIUM SOCKET. THE WOOD SKID WAS CUT OFF TOO SHORT, AND A PACKING PIECE (B) WAS INTRODUCED INTO THE SPACE BELOW.

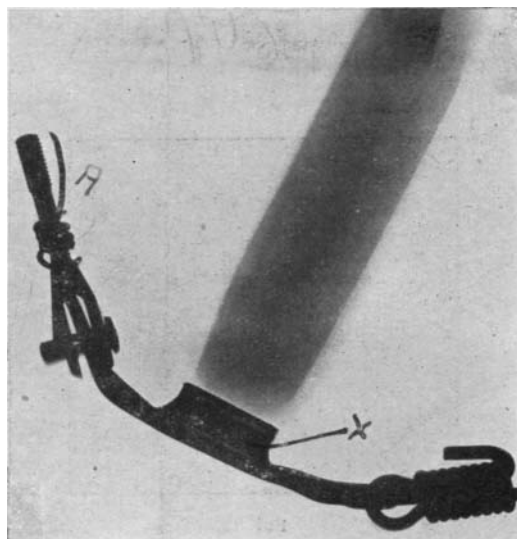
*Figure 13.* This is another example of defective work at the base of a strut—in this case an internal compression strut in a wing. The strut was not made to enter the steel socket properly, and left an empty space at "X." Externally nothing could be seen that would suggest defective work, but the effect of this bad fitting would be that under vibration the strut would gradually work its way into the bottom of the socket, the straining wires "A" would become slack, thus increasing the chances of an accident in the air. The steel socket was 1/20th inch thick.

FIG. 13.  
X-RAY PHOTOGRAPH OF AN INTERNAL COMPRESSION STRUT  
WHICH DID NOT PROPERLY BED INTO ITS STEEL SOCKET.

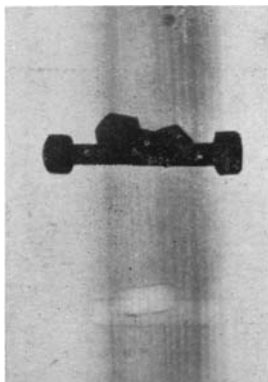
*Figure 14.* In the assembly of certain components in aeroplane construction, bolts which cross a member in various directions frequently occur in close proximity to each other. A mistake in the boring of the bolt-holes sometimes results in insufficient clearance between the bolts. This has occurred both in spars and in longerons. *Figure 14* shows an X-ray projection of two such bolts in position. They presented a correct external appearance. The radiograph shows that something is wrong.

FIG. 14.  
X-RAY PHOTOGRAPH SHOWING  
TWO BOLTS FOULING EACH OTHER  
IN CROSSING AN AEROPLANE  
SPAR

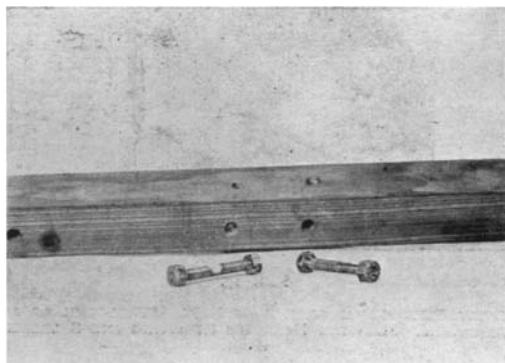
*Figure 15* is an ordinary photograph of the same bolts taken out. It will be noted that the bolt on the left-hand side has been heavily grooved. In one case alone where this condition was detected further examination of the batch resulted in the rejection of dozens of completely finished main wing planes. Had this condition remained undetected, it would undoubtedly in some cases have resulted in loss of life.

FIG. 15.  
SHOWS SAME BOLTS WITHDRAWN.

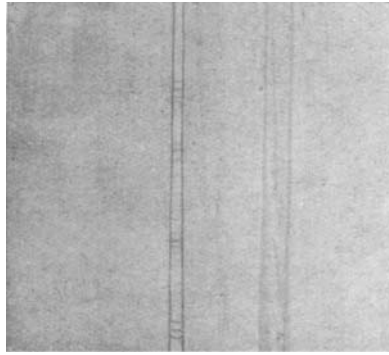
FIG. 16.

In other minor cases, also, X-rays could be made to provide useful information. For example, in the use of knotty or split wood or bad distribution of cement in the centres of three-ply boards. Or again, in *Figure 16*, where a defective overlap together with a gap occur in the internal plies. This example occurred in multi-ply intended for use in engine bulkheads and engine bearers, and the defects in each case lie deep in the body of the plywood. They could not be seen by any external examination, and might have had disastrous effects.

X-RAY PHOTOGRAPH SHOWING OVERLAP AND GAP IN INNER LAYERS OF MULTI-PLYWOOD.

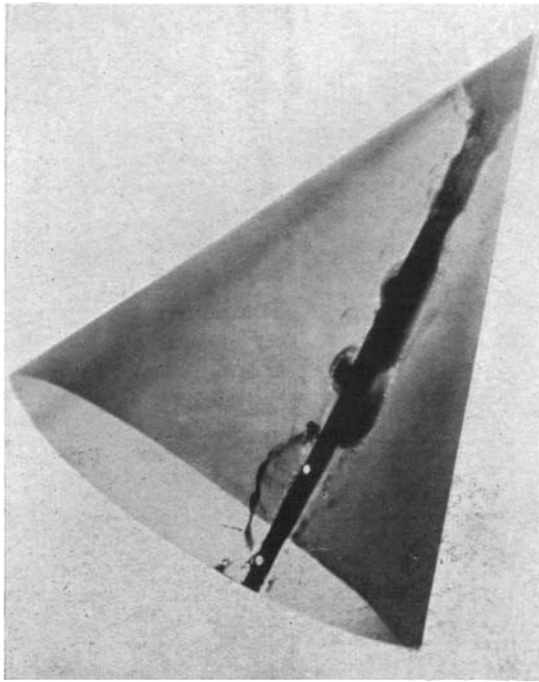
FIG. 17.

Or finally the case of the rivets in the petrol tank, which proved to have heads on the outside only and none inside. *Figure 17* is a radiograph of the end of a steel petrol tank showing soldered seam.

X RAY PHOTOGRAPH OF END OF STEEL PETROL-TANK OF AN AEROPLANE. SHOWING DEFECTIVE RIVETTING AND SOLDERED SEAM.
