# The Ice Particle Threat to Engines in Flight

**This paper discusses jet engine powerloss and damage due to ingestion of ice particles. In the mid-90s several commercial airplane jet engines experienced more frequent powerloss in ice particle conditions, resulting in a focused investigation, and a greater awareness that led to recognition of similar events on other aircraft. Since the mid-90s, events have been more numerous, and costly, and have generated greater industry interest. These events have been predominately associated with flight at high altitude near deep convective systems, often in tropical regions. Data are presented from flight-testing and an event data base to support the contention that the events are caused by ingestion of high concentrations of ice particles, and that supercooled liquid water is either of secondary importance or not required. The basic theory of how ice accretes in the engine by this process is described. Complex issues facing industry to mitigate the problem, and simulation of the ice particle environment are discussed.**

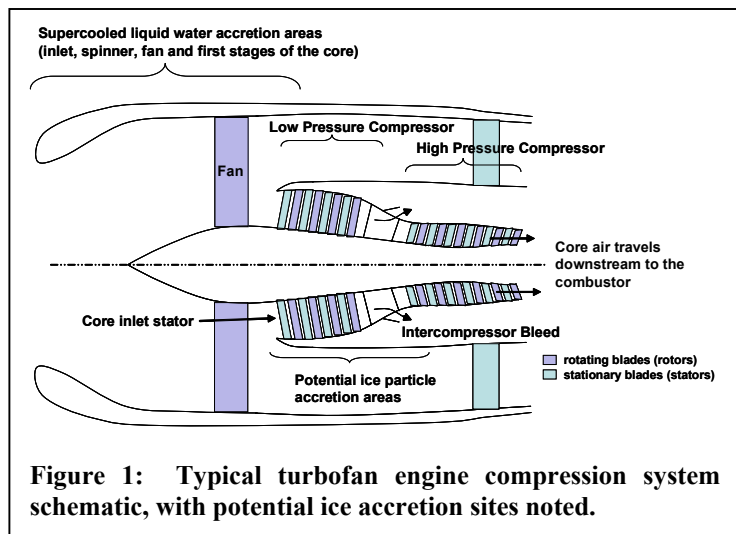
Following considerable research and analysis complemented by flight tests conducted by the airframe and engine manufacturers, the cause of the rollbacks was determined to be the build up of ice on the second stage stator inside the engine core passage (Fig. 1) in ice particle meteorological conditions, and without the presence of significant supercooled liquid water. As the aircraft descended to warmer air at a lower altitude after the event, the ice blockage was released, making the engine recovery process possible. In the case of this specific type of commuter aircraft, results of the investigations have led to successful engine modifications, and events from this commuter aircraft have ceased. The data from one of the flights conducted during this flight test program are described in section IV, and the accretion of ice in the engine is further discussed in section VIIB.

**Figure 1: Typical turbofan engine compression system schematic, with potential ice accretion sites noted.**

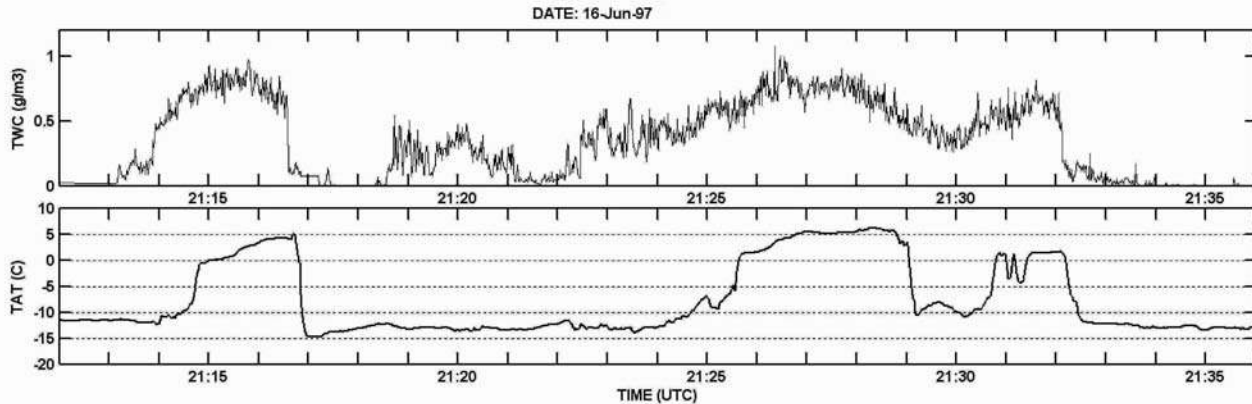
**Figure 6: Time history of TWC (top panel) and Rosemount total air temperature (TAT, bottom panel), showing the TAT ‘anomaly’ caused by ingestion of ice particles, for a portion of the commuter test flight on 16 June 1997.**

The flight test aircraft was equipped with a Rosemount TAT sensor of similar design to those installed on all the aircraft of the event database. Fig. 6 illustrates an example from this project of a TAT anomaly encountered while flying straight and level at an ambient temperature of about  $-26^{\circ}\text{C}$  ( $\text{TAT} \sim -12^{\circ}\text{C}$ ) across a cloud with moderately high IWC. The cloud was determined to contain at most trace amounts of supercooled LWC, because the Rosemount Ice Detector ramp voltage trace was very flat during this entire pass (not shown). Shortly after the estimated IWC (top panel) rose in the first cloud encounter ( $\sim 21:14$  UTC), the TAT (bottom panel) also rose from an undisturbed value of about  $-12^{\circ}\text{C}$  to a plateau value of about  $0^{\circ}\text{C}$ , but then continued to rise to about  $5^{\circ}\text{C}$ . On exit from the high IWC region, the temperature quickly dropped back to approximate pre-cloud values. Similar behavior was observed during a second cloud encounter from 21:22-21:32, although there did not appear to be much TAT effect in a lower IWC cloud between the two high IWC clouds. In fact, for this case, the anomaly appeared to trigger within 60 seconds of the IWC exceeding  $0.5\text{ gm}^{-3}$ , and had cleared within 30 seconds of the IWC dropping below  $0.5\text{ gm}^{-3}$ . Lawson et al. (1998)<sup>1</sup> have discussed the TAT anomaly at length, and have displayed a similar figure illustrating the correlation of temperature change to apparent IWC, and the rapid clearing of the probe after exit from ice particle conditions. They pointed out that a similar TAT experience had been reported by Holland et al. (1984)<sup>9</sup> while flying in a broad convective outflow region of a tropical storm near Australia, and incorrectly interpreted as an intrusion of warm air from the stratosphere. The same misinterpretation of the TAT anomaly as a warm zone was made at the initial stage of this commuter engine event investigation. Lawson et al. (1998)<sup>1</sup> further reported that wind tunnel testing by the probe manufacturer confirmed that it could ice up in super cooled liquid water/ice particle concentrations that could have been encountered during rollback events.

As in Lawson et al. (1998)<sup>1</sup>, in this article we link the TAT anomaly to ingestion of ice particles, presumably which block the airflow through the heated housing, and corrupt the measurement. Further information on the incidence of the TAT anomaly is available from the event database. All the aircraft involved in the 46 engine powerloss cases (both large transport and commuter aircraft) investigated in this report are equipped with a total air temperature (TAT) probe of similar design. The event database contains four engine events in which a TAT anomaly was observed at an outside air temperature below  $-40^{\circ}\text{C}$ , the minimum temperature at which supercooled LWC can occur. Furthermore, of the 35 cases in the event database in which the existence of a TAT anomaly could be determined from available data, in only one of those cases was there a conclusive report of some airframe icing. It is therefore concluded that TAT icing occurs in glaciated cloud, as it did in the case study above, and all but one

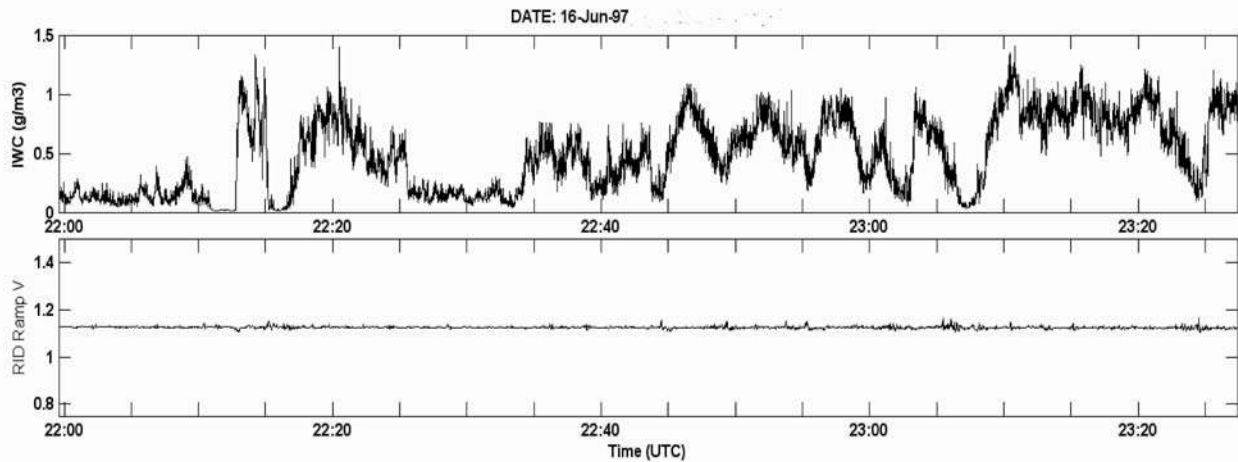
**Figure 7. Time history of estimated TWC (top panel), and Rosemount Ice Detector (RID) Ramp Voltage (lower panel) during an orbit at 8800 m and  $-28$  C downwind of an isolated cumulonimbus cloud. An engine rollback process was completed between 23:13-23:28.**

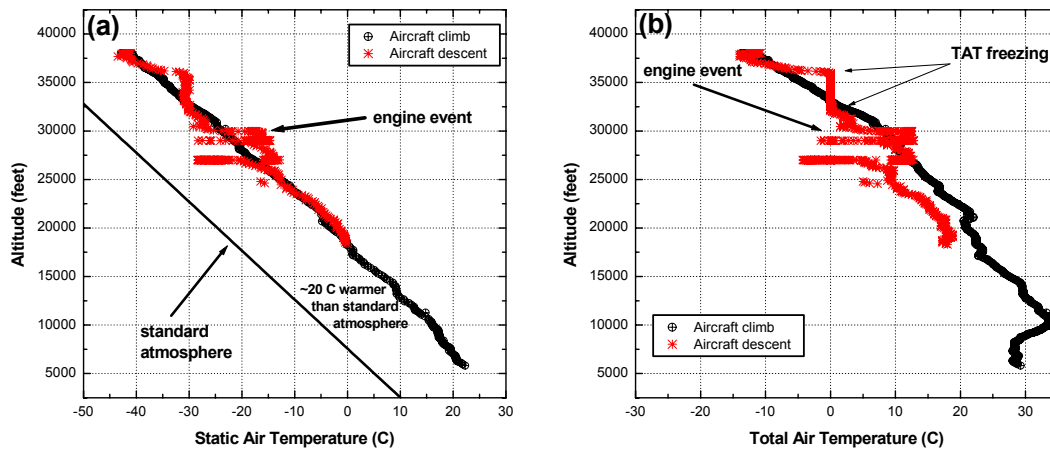
Below 32,000', the TAT is erratic, with perturbations towards warmer temperatures until about 26,000', after

**Figure 10: Static air Temperature (a) and Total Air Temperature (b) measured during climb from Hong Kong (black symbols) and during descent towards Taipei (red symbols), illustrating the TAT anomaly observed before the engine event**

which point it resumes normal behavior. Based on the correlation between TAT and IWC observed in Fig. 6, it is therefore surmised that the aircraft entered a region of high IWC at about 37,000' (~ -40°C) that continued to at least 32,000' (~ -28°C). The timing of the event can be observed in Fig. 11. The TAT anomaly commences shortly after 12:46, and continues until at least 12:50. The engine powerloss occurs at 12:52:58, or about 7 minutes after entering the region of presumed high IWC. It is uncertain what can be inferred from the continued peculiar TAT behavior after the engine event. The elevated readings between 12:51 and 13:01, implying significantly higher than the expected SAT values, may be some unknown clearing behavior of the probe as the TAT goes above 0°C. It is therefore impossible to speculate in this case on whether further high IWC regions were encountered during this later period. However, a second characteristic region of TAT pegging to 0 C is observed at 27,000' and -22°C from approximately 13:01:30 – 13:03:30, and shortly thereafter the temperature probe clears and provides SAT values similar to the climb profile.

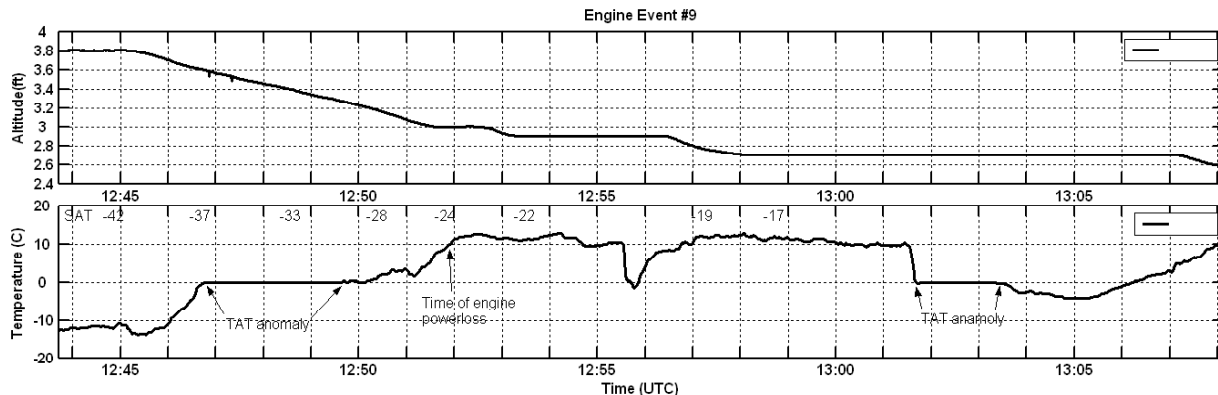
**Figure 11: Time history of altitude and Total Air Temperature (TAT), surrounding the time of the engine event at 12:52:58. The estimated Static Air Temperatures (SAT) are shown in text at the top of the lower panel for reference. Note the time of powerloss is identified in figure.**

The crew reported a multiple engine shutdown at 30,000' (~12:52:58 UTC). The multiple engine failure checklist was immediately performed, and the engines recovered to idle within 75 seconds. The aircraft was flown without further incident to its intended landing in Taipei approximately 20 minutes later.

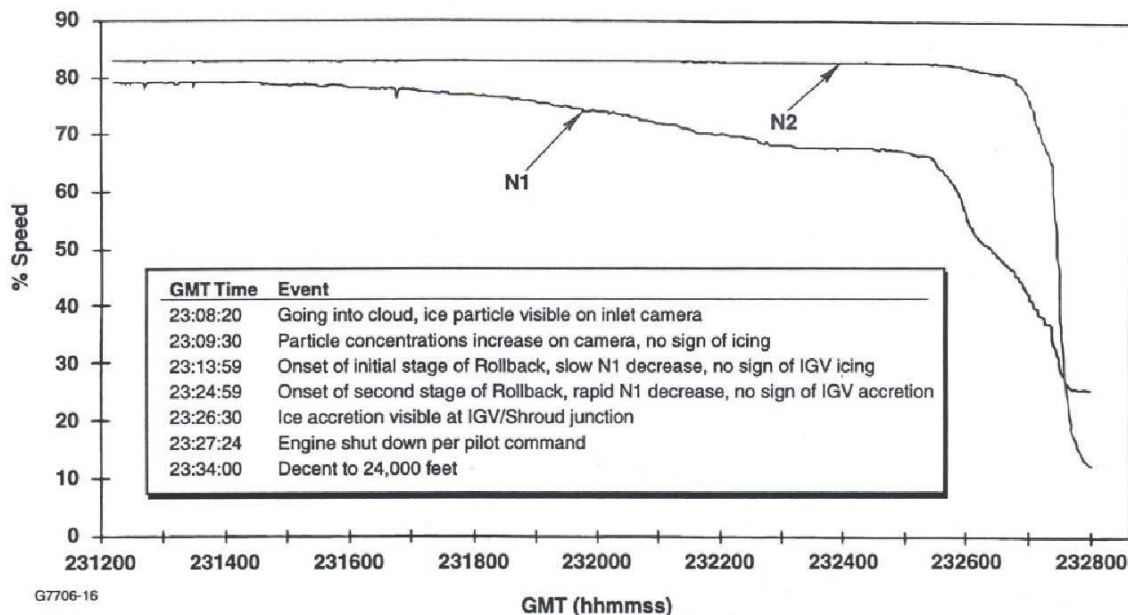
Test results on the rollback engine clearly showed that all engine parts visible on the inlet camera were free of ice during the initial slow speed decay stage of the rollback event. These included the fan spinner, a rotating fan rotor and the first stage compressor stator vanes at the engine core passage inlet. Ice formation on the core inlet vanes was visible after the engine rollback occurred, because the engine core and fan speeds had significantly reduced and could no longer support the energy requirement of the inlet anti-ice system. A correlation of the cloud microphysical data, and the engine data plotted in Fig. 12, showed that the onset of the initial rollback stage took place 5 minutes and 40 seconds after cloud entry. The flight test rollback scenario was similar to all the recorded

**Figure 12: Engine data from the rollback test flight described in section IV, with text description of the cloud and engine observations. N1 and N2 are the fan and core speed respectively**

field events in that the engine remained on a slow decay stage for seven minutes before the onset of a rapid decay stage. The test data supports the theory that icing blockage of the flow path behind the first compressor stator vanes was the root cause of the engine incidents. Thermocouple data, shown in Fig. 13, recorded on stator vanes further downstream of the core inlet also supported this theory. The data taken on the unmodified (build-of-material) compressor second stage stator vanes, also known as exit guide vanes (EGV), indicated a rapid surface metal temperature reduction soon after entry into the cloud. The temperature hovered around the freezing point (within instrumentation errors) until the onset of the rapid decay stage of the rollback. This period of freezing point measurements was an indication that ice was accreting continuously on the EGV surfaces. This temperature data indicated that ice started to accrete on the EGV surfaces soon after cloud entry, creating blockage and initiating the slow decay stage of the rollback. Ice continued to build and pressure loss increased until the final rapid decay stage of the rollback was reached. In the rapid decay stage, the local air temperature dropped below freezing. In this stage, due to the rollback rotor speeds, the fan and compressor could no longer increase the local air temperature and therefore the entire front section of the engine was bathed in cold ambient air, as reflected in the metal temperature measurements. The ice accreted on the EGV and the metal temperatures underneath the ice followed this temperature trend.

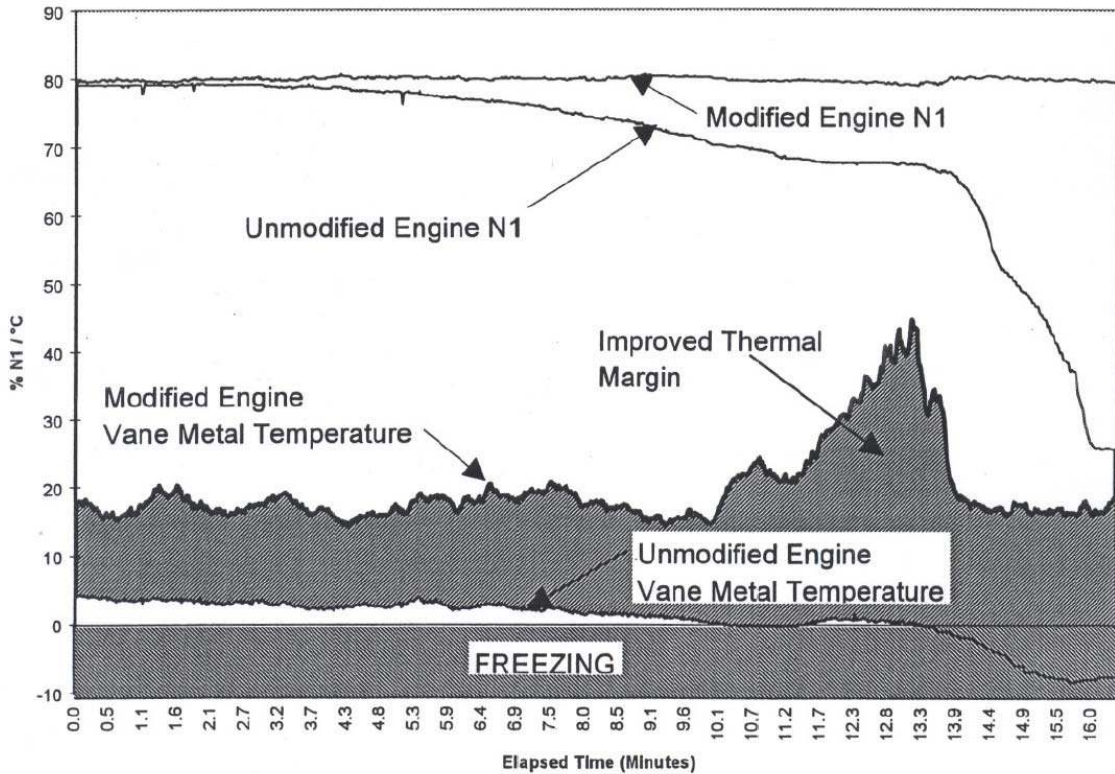
**Figure 13: Modified and unmodified engine vane metal temperature for the period as Fig. 12. Elapsed time is from 23:12:00 UTC.**

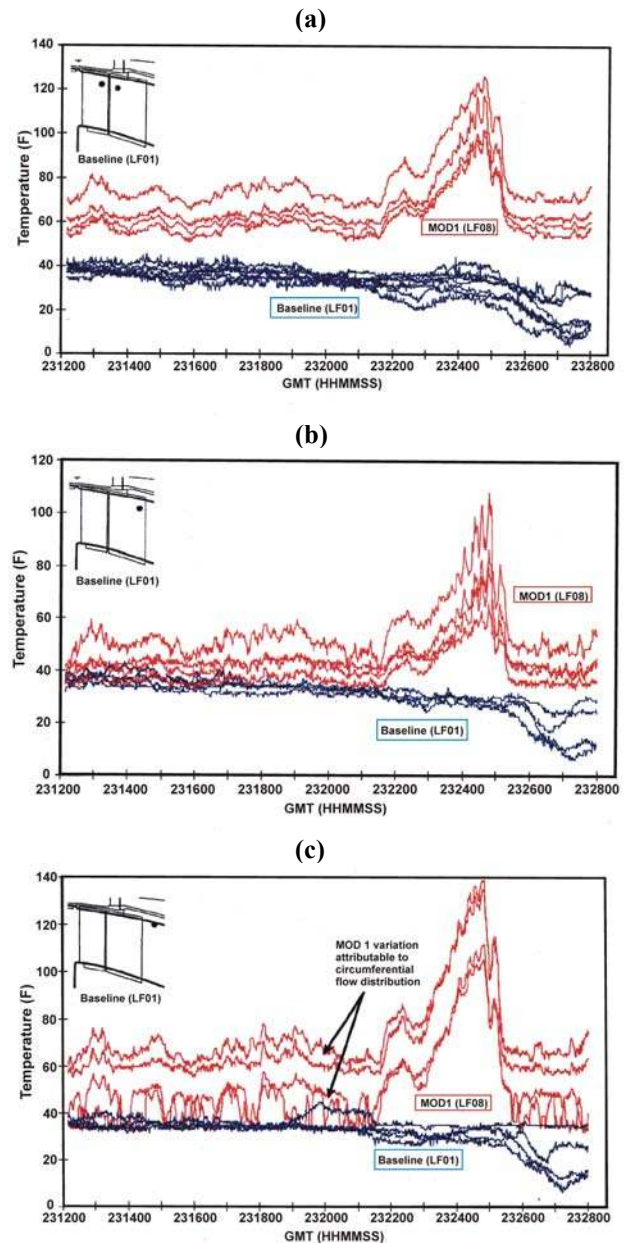
This engine utilized a unique dual-airfoil EGV design as shown in Fig. 14. During the initial investigation of the rollback events, it was suspected that ice was accreting at the junction of the front vane trailing edge and the aft vane leading edge only. However, since freezing point temperature measurements were recorded in many locations on the EGV which included the junction point (Fig.14a blue curve), the trailing edge of the aft vane (Fig.14b blue curve), and the flow path shroud wall immediately behind the EGV (Fig.14c blue curve), these data dismissed the speculation that the dual-airfoil vane was the primary reason for ice blockage. It was concluded that any unheated airfoil located at the EGV location with similar turning characteristics would produce ice accretion and the associated flow blockage.

The modified engine hardware incorporated an anti-ice heat supply within the EGV. Its metal temperatures remained above freezing during the entire flight test, indicating ice-free metal surfaces throughout (Figs.14a-14c, red

**Figures 14 a-c: Thermocouple temperatures on the Exit Guide Vanes of the modified (MOD1) and unmodified (Baseline) engines during the rollback flight test described in section IV. Inset geometry shows location of thermocouple for each figure**
