The Mars Rover Spirit FLASH Anomaly

Glenn Reeves
Tracy Neilson
Jet Propulsion Laboratory (JPL)
Pasadena, CA 91109
818-393-1051

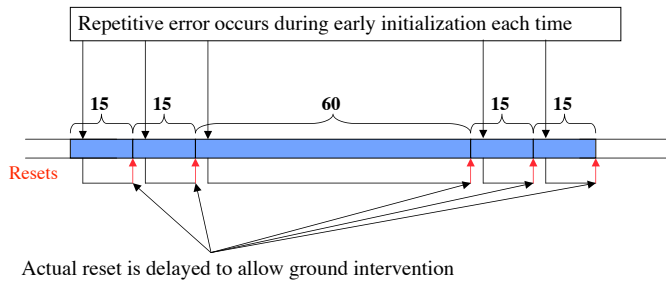
When the FSW detects a severe error, it reacts by forcing a reset of the flight computer and a re-initialization of the FSW. If the FSW determines that a reset is necessary during the FSW initialization process, the FSW delays the actual reset until a minimum time period has passed. This process is referred to as a “delayed reset”. The intent is to allow sufficient time for ground intervention.

When the delayed reset time expires, the reset is initiated. The system keeps track of the number of repetitive resets and modifies the delayed reset time interval. The boot logic part of the software also keeps track of the number of initialization attempts and is designed to load and start alternating copies of the FSW with each reset. By design, the time period between resets is set to a fifteen minute delay for the first severe error, fifteen minutes for the second, and then one hour for the third. This pattern then

Figure 1: Delayed reset behavior

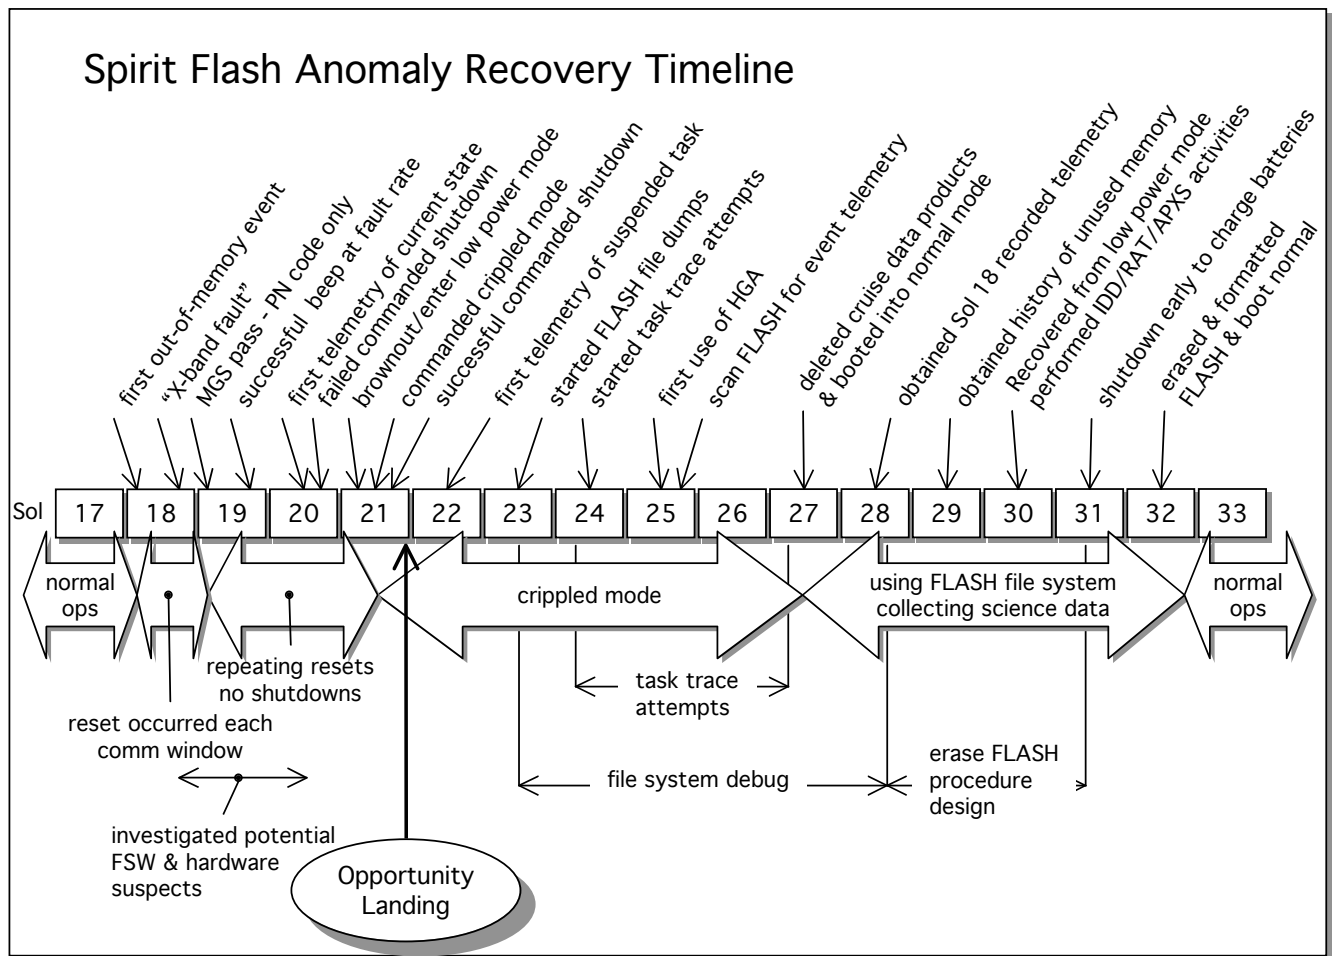
and engineering data still in the FLASH memory, and return the vehicle to a science-taking machine. During this time, the press started to refer to us as us “space-age surgeons”. The timeline of the anomaly investigation and recovery is shown in Figure 2.

Figure 2: Anomaly events and recovery timeline

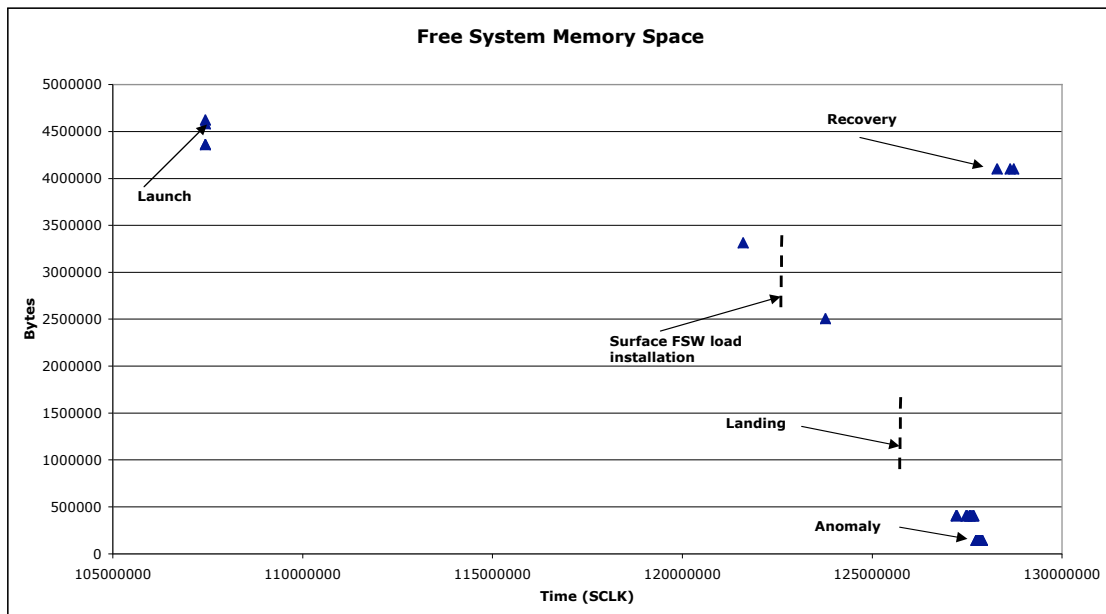
Figure 3 shows Spirit's in-flight telemetry of the free memory space from launch through recovery. Note the segments are not connected on the figure because that would be misleading regarding the rate of decrease in the system memory space. Insufficient data exists to extrapolate when each request for new space occurred. This data was not examined until the anomaly occurred.

Figure 3: Flight telemetry of Spirit's free memory space

Lesson—The FSW should have included flight telemetry for resources (such as the free system memory space) so that the actual and expected behavior of the system can be compared.

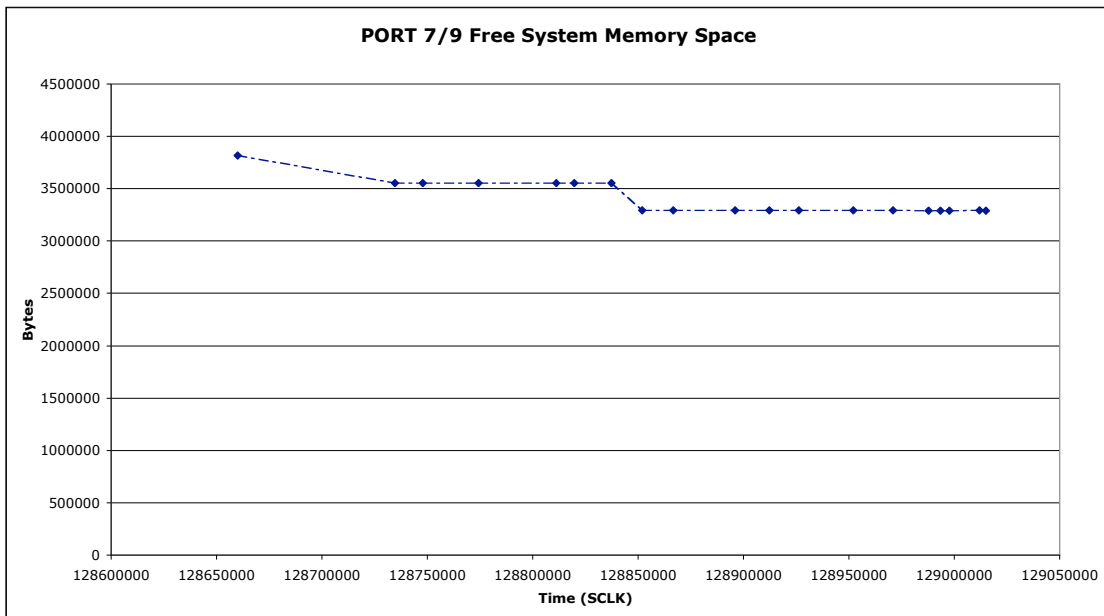
A post-anomaly review of one operational test showed that the memory leak was evident in the data. Figure 4 shows a portion of the telemetry of free system memory space and it indicates a memory consumption trend. The data set is sparse because the telemetry for this data was set to a low priority and was not consistently telemetered. Unfortunately, the team did not analyze this data during the test execution or during the post-test data review.

Figure 4: Project operational test 7/9 free system memory space

Lesson—A suite of tests and automated analysis tools should have been created early in the development process.

The FSW should have included support for reporting resource usage. The system (FSW, test scripts, ground support equipment) should have included (additional) support for collecting, archiving, and analyzing this information.
