**THE MECHANICS OF LANDSLIDES IN LEDA CLAY**

W. J. EDEN AND R. J. MITCHELL

*Reprinted from*  
CANADIAN GEOTECHNICAL JOURNAL  
VOL. VII, NO. 3, AUGUST 1970  
p. 285

RESEARCH PAPER NO. 441  
OF THE  
DIVISION OF BUILDING RESEARCH

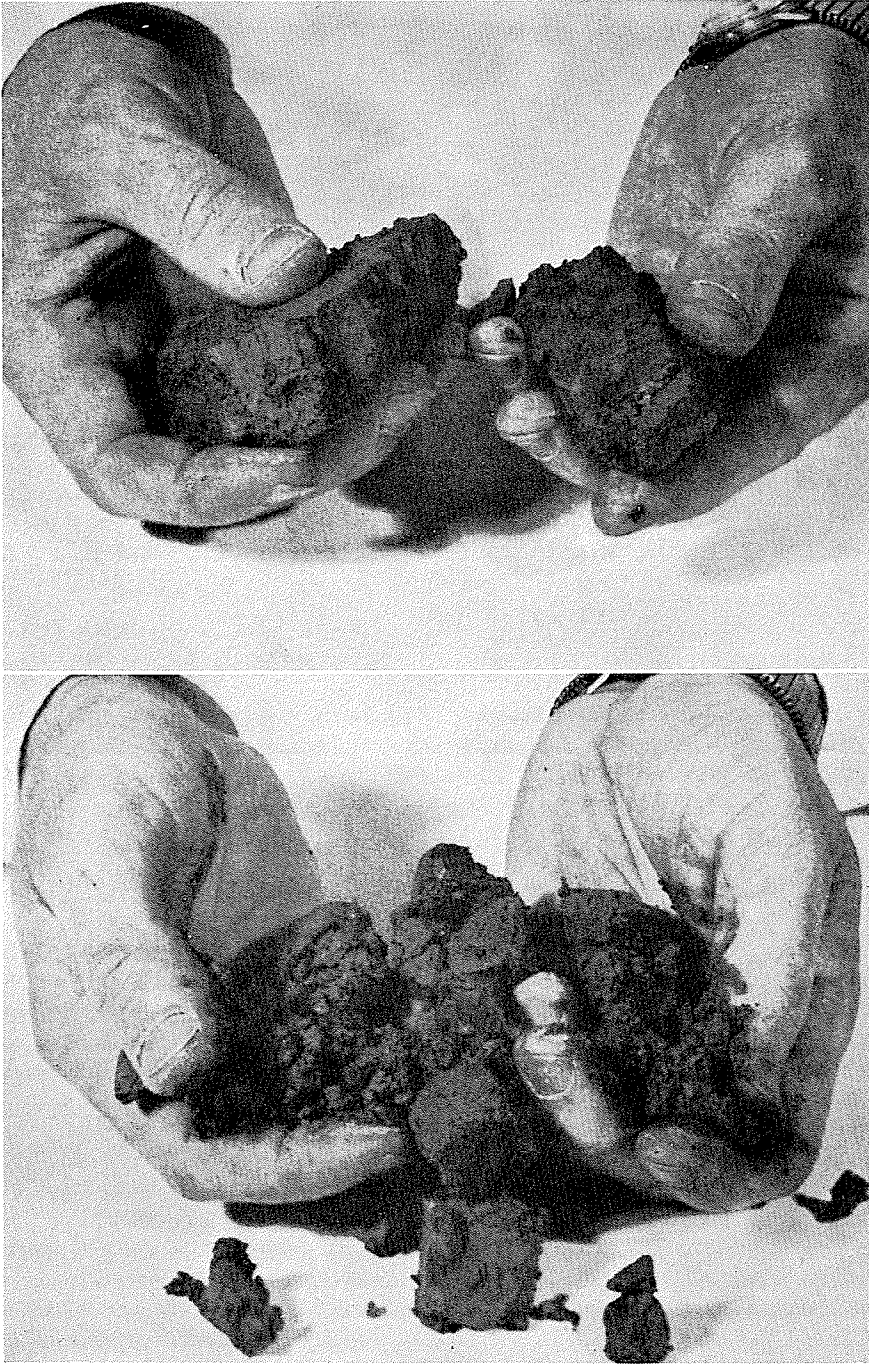
FIG. 1. Nodular composition of Leda clay.

The strength of Leda clay in the low stress region appears to be predominantly frictional, i.e. dependent on normal stress. Dilatant behavior is attributed to the existence of structural defects (closely spaced hairline fractures or 'closed fissures') which allow strain discontinuities to occur within the material. Features illustrated in Fig. 1 were observed in the test specimens after failure.

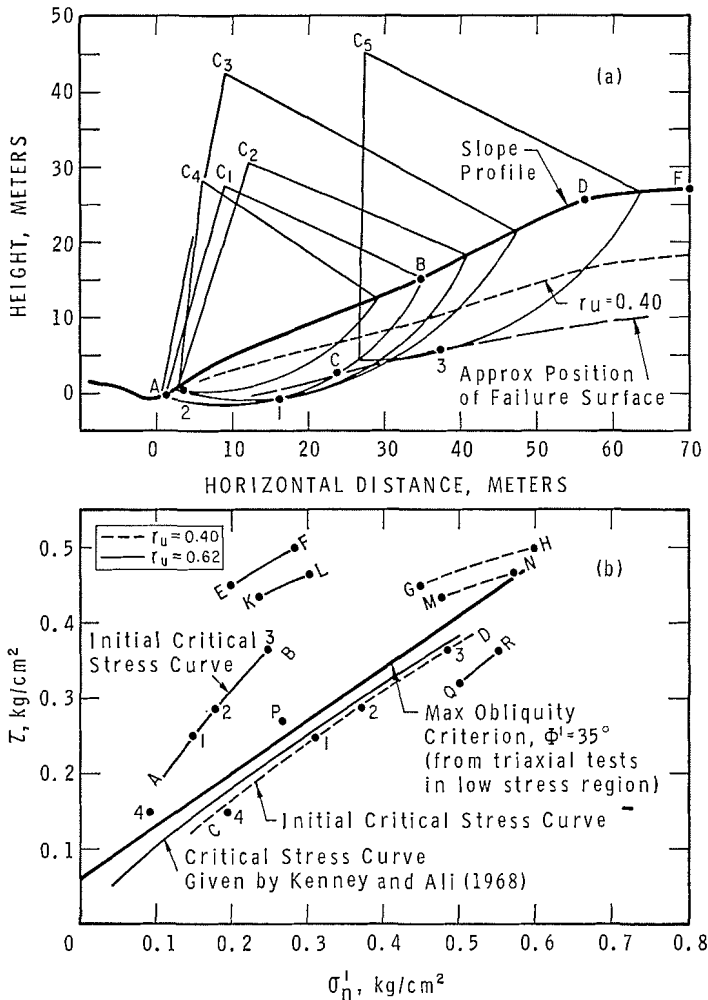
Fig. 6. Analysis of the Breckenridge landslide. (a) trial circles; (b) critical stress curves.

Because of the geometry of the Breckenridge slope it is believed that the initial slide did not involve the total slope height (Kenney and Ali 1968). In Fig. 6a various possible circular slip surfaces for the Breckenridge slope are drawn with centers  $c_1$  to  $c_4$  and passing through points 1 and 2 in the vicinity of the failure surface. Stability analyses based on these failure surfaces and two values of  $r_u$  yield the critical stress curves AB and CD in Fig. 6b. The critical stress curves can be compared directly with the maximum obliquity criterion ( $c', \Phi'$ ) obtained

A variable  $r_u$  factor (varying from 0.50 at the top of the slope to 0.62 at the toe to approximate the conditions considered applicable at the time of the slide) was used in a modified computer program to obtain a critical toe circle for  $\Phi' = 35^\circ$ . This circle lies between circles  $c_1$  and  $c_2$  in Fig. 6a and gives a factor of safety, F.S. = 0.95 (point  $P$  in Fig. 6b, where

Assuming that the initial slide occurred along the arc given by circle  $c_1$  in Fig. 6a the first retrogressive slide was analyzed using the geometry ACBDF. The computer was restricted to searching for critical circles through point 3 (Fig. 6a) on the failure surface and yielded the critical stress curves EF and GH in Fig. 6b. A second retrogressive slide was analyzed in a similar manner by approximating the geometry of the slope after the most critical circle (center  $c_5$  in Fig. 6a) was assumed to slide during the first retrogressive failure. This analysis yielded the critical stress curves KL and MN in Fig. 6b. These critical stress curves all lie above the failure criterion in Fig. 6b indicating that retrogressive sliding would occur at average  $r_u$  values of 0.4. These calculations make no allowance, however, for the stabilizing effect of that spoil material which comes to rest in the landslide crater.

Finally, the existing stable back scarp was analyzed with respect to circles tangential to the projected failure surface. These computations yielded the critical stress curve QR in Fig. 6b and predicted the stability of the scarp under the extreme conditions of full hydrostatic saturation.

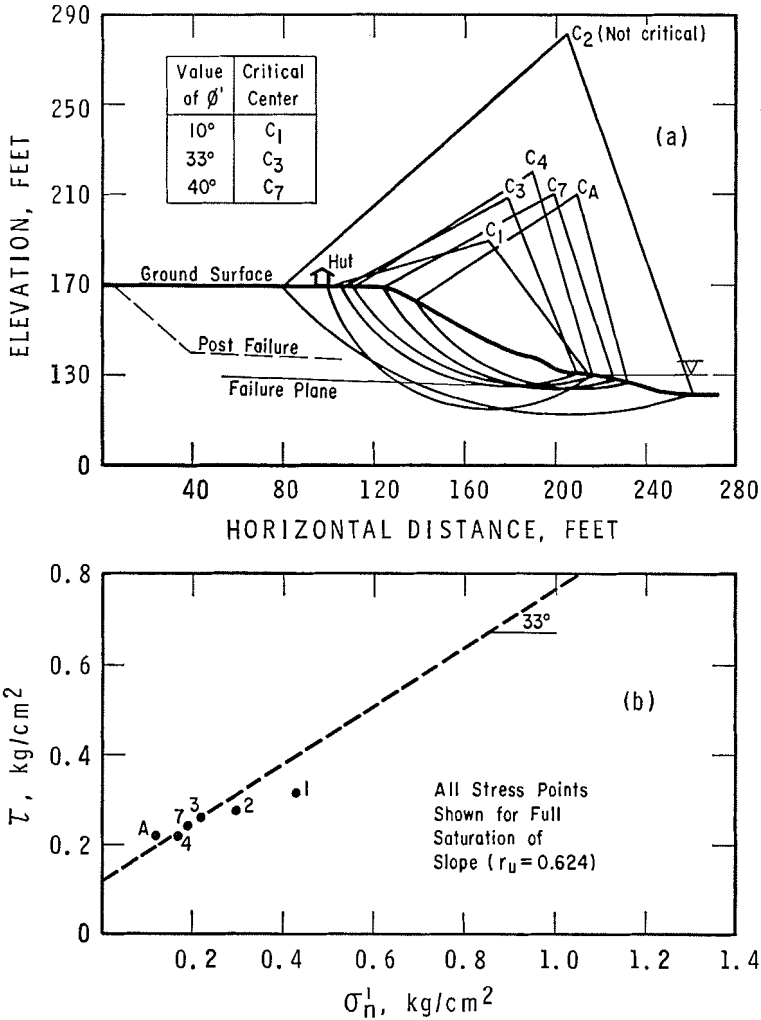
Average stress points are plotted in Fig. 7b for several trial circles shown in Fig. 7a (the stress points are numbered to correspond to

the trial circle numbers). A failure envelope ( $c' = 0.12 \text{ kg/cm}^2$ ,  $\Phi' = 33^\circ$ ) was chosen to approximate the triaxial test data in Fig. 4. The circles with centers at  $c_3$ ,  $c_4$ , and  $c_7$  in Fig. 7a yield stress points 3, 4, and 7 which lie on this failure line. As the circle with center  $c_3$  was calculated to be critical for  $\Phi' = 33^\circ$  the analysis indicates that the slope would be at a condition of limiting equilibrium when fully saturated under a hydrostatic groundwater condition.

Personnel working in the vicinity of the slide claimed that a hut located on the upper terrace (Fig. 7a) was missing immediately after they heard the noise caused by the initial slide. Stability analysis suggests that the initial failure surface would intersect the upper terrace quite close to the hut. Some approximate calculations regarding the retrogressive slips indicate the gross instability of the slope remaining after the initial slide. The stability of the post failure ground surface (Fig. 7a) was considered with respect to trial circles tangential to the projection of the failure plane and with respect to trial circles emerging at the toe of the back scarp. In both cases a safety factor in excess of unity was obtained.

FIG. 7. Analysis of the Rockcliffe landslide. (a) critical circles; (b) critical stress points.

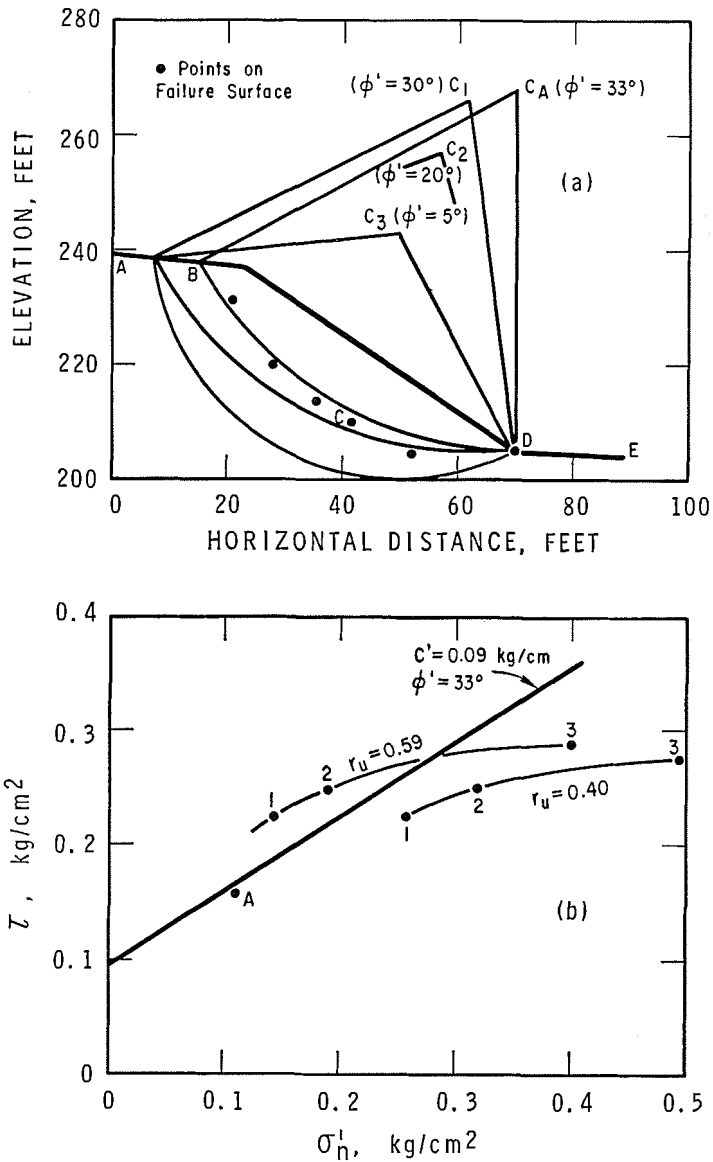
Three critical circles, as shown in Fig. 8a, were analyzed and gave the average stress

points 1, 2, and 3 plotted in Fig. 8b for the two limits of  $r_u$ . A comparison of these stress points with the failure criterion indicates that failure would not occur on the deeper circles (calculated critical for  $\Phi' < 20^\circ$ ). For the condition of full saturation instability is predicted for circles with centers  $c_1$  and  $c_2$ . The factor of safety calculated for circle  $c_1$  is 0.84. For an average  $r_u$  value of 0.40 the slope would be considered stable with respect to these circles.

$\Phi' = 33^\circ$ , in Fig. 8a and appears to approximate the observed failure surface reasonably well. The closed solution gives the average stress point A in Fig. 8b for the condition of full saturation. The factor of safety predicted by the latter calculation is 1.05. A similar analysis of the profile ABCDE in Fig. 8a gave a factor of safety of 1.10 for the slope remaining after the slide.

FIG. 8. Analysis of the Orleans landslide. (a) critical toe circles; (b) critical stress curves.
