The Potential Danger of Fire in Gas Turbine Heat Exchangers

C. F. MC DONALD

Senior Analytical Engineer,
Solar Division,
International Harvester Co.,
San Diego, Calif.
Assoc. Mem. ASME.

Contributed by the Gas Turbine Division for presentation at the Gas Turbine Conference and Products Show, Cleveland, Ohio, March 9-13, 1969, of The American Society of Mechanical Engineers. Manuscript received at ASME Headquarters, December 20, 1968.

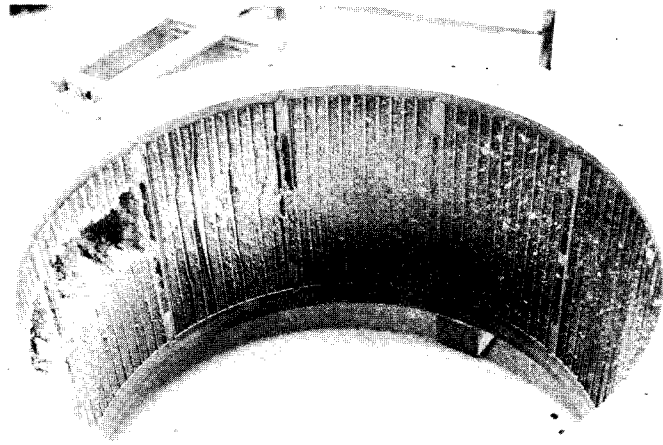
Fig.1 Fire damage to drum type rotary regenerator matrix (S0891)

(a) In Fig.1 the damage to a regenerator drum matrix as a result of a metal fire can be

clearly seen. The fire occurred during a performance test on a development rig. A series of aborted starts were experienced, and because a thorough purging procedure was not adhered to, the resultant diesel fuel trapped in the matrix started a metal fire after a subsequent combustor light off was achieved. The compact matrix was made from 321 stainless steel.

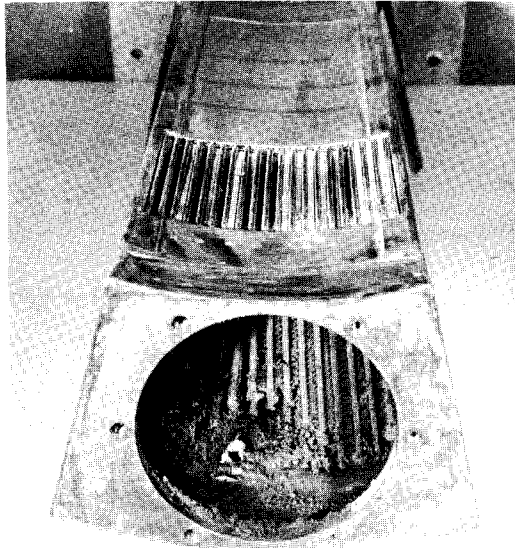
Fig. 2 Fire damage to plate-fin type modular recuperator matrix (V860)

(b) As outlined by McDonald (4), a fire was experienced in a thin foil plate-fin recuperator module manufactured from 347 stainless steel. The fire occurred during a rig test in which the unit was being thermally cycled, and it appeared that the matrix structurally collapsed allowing a large internal leakage. This caused a reduction in the air flow through the natural gas combustor, and for the fixed natural gas fuel flow schedule, excessively high burner outlet temperatures were experienced. This resulted in failure of the upstream flow straighteners, and these disintegrated and impinged on the core face. This particular fire was related to the test rig design and operation, and such a failure would be unlikely in engine operation. During the thermal cycling, the immediate upstream baffle temperature during a simulated engine acceleration period was in excess of 2000 F. A subsequent analysis of the resultant slag in the matrix indicated that an aluminum particle might have initiated the fire. A view of the damaged core can be seen in Fig. 2.

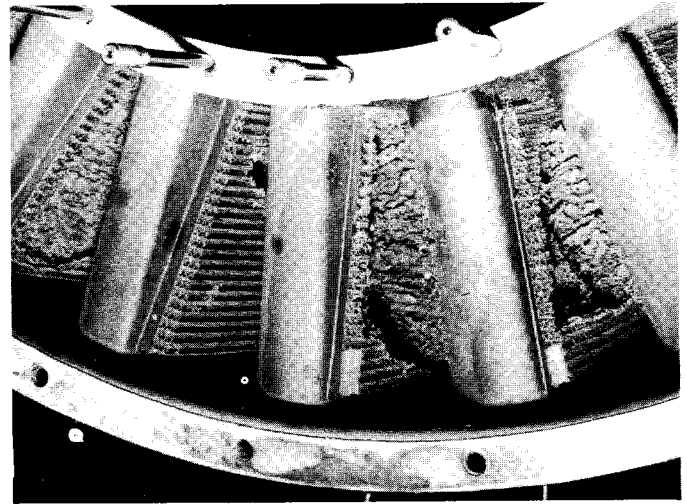
(c) As shown in Fig. 3, a fire was experienced in a full-size plate-fin recuperator (347 stainless steel) as a result of excess fuel becom-

Fig. 3 Fire damage to recuperator gas inlet face (67-1756)

ing trapped after a series of aborted engine starts. It was found that a considerable quantity of diesel fuel had become trapped in the matrix and ducting as a result of an inadequate fuel draining system and lack of a thorough purging procedure. A CO₂ fire extinguishing system was activated after the fire had started, and although this prevented damage to the rest of the engine, the response time of the exhaust overtemperature sensor was too slow to prevent severe damage to the recuperator.

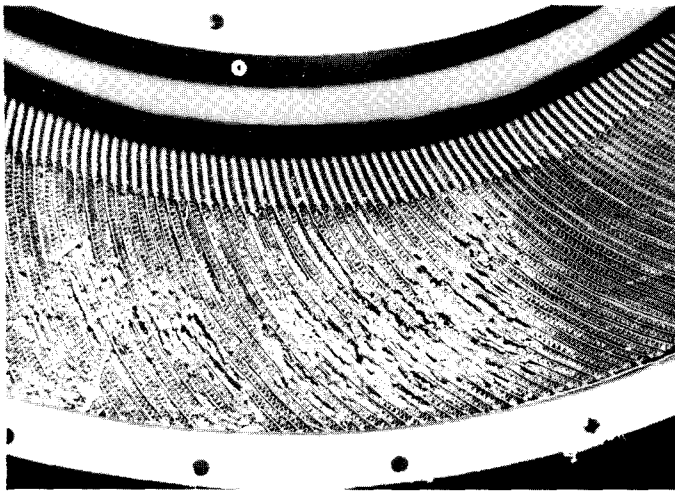
(d) The damage to the recuperator, shown in Fig. 4, occurred in a development engine as a result of a control malfunction during engine deceleration. During the engine speed reduction, a compressor surge was experienced and this, associated with the control malfunction, resulted in an excessively high turbine exhaust temperature. During periods of compressor surge, an excessively poor combustion efficiency would of course result in, either unburnt fuel passing through into the recuperator, or propagation of the flame front to the point of impingement on the recuperator gas inlet face. Again, as in the previous case, the response of the exhaust overtemperature sensor was not sufficiently rapid to prevent damage to the recuperator. During the engine run down, 50 lb of CO₂ were introduced into the compressor intake and, when the engine stopped rotating, a further 20 lb of CO₂ were injected into the recuperator from the exhaust duct. The engine was cranked on the starter for a minute to aid cooling, and as a result of these procedures, the damage was localized to the recuperator gas inlet face. In all the failures outlined in the foregoing, the emergency procedures adopted resulted in localized recuperator damage only; in no cases did the fire result

Fig. 4 Local fire damage on recuperator gas inlet face as a result of excess fuel during engine start (W4812)

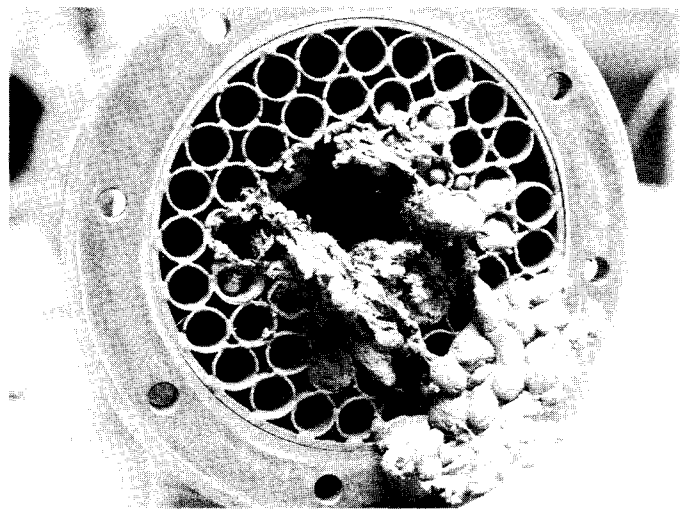
Fig. 7 Fire damage to tubular flow straightener
(67-6462)

During the initial run to calibrate the rig, the gas temperature was increased to about 2000 F, at which point a fire started in the upstream tubular flow straightener, causing severe damage as shown in Fig. 7. The rig had been constructed from Hastelloy material, but by mistake the tube bundle had been made from 410 stainless steel. Prior to replacing the flow straightener, this time made from 713 C, a test showed that the flame from the natural gas burner was actually extending downstream and must have actually been impinging on the tube bundle during the initial test. After modifications to the combustor hole pattern, it was found that the rig could be operated up to temperature of 2500 F without damage to the ducting, and with a representative flow distribution into the matrix.

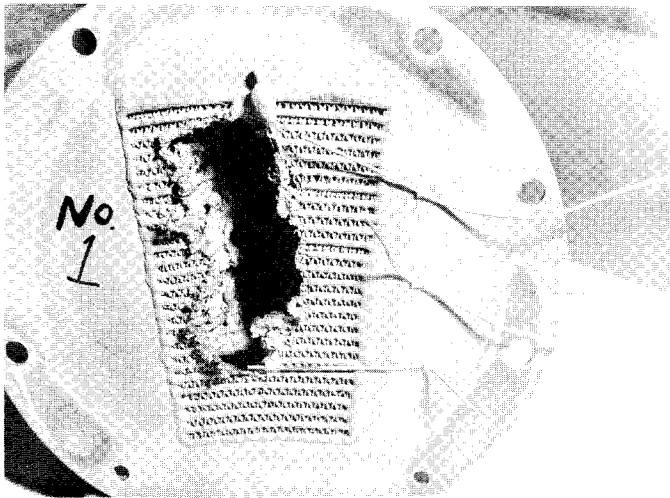
Fig. 8 Rear burn-out damage to first test module (67-7642)

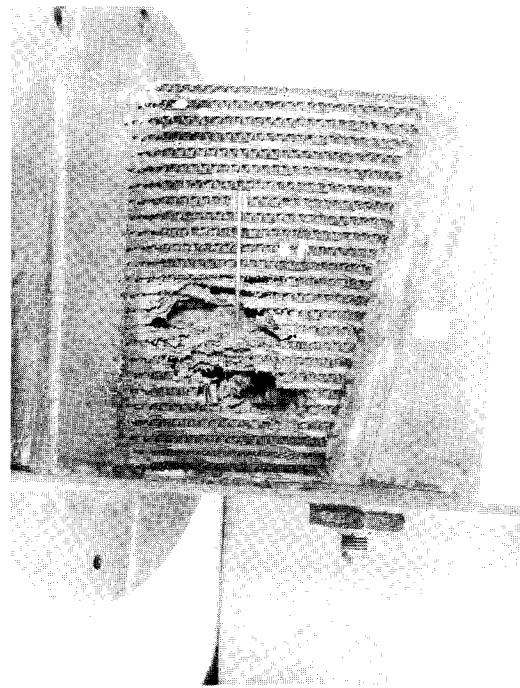
Fig. 9 Typical front burn-out damage with diesel fuel injection (68-0695)

(g) Effect of Diesel Fuel Impingement on the Matrix Face. To simulate over rich or poor combustion characteristics, a series of tests to find the effect of diesel fuel impingement on the hot matrix were carried out. An approximate computation was made of the amounts of fuel which could be present for cases such as an aborted start with a hot and cold recuperator and high-speed surge. With an intermittent, and continuous injection of diesel in varying amounts, it was found that core leakage did not significantly influence the matrix burning temperature. For certain fuel flows, it was noticed that at temperatures up to about 1350 F no burning or flame was experienced, but above 1400 F, a continuous flame could be seen, and under these conditions, the matrix seemed to act as a flame holder, and local hot spots could be seen on the rear face. Some modules were tested in which a pickling process had been carried out to remove all the oxide film from the plates and fins prior to installation in the rig. The temperatures at which these modules burned were not significantly different from the rest of the modules tested. The lowest temperature at which a module burned was 1550 F, and a view of a typical failure is shown in Fig.9. From the Sanborn temperature trace shown in Fig.10, it can be seen that burning of the fuel on the front face took place, and that a rather violent front burnout was experienced. With the design gas flow, the amount of diesel injected represented an air-to-fuel ratio in the order of 185, which is a little lean for expected combustion to give direct flame impingement onto the matrix. A module was thoroughly saturated with diesel oil and a light off to 1500 F resulted in a lot of smoke but no evidence of fire. This test simulated an engine cold start where poor combustion efficiency at low speeds had resulted in unburned fuel passing into the recuperator. Based on the module tests carried out, it can be concluded that one of the main matrix fire hazards is that associated with unburned fuel being deposited on a hot recuperator face. On the units which burned out the rear, little evidence was seen of oxidation of the leading edge of the fins at the inlet face. Without more scientific tests to study the actual mode of ignition, it would appear that the gas side corrugations act as flame holders and burning starts on the fin just inside the core within the laminar boundary layer, some fuel being carried over into the center of the matrix where combustion is completed. Proof of the fact that the metal combustion starts inside the core was evidenced on one module in which the fuel flow was cut and the CO₂ turned on after a few sparks had been observed, and a rapid increase in outlet temperature noted.

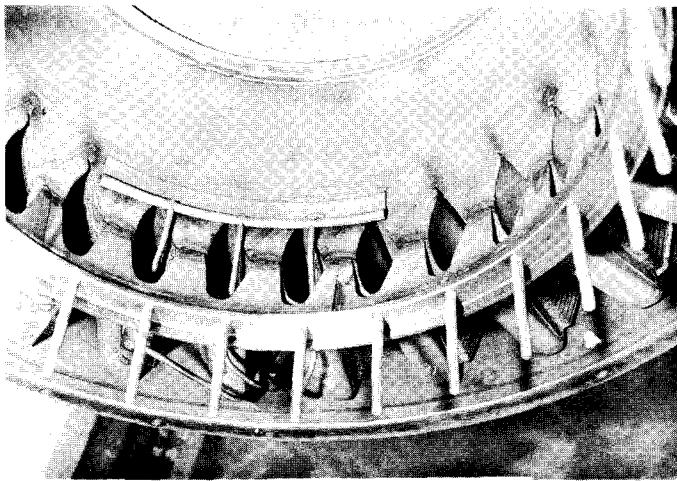
Fig.11 An example of an effective recuperator fuel drain system (67-6020)

To minimize the risk of fires in new gas turbine heat exchangers, during the engine development period, a combination of the following should be observed. A relay in the starter system should be provided to prevent repeated start attempts, until some of the excess fuel had drained

away or vaporized. A good drainage system, such that fuel cannot become trapped in the combustor, ducts, and matrix for all engine attitudes, should be incorporated. A typical fuel drain arrangement is shown in Fig.11 in which the recuperator drain valve remains open during the starting procedure until the compressor discharge pressure reaches about 5 lb/sq in. to insure that any excess fuel is bled overboard. As a further precaution after an aborted start, the system should be purged thoroughly by motoring the engine over on the starter for 20 to 30 sec. Rapid over temperature sensors should be installed, which would actuate a CO₂ injection system, hopefully to prevent an actual metal fire from starting, even though the excess fuel may ignite locally in the ducts. In Fig.12, a development engine is shown in which CO₂ injectors were installed in the compressor inlet ducting and exhaust ducting. In Appendix 3 the details of a CO₂ injection system to smother any fire that might start are described. Any visible fouling deposits should be removed by steam or water washing and by fitting nozzles at the recuperator gas inlet plane; this can be done during engine operation.

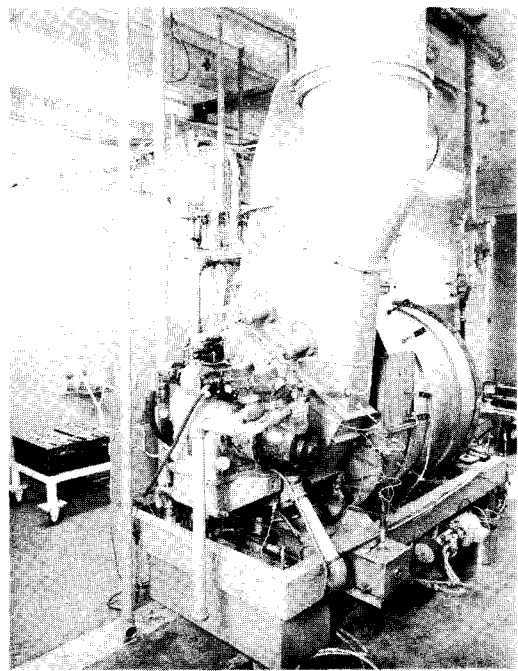
Fig.12 Development recuperative engine with CO₂ injectors installed in the ducting for over temperature protection (W5382)

As a safeguard, to minimize engine damage during the testing of a new heat-exchanger engine, it is desirable to install a system which would inject CO_2 into the compressor inlet in the advent of a fire starting in the heat exchanger. If a heat-exchanger fire occurred, an exhaust over temperature sensor would detect the sudden rise in gas temperature, actuate a control device which would cut the fuel flow, and inject CO_2 into the inlet as the engine coasted down. Initial discharge rates and system capacities for each particular application can be simply calculated by making the following assumptions.

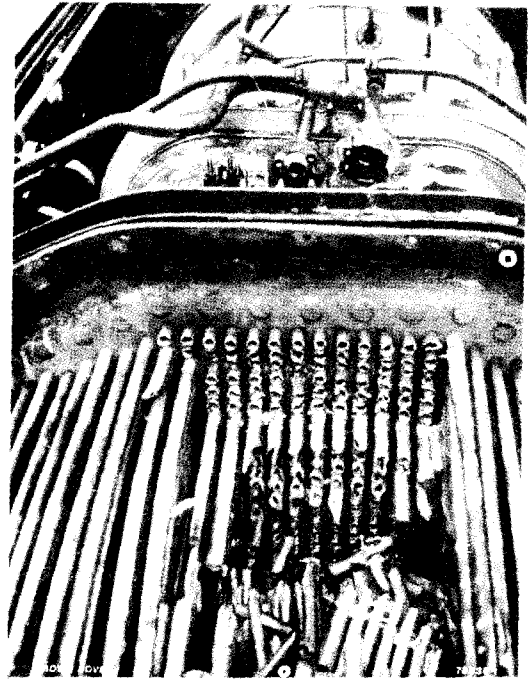
(a) A brief account of a fire experienced in an early gas turbine locomotive is discussed by Pfenninger (6). The fire occurred in a large cross-flow recuperator and details of the damage are shown in Fig.13. The Brown Boveri locomotive was being used by British Railways, and after an express run from London to Bristol, it was left standing in the yard, and, when two hours later the return journey should have started, a fire was discovered in the recuperator. A heavy fuel oil had been used in this turbine, and it was concluded that the fire was caused by soot deposits, probably ignited by a spark. The locomotive was back in working order very quickly as only the recuperator tube bundle had to be replaced. As a result of this accident, a recuperator washing procedure was regularly adhered to after a certain number of running hours, to remove any soot deposits and exclude recuperator fires with certainty.

Fig.13 Fire damage in gas turbine locomotive tubular recuperator (by courtesy Brown Boveri) (68-4742)

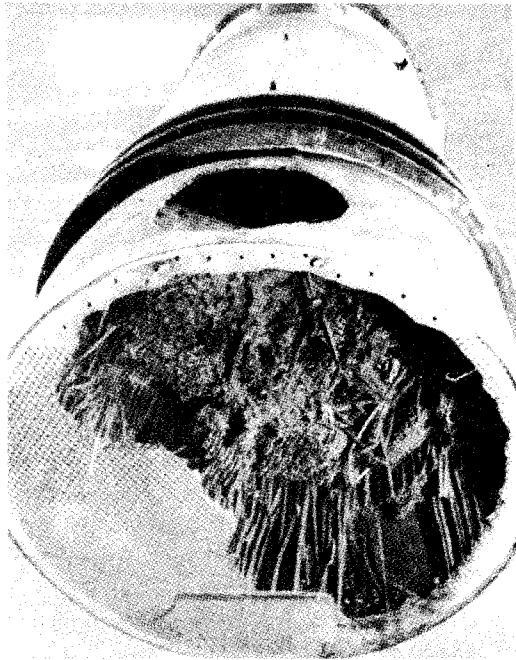
(b) Details of a recuperator fire in a 27,000-kw gas turbine plant are also reported by Pfenninger (6), and the resultant damage is shown in Fig.14. The gas turbine was fired using a

heavy fuel oil, and after an unsuccessful starting attempt, a fire was discovered in one of the large tubular recuperators two hours after the machine had come to rest. It was found that soot deposits had ignited, practically destroying three of the ten recuperators. The remaining seven recuperators exhibited only a slight soot coating. In five of the recuperators there had probably been no fire, while two seemed to have been on fire though no damage could be seen. With the installation of soot blowers, actuated regularly during operation, the danger of such recuperator fires was eliminated. After this experience, all the other gas turbine installations with recuperators were fitted with soot blowers.

Fig.14 Fire damage in 27,000-kw plant gas turbine tubular recuperator (by courtesy Brown Boveri) (68-4743)
