### **The San Francisco area earthquake of 1989 and implications for the greater Vancouver area**

Rainer, J. H.; Jablonski, A. M.; Law, K. T.; Allen, D. E.

*Canadian Journal of Civil Engineering*, 17, 5, pp. 798-812, 1990-10

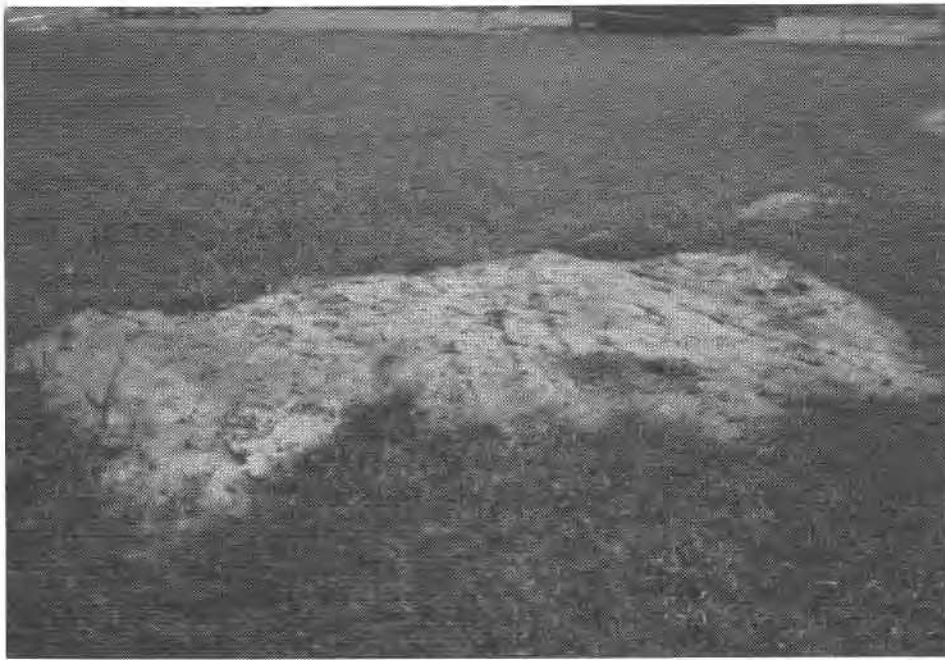
In the Marina District, liquefaction failure was widespread. More than 20 sand boils were noted by the visiting team (e.g., Fig. 4). Differential settlement, bearing capacity failure, pavement damage, and buckled sidewalks were observed (Fig. 5). Buried utilities, including gas lines, were broken and led to spectacular fires. The material that flowed to the surface was a dark grey uniform sand with occasional sea shells, indicating that the hydraulic fill placed on site liquefied during the earthquake.

FIG. 4. Sand boil, Marina District, San Francisco.

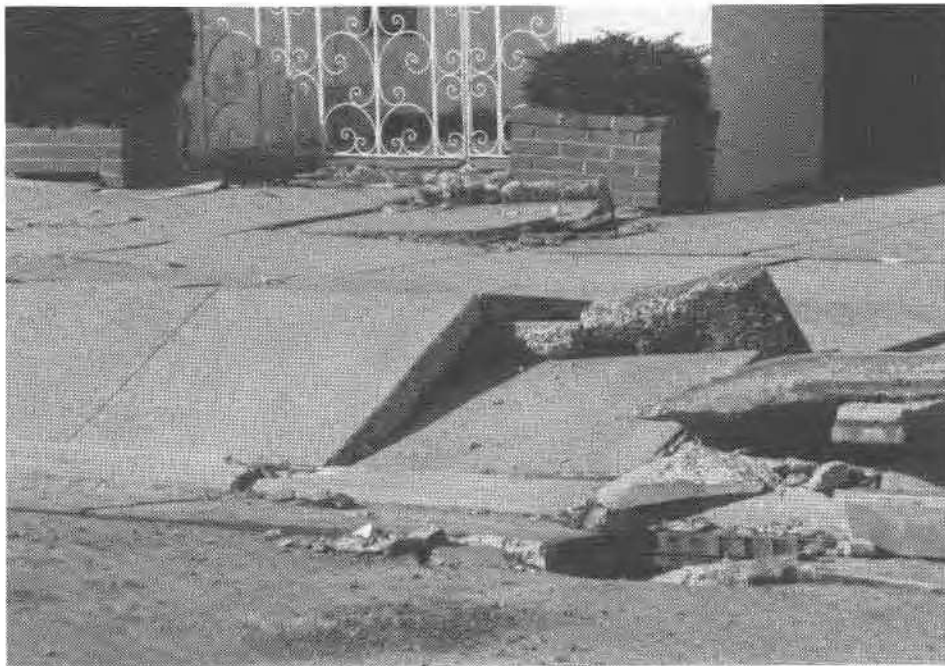
FIG. 5. Buckled pavement, Marina District, San Francisco.

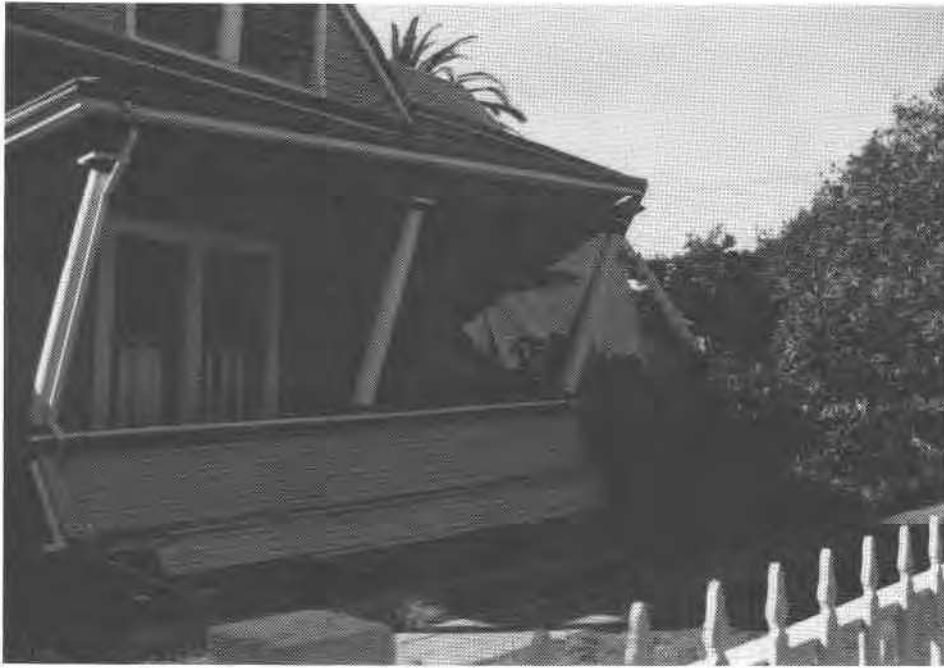
In the epicentral area (e.g., in Watsonville and in Los Gatos) "cripple" stud foundation walls (or "pony" walls) failed in many old wood frame houses, causing serious damage. Cripple stud walls form the connections between foundations (concrete or masonry) and the first-floor framing. They are usually short, but in some modern wooden houses could reach a height of close to one full storey. Improper bracing and

inadequate connections to the foundations as well as to the first-floor framing caused older buildings to be moved laterally off their foundations. The cripple walls were in some cases laying flat on their side (Fig. 6) where the acceleration reached  $0.40g$  for about 16 s. Nailing on some failed walls was sparser than required by the building code. Also, large openings (e.g., porches) collapsed owing to lack of lateral resistance and settlement of the foundations.

FIG. 6. Collapsed cripple wall and porch in a residence at Main Street in Los Gatos.

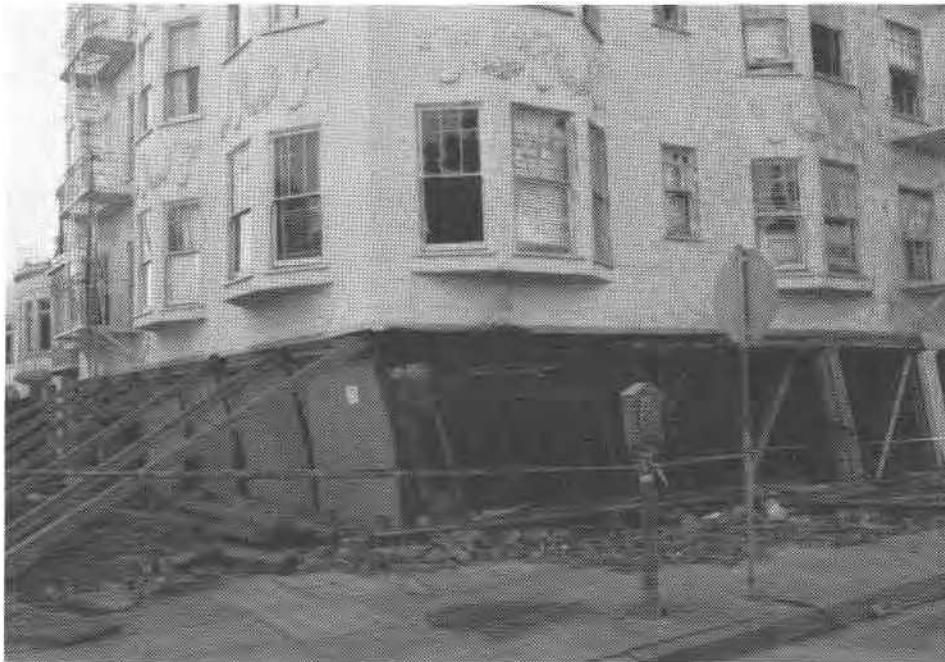
in the Presidio (U.S. Army Base), a few blocks northwest from the Marina District and 105 km from the epicentre. The wood frame houses, constructed in the early 1920s, consist of two main types: two- and three-storey townhouses with garages on the street level, and three- and four-storey apartment buildings also with street-level garages. There is almost no separation between buildings. Many older three- and four-storey apartment houses situated at the street corners were badly damaged (Fig. 7). Some spectacular collapses of the entire building occurred when the one or two storeys were

completely leveled. The garage floors had acted as a "soft storey" that appeared to have only limited bracing or none at all, or had sheathed walls constructed with boards nailed to posts. External stucco, brick, or fake stone walls were severely damaged and some collapsed. Many two-storey townhouses within the blocks also sustained some damage over garage doors and in walls. Entire blocks of buildings apparently responded together during the earthquake.

FIG. 7. Near collapse of a four-storey wood frame apartment building at the corner of Beach and Broderick streets, Marina District, San Francisco.

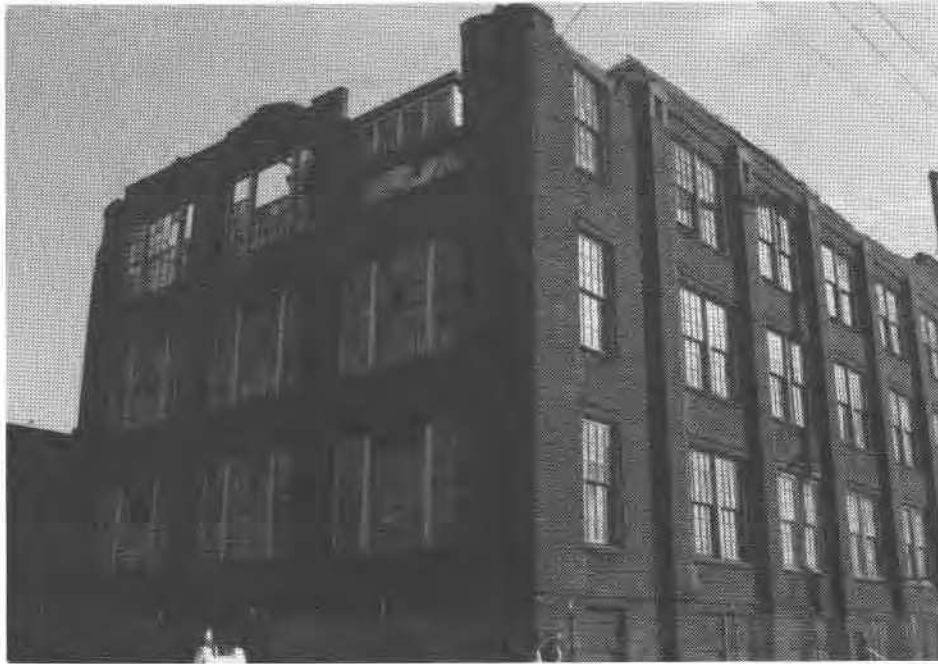
Unreinforced masonry buildings near the epicentre built at the turn of this century suffered severe damage or collapsed (Figs. 8 and 9). Out-of-plane failures of upper portions of

walls and of parapets were common. In some cases the severe shaking at the roof level resulted in separation of the roof from the walls. The result was not only the collapse of upper portions of walls but also of the roof structure, and this inflicted heavy damage to lower floors. Other old unreinforced masonry buildings in Oakland were heavily damaged.

FIG. 8. Collapsed roof caused damage to the lower floors in the unreinforced masonry building on Campbell Street in Oakland.

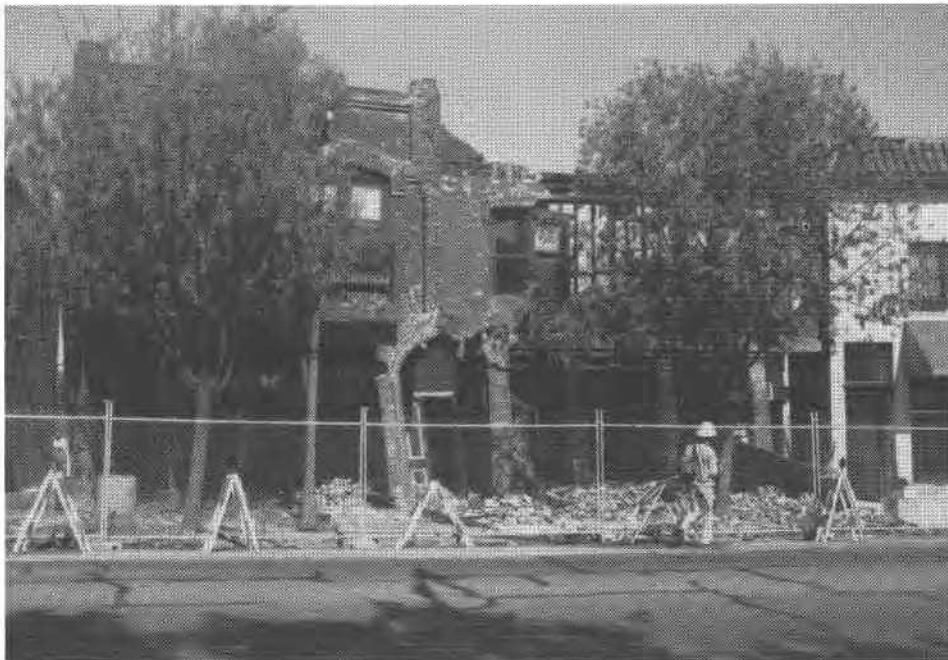
FIG. 9. Major damage to unreinforced masonry wall building, 39 Main Street, Los Gatos.
